INVESTIGATION REPORT

VENT COLLECTION SYSTEM EXPLOSION

TECHNIC INC.

REPORT NO. 2003-08-I-RI

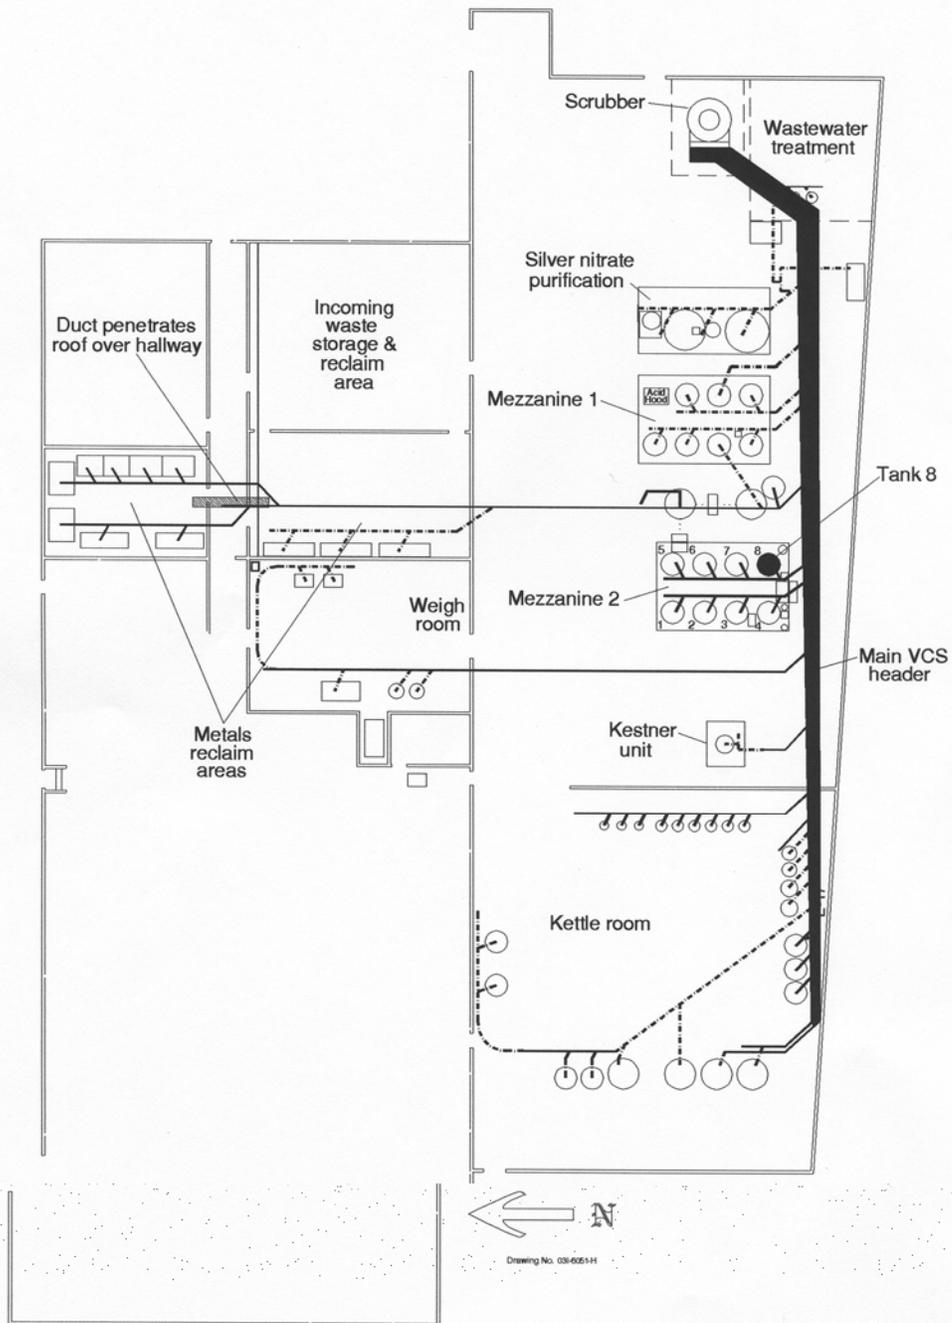
Figure 3. Vent collection system as of February 7, 2003 (modifications to original design are shown by dashed lines).

From April 2001 until the date of the explosion, additional kettles were added in the kettle room, and the baghouse in the weigh room was disconnected in an attempt to increase the duct capture efficiency of the packaging equipment. Discussions with the loss prevention carrier revealed that none of these modifications were submitted to the carrier for review.

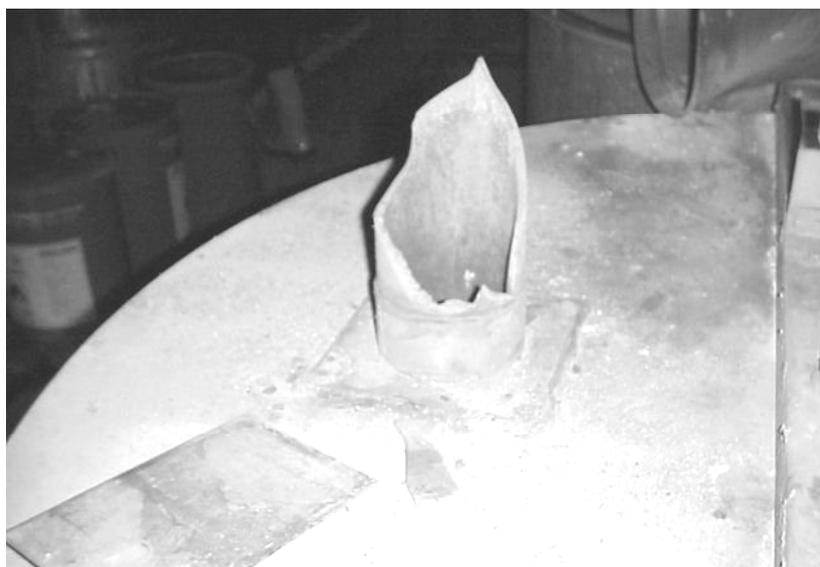
The explosion likely originated at the vertical exhaust duct connected to tank 8 on mezzanine 2 (Figures 1 and 3). This section of duct was shattered into small fragments that dispersed in all directions. Figures 4 through 8 show the extent of the explosion and fire damage to the vent collection system and its connected equipment. Table 1 outlines the sequence of events in the explosion and fire.

Figure 4. Sharp fracture of 4-inch exhaust duct above tank 8.

Location	Damage	Discussion
Mezzanine 2	4-inch-dia vertical duct connected to tank 8 fractured and shattered (Figure 4)	Explosion originated inside exhaust duct, initiated by hammer blow
Mezzanine 2	10-inch-dia overhead horizontal branch duct connecting tanks 5, 6, and 7 (Figure 5) had a large crack at main header connection and sharp fractures where vertical ducts were attached	Pressure from explosion traveled against airflow
Mezzanine 2	4-inch vertical ducts connected to tanks 5, 6, and 7 blown off overhead horizontal branch duct	Damage limited to western overhead branch duct
Area between mezzanines 2 and 1	4-inch vertical duct connected to silver cyanide reactor blown off where it connected to horizontal branch header	Pressure from explosion traveled against airflow
Area between mezzanines 2 and 1	Hole blown out of 90-degree elbow connecting 4-inch vertical duct to silver cyanide centrifuge	Pressure from explosion traveled against airflow

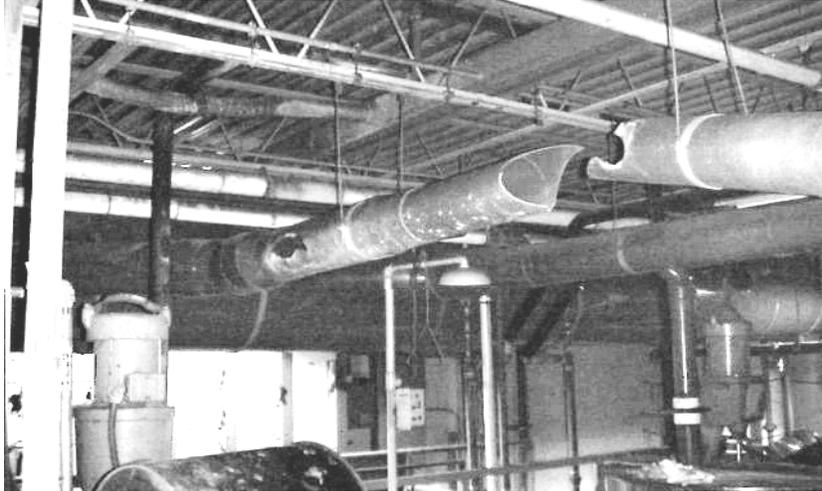
Figure 5. Large fracture of 10-inch branch duct above mezzanine 2 production area.

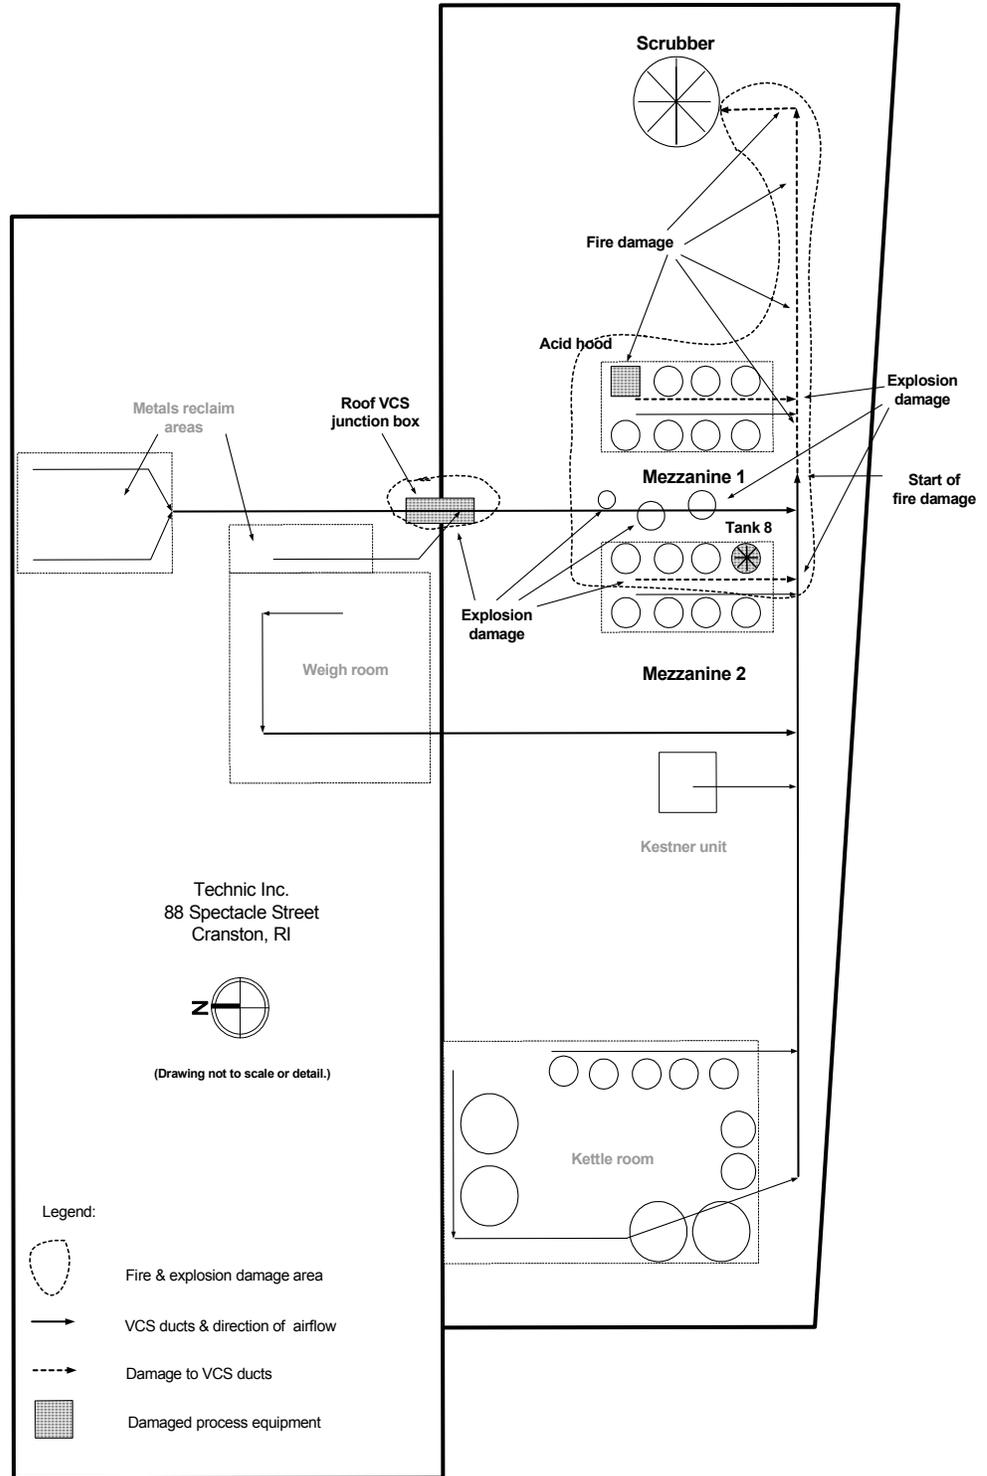
Figure 6. Depiction of explosion and fire damage, February 7, 2003.

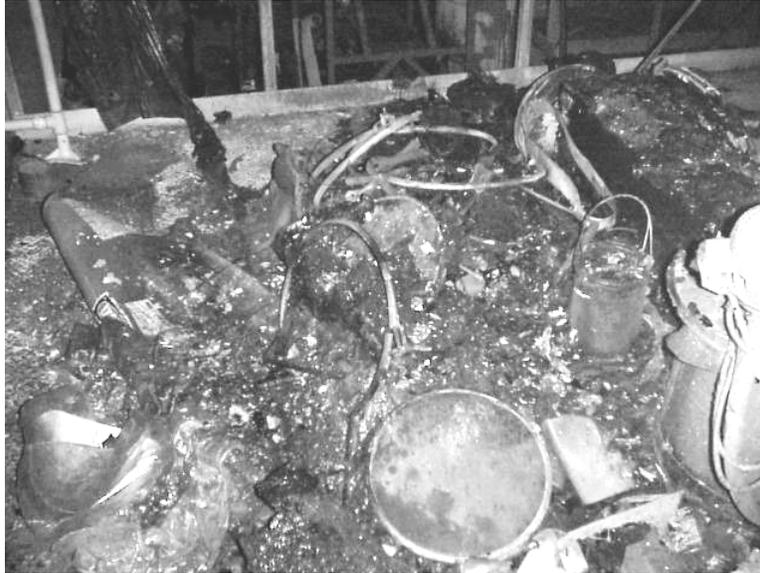
Figure 7. Remains of acid hood on mezzanine 1.

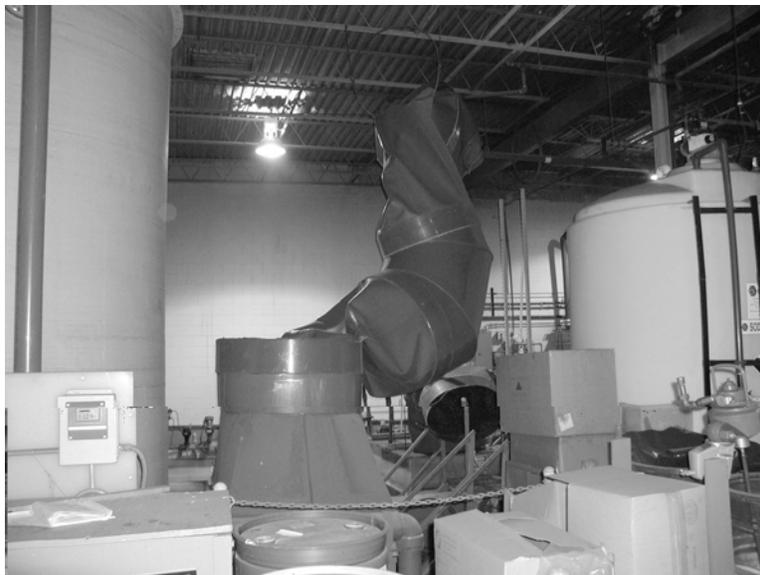
Figure 8. Collapsed 36-inch-diameter main header at scrubber along east wall.

Above northernmost end of mezzanine 1	Firefighters opened this section of roof to extinguish fire	Radiant heat from burning acid hood charred building roof
Main header from mezzanine 1 to scrubber	50 feet of duct melted and collapsed (Figure 8); hazmat team opened section of duct to extinguish smoldering fire	Duct contained large amount of deposited combustible material that continued to smolder and flare

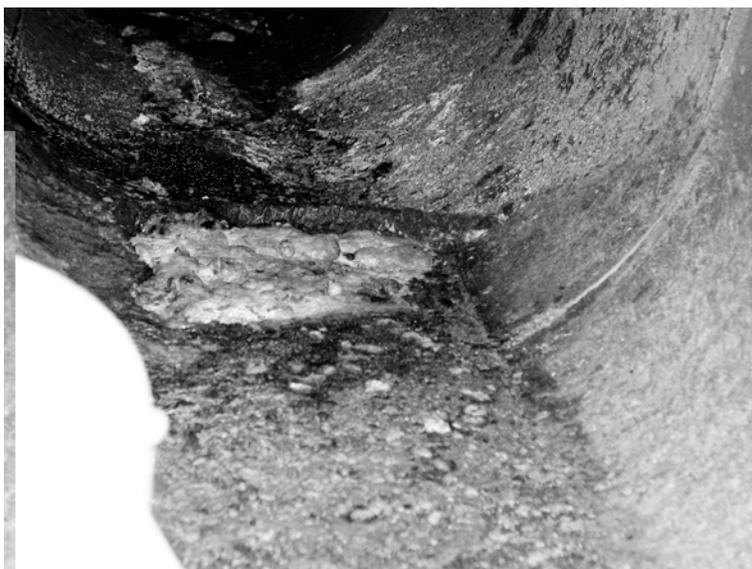
CSB examined all of the process areas connected to the vent collection system and the chemicals used in each area. Through years of accumulation of solids (Figure 10) and mixing, many materials could have resulted in violent reactions such as the one that caused this incident. CSB evaluated only a sample of

Figure 10. Solid deposits in main header duct.

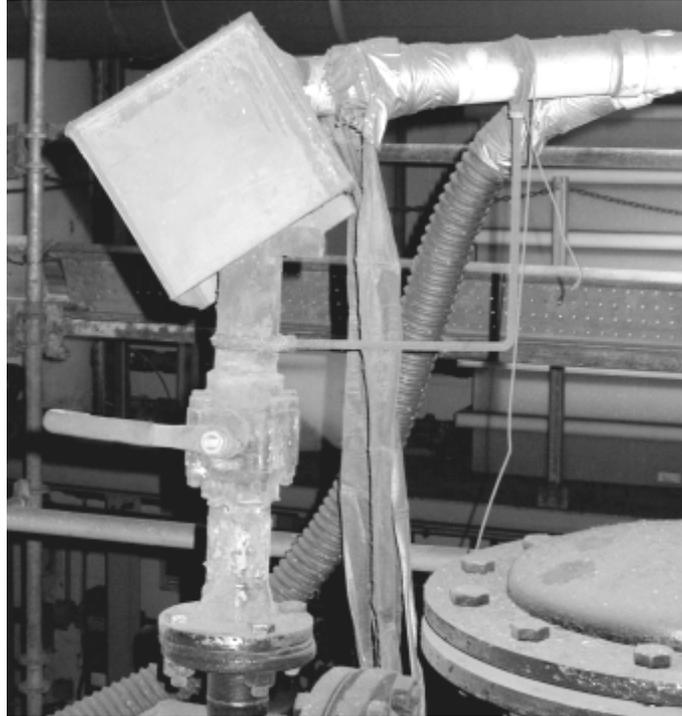
- Kestner unit: Interviews with employees revealed that during occasional process upsets, fumes from this distillation vessel overwhelmed the vent collection system and vented into the plant. In-house maintenance personnel connected the Kestner unit to the vent collection system as shown in Figure A-1. This unit was in full operation on the day of the explosion.
- Mezzanine 1: Employees stated that on occasion dark red smoke overwhelmed the vent collection system and escaped through the loose-fitting tank access door into the plant (Figure A-2). On the day of the explosion, three batches of silver nitrate were being held on mezzanine 1 for future use, but none were being processed.

Figure A-1. Kestner unit exhaust ventilation.

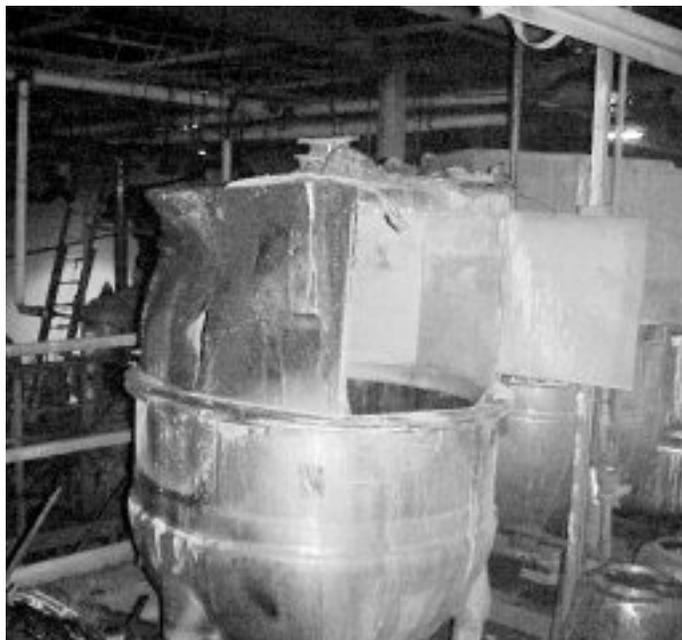
Figure A-2. Silver nitrate reactor on mezzanine 1 with open tank door (following explosion and fire).
