U.S. Chemical Safety and Hazard Investigation Board

Tesoro Martinez Refinery

Process Safety Culture Case Study

February 12, 2014 and March 10, 2014 Sulfuric Acid Release Incidents

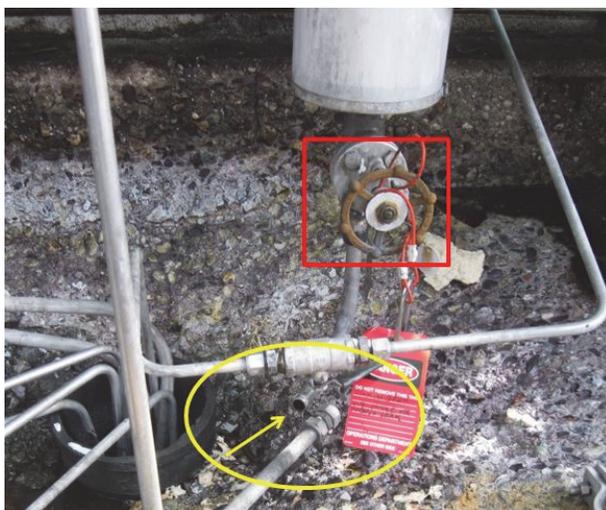
The incident occurred when the operators opened a valve (Figure 2) to return an acid sampling system back to service (Figure 3). Shortly after fully opening this valve, the tubing directly downstream of the valve came apart at the connector, spraying the two operators with acid. The operators immediately went to a nearby safety shower. Until responders were able to isolate the system, acid continued to spray out of the failed tubing for over two hours from a nearly 100,000-gallon acid settler²¹ that was operating below 100 pounds per square inch gauge (psig) and near the ambient temperature of approximately 50 degrees Fahrenheit (°F). This resulted in the release of approximately 84,000 pounds of sulfuric acid.

Figure 2. Photo showing the tubing that separated (yellow oval) after the valve (red square) was opened in order to return the sample system back to service following maintenance. Two workers were injured from this acid release incident on February 12, 2014. This loss of containment from the open-ended tubing released 84,000 pounds of sulfuric acid.

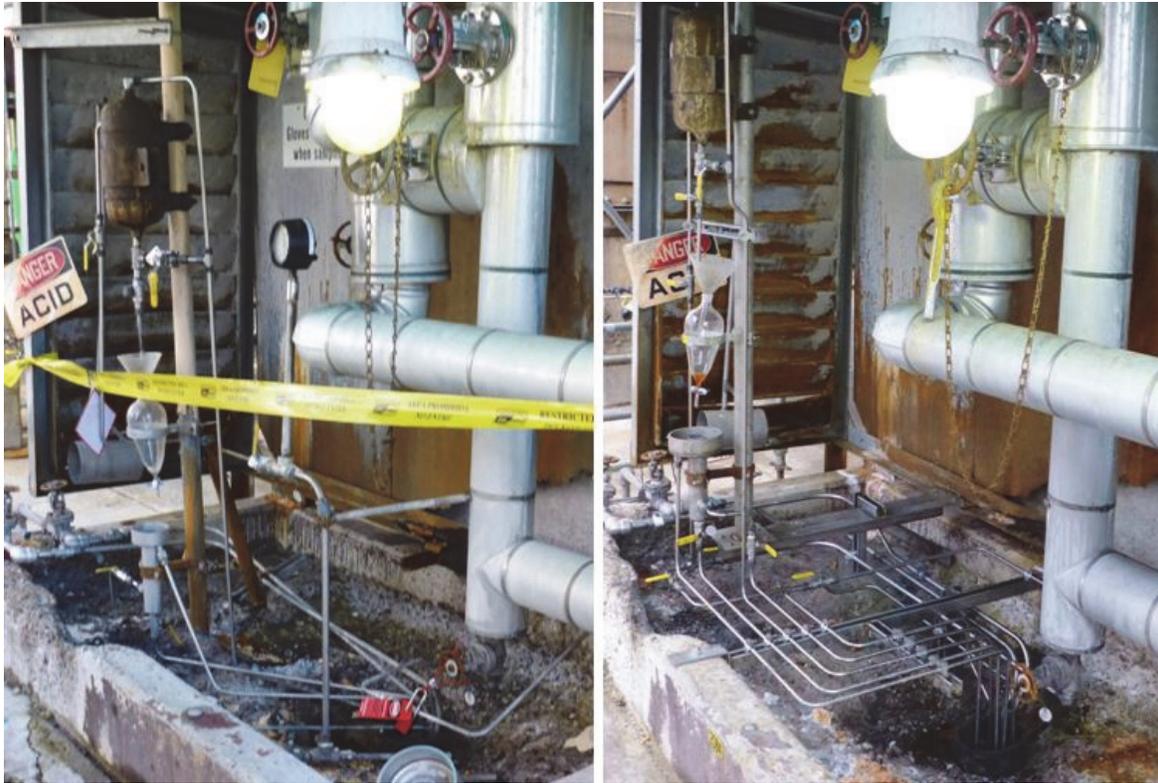
Figure 3. Photo showing the sulfuric acid sampling station at the Tesoro Martinez refinery. The photo on the left shows the sample station just after the February 12, 2014 incident and the photo on the right shows the sample station after repairs were made and the alkylation unit was again operating. Workers informed the CSB that the concrete containment area, clearly visible in the photos above, had badly deteriorated from routine exposure to sulfuric acid.

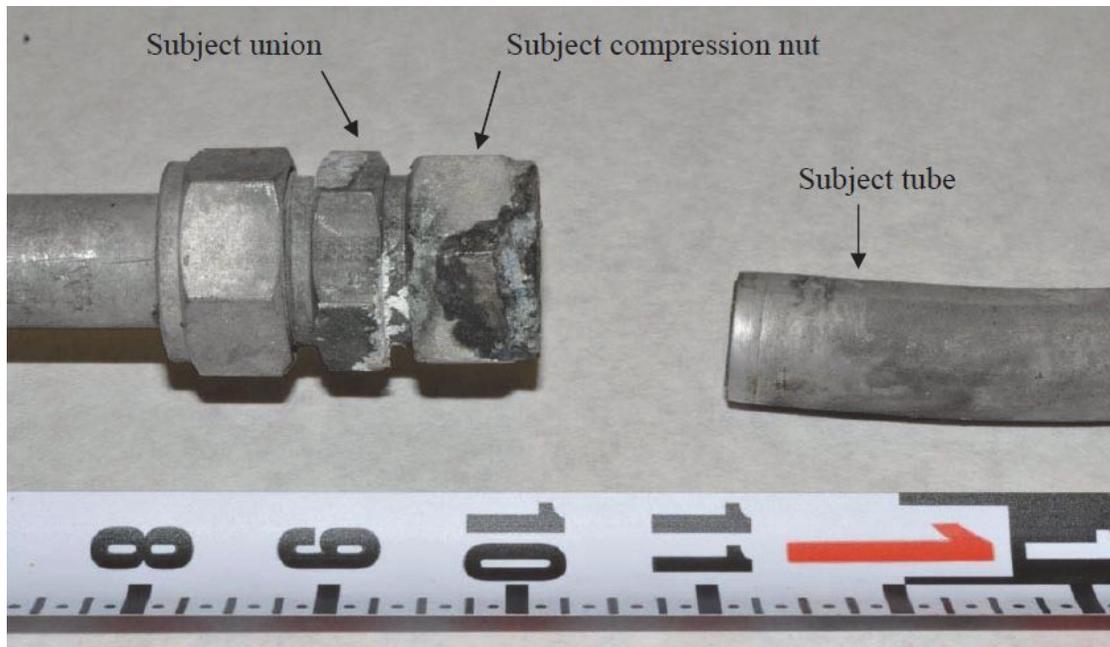
2014.²⁹ The report concluded that the sulfuric acid release on February 12, 2014 resulted from the failure of a ¾-inch diameter stainless steel tubing connector that came apart due to insufficient tightening between a tube and a compression joint at the sulfuric acid sampling station.

Figure 4. Photo of the tubing connection that failed and resulted in the February 12, 2014 incident. This photo is from the CSB's technical evaluation report that determined the compression joint was insufficiently tightened.

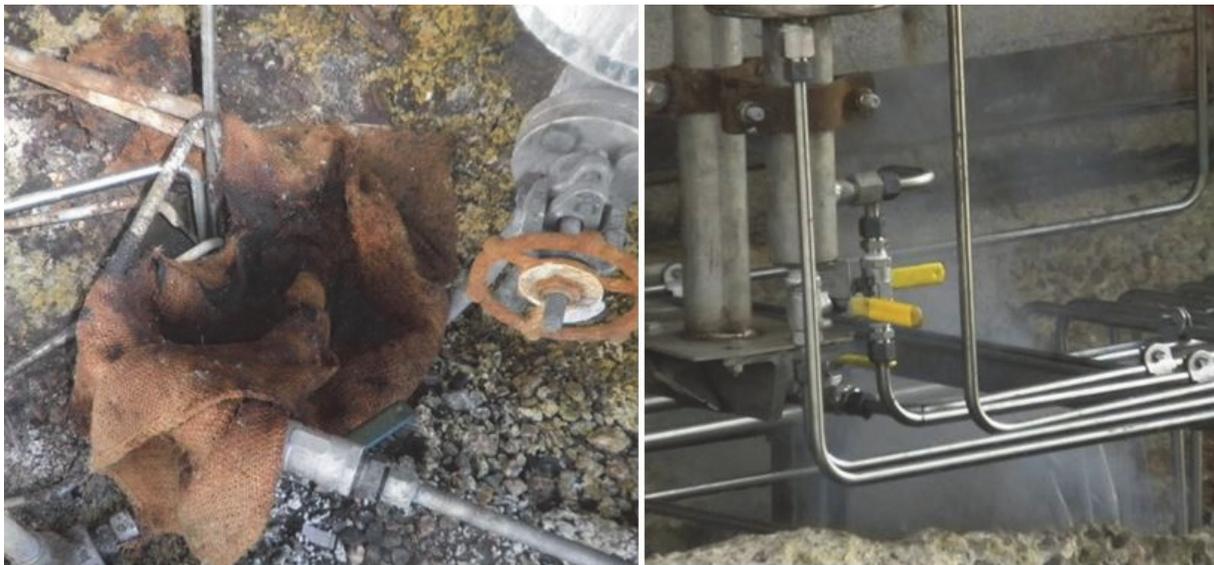
sampling. Additionally, due to the dangers this sampling station presented, the Tesoro Martinez refinery's acid sampling procedure required operators to evacuate nearby workers from the area prior to initiating the sampling procedure. Rather than reengineering the process to eliminate the vapor cloud, Tesoro placed burlap bags around the process sewer drain opening to attempt to reduce the size of the vapor cloud generated by the sampling process (Figure 5).

Figure 5. The photo on the left shows a burlap bag covering the process sewer drain at one of the Tesoro Martinez refinery sulfuric acid sample stations. The photo on the right shows the white vapor cloud released from the process sewer drain when Tesoro operators conduct the procedure to sample the sulfuric acid.

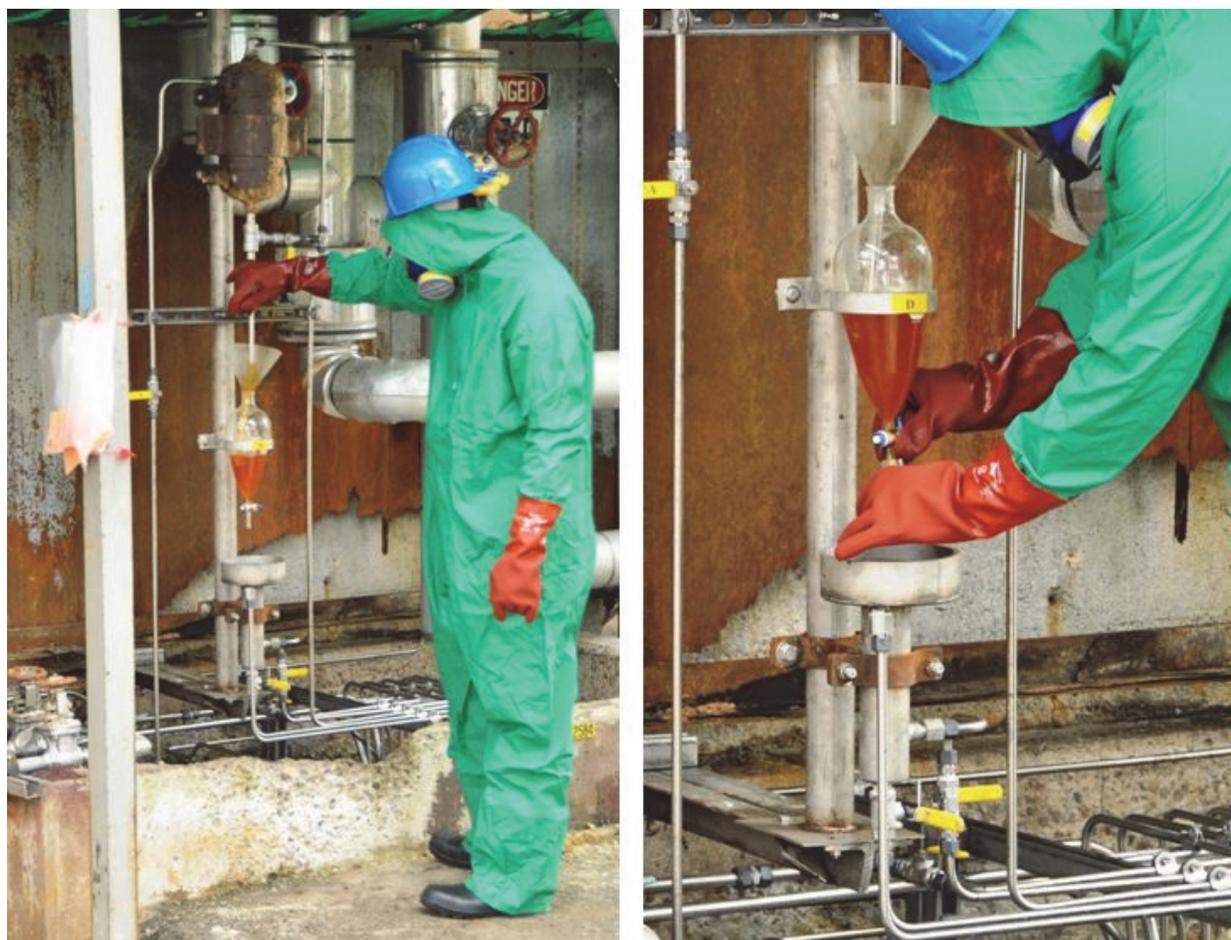
Figure 7. Photos of an operator at the Tesoro Martinez refinery taking a sulfuric acid sample. These photos were taken following the February 12, 2014 incident with the new PPE requirements in place. Tesoro’s sulfuric acid sampling system requires two separate one-hour waiting periods to allow hydrocarbons to vent to the atmosphere. In addition to potential liquid acid exposure, the sampling process exposes the operator to hydrocarbon vapor, and sulfuric acid vapor. Following the incident, Tesoro upgraded the PPE requirements to include a full-face respirator and a full-body acid suit.

After the February 12, 2014 incident, Tesoro upgraded the PPE requirements during acid sampling to include a full acid suit and air-purifying respirator (Figure 7).

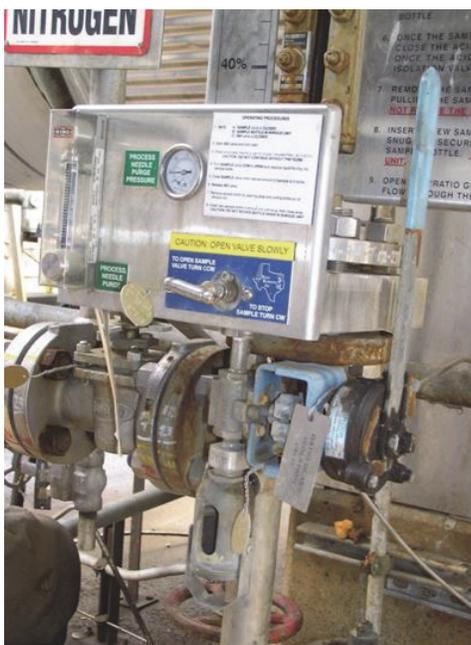
Figure 8. Photo showing one of the upgraded sample stations that Tesoro installed to reduce operator exposure to acid during sampling. Tesoro never resolved the reliability issues with these sample stations and the sample stations were taken out of service. As a result, they were not in use at the time of the February 12, 2014 incident.

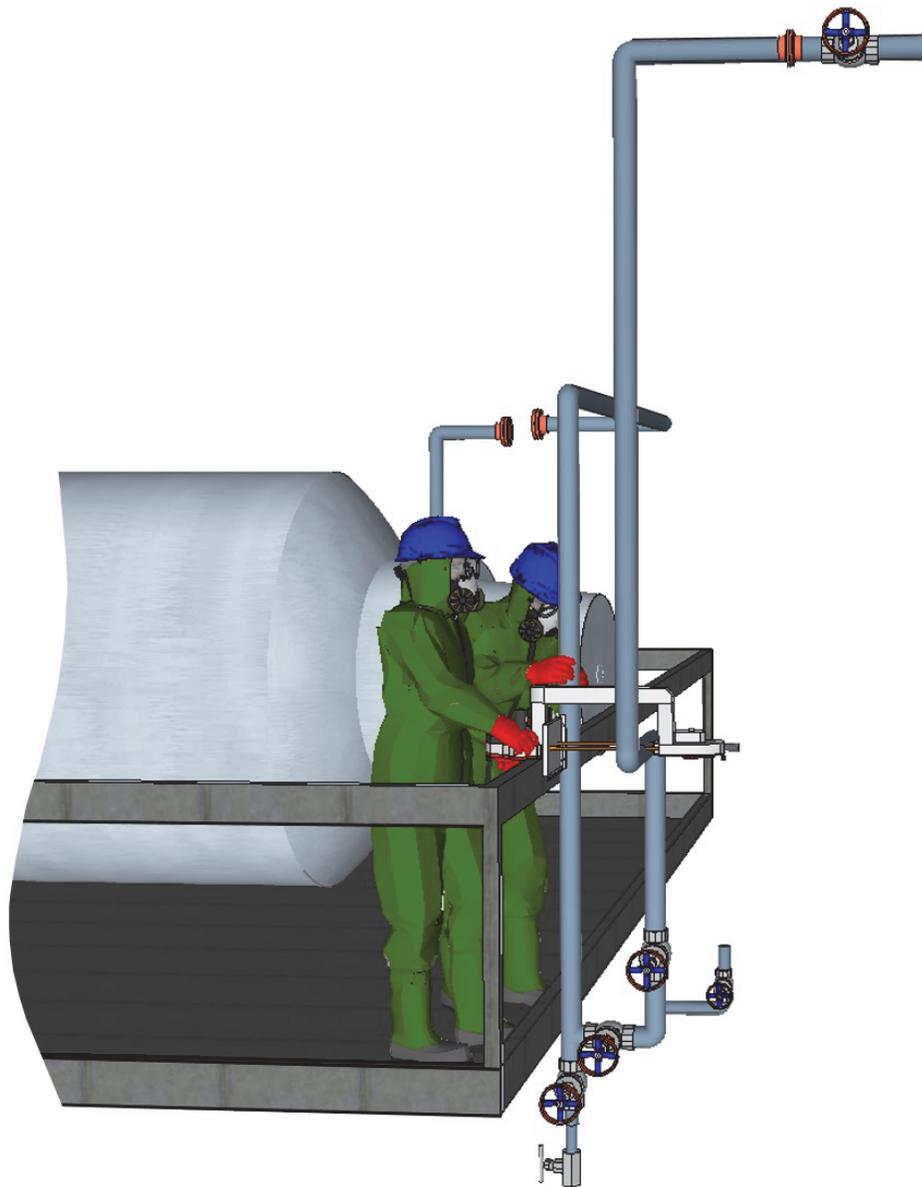
Figure 12. CSB depiction of the workers cutting the 1-inch butane piping just prior to the sulfuric acid spray incident on March 10, 2014.

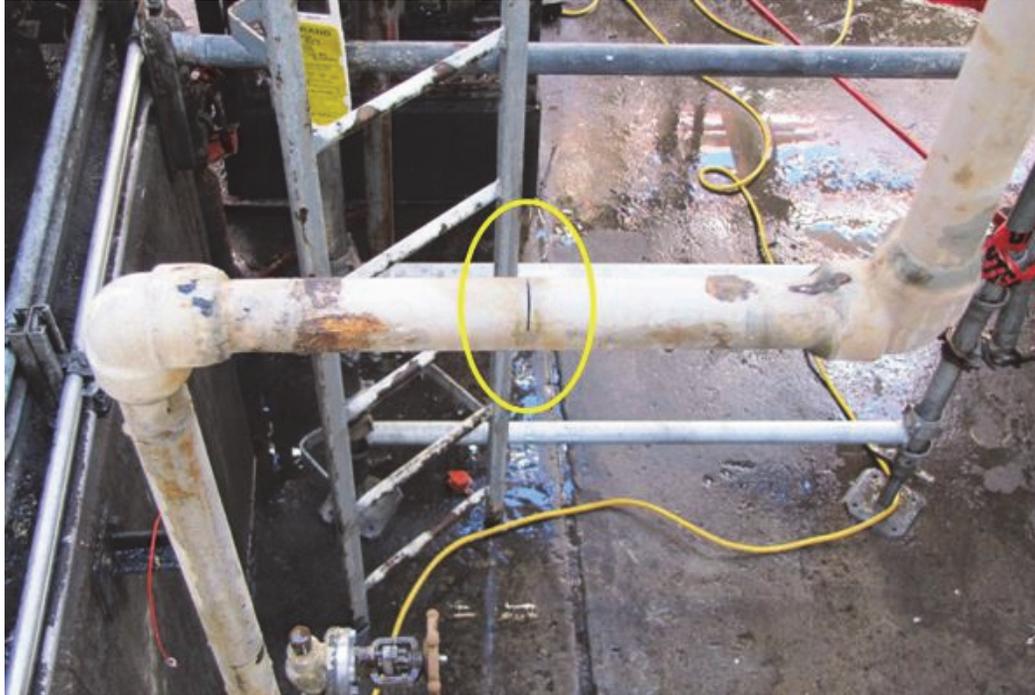
Figure 13. Photo of piping involved with the March 10, 2014 incident. The yellow oval shows the cut the workers made using a band saw that resulted in the acid release. Figure 14 also shows the location of this piping.

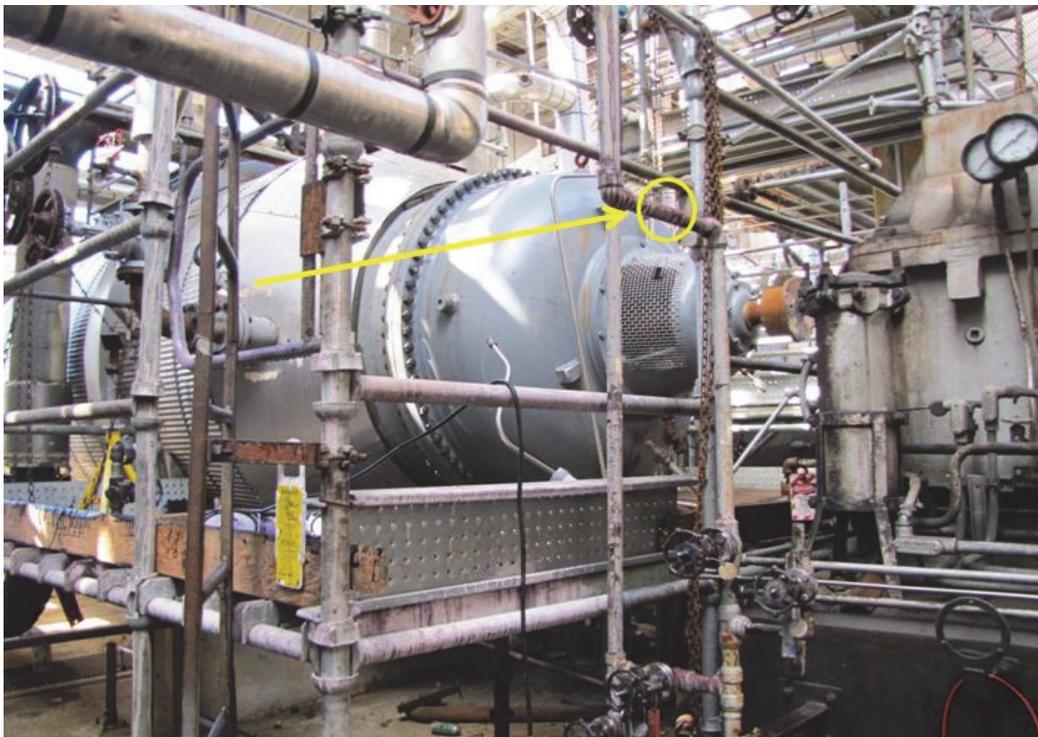
Figure 14. Photo of location of the March 10, 2014 incident. As depicted in Figure 12, two workers were located on this temporary scaffold platform and were cutting the piping (yellow circle) with a portable band saw.

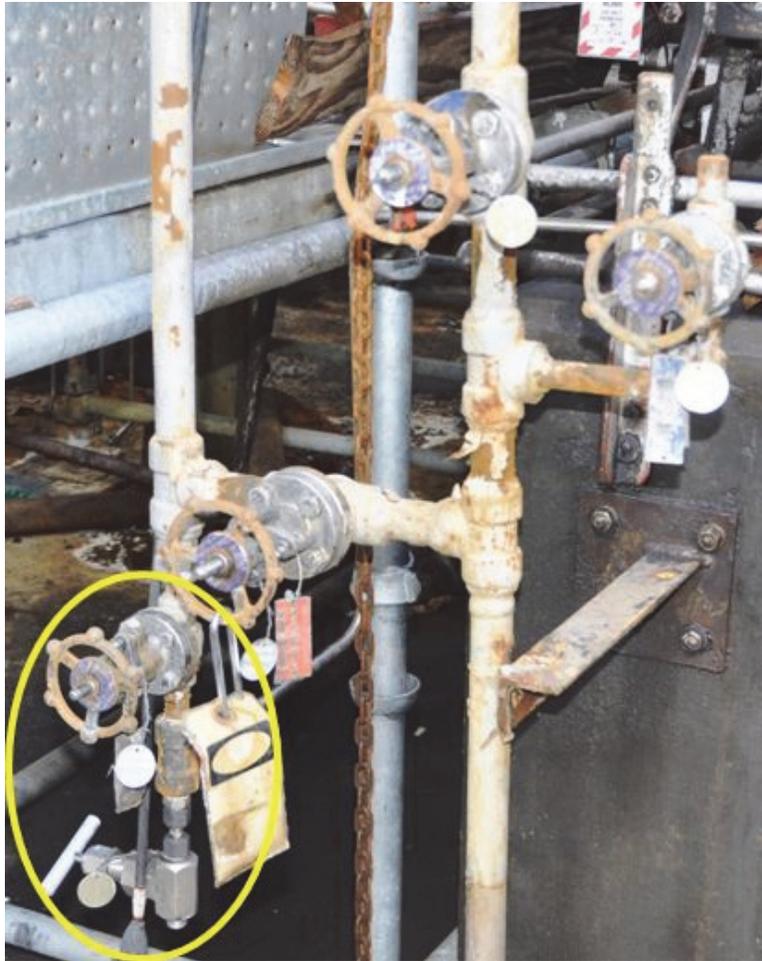
A Tesoro alkylation unit operator stated to the CSB that on the day of the incident he understood (correctly) that the “line had already been opened once before.” In addition, the system was blinded on one end and locked closed on the other, giving him no reason to believe the pipe was not already empty and safe for workers to cut and remove. Regardless, prior to issuing the hot work permit for the job, the operator opened a drain valve associated with the piping system and he observed what appeared to be a “wisp” of butane vapor come out of the valve. The operator then used his gas meter to perform an atmospheric check for additional hydrocarbon flow from the drain valve, and found none. The operator explained: “So to me that meant that the line, in my mind, was cleared because I didn’t have a pressure gauge on that line to determine if there was in fact any pressure on there.” The contract workers who were present to cut and remove the piping also both knew the pipe was worked on before, had already been disconnected from the alkylation reactor with a blind flange installed, and saw that the drain valve was opened with no hydrocarbons detected on the operator’s gas meter. These factors reinforced to them the appearance of a safe condition for performing the work. After the incident, however, it was determined that the drain piping was internally plugged, preventing flow through the open drain valves, and as a result it provided the operator and contract workers with a false sense of security that the piping had been depressurized and drained of its contents (Figure 16).

Figure 16. Photo of drain piping and valves. Evaluation of this equipment after the incident identified plugging in these piping components that prevented liquid from freely draining through the open valves.

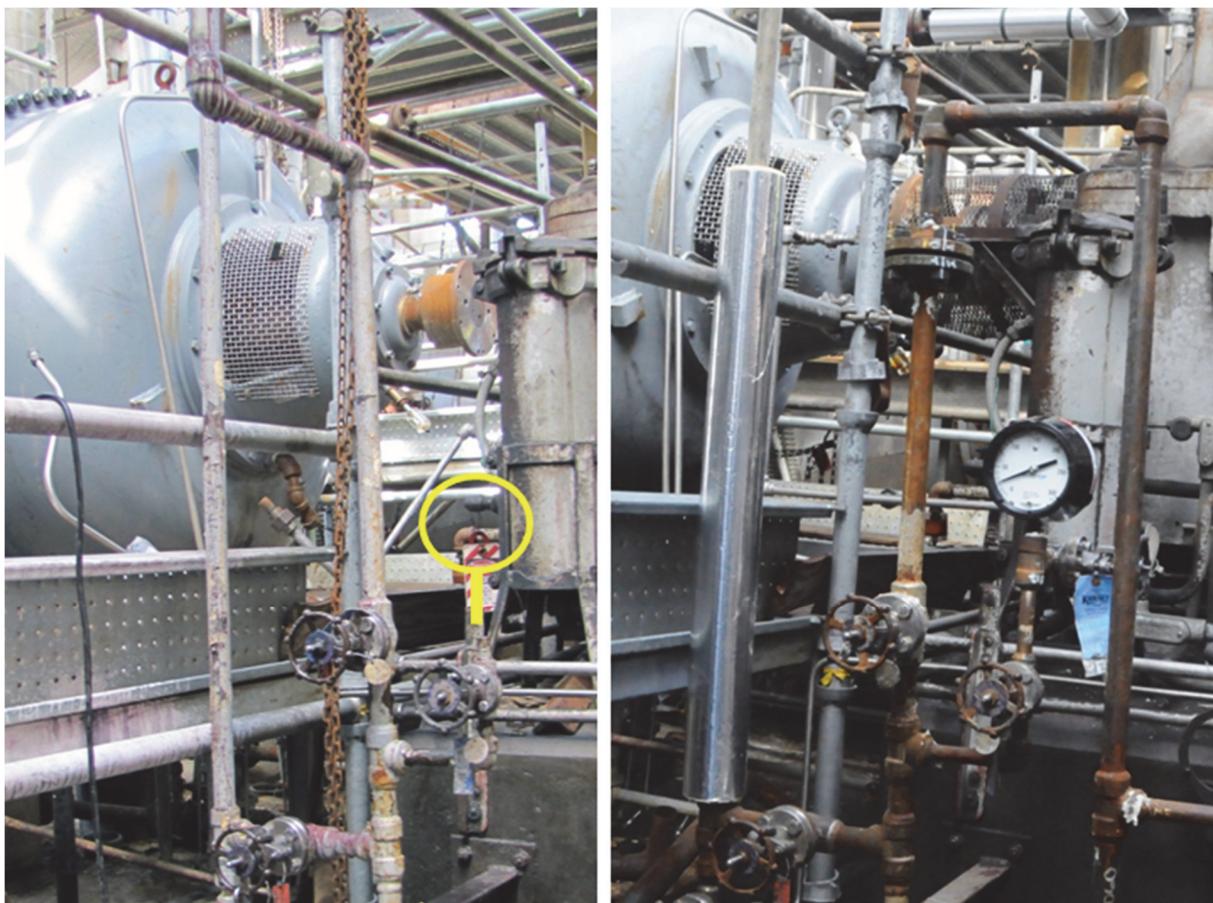
As a result, the operator and contractors did not take any extra steps to ascertain whether the piping was properly drained and depressurized. All available evidence suggested that the pipe was properly drained and depressurized. Combined with the fact that the pressure indicator on this piping system was not available to alert the workers to hazardous conditions (because the pressure indicator had been previously removed and replaced with a plug as shown in Figure 17), the operator had no indication of the dangerous condition – that a pressurized inventory of concentrated (94 weight percent) sulfuric acid remained in the piping.⁴²

Figure 17. Photo of piping involved with the March 10, 2014 incident (left photo). The photo on the right shows the piping after repairs were made and the pressure indicator was reinstalled. Note the yellow circle in the photo on the left that shows the location where a pressure indicator was supposed to be located, but had been removed. Had this pressure indicator been available it could have alerted workers that dangerous pressure remained in the piping system.

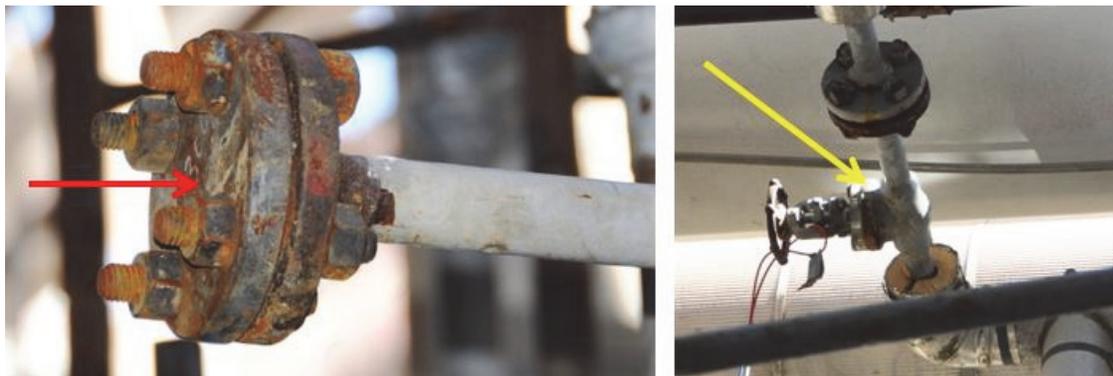
In December 2013, workers disconnected the butane piping involved in the incident from the alkylation reactor, and then installed a blind flange on the reactor side in accordance with Tesoro standards and good industry practice, as shown in Figure 18. On the butane supply side, however, Tesoro relied on a single isolation valve, rather than disconnecting and/or blinding, contrary to corporate standards. The CSB learned that this was a common practice at the Tesoro Martinez refinery’s alkylation unit during hot work that involved “low energy” tools that met the site’s concept of “low risk.” The Tesoro Martinez policy defines “high risk” work as jobs that involve working on high-pressure systems, high hydrogen sulfide, sulfur dioxide, ammonia, and process streams above the auto ignition temperature. The policy provided no actual definition of “low risk.” The workers commonly understood that “low risk” applied to anything not defined as “high risk.” The workers considered the task performed on March 10, 2014, to be “low risk” work with a “low energy” cutting tool.

Figure 18. Photo of piping isolation at time of March 10, 2014 incident. The photo on the left shows the piping isolation on the reactor side. A blind flange (red arrow) was installed in December 2013 when the piping was disconnected from the alkylation reactor. The photo on the right (yellow arrow) shows the single valve used to isolate butane from the piping workers were cutting.

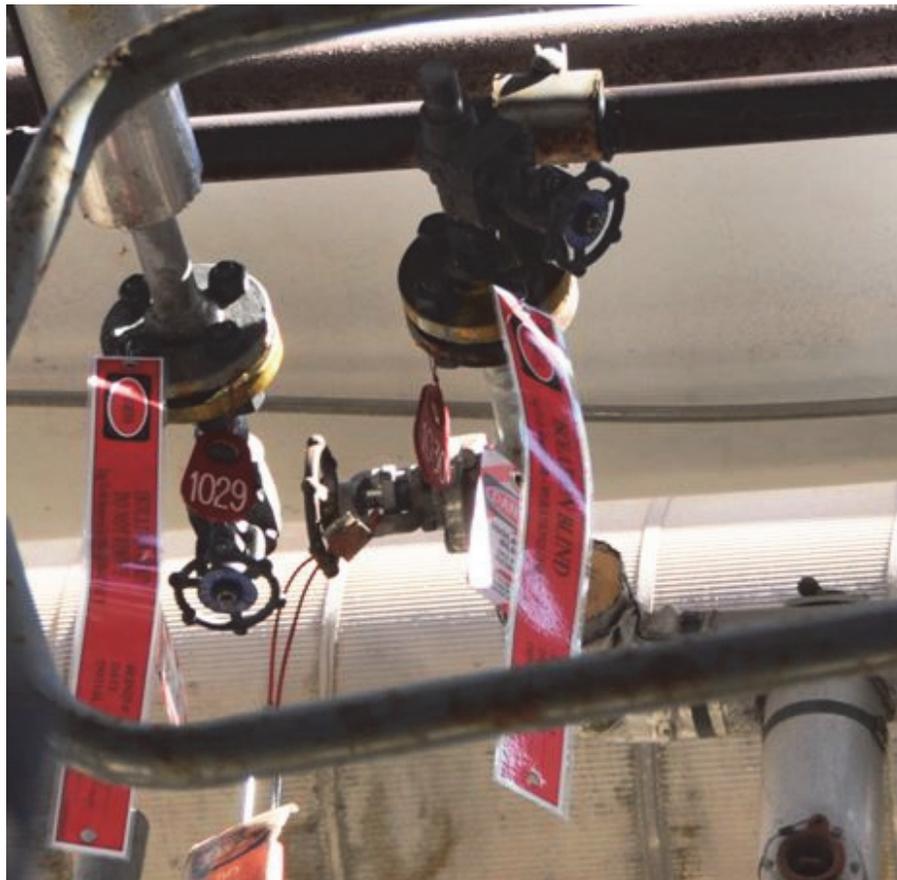
Figure 19. Photo of post-incident isolation of liquid butane supply piping to alkylation reactor. This photo shows the same piping shown in the right photo of Figure 18. Two days after the March incident, Tesoro modified the liquid butane isolation to match the API recommend practice, Tesoro’s corporate standards requirement, and Tesoro Martinez procedure recommendations by disconnecting and installing isolation flanges on each end of the isolated piping.

Two days after the March 2014 incident, Tesoro modified the isolation for the liquid butane piping from using single valve isolation to blinding, a more robust isolation approach that followed the best practice methods detailed in refinery procedures, corporate standards, and industry standards (Figure 19). Had Tesoro followed its own standards and recommended practices during the initial December 2013 isolation of this butane piping system, the March 10, 2014 incident could have been prevented. Piping should have been flushed to remove the acid, drained to ensure no residual liquid, and blinded to eliminate the potential for a slow leaking valve to pressure the piping system.
