U.S. CHEMICAL SAFETY AND HAZARD INVESTIGATION BOARD

INVESTIGATION REPORT

PETROLEUM PRODUCTS FACILITY INCIDENT

THIRD COAST INDUSTRIES

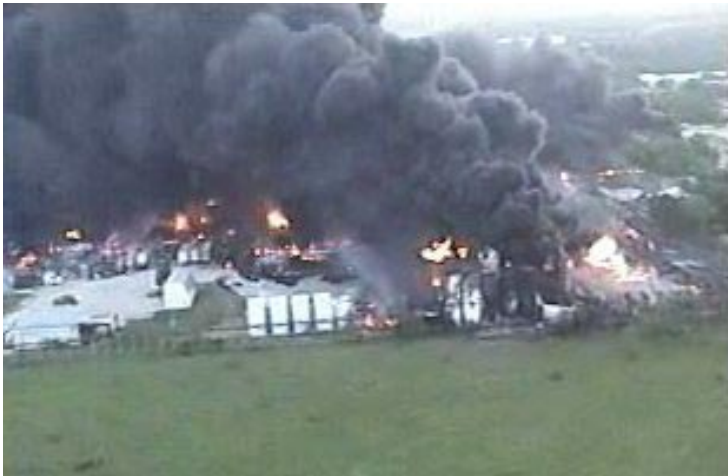
Figure 5. Fire at approximately 7 am, May 1, 2002.

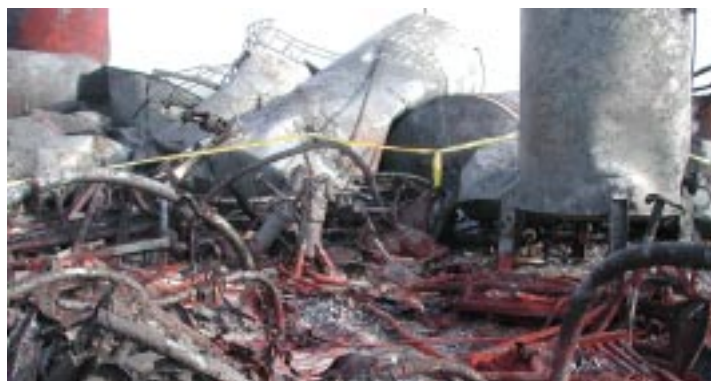
Several 2,000-gallon blend tanks were located to the northeast of warehouse 1. The tanks were supported about 3 feet above ground by steel legs with no external fireproofing. As the pool fire surrounded this area, the legs buckled, and the tanks toppled and contributed their contents to the fire (Figure 7).

Figure 7. Collapsed blend tanks located near warehouse 1.

As the pool fire surrounded this area, the [tank] legs buckled, and the tanks toppled and contributed their contents to the fire.

The blend tanks were located directly adjacent to the storage tank farm, separated by a low dike wall. In addition, numerous steel pipes from the storage tanks traversed the dike walls. Although valves were closed at the end of each pipe, the lines were typically not isolated with closed valves at the storage tanks. As the pipelines failed due to fire exposure, they released materials from the storage tanks that also contributed to the pool fire.
