CASE STUDY

Explosion and Fire in West Carrollton, Ohio

2009-10-I-OH
JULY 21, 2010

Veolia Technical Solutions, LLC

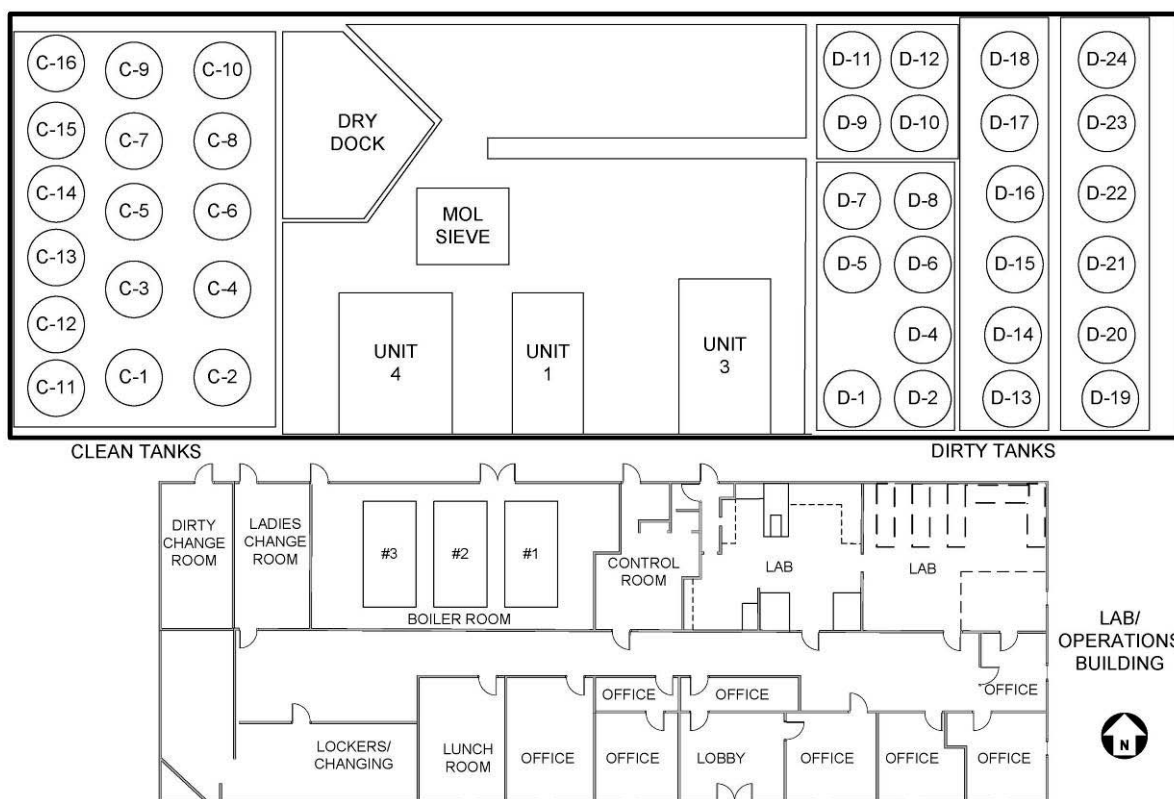
Figure 2. Plot plan of Units 1, 3, and 4; clean and dirty tanks; and the lab/operations building (not to scale)

The lab/operations building, which is likely the point of origin for the initial ignition of flammable vapor, was also severely damaged. The interior of the structure displayed minimal fire damage based on post-incident inspection; however, the masonry block, drywall, and doors in the boiler room deflected in an outward direction from the center of the room (Figure 4). Walls throughout the structure were similarly oriented outward, including most of the exterior south wall of the lab/operations building. Roof panels above the boiler area blew upward. The north side of the building, directly facing the operating plant, remained intact with the exception of the northeast corner, which was due

south of the suspected source of the release (Figure 2).

- The lab/operations building, which housed the source of the ignition, was located about 30 feet south of the operating plant and served as a mixed-use structure, which was occupied primarily by non-essential personnel throughout the day shift.

Conduct a process hazard analysis on all OSHA Process Safety Management covered processes to ensure all buildings and structures at the West Carrollton facility are located and designed in accordance with electrical classification and spacing as defined in NFPA 70.

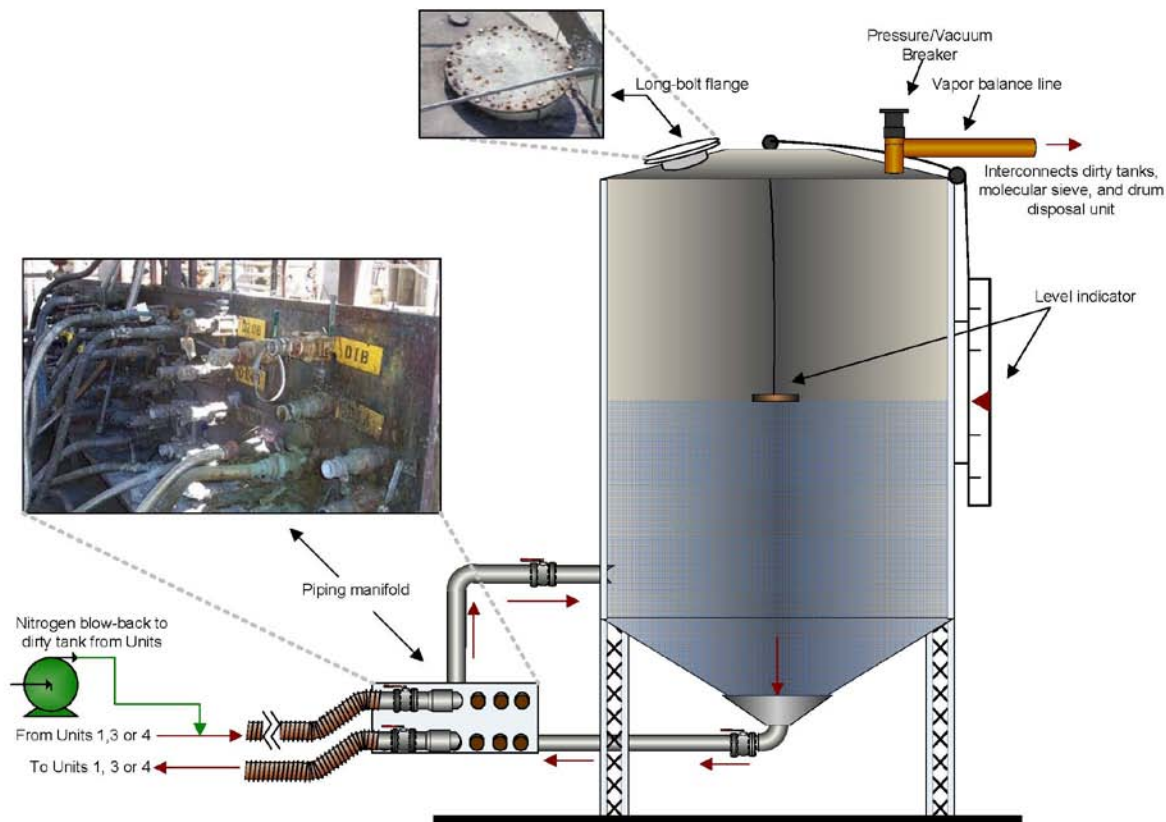
Figure 3. Dirty tank, manifold, and relief systems

The U.S. Chemical Safety Board (CSB) concluded that uncontrolled venting allowed vapors to accumulate to explosive concentrations outside process equipment. Relief valves and rupture disks protected equipment in Units 1, 3, and 4 and relieved to the atmosphere. A two-inch pressure/vacuum vent relief device provided protection for “normal breathing” when pressure exceeded 0.5 psig or vacuum exceeded 1.55 mmHg for each tank in the dirty and clean tank farms. This device relieved pressure whenever an unbalanced transfer occurred or brought in ambient air to avoid tank collapse under negative pressure. On the dirty

tanks, 18-inch “long-bolt” manways⁸ provided emergency venting. The weight of the manway cover kept the opening sealed against the gasket. When pressure developed to lift the cover, the bolts allowed the cover to lift at least 1.5 inches. Both of these relief devices vented directly to the atmosphere.

All relief valves and rupture disks for pressure vessels relieved directly to the atmosphere. Units 3 and 4 rupture disks were oriented upward toward the north while the relief valves vented to the east or the north. Tanks and vessels that suffered the most severe damage were located near the D-14 tank that served as the source of feed to Unit 3. The unit operator blew nitrogen into this tank just prior to the release.

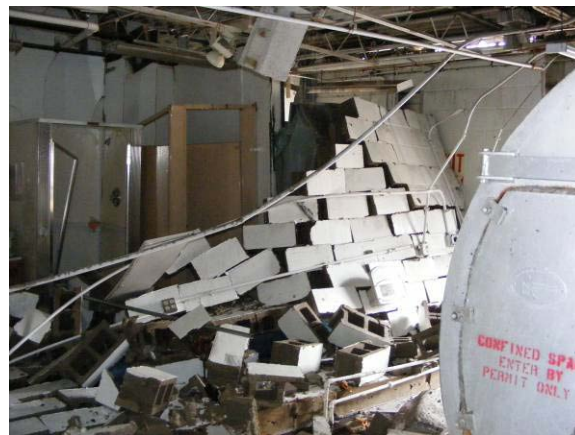
Figure 4. Boiler and locker room damage

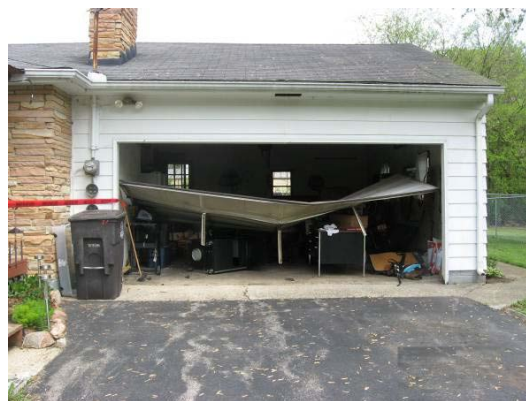
The West Carrollton Code Enforcement Officer and company records estimate that about 20 residences sustained damage from the explosion. Residents reported broken windows, bent garage doors, and chimney detachment. The Code Enforcement Officer condemned the garage of one residence. About five neighboring businesses also sustained damage. One local business less than a quarter-mile away suffered extensive damage, including cracked masonry block walls, broken windows, cracked walls, misaligned doors, broken ceiling light fixtures, foundation shift, bent steel framing, and fallen ductwork. Some offices displayed damage, suggesting workers may have been injured had they been present at the time of the explosion. Preliminary estimates, including lost production, property damage, and business disruption, place total costs at about \$27 million.

Figure 5. Residential damage
