Investigation Update

September 2022

This document provides an update on the CSB investigation of the January 24, 2020, incident at the Watson Grinding and Manufacturing Co. facility in Houston, Texas. The investigation is ongoing. Complete findings, analyses, and recommendations, if appropriate, will be detailed in the CSB’s final investigation report.

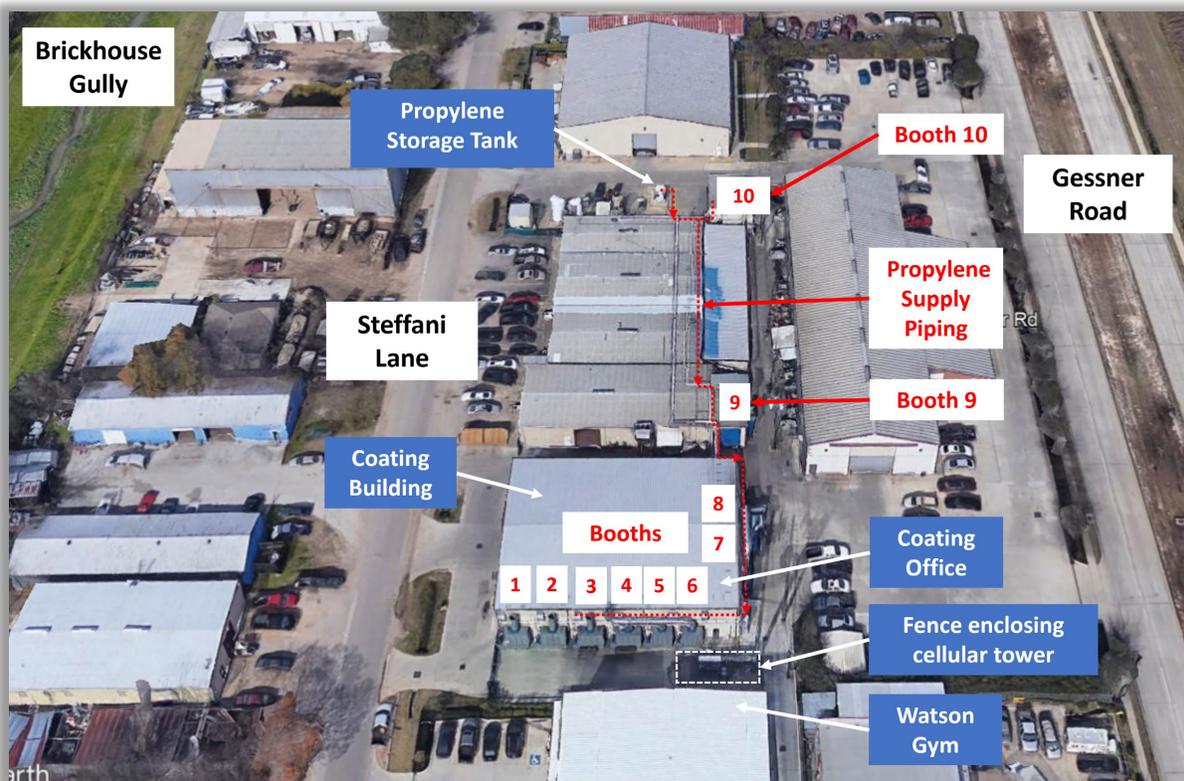
The company stored propylene in a 2000-gallon bulk tank (propylene storage tank). Propylene flowed from the propylene storage tank and into the propylene supply piping, which ran along the buildings’ exteriors (see red dashed line in **Figure 4**) to the branched “tee” takeoffs into each of the eight HVOF coating booths (Booths 3 through 10).^c At each booth, the propylene takeoff piping entered near the top, about fifteen feet above ground level. The piping ran downward near ground level and connected to the booth’s control equipment and the robotic arm. Each robotic arm was equipped with a spray gun to apply the HVOF coating (**Figure 4**).

Figure 4. Propylene Supply Piping. This photo shows how Watson Grinding routed the propylene supply piping from the propylene storage tank to the eight HVOF coating booths. (Source: Google Earth Pro image from before the incident [7]; Annotations: CSB)^d

At about 4:00 a.m., the two employees left the Watson Gym and walked to the coating building (located next door). While standing outside of the coating building (in the area directly behind Booth 4; see **Figure 4**), they smelled a “strong” propylene odor and heard a “really loud hissing” noise coming from inside the coating building. Employees later stated the propylene leak sounded like it was originating about three to four feet above ground level. After smelling and hearing the leaking propylene, both employees returned to the Watson Gym and resumed exercising. Shortly after, Employee Two stopped exercising, contacted two Watson Grinding supervisors, and informed them of the suspect propylene leak. Neither supervisor reported directing Employee Two to evacuate himself and others from the facility immediately. After alerting these supervisors, Employee Two left the Watson Gym to investigate the propylene leak further.

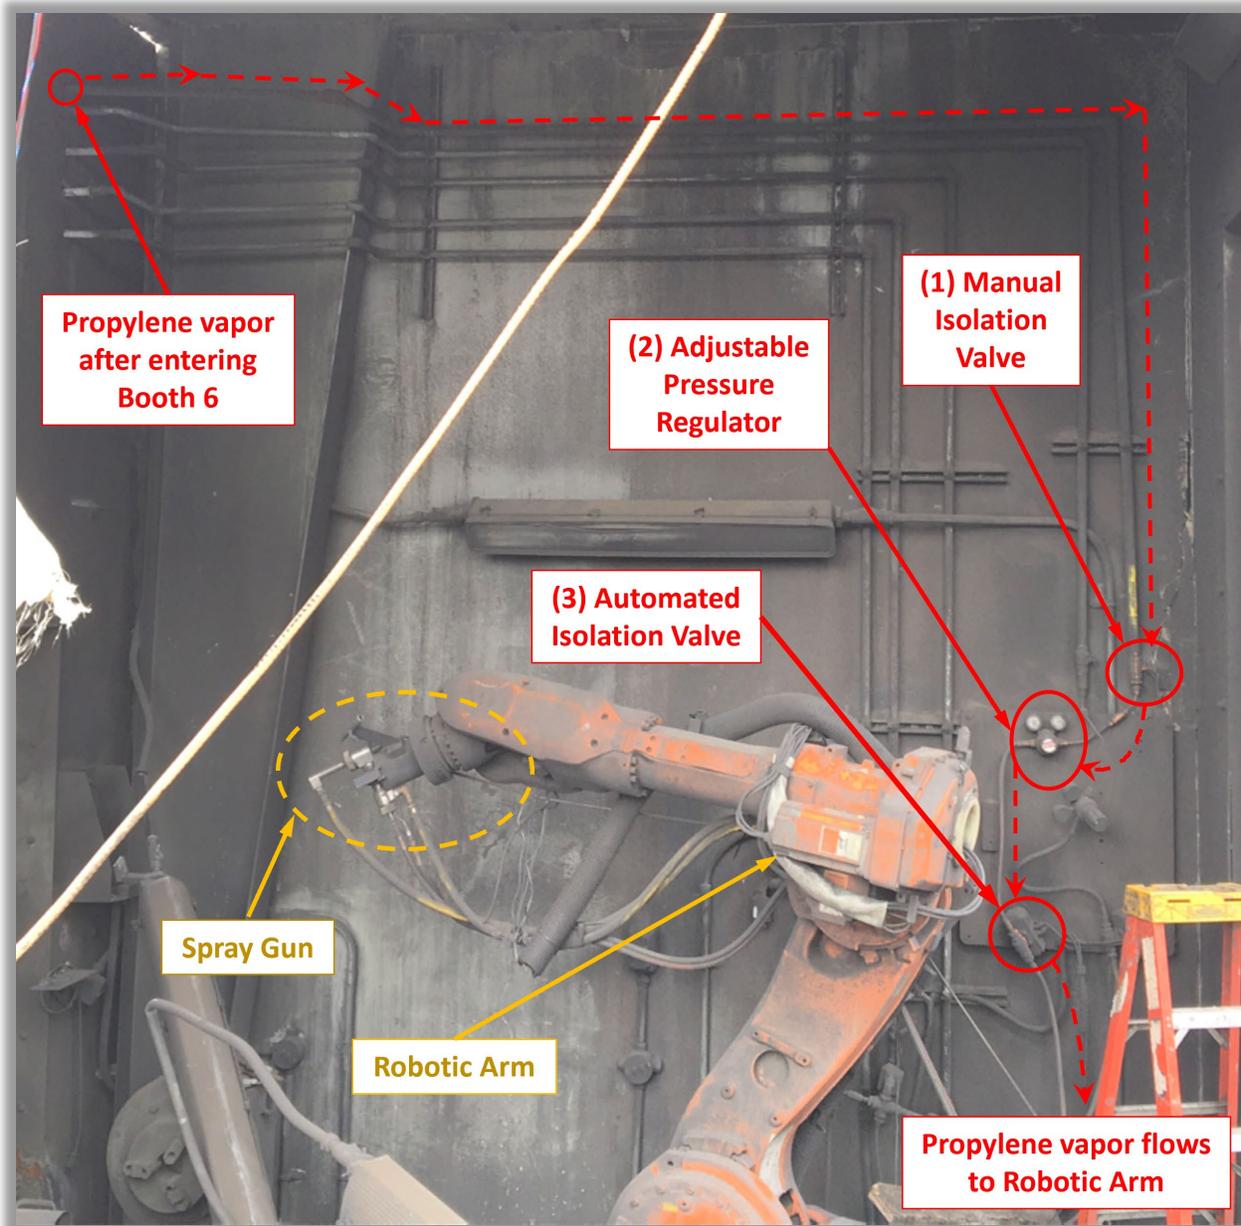
1. a manual isolation valve;
2. an adjustable pressure regulator; and
3. an automated isolation valve (**Figure 5**).^b

^b Booth 6 is indicative of the arrangement of piping and pressure control system components inside of an HVOF control booth. The piping configuration to other coating booths might differ, slightly.

Figure 5. Propylene system inside Booth 6. This post-incident photo shows the location of the propylene piping after entering the top of Booth 6, flowing through the booth’s propylene pressure control system and continuing to the robotic arm. (Source: Watson Grinding; Annotations: CSB)
