Chevron Phillips Port Arthur, Texas

February 15, 2021

Incident Summary

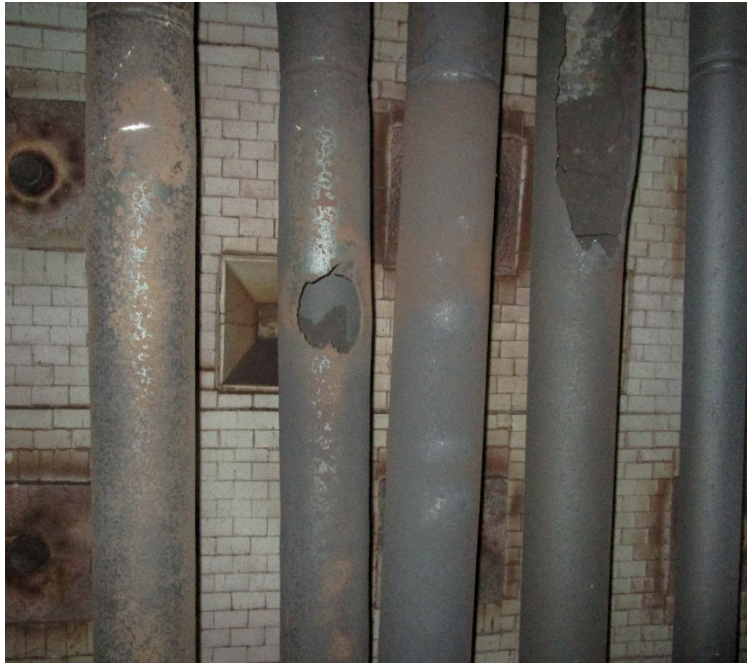
Chevron Phillips’ investigation determined that freeze-related operational issues due to extreme cold weather from Winter Storm Uri caused the facility’s boiler units to shut down. This shutdown decreased the supply of steam and water to an ethylene unit at the facility. A safety system automatically shut the fired heater down due to insufficient steam and water flow. Although the automatic valves closed to prevent feed from entering the tubes, the fired heater’s fuel gas isolation valve failed to close as intended. This failure allowed the burners to continue operating. Without any flow through the tubes to remove heat from their walls, the tubes in the fired heater reached excessively high temperatures. Some tubes ruptured, likely due to short-term overheating, but a metallurgical analysis was not performed to confirm the cause of the tube failures (**Figure 2**). When the tubes ruptured, hydrocarbons downstream from the fired heater were released through the broken tubes and ignited by the burner flames inside the firebox, causing a fire.

Figure 2. Failed fired heater tubes. (Credit: Chevron-Phillips)

Based on Chevron Phillips's investigation, the CSB determined that the probable cause of the incident was the rupture of fired heater tubes from short-term overheating. When the tubes were broken, a hydrogen and hydrocarbon gas mixture flowed from downstream equipment into the firebox. Flames from the burners ignited the flammable materials, resulting in the fire. Inadequate winterization of flow control equipment contributed to the incident.
