## Valero Texas City, Texas

August 19, 2022

### Incident Summary

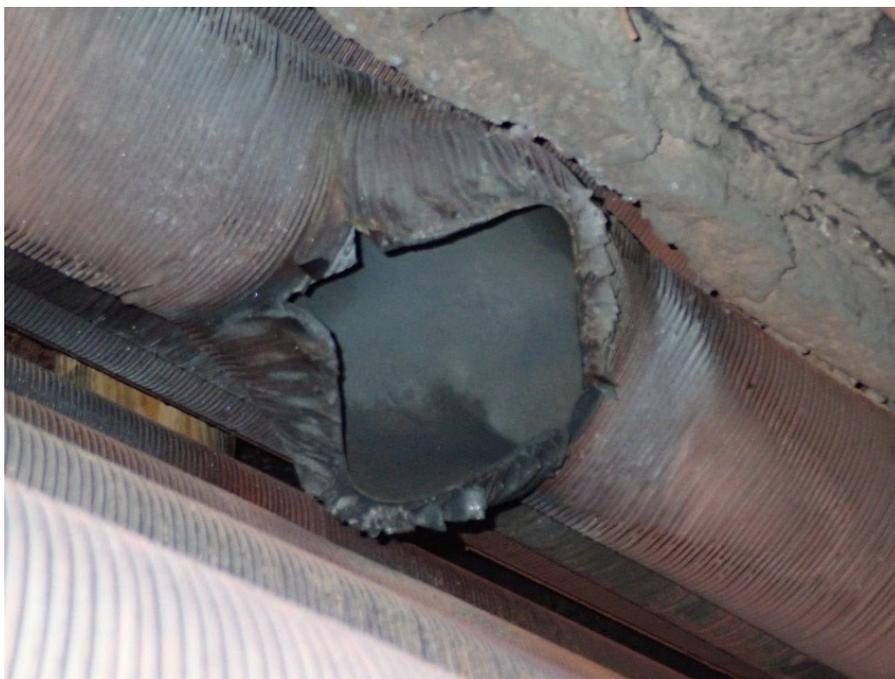
Valero's investigation of the incident found that without the fluid flowing through the fourth pass to remove heat, the tube's metal wall temperature reached 1,500 degrees Fahrenheit (°F), which exceeded the design temperature limit. After the operations supervisor noticed the high temperature, field operators were sent to inspect the heater tubes. The field operators reported that some tubes were "glowing red hot," and consequently they manually turned off two of the fired heater's eight burners. The field operators then reduced the flow through the first three passes to help drive feed material into the fourth pass. Although operators reported hearing material flowing in the fourth pass, the meter indicated no flow. The Valero operations team concluded that the flow meter was malfunctioning.

Less than an hour later, a convection section tube in the fourth pass ruptured due to short-term overheating (**Figure 2**), releasing a flammable mixture of hydrogen and hydrocarbons into the firebox. Flames from the gas-fired burners ignited the mixture, resulting in a large fire.

**Figure 2.** Ruptured fired heater tubing. (Credit: Valero)

Based on Valero’s investigation, the CSB determined that the probable cause of the incident was a ruptured fired heater tube from short-term overheating. Flames from the fired heater’s gas-fired burners ignited these flammable chemicals, resulting in the fire. The lack of automated safeguards that did not prevent the burners from being ignited before the minimum flow was established through each of the four tube passes contributed to the incident. Had Valero had such automated safeguards in place, this incident likely could have been prevented.

Additionally, Valero found that the fired heater lacked engineered safeguards to prevent the burners from being lit before establishing flow in each of the four passes. In response to the incident, Valero modified its automated burner controls to help ensure that the flow rate through every pass exceeds a predetermined minimum flow rate before operators can ignite a burner.
