Investigation Update

March 2026

This document provides an update on the CSB’s investigation of the October 10, 2025, incident at Accurate Energetic Systems, LLC.

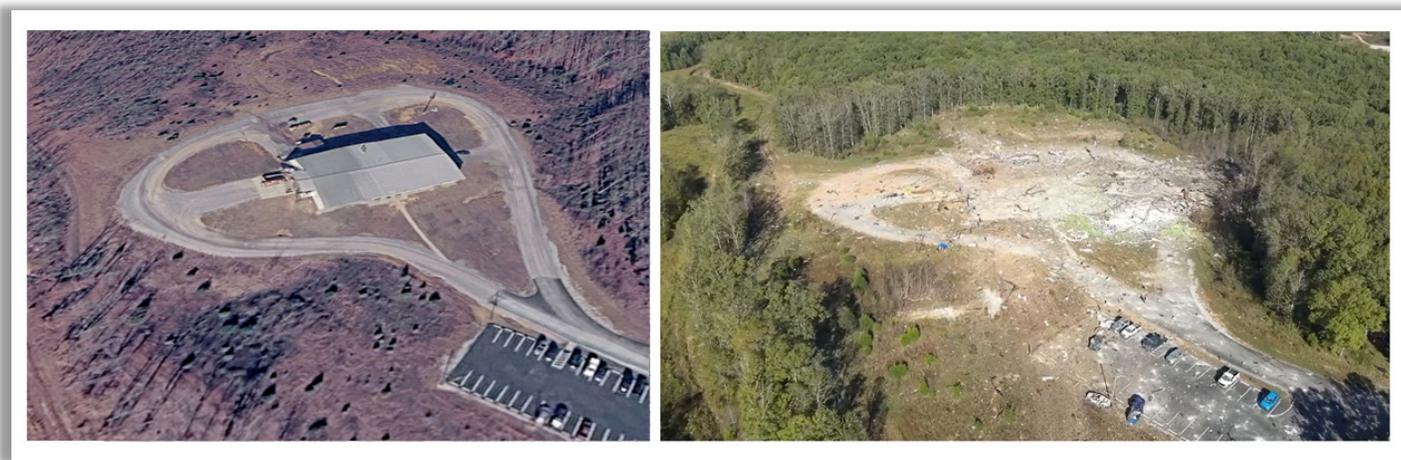
On October 10, 2025, at 7:47 a.m., multiple catastrophic explosions fatally injured 16 employees at the Accurate Energetic Systems, LLC (“AES”) facility in McEwen, Tennessee (**Figure 1**). Another employee was seriously injured in the incident, and six additional employees reported injuries. The incident occurred in a building used to manufacture commercial explosive products. The explosions razed the building and launched debris up to 700 feet [1]. The blast reportedly was felt more than 20 miles away. At the time of the incident, approximately 24,600 pounds of explosives were in the building, approximately 23,000 pounds of which were consumed in multiple detonations. Roughly 1,000 pounds of unexploded energetic material that had been launched from the building were recovered on-site and subsequently disposed of by burning it on-site.

Figure 1. Incident building before (left) and after (right) the October 10, 2025, incident. (Credit: Google Earth (left); WZTV Nashville [2] (right))

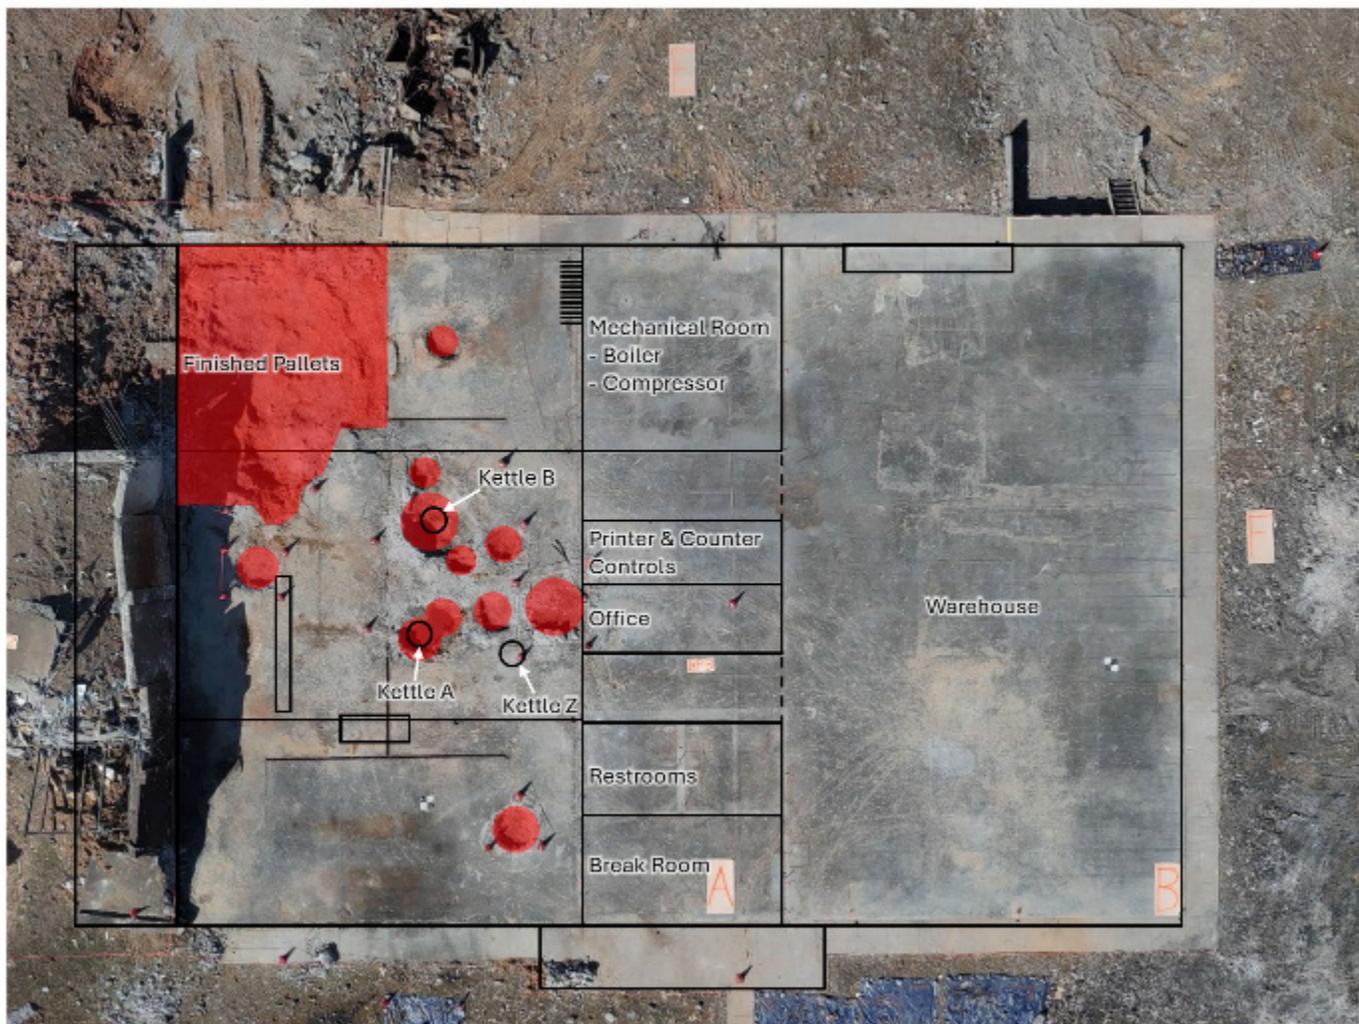
6. A shipping and receiving clerk, who was managing inert goods on the warehouse side of Building 602.
- At 7:47 a.m., the first explosion occurred in Building 602. Based on the debris field and blast indications, this first explosion likely occurred on the ground floor. The pressure wave from the initial detonation likely caused other explosives in the building to sympathetically detonate. In total, approximately 23,000 pounds of the explosive material detonated, deflagrated, or burned. ^a

- Following the incident, Building 602's foundation was cleared to reveal damage and craters, indicating the locations where high explosives detonated in the building at the time of the incident (**Figure 9**).

Figure 9. Building 602's foundation after the incident with walls and equipment overlaid. Craters and foundation damage are indicated in red. (Credit: ATF via WKRN [17] with annotations by CSB)

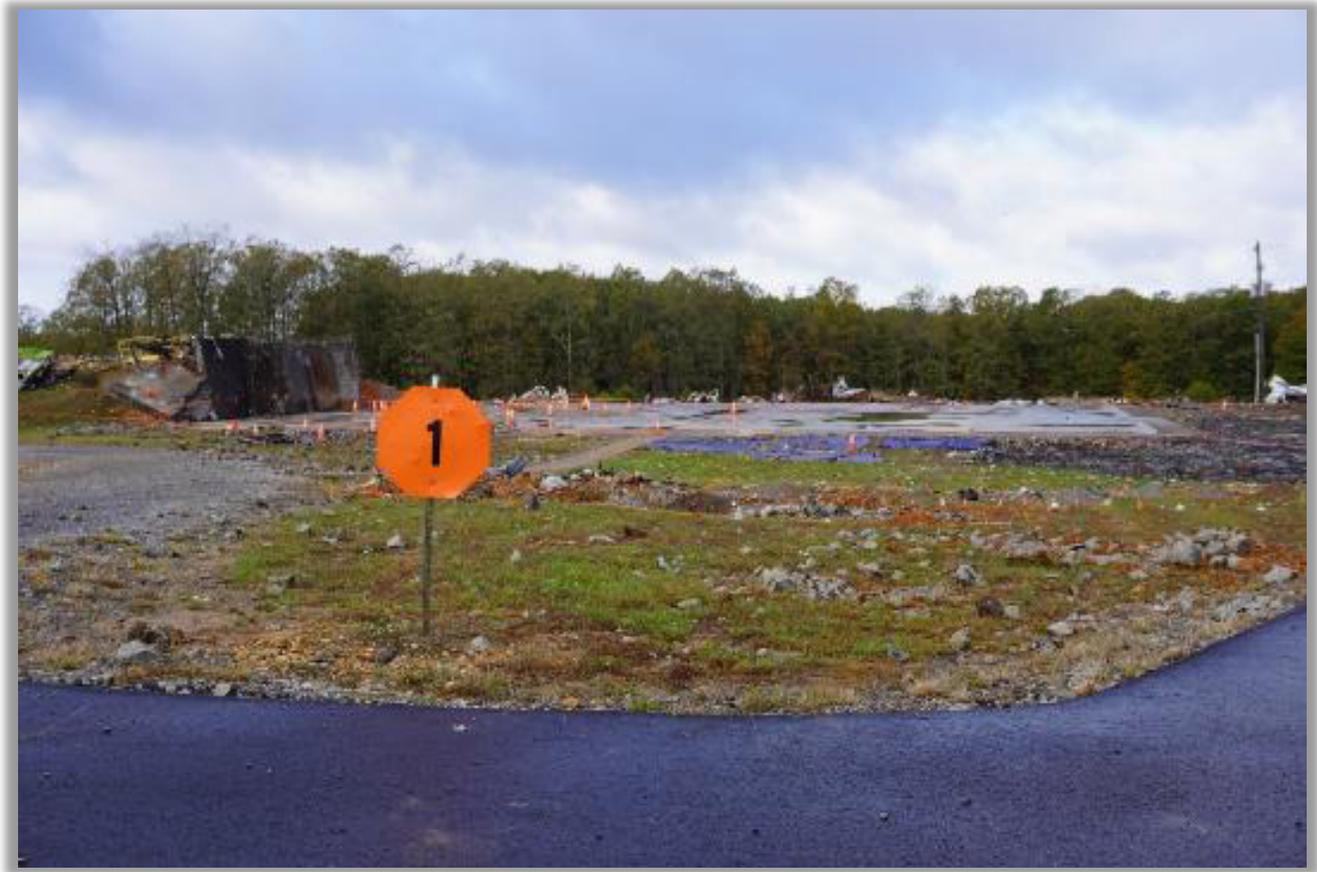
- The Bureau of Alcohol, Tobacco, Firearms, and Explosives (ATF), which responded initially to the incident, recovered approximately 1,000 pounds of unexploded energetic material that was launched from the building. This explosive material was disposed of by burning it on-site [1].
- AES reported to the CSB that the incident resulted in approximately \$4.3 million in property damage. Building 602 was completely destroyed as a result of the incident (**Figure 10**), and nine additional buildings within the AES complex were damaged (**Figure 11**).

Figure 10. Post-incident photo of the Building 602 location after the foundation was cleared.^a (Credit: CSB)

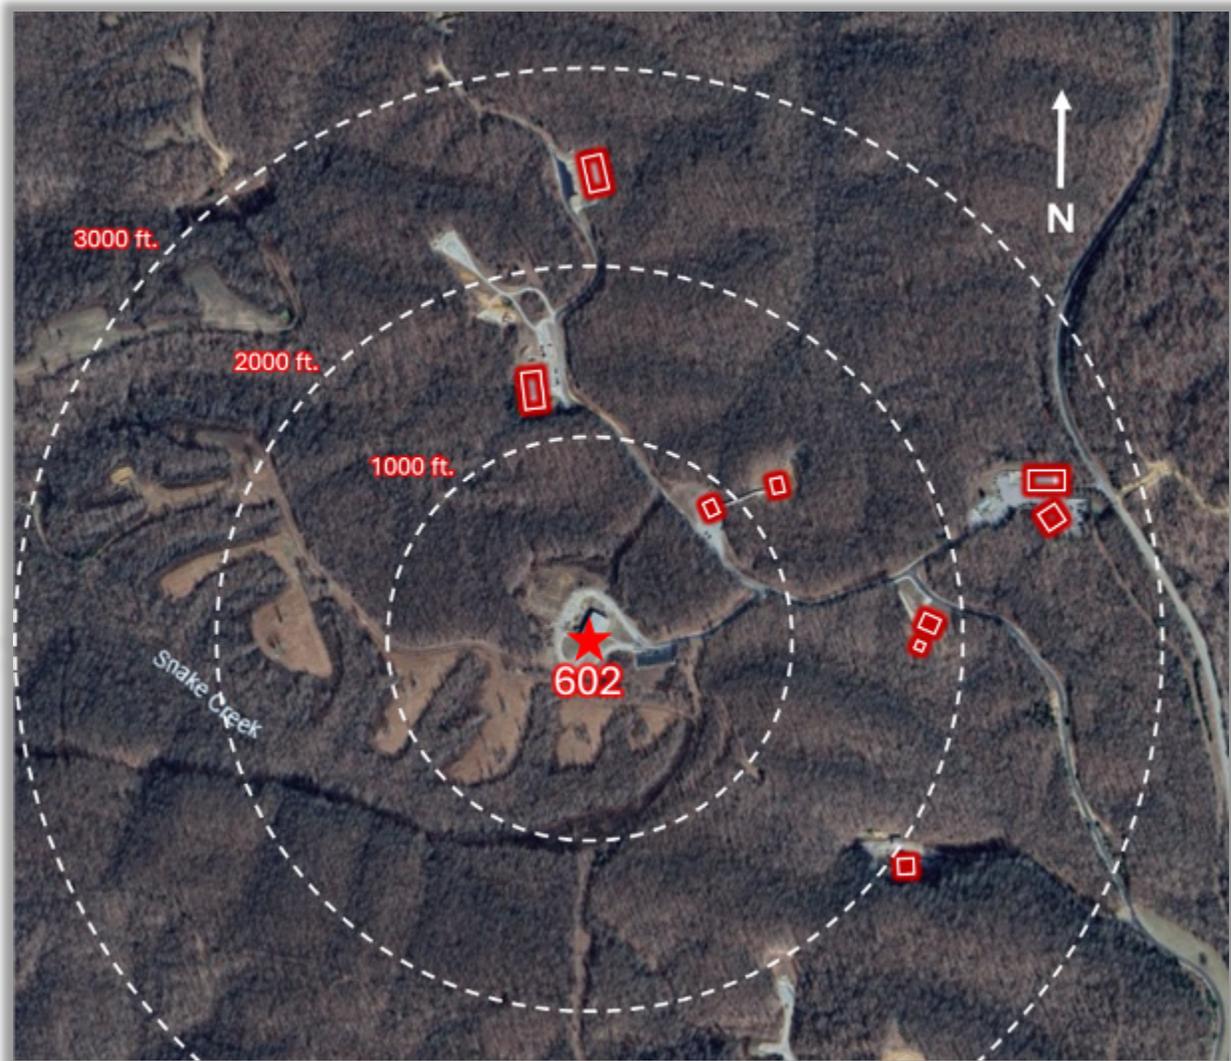
Figure 11. Map of buildings damaged by the incident. (Credit: Google Earth with annotations by CSB)

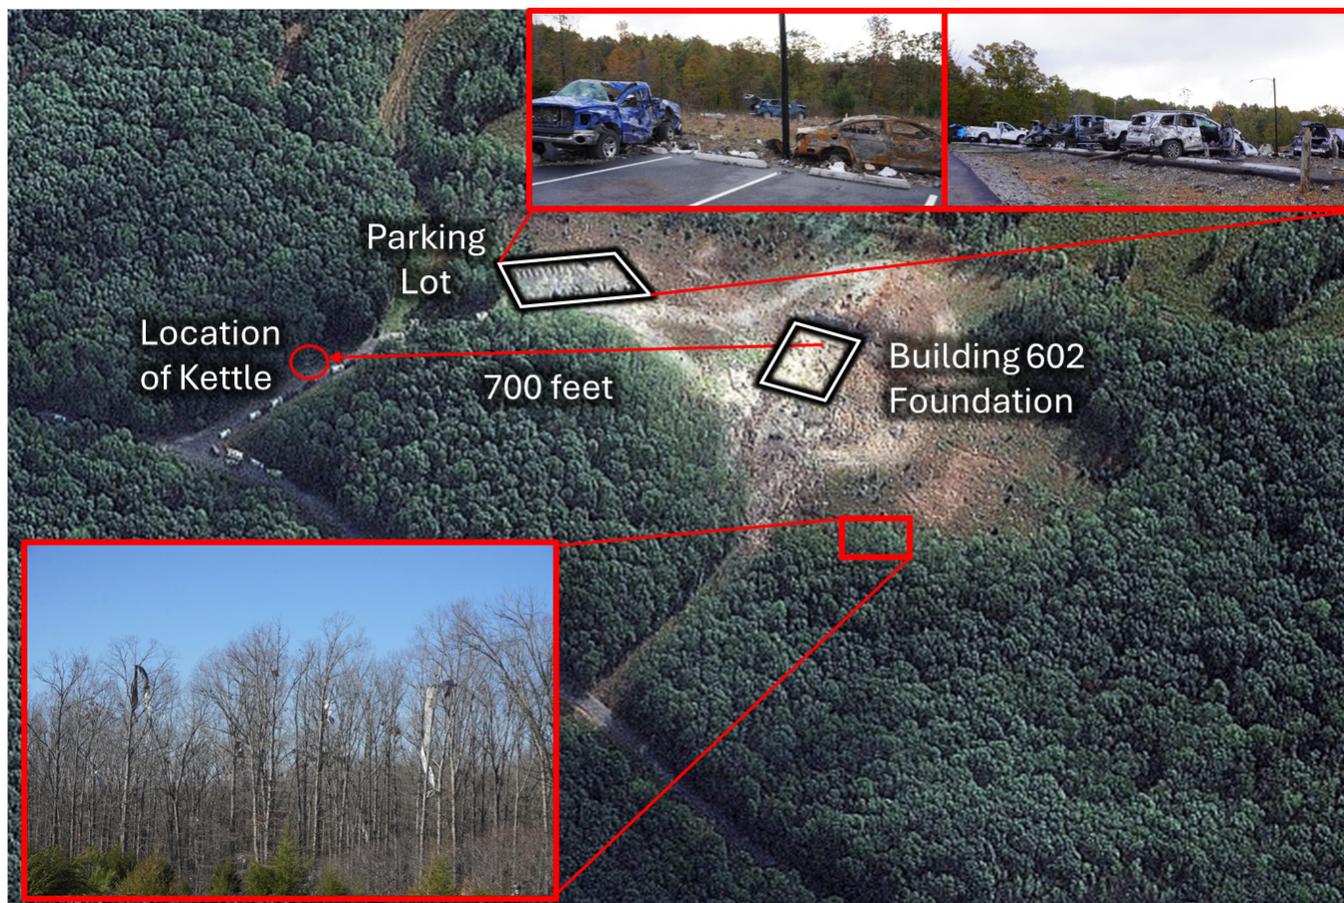
- Debris from the event was propelled over 700 feet from Building 602. At least six of the nine kettles were recovered after the incident. A kettle was found more than 700 feet from the initial location (**Figure 12**). Explosion debris was found scattered throughout the wooded area surrounding the building. The incident destroyed vehicles located in the parking lot, approximately 250 feet from the building (**Figure 12**).

Figure 12. Debris locations from the explosion (Credit: WSJ [18], annotations and inset by CSB)
