## Investigation Update

March 2026

This document provides an update on the CSB's investigation of the October 10, 2025, incident at Accurate Energetic Systems, LLC.

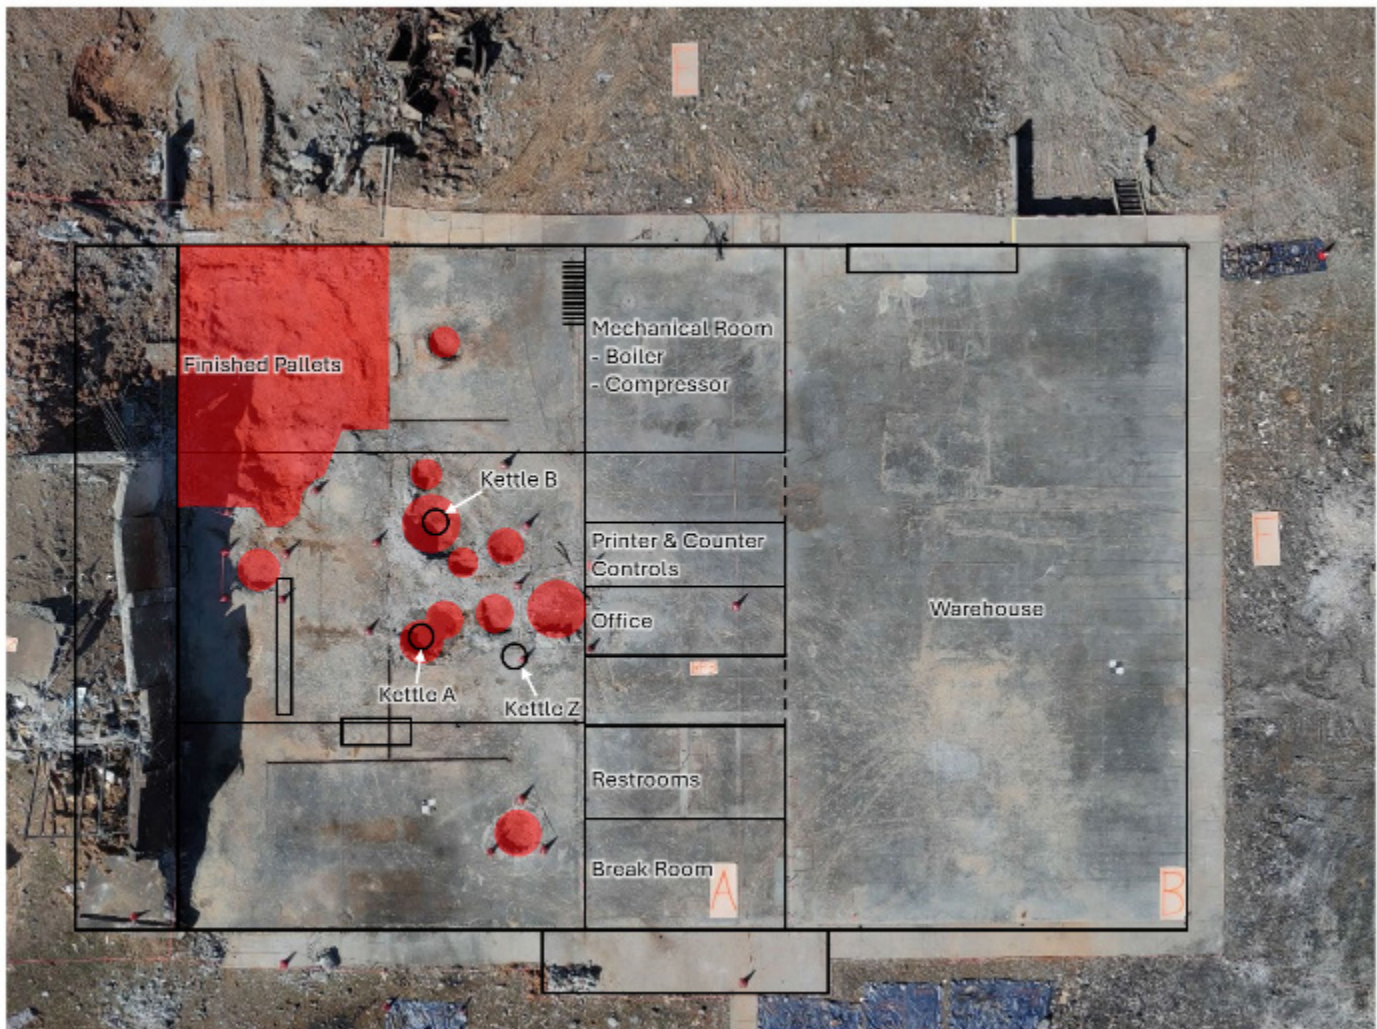
- Following the incident, Building 602's foundation was cleared to reveal damage and craters, indicating the locations where high explosives detonated in the building at the time of the incident (**Figure 9**).

**Figure 9.** Building 602's foundation after the incident with walls and equipment overlaid. Craters and foundation damage are indicated in red. (Credit: ATF via WKRN [17] with annotations by CSB)

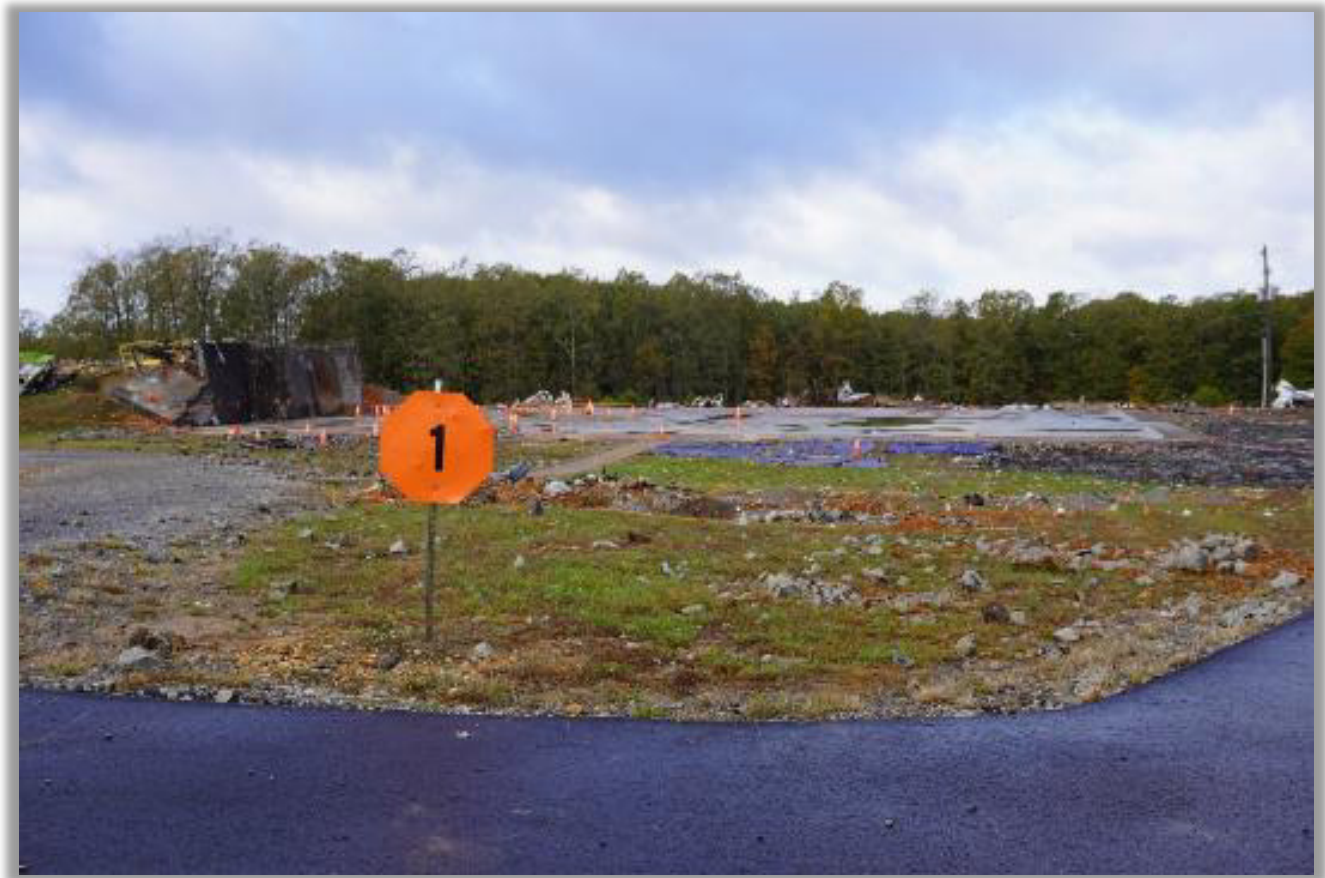
- The Bureau of Alcohol, Tobacco, Firearms, and Explosives (ATF), which responded initially to the incident, recovered approximately 1,000 pounds of unexploded energetic material that was launched from the building. This explosive material was disposed of by burning it on-site [1].
- AES reported to the CSB that the incident resulted in approximately \$4.3 million in property damage. Building 602 was completely destroyed as a result of the incident (**Figure 10**), and nine additional buildings within the AES complex were damaged (**Figure 11**).

**Figure 10.** Post-incident photo of the Building 602 location after the foundation was cleared.<sup>a</sup> (Credit: CSB)

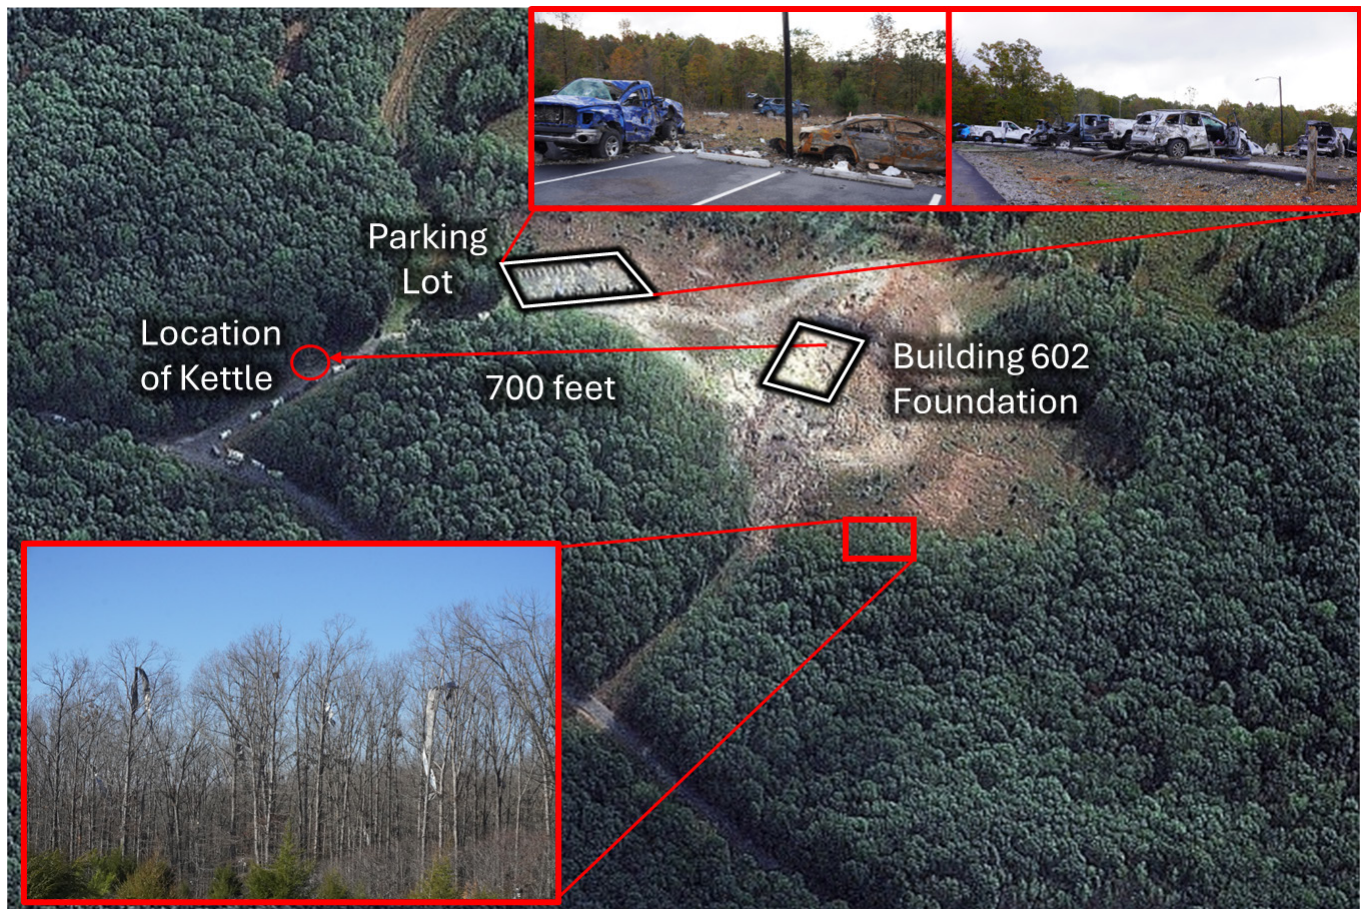
- Debris from the event was propelled over 700 feet from Building 602. At least six of the nine kettles were recovered after the incident. A kettle was found more than 700 feet from the initial location (**Figure 12**). Explosion debris was found scattered throughout the wooded area surrounding the building. The incident destroyed vehicles located in the parking lot, approximately 250 feet from the building (**Figure 12**).

**Figure 12.** Debris locations from the explosion (Credit: WSJ [18], annotations and inset by CSB)
