U.S. Chemical Safety and  
Hazard Investigation Board

# Chemical Decomposition, Fires, and Toxic Gas Release at KIK Consumer Products / Bio-Lab Conyers Facility

Conyers, Georgia | Incident Date: September 29, 2024 | No. 2024-04-I-GA

## Investigation Report

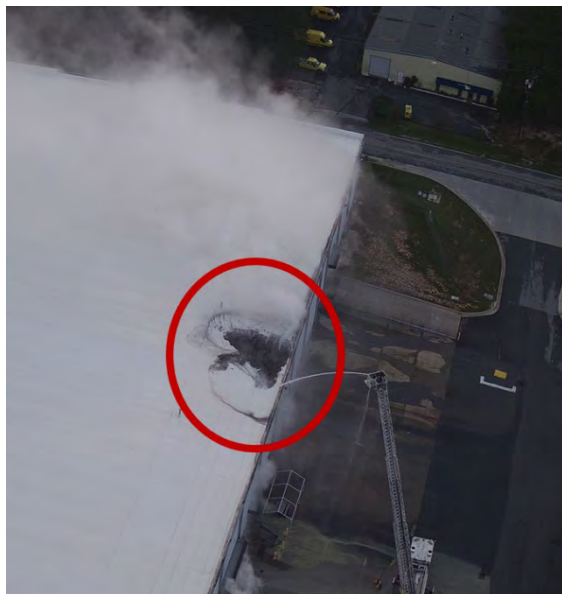
**Figure 41.** Location of the roof fire (red circle) resulting from the single-point heat source developed outside the bunker, in front of the fire barrier wall at Plant 12 Storage Warehouse. (Credit: CSB)

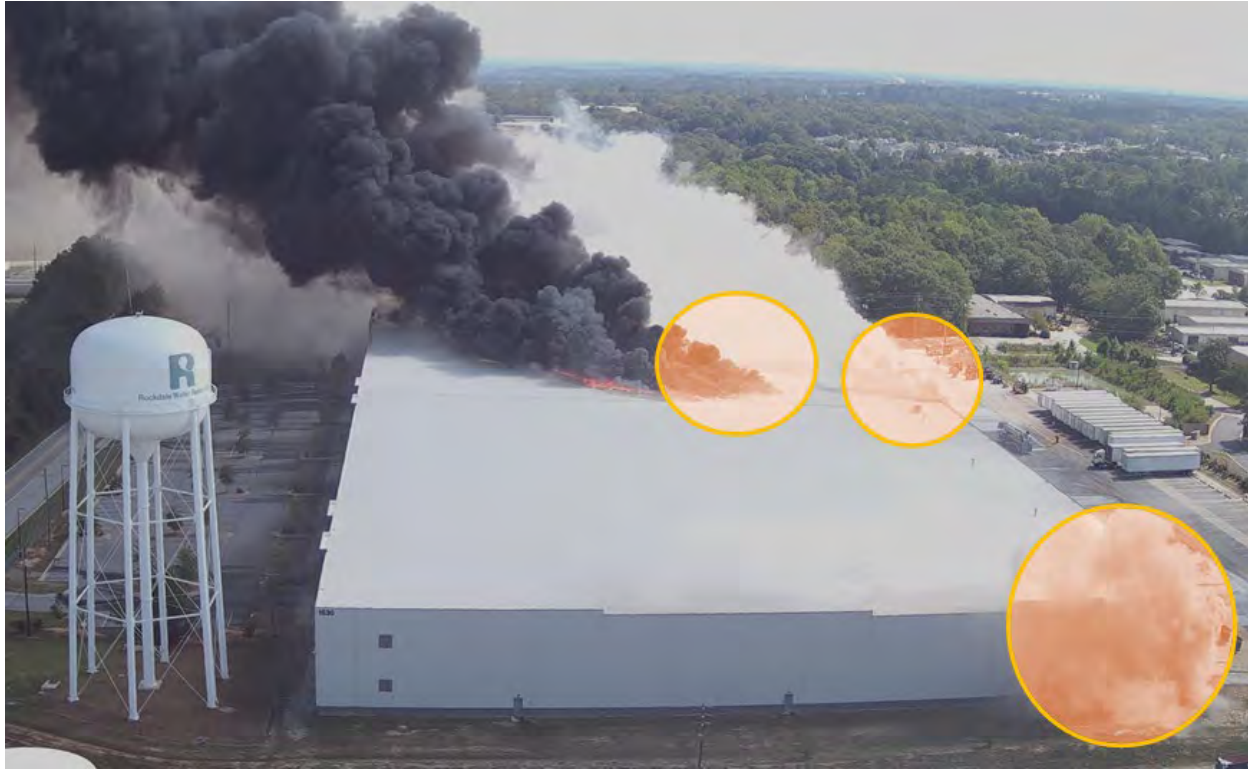
**Figure 43.** Aerial shot of the second building fire at Bio-Lab Conyers 12 Storage Warehouse on September 29, 2024, resulting from the multiple-point heat source generated by decomposing oxidizers and combustible materials. (Credit: RCFR, annotated by CSB)
