U.S. Chemical Safety and Hazard Investigation Board

Factual Investigative Update

Midland Resource Recovery Investigation Update

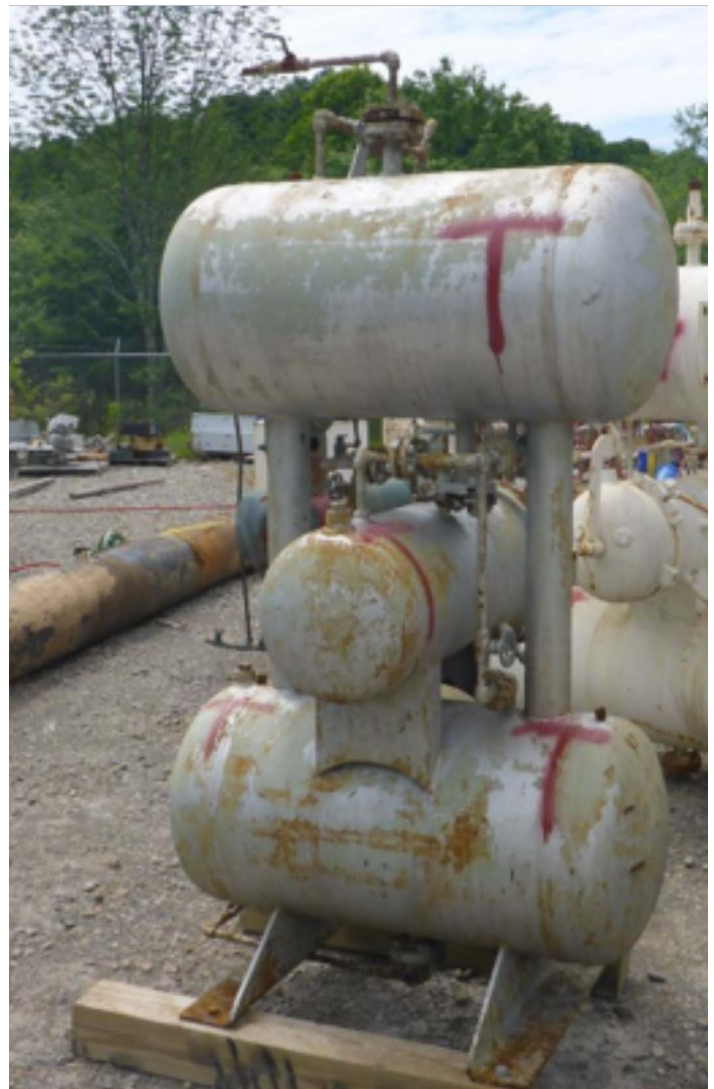
Figure 2. Exemplar vessel involved in the explosion.

The vessels involved in both of the incidents were referred to as Peerless MP-85 Odorizers. They were constructed of carbon steel and consisted of three interconnected tanks (see Figure 2). The top tank was the mercaptan storage tank which held concentrated mercaptan. In the middle tank, a slip stream of the natural gas pipeline entered the vessel so that mercaptan could be added to the pipeline from the top tank. In some MP-85s there is an aluminum component in the interior of the middle tank as well. The bottom tank served as an overflow tank for the top and middle tanks.

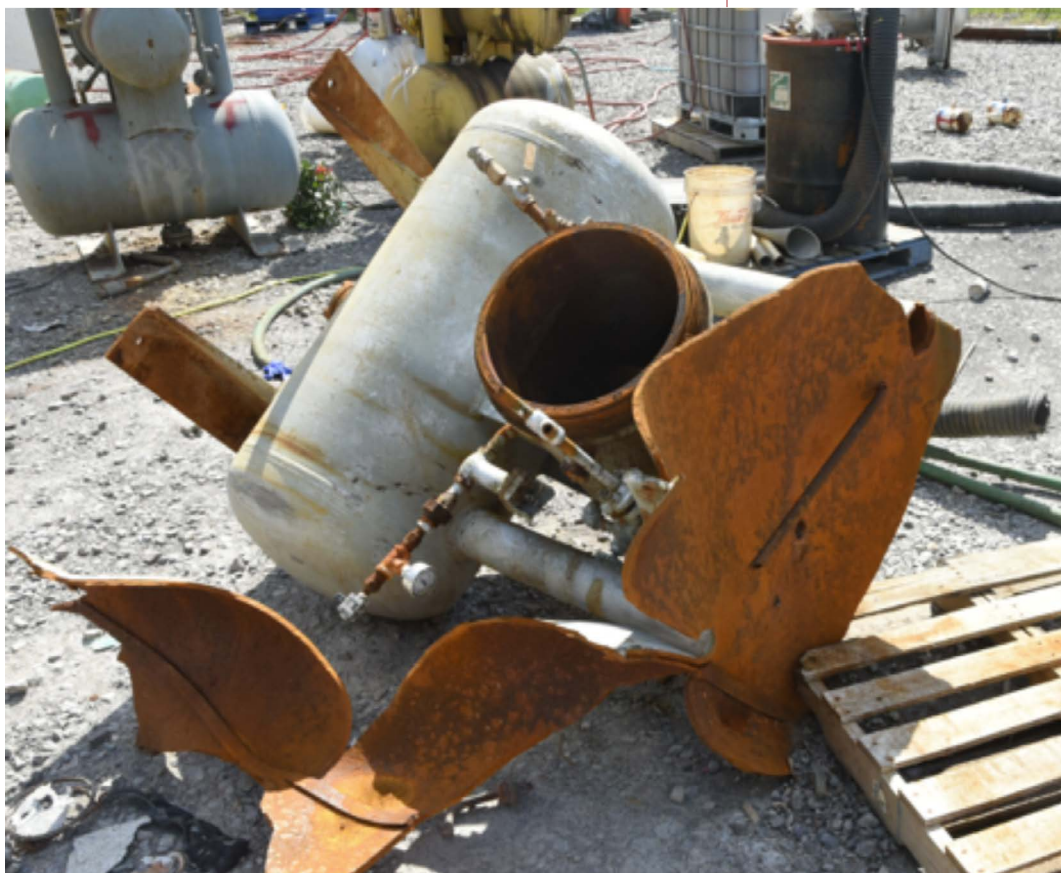
On May 24, 2017 three MRR workers, including the company founder and president, were working to drain a number of MP-85s that had been filled with cleaning material about a month prior. Fourteen MP-85s had been filled with sodium hypochlorite and needed to be drained. During the initial stages of the draining, one of the MP-85s violently exploded, killing two workers and seriously injuring the third worker. Workers were likely preparing to pump process water out of the top tank and were either removing plugs from the top of the top tank or beginning to pump out the liquid from the tank. The container that failed on May 24, 2017 is pictured in Figure 3, which shows a rupture of the vessel at both the top and middle of the tank.

The explosions likely occurred when unintended chemical reaction(s) caused highly reactive or unstable chemicals to form in the respective vessels, which resulted in the two explosions.

Figure 3. Tank that failed after the May 24, 2017 explosion. The middle tank failure was located at a threaded connection that connected an end cap to the middle tank.
