Investigation Report

SAFETY ISSUES:

The November 12, 2024, explosion at the Givaudan facility in Louisville, Kentucky, fatally injured two people:

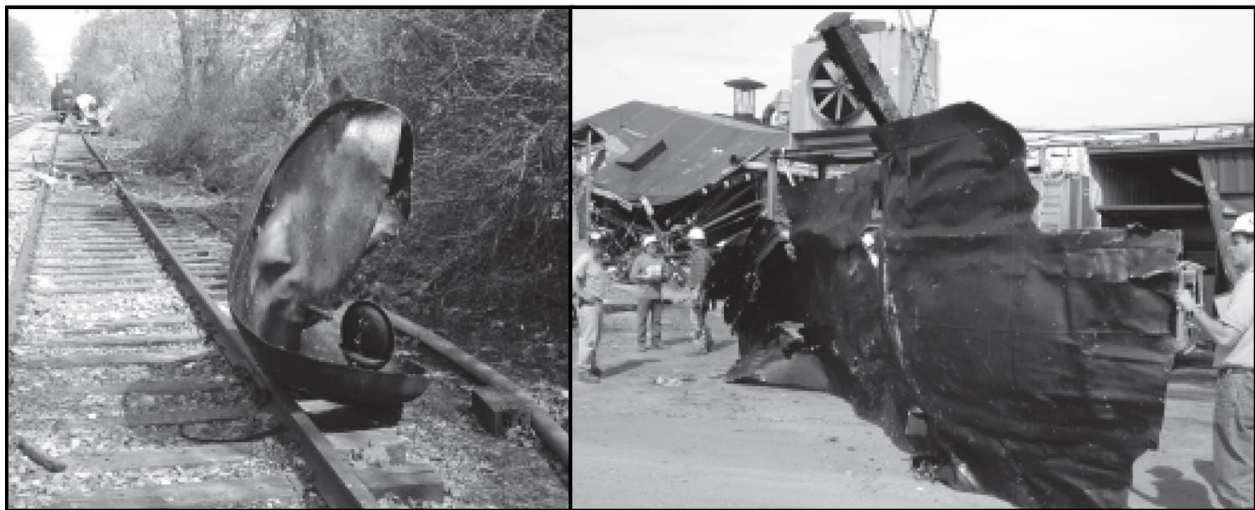
Leading to the incident, operators had been heating caramel coloring inside the vessel^a (**Figure 8**) to a target temperature of 160°F. The vessel was not equipped with a process control or alarm system, and operators monitored the vessel conditions using local temperature and pressure gauges. While heating the vessel, the operators were also conducting other work, and they did not notice when the vessel temperature rose above 160°F. The vessel, which had a MAWP of 40 pounds per square inch (psi), was not equipped with a pressure relief device.^b The air vent valve (**Figure 8**) was also likely closed while the vessel was being heated, blocking all relief capability. The pressure in the vessel increased as the caramel coloring overheated until the vessel overpressured and failed catastrophically (**Figure 9**).

Figure 9. Left photo: Top head of ruptured vessel from 2003 incident; Right photo: shell of ruptured vessel from 2003 incident. (Credit: CSB [7])

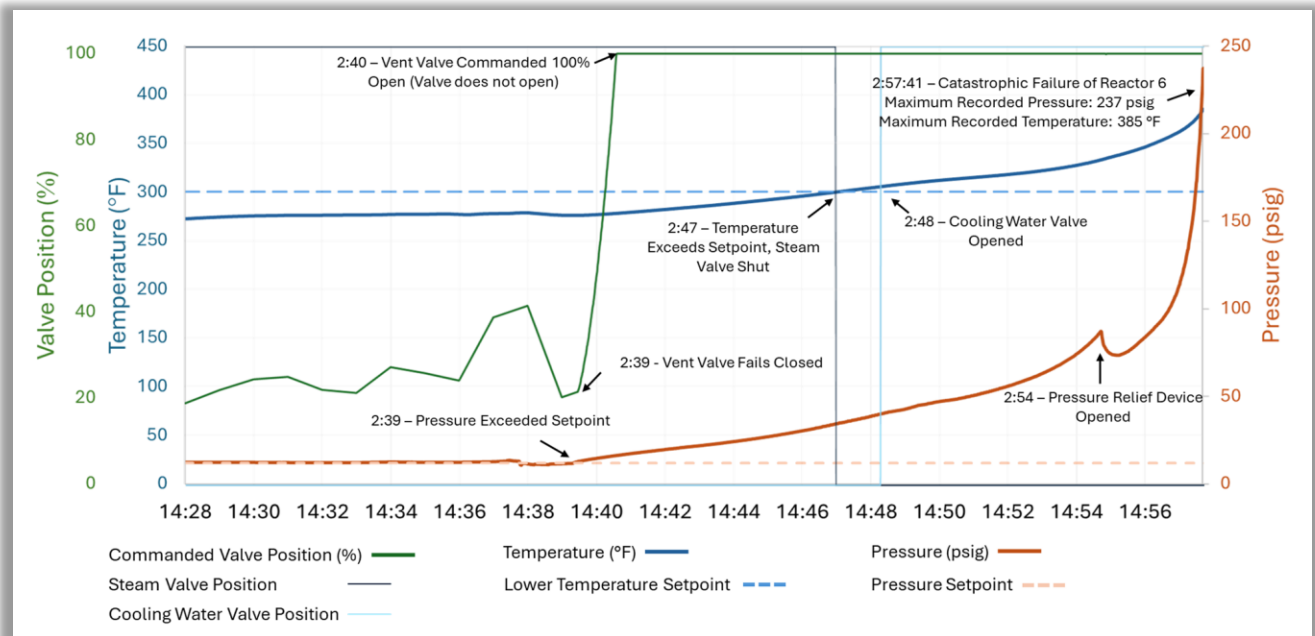
Figure 11. Process data from Reactor 6 leading up to the explosion. (Credit: CSB)

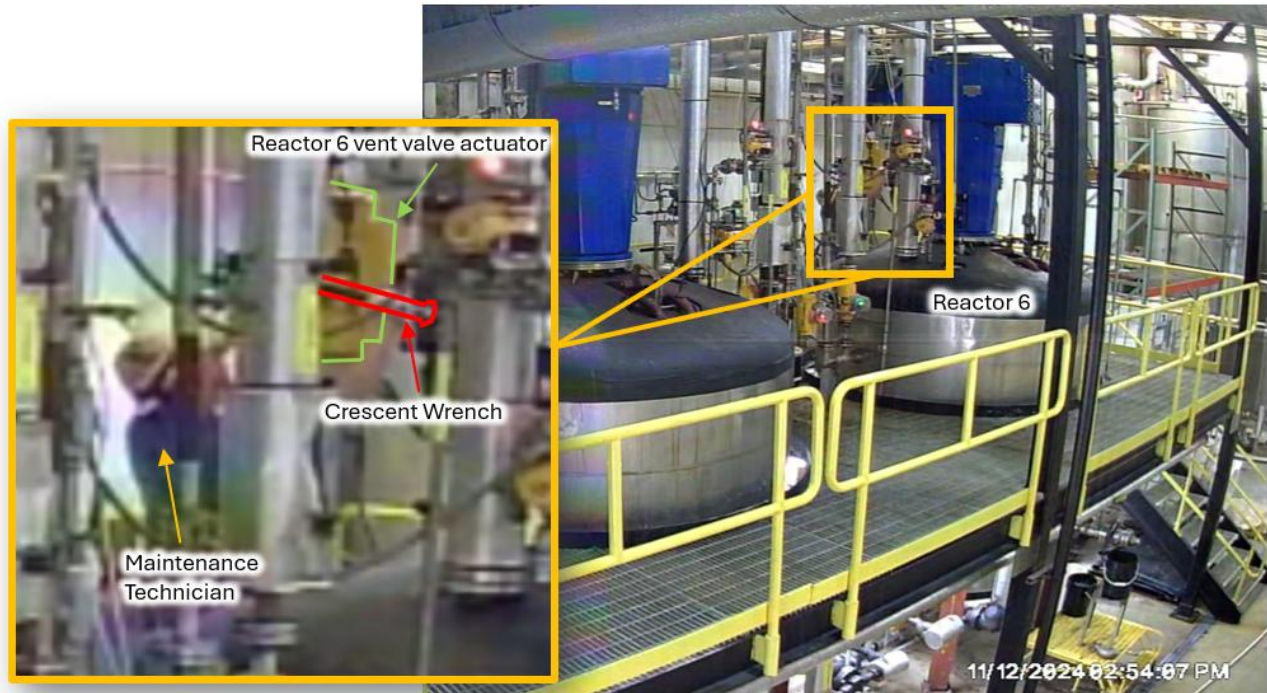
Figure 12. Surveillance footage showing a maintenance technician using a crescent wrench on the actuator to attempt to open the Reactor 6 vent valve. The crescent wrench is positioned perpendicular to the actuator, indicating the valve was in the closed position. (Credit: Givaudan, annotated by CSB)

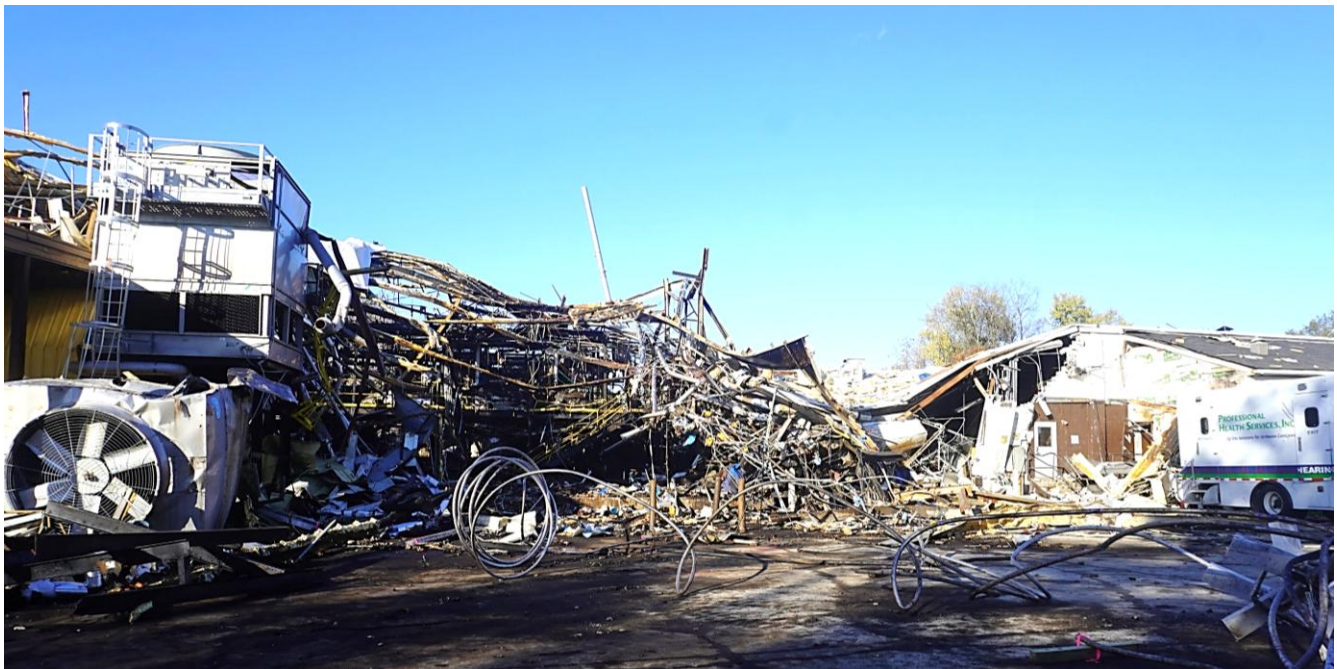
In addition to the two fatalities and three serious injuries, the explosion caused large pieces of the batch reactor, pipe fragments, instrumentation, valves, and other materials, equipment, and debris to propel outside the facility fence line as far as 400 feet from the facility and resulted in an estimated \$30 million in property damage to the facility, as well as \$10 million in property damage to nearby homes and businesses. The Reactor 6 shell, which weighed about 2,000 pounds, was launched 245 feet and landed in a residential yard, coming to rest against a home. Local officials issued a shelter-in-place order for a 1-mile radius around the facility. The Louisville facility has since ceased operations and has been demolished.

Figure 15. The Reactor 6 explosion destroyed the Louisville facility. (Credit: CSB)

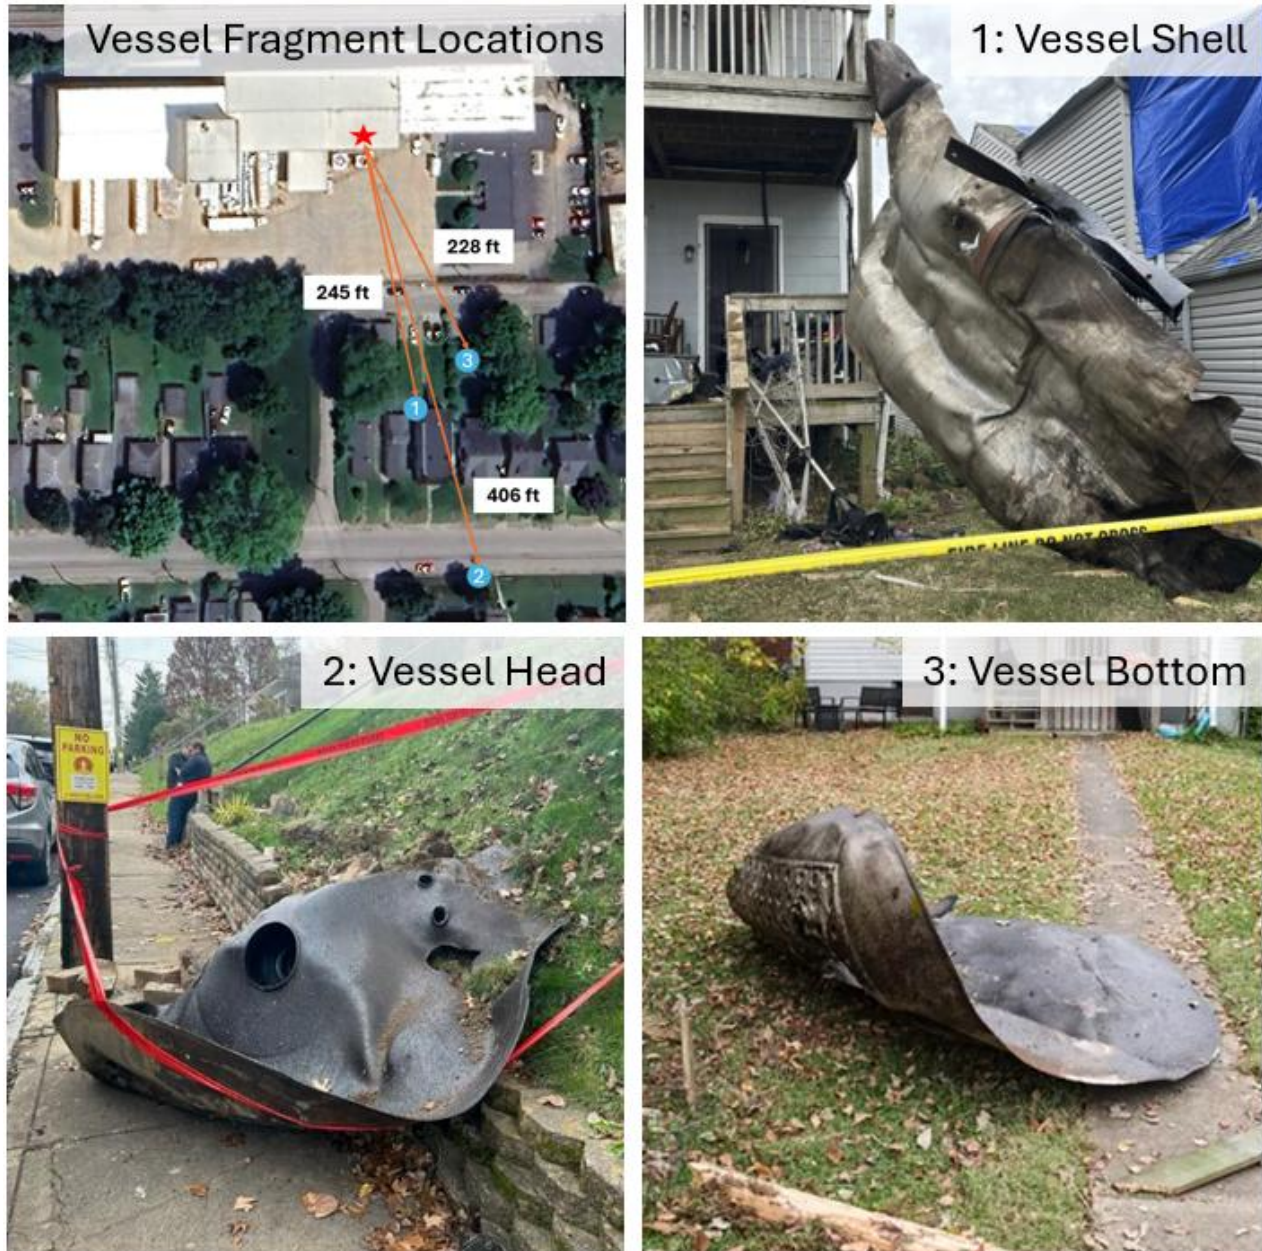
Figure 16. Locations of Reactor 6 debris scattered throughout the surrounding neighborhood. The vessel shell weighed about 2,000 pounds. (Credit: Map: Google Earth, annotated by CSB; Photo 1: Dylan Lovan, Associated Press via Louisville Public Media [9]; Photo 2: WDRB News [10]; Photo 3: Louisville Courier Journal [11])

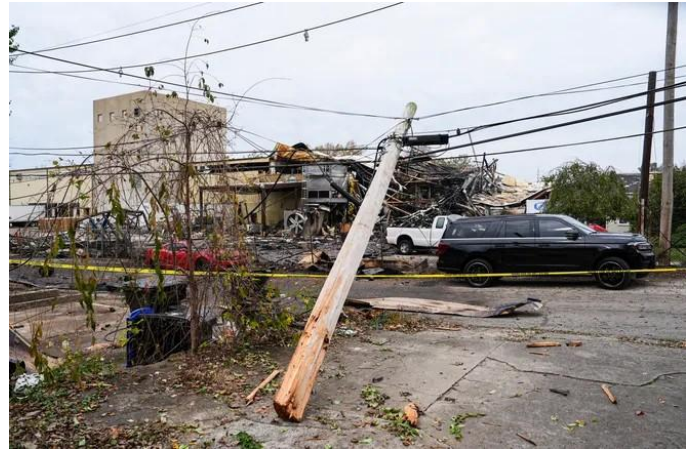
Debris and a downed power line (**Figure 17**) caused by the explosion prevented employees from evacuating to their planned emergency gathering location. Instead, employees who evacuated from the east side of the building remained together in a group to the east, and the employees who evacuated from the west side of the building remained together in a group to the west (**Figure 18**). The groups had no documentation with them detailing who had been inside the facility at the time of the incident, and they therefore relied on memory when conducting head counts to determine whether anyone was remaining in the building.

Figure 17. Damage to a nearby power line, which prevented employees from meeting at the planned muster location. (Credit: Matt Stone, Louisville Courier Journal [11])

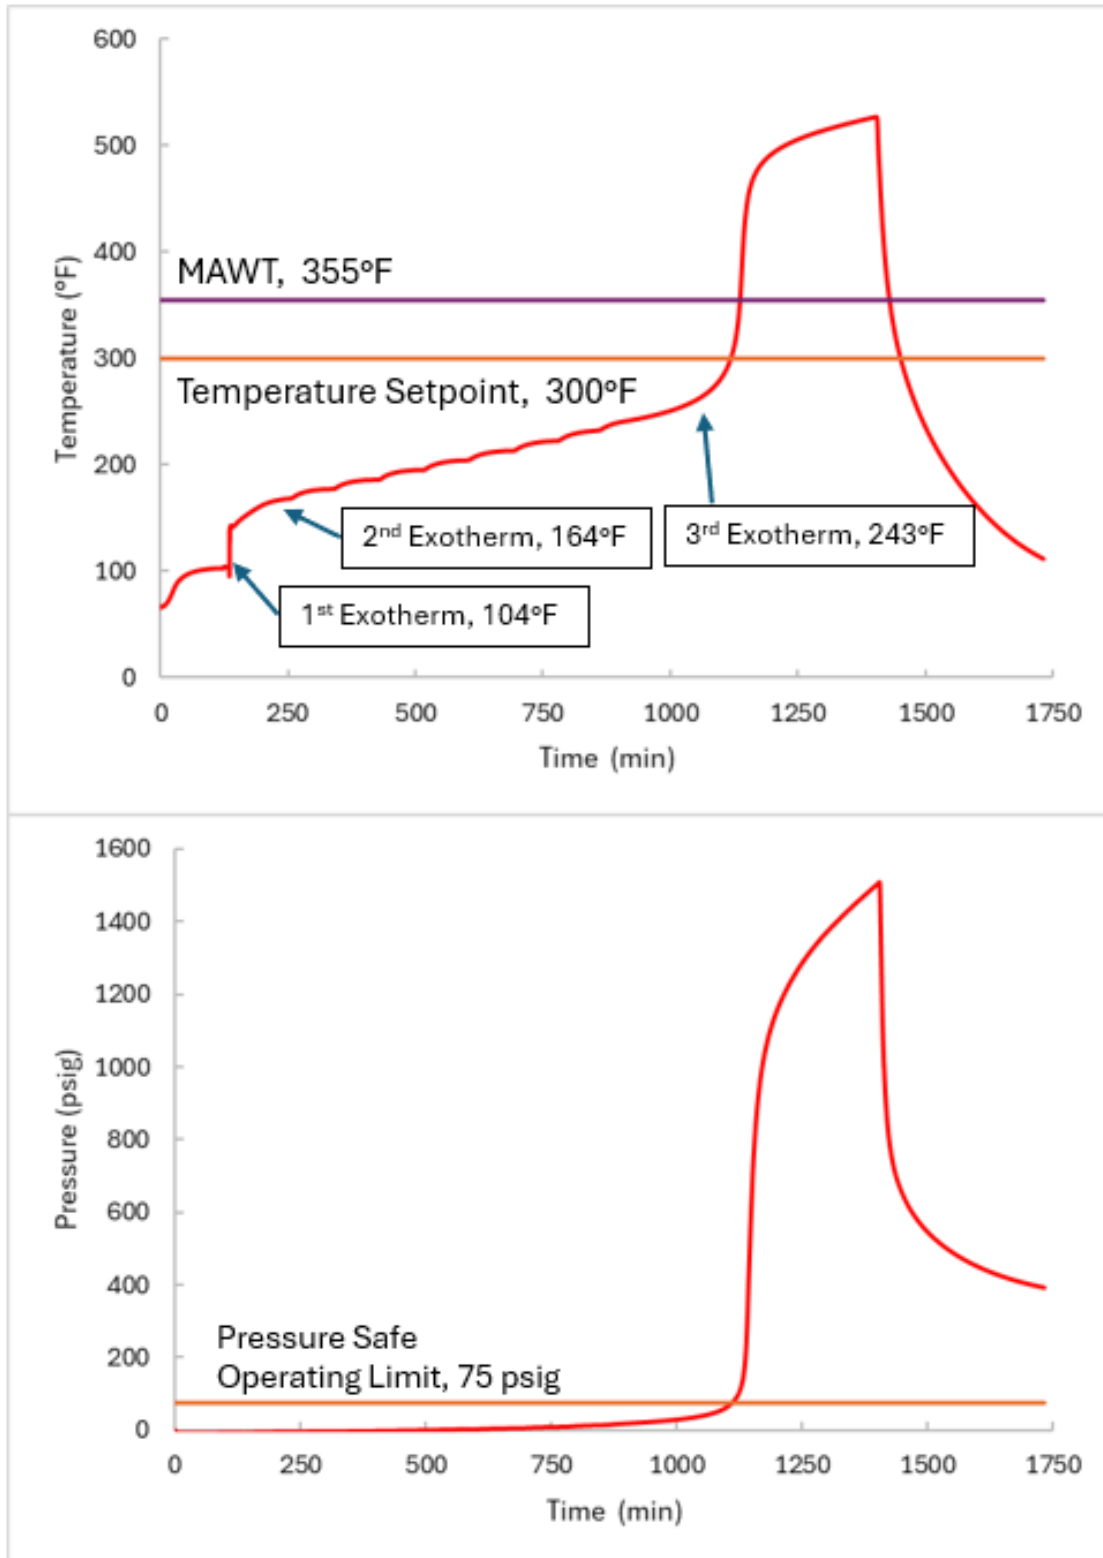
Figure 19. APTAC temperature and pressure versus time results for Reactor 6 mixture. The Reactor 6 MAWT, temperature set point on the day of the incident, and the pressure safe operating limit, are indicated. (Credit: CSB)

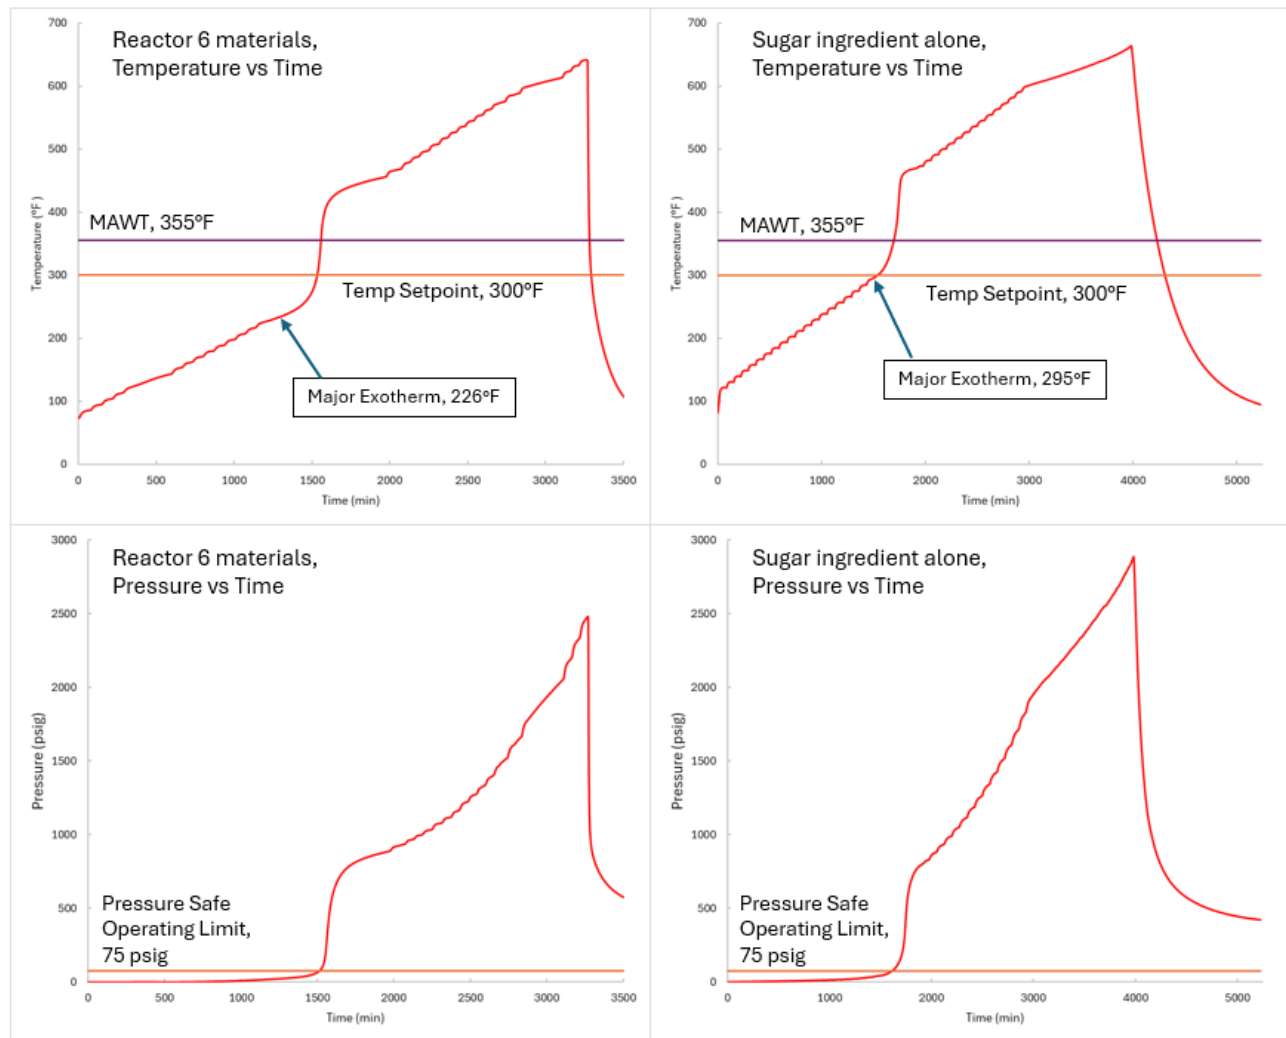
Additional reactivity tests were conducted on both the Reactor 6 mixture and the sugar ingredient alone using ARC^a to determine the extent to which each might have contributed to the runaway reaction in the reactor. The ARC temperature and pressure versus time results from both tests are shown in **Figure 20**. Both tests identified major exotherms^b beginning within the normal operating limits of the reactor, which generated high temperature and high pressure. Gas evolved from the materials during the tests, contributing to the observed pressure rise in each test. After the samples in each test were cooled, the non-condensable gas pressures were 490 psig (for the reactor mixture) and 419 psig (for the sugar ingredient alone). Similar to the previous calorimetry testing performed on the Reactor 6 mixture, the gas from each test was sampled and also determined to be predominantly carbon dioxide.

Figure 20. ARC temperature and pressure versus time test results for reactor mixture and sugar ingredient alone. The Reactor 6 MAWT, temperature set point on the day of the incident, and the pressure safe operating limit, are indicated. (Credit: CSB)

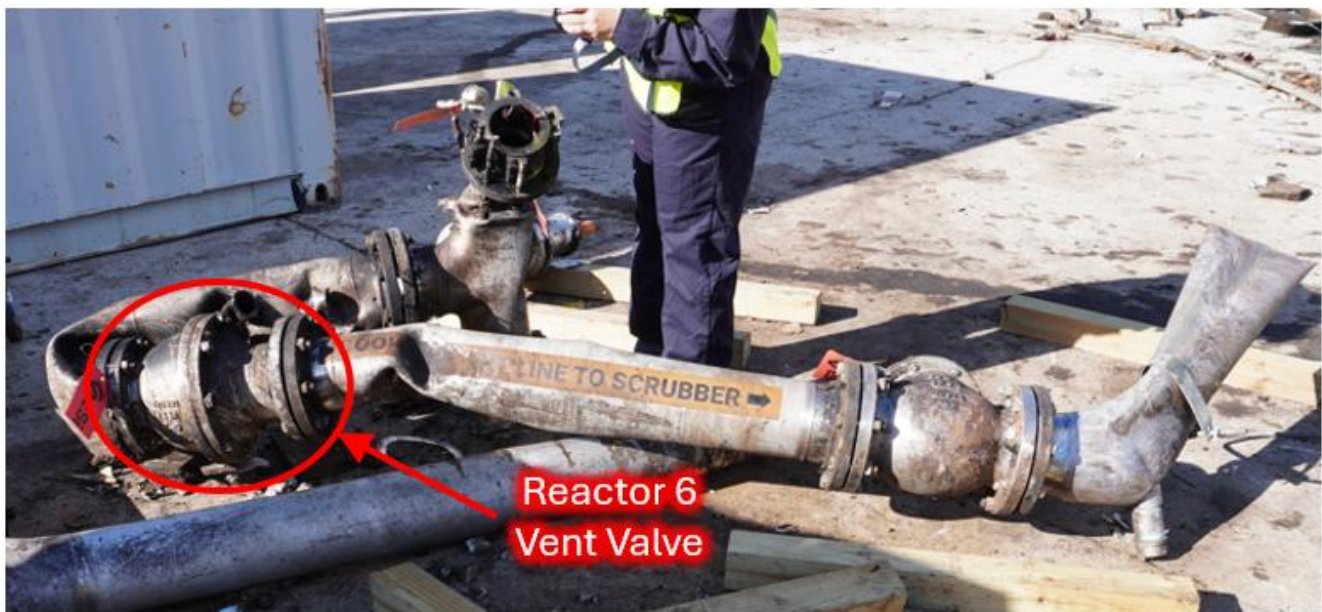
Surveillance footage indicates that the Reactor 6 vent valve was in the closed position leading up to the incident (*Section 2.2*). The vent valve was recovered after the incident, still connected to the vent piping (**Figure 22**), and post-incident inspection confirmed that the valve was in the closed position (**Figure 23**).

Figure 22. Reactor 6 vent valve attached to vent piping. Photo was captured after piping segment had been manually disconnected and relocated outside the building after the incident. (Credit: CSB)

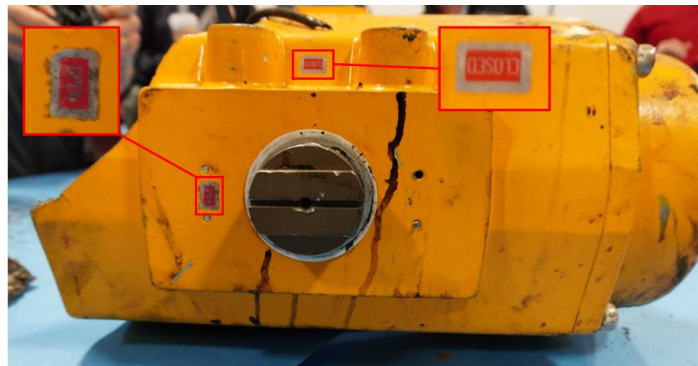
The Reactor 6 vent valve pneumatic actuator was located and recovered after the incident. The actuator was found disconnected from the vent valve, outside the building, approximately 165 feet from its original location, with a fractured case and missing internal springs on one side. Although damaged, the actuator was recovered in the open configuration, as shown by the position of the pinion indicator (Figure 24). The sticker to the left of the pinion is labeled “OPEN,” and the sticker above the pinion is labeled

Figure 24. Recovered pneumatic actuator from Reactor 6 vent valve (pinion indicator labels highlighted and enlarged). (Credit: CSB)

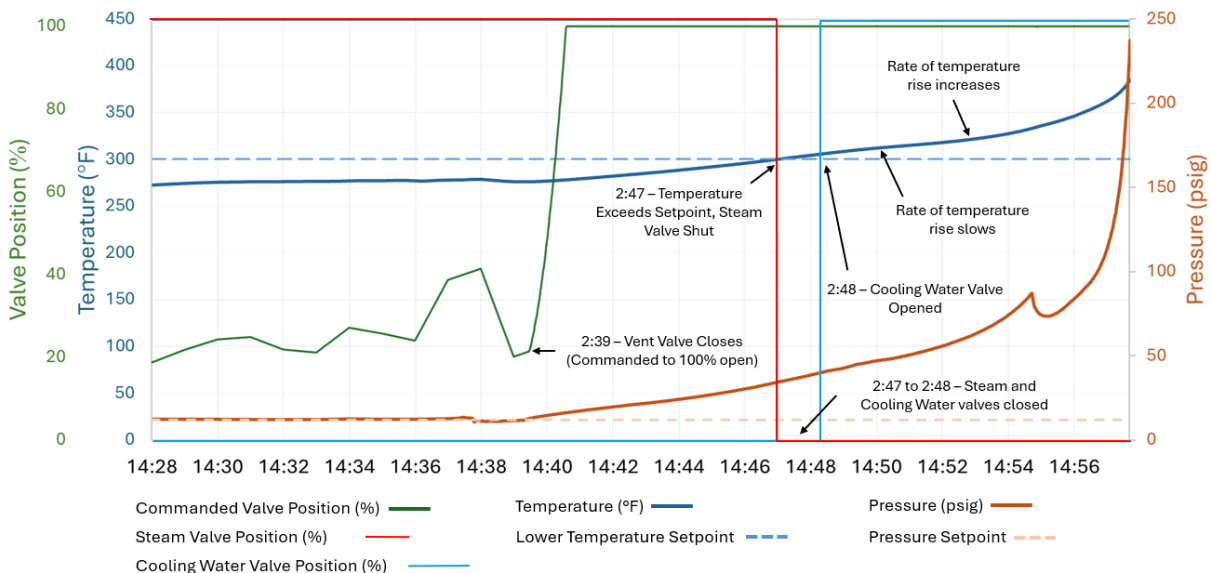
The temperature continued to rise for 9 more minutes until Reactor 6 ruptured at 2:57 p.m. The steam applied to the reactor coils, after the vent valve was closed, may have contributed to the acceleration of the decomposition reaction.

Figure 28. Reactor 6 temperature trend with valve commands on the day of the incident (Credit: CSB)

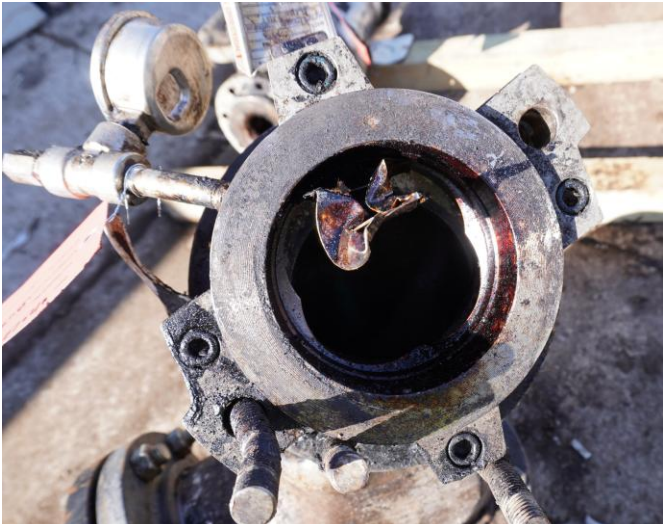
The Reactor 6 emergency pressure relief system components (rupture disc and pressure relief valve) were recovered after the incident. The rupture disc was found fully open, which is the expected position after activation. **Figure 30** shows the rupture disc as found.

Figure 30. Reactor 6 rupture disc as found post-incident, fully open. (Credit: CSB)

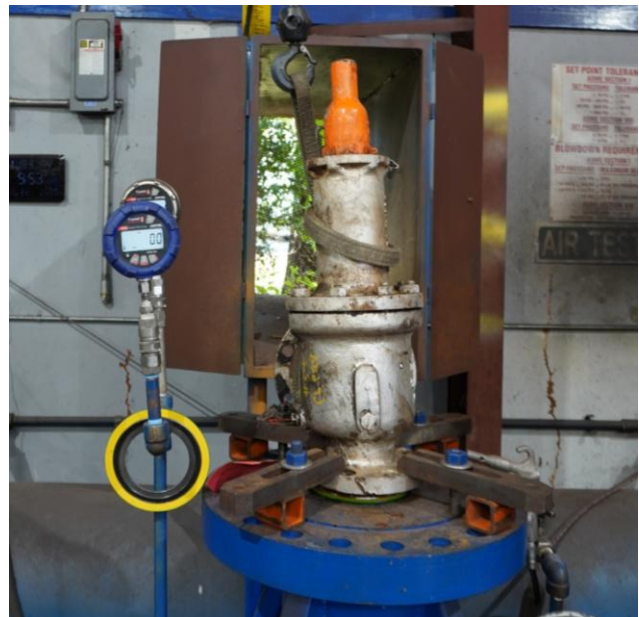
The CSB conducted testing of the recovered Reactor 6 pressure relief valve to determine whether it would activate at the correct set pressure as designated in the most recent service documents. The CSB conducted a “pop test” (**Figure 31**), which involved applying pressure to the closed pressure relief valve to determine the pressure at which it opened. The Reactor 6 pressure relief valve, however, sustained damage during the explosion, and as a result, the valve seat could not hold pressure to conduct the test. The CSB then disassembled the valve to inspect its internal components and found no obvious signs of malfunction.

Figure 31. Reactor 6 pressure relief valve set up on the testing stand for pop testing. (Credit: CSB)

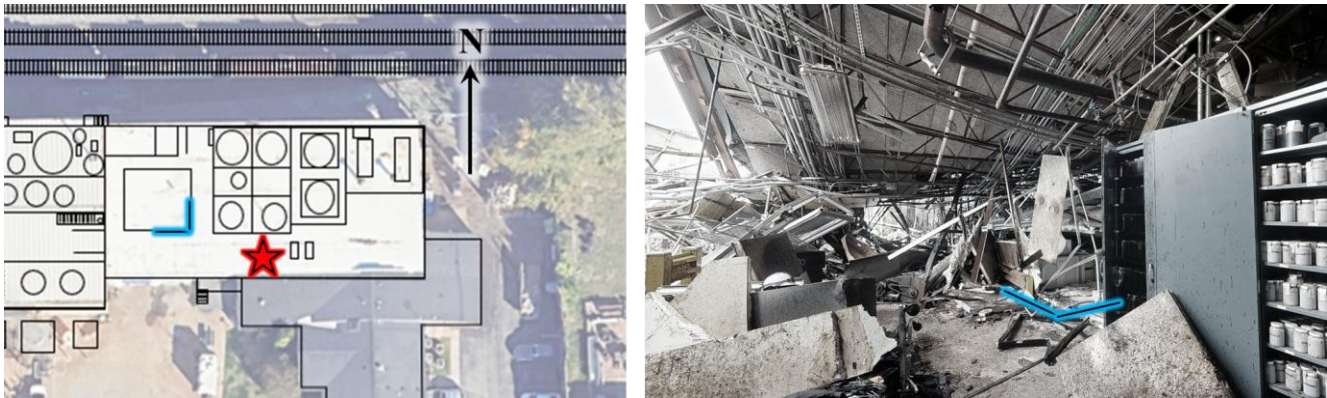
The two employees who died were fatally injured when the blast wave created by the bursting Reactor 6 damaged the control room where they were working, causing the control room to collapse on top of them. The control room was located just 40 feet from Reactor 6 and was not constructed to be blast-resistant.

to troubleshoot while Reactor 6 was in an unsafe condition and did not evacuate the building. Also contributing to the severity of the incident was the lack of a facility siting analysis for the location of the control room, which was situated near the reactor and constructed without blast protection.

Figure 37. The collapsed control room at the Louisville facility after the incident. The red star in the left photo is approximately the camera perspective for the right photo, with the southeast corner of the control room indicated by blue highlighted lines. (Credit: Givaudan and Google Earth, annotated by CSB)
