DATE: JULY 22, 2025

INCIDENT REPORTS

EVENTS REPORTED TO THE CSB UNDER THE ACCIDENTAL RELEASE REPORTING RULE

U.S. Chemical Safety and
Hazard Investigation Board

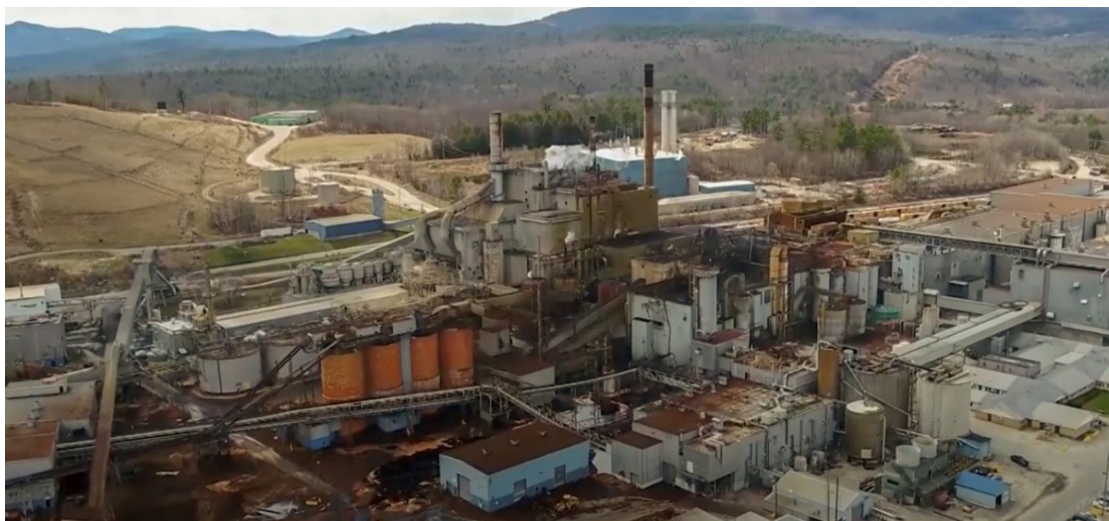
Figure 1. Post-incident image of the Pixelle paper mill in Jay, Maine (Credit: WMTW)

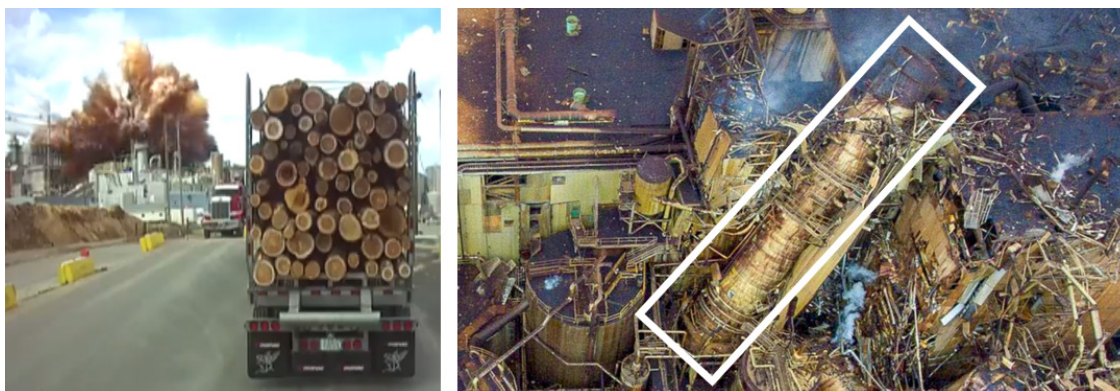
Figure 2. Explosion (left), and the bottom of the remaining portion of the pulp digester (right). (Credit: Richard Carrier Trucking via WMUR 9 (left), and Pixelle (right))

Pixelle's investigation found that the digester failed while operating within the normal pressure and temperature range. The company's metallurgical examination revealed that the pressure vessel failed along a weld seam joining two sections of carbon steel plate in its shell. Extensive preexisting cracks were found throughout the area where the digester failed. These cracks were caused by caustic stress corrosion cracking, a damage mechanism known to occur in pulp digesters. Cracking was located along weld fusion lines and in weld heat-affected zones. The failure-initiating crack was found to have breached roughly 70 percent of the vessel's wall thickness. At that point, the normal operating temperature and pressure stretched the remaining metal to failure, initiating the explosion as the crack propagated through the wall and into adjacent wall sections, as the digester catastrophically ruptured.

Pixelle's investigation identified many preexisting cracks in the digester near welds with high metal hardness. The company concluded that these welds were from vessel repairs where the heat was not controlled during or after the welding or from poor welding practices.

Based on Pixelle's investigation, the CSB determined that the probable cause of the incident was the catastrophic failure of a large pressure vessel that served as a pulp digester. The digester failed from extensive caustic stress corrosion cracking along weld seams in the vessel's carbon steel shell. The facility's mechanical integrity program lacked effective inspection and weld repair practices, contributing to the incident.

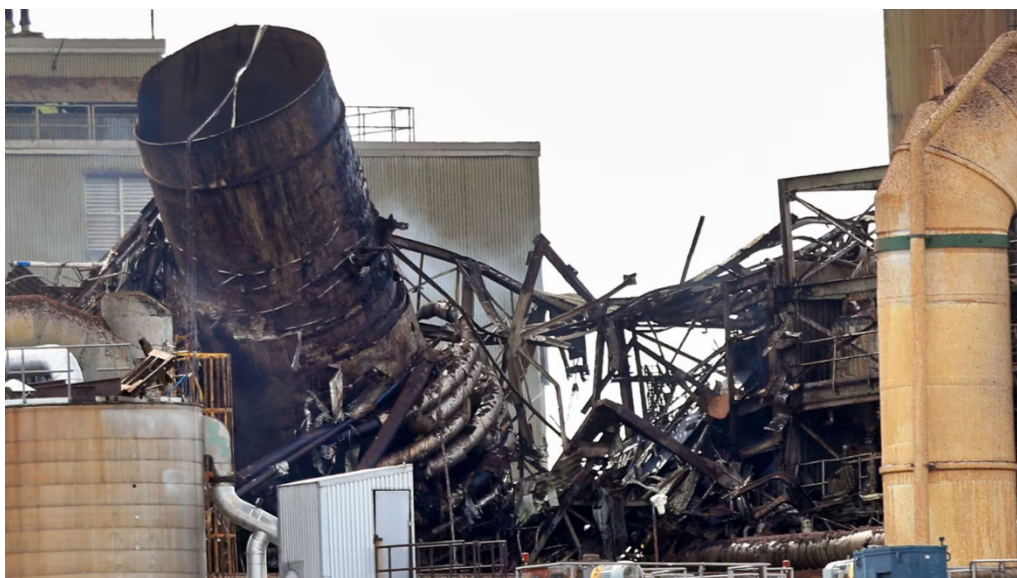
Figure 3. Damaged equipment at the Pixelle paper mill. (Credit: Robert F. Bukaty/AP)

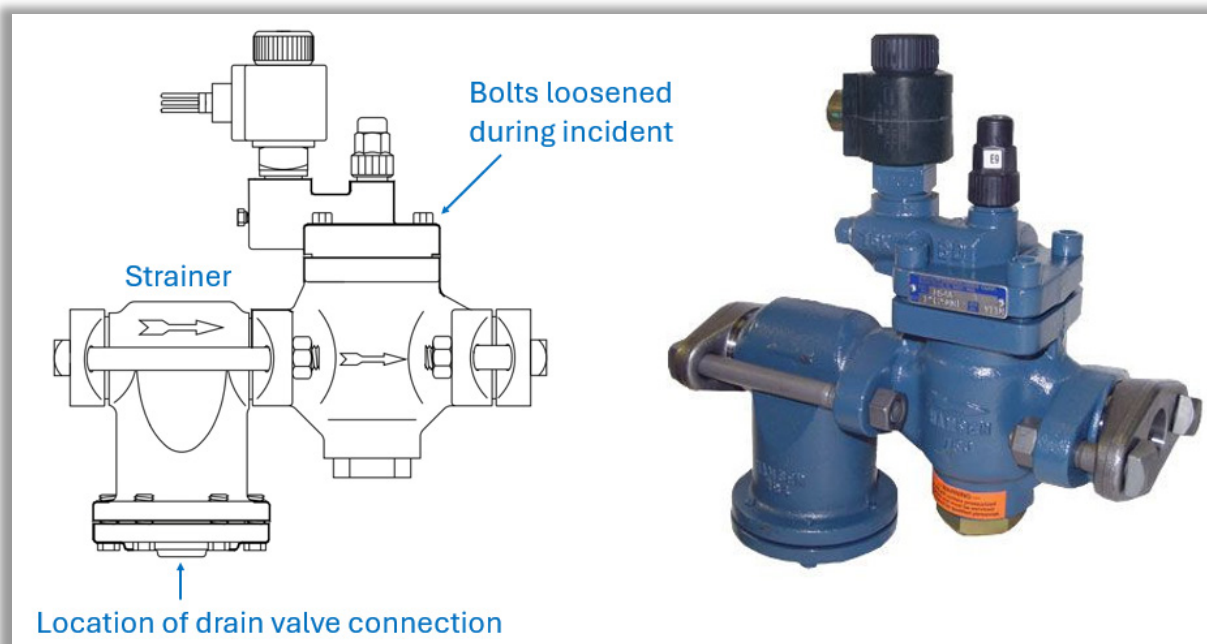
Tyson Foods’ investigation found that its procedure for opening ammonia equipment required depressurizing the strainer by connecting a hose to the strainer’s drain valve (**Figure 2**) and directing residual ammonia into a water drum to absorb the ammonia. On this occasion, the technician did not connect a hose to the strainer because the drain valve’s plug was damaged, and the technician could not remove it. Tyson Foods’ investigation concluded that had the strainer plug been in good condition, the technician could have used the drain valve to direct the residual ammonia into water, which should have prevented the incident.

Figure 2. Schematic of strainer assembly. (Credit: Hansen Technologies Corporation and Keep Supply, modified by CSB)

Based on Tyson Foods' investigation, the CSB determined that the probable cause of the incident was opening equipment while it was pressurized with anhydrous ammonia. The damaged condition of the strainer's drain valve plug prevented the technician from depressurizing the equipment through the drain valve and into a water drum, contributing to the incident. Not wearing respiratory protection during the equipment opening work contributed to the severity of the incident.

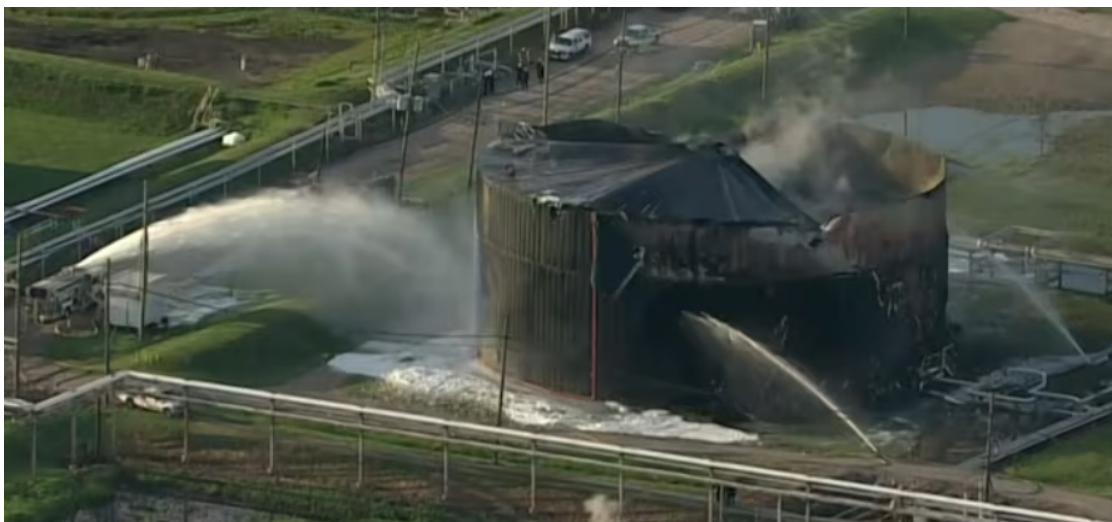
Figure 1. The damaged storage tank at the Chevron refinery. (Credit: KHOU 11)

The storage tank was designed to hold vacuum residuum, the heaviest crude oil fraction from the bottom of the refinery's vacuum distillation column. On the morning of the incident, high-pressure conditions developed inside the tank, tearing the top of the tank open along its frangible roof seam. A frangible roof seam is an intentionally weaker roof-to-shell weld that will preferentially tear open to relieve pressure before other welded joints when the tank is overpressurized. As the hot hydrocarbon escaped from the open roof, a fire erupted. Emergency responders extinguished the fire in approximately 36 minutes.

Chevron's investigation found that after power was restored and the crude unit was restarted on the morning of the incident, a flow restriction in the vacuum tower bottoms coolers resulted in hotter material being directed into the storage tank. The combination of this hotter and lighter hydrocarbon material inside the storage tank created high-pressure conditions that overwhelmed the tank's atmospheric vents, causing the top of the tank to tear open along the seam of the frangible roof. The fire was likely ignited by a spark produced by metal-to-metal contact when the roof seam opened.

Based on Chevron's investigation, the CSB determined that the probable cause of the incident was combining hot heavy hydrocarbons (vacuum residuum) with lighter hydrocarbons (crude oil) in a tank designed to store heavy hydrocarbon liquids. The heating of the lighter hydrocarbon material generated vapor that pressurized the storage tank and ultimately ripped its frangible roof open. The flammable hydrocarbons were likely ignited by a spark created by metal-to-metal contact when the roof separated at its seam, resulting in the fire. The lack of sufficient safeguards to prevent sending materials into a storage tank not designed to contain them contributed to the incident.

at elevated temperatures, so additional safeguards were necessary to prevent these materials from being added. The company's investigation recommended conducting a hazard analysis to identify and implement safety measures to keep light hydrocarbons out of this storage tank.

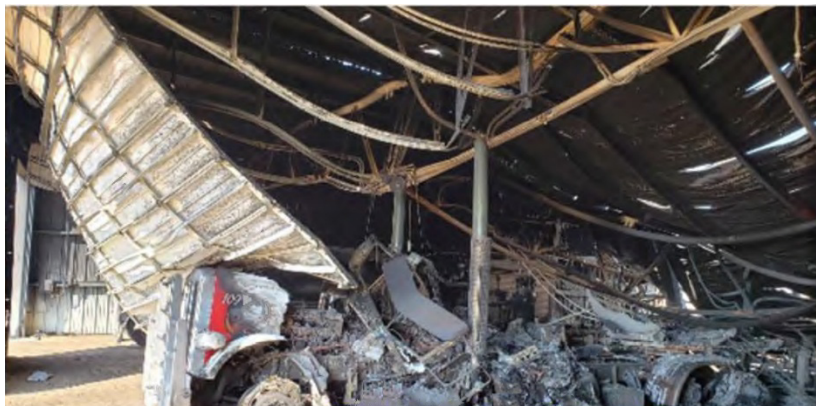
Figure 1. Post-incident image of the truck and the loading rack at the Silver Eagle refinery. (Credit: Silver Eagle, modified by CSB)

Silver Eagle's investigation determined that high-pressure conditions developed while loading Compartment 2 with liquid diesel fuel because the air-operated vapor recovery valve to the flare was closed. With no open path for the displaced vapor to flow to the flare system, the pressure inside Compartment 2 increased and ultimately activated the truck's emergency pressure-relief system (set at 3 pounds per square inch), which directed the flammable vapor above the truck but within the enclosed building, forming a vapor cloud. The flammable vapor then ignited, triggering the explosion and fire.

In addition, Silver Eagle's investigation also evaluated several potential ignition sources, concluding that the building's overhead lighting or the electrical wiring for these lights was the most likely ignition source. The company's investigation also identified that the building's electrical classification was based on an outdoor hazardous area (well-ventilated) classification rather than on indoor requirements.

Based on Silver Eagle's investigation, the CSB determined that the incident was caused by high-pressure conditions that developed in Compartment 2 during loading, due to the air-operated vapor recovery valve being closed because the truck's compressed air system lacked sufficient pressure to keep the valve open. Ultimately, the increasing pressure activated the truck's pressure relief device, which discharged excess vapor from Compartment 2 into the air above the truck, but inside the building. The released flammable hydrocarbon formed a vapor cloud that was most likely ignited by an overhead light or its electrical wiring, triggering the explosion.

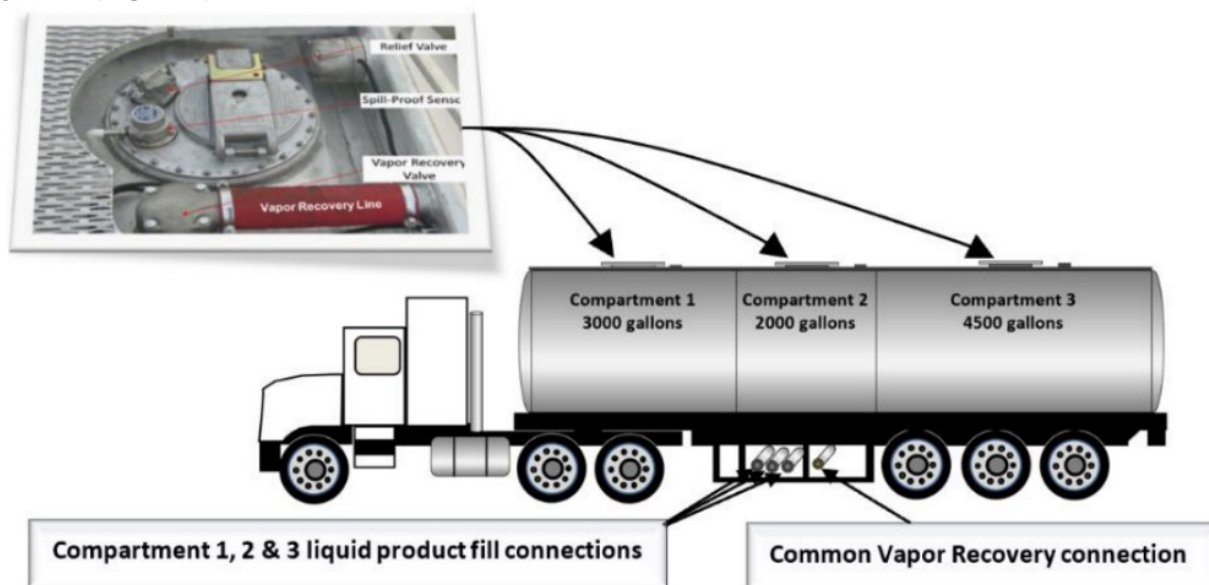
Figure 2. The truck's compartments and hose connections. (Credit: Silver Eagle)

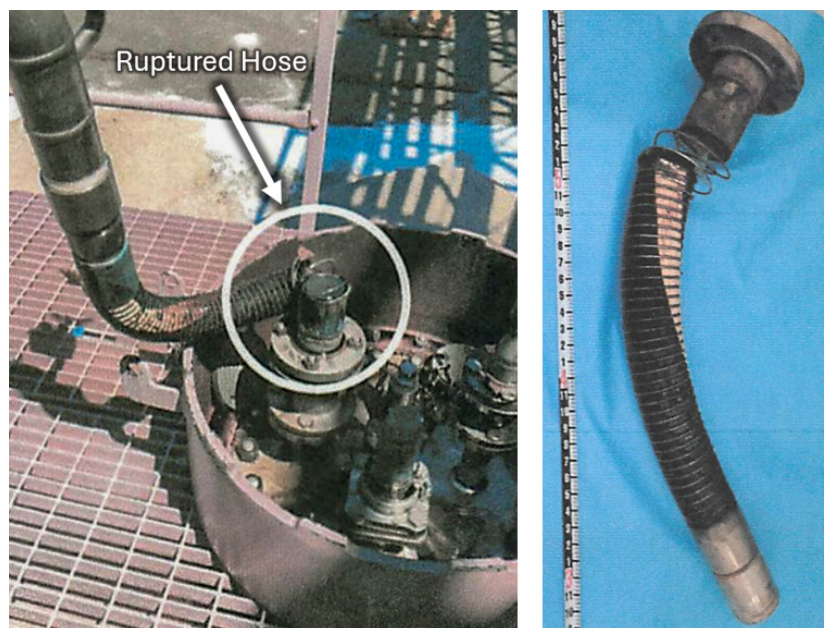
The operator opened a valve to begin the transfer. Immediately after opening the valve, the flexible hose ruptured (**Figure 2**), spraying the operator and the surroundings with liquid oleum. The operator's personal protective equipment (PPE) did not protect him from being sprayed with corrosive oleum. For example, the fire-resistant clothing fibers absorbed the acid, allowing it to contact his skin. The release blocked the operator's path to the tank car's ladder. The operator jumped from the tank car to the ground and ran to a nearby building, where emergency responders initially treated him. The operator was then transported by helicopter to a regional burn center, where he was admitted for treatment of chemical burns. There was no remotely operated isolation valve capable of stopping the release, and the oleum continued to release from the hose for 73 minutes. At 8:35 a.m., FutureFuel emergency responders manually closed the valve, stopping the release.

Figure 2. Ruptured Hose. (Credit: FutureFuel)

FutureFuel's investigation determined that the failure of the incident hose occurred at the connection to the flange fitting because the hose's chemically protective inner fluoropolymer layer was damaged. This damage may have occurred due to creep during nearly seven years of storage or from a manufacturing defect, such as during the fitting's attachment. As a result, the compromised fluoropolymer layer allowed oleum to contact and degrade the structural layers of the hose, ultimately leading to its failure. Following the incident, FutureFuel eliminated the flexible hose connection and added a remotely operated isolation valve.

Based on FutureFuel's investigation, the CSB determined that the probable cause of the accidental release was the catastrophic failure of a flexible polymer hose during the oleum transfer operation. Damage to the hose's chemically protective layer allowed oleum to come into contact with and degrade its structural layers, leading to the hose's failure. Not wearing PPE that could protect the operator from corrosive oleum exposure and the lack of a remotely operated isolation valve contributed to the severity of the incident.

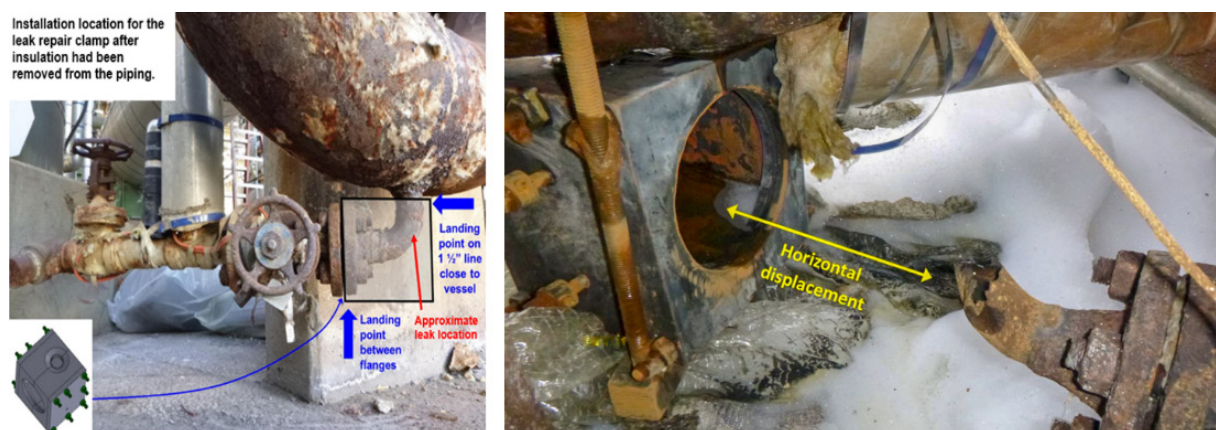
Figure 2. Pre-incident (left) and post-incident (right) images of the drain piping and clamp. (Credit: PBF Energy)

PBF Energy's investigation found that during the installation of the leak repair clamp, a grinder was used to reduce the size of the clamp's horizontal support to enable the clamp to fit. Because this modification effectively removed the clamp's horizontal support, the contractor informed PBF Energy that they planned to design and install a different type of support later. The investigation also revealed that when the clamp continued to leak, the contractor had likely applied too much sealant pressure within the clamp. PBF Energy's investigation concluded that high sealant pressure during the injection without adequate horizontal clamp support stretched and broke the drain piping.

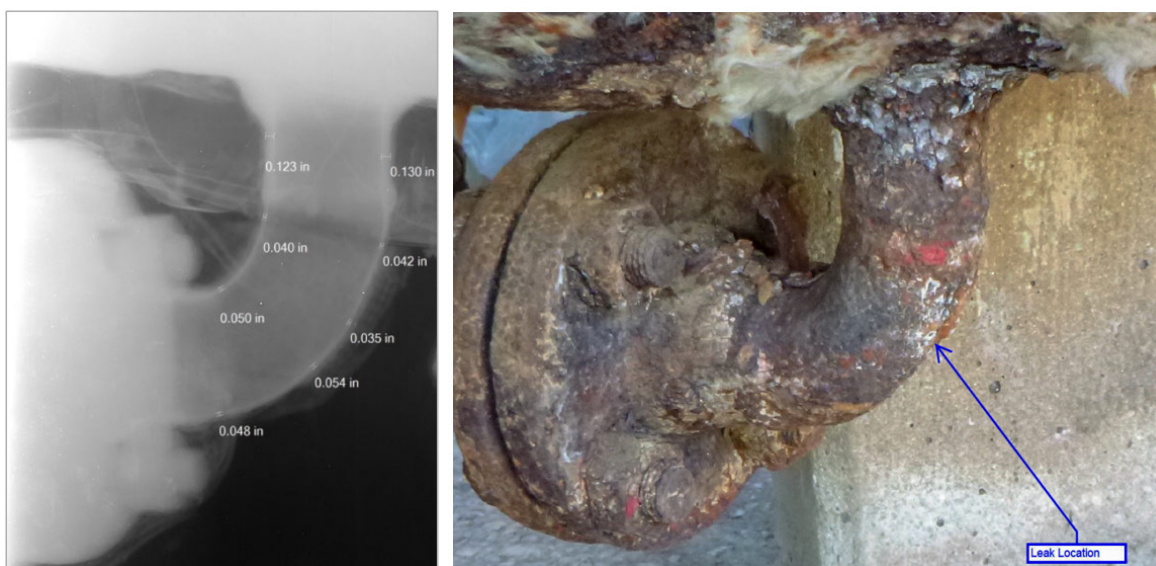
PBF Energy's investigation determined that the drain piping was installed in 1967 and was considered an essential deadleg—necessary piping that does not usually have flow through it. In 2011, the drain piping still had over 80 percent of its original wall thickness. However, an inspection on November 11, 2021, revealed that the drain piping was severely corroded (**Figure 3**).

Figure 3. Pre-incident x-ray (left) and photo (right) of the drain piping. (Credit: PBF Energy)

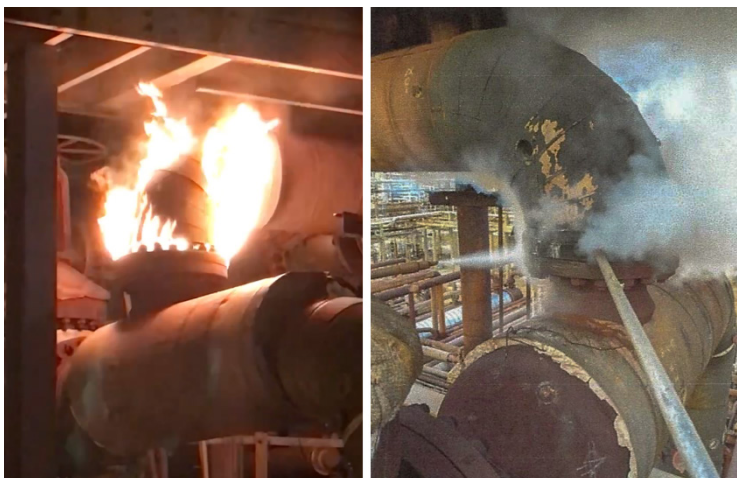
ExxonMobil's investigation found that on December 21, 2021, two days before the incident, there was a fire at a 14-inch flange in a hydrodesulfurization unit at the refinery (**Figure 2**). The flange was on a piping elbow that was part of a reactor system. ExxonMobil personnel extinguished the fire using steam lances and continued applying steam to prevent the hydrocarbon vapor from igniting. The next day, refinery personnel examined the piping and concluded there was a leak on the 14-inch flange. At this location, the process temperature is more than 600 degrees Fahrenheit, far above the autoignition temperature of the flammable hydrocarbons. ExxonMobil

Figure 2. Fire on December 21, 2021 (left) and steam lances being used to keep the released naphtha from catching on fire (right). (Credit: ExxonMobil)

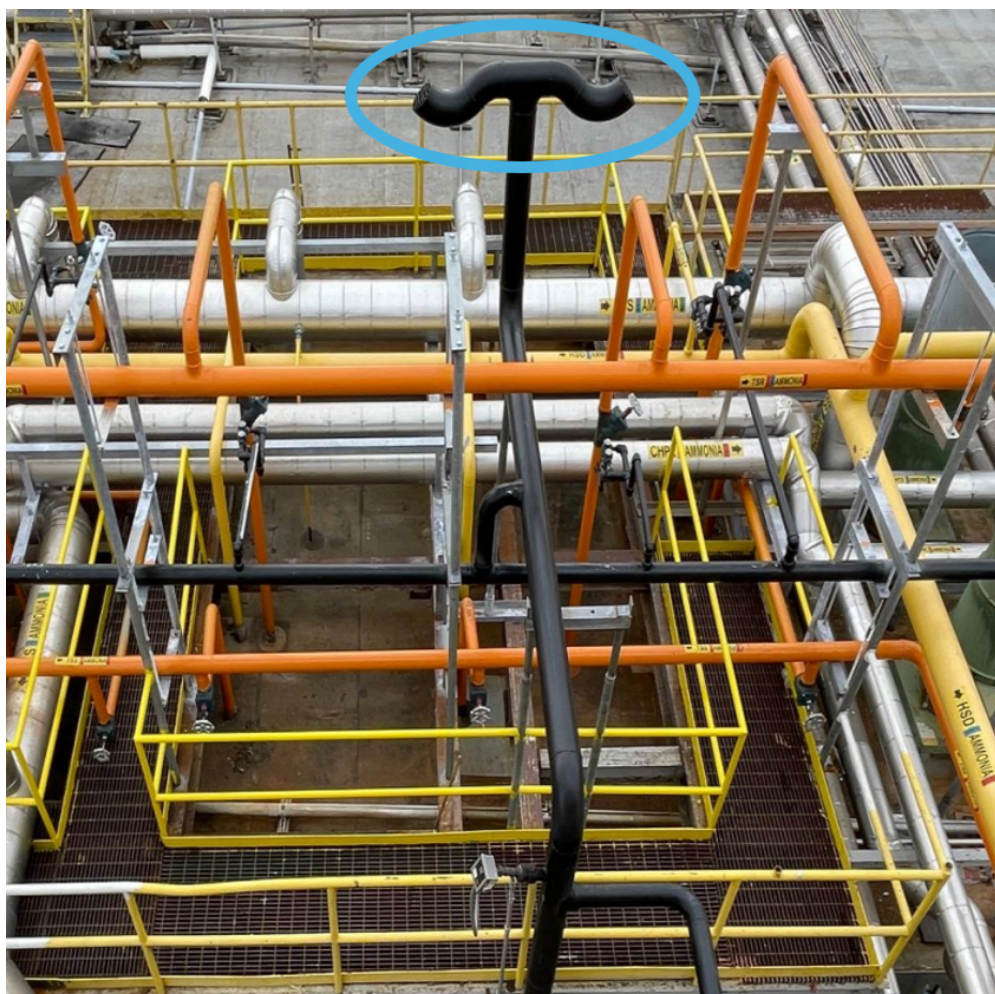
containing ammonia. The relief system's atmospheric vent piping was located above a working platform near two compressor room exit doors. After the incident, Pilgrim's redesigned the relief system piping to discharge ammonia vapor at a higher location, further away from the compressor room's exit doors.

Figure 2. Discharge location (blue oval) from relief system piping. (Credit: Pilgrim's)

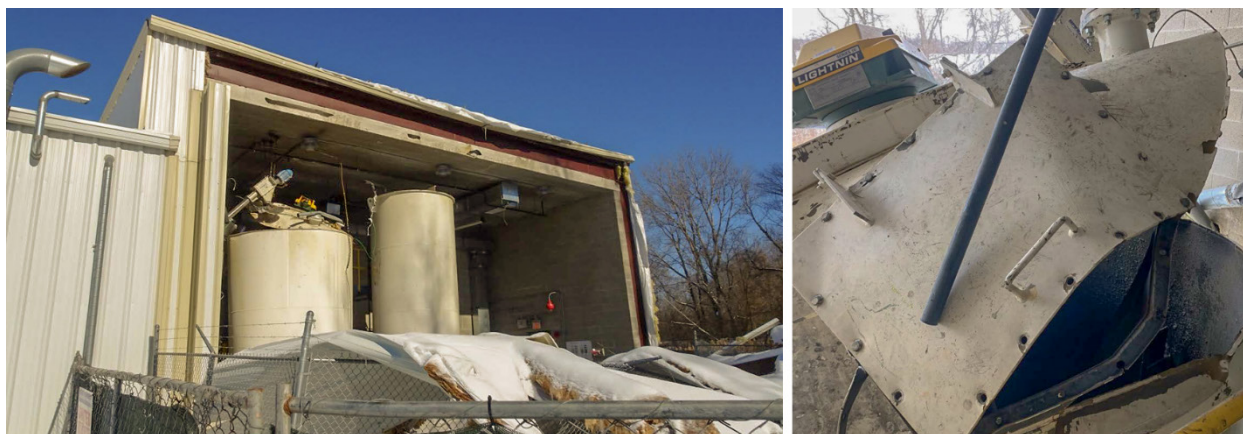
During this cleaning activity, the vapor in the tank ignited and exploded. The explosion damaged the tank and blew out the room’s sacrificial wall, which was designed to vent the pressure from an explosion (**Figure 2**). The worker vacuuming the dust was fatally injured by the explosion. The other employee sustained chemical and thermal burns and was transferred and admitted to a hospital for treatment.

Figure 2. Damage from the explosion. (Credit: WR Meadows)

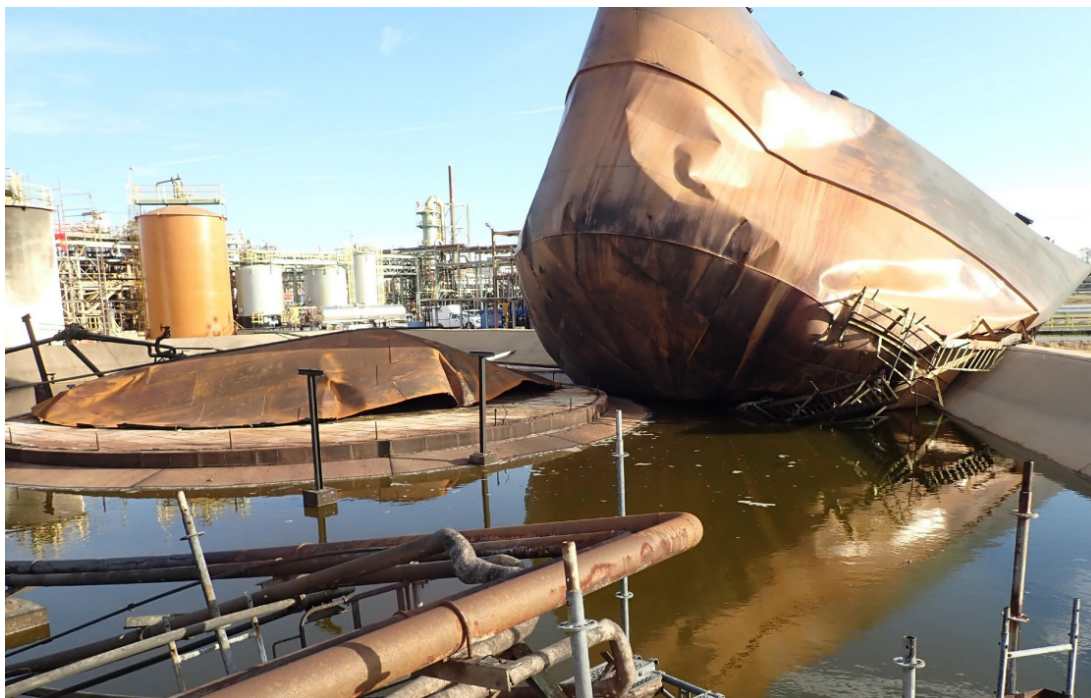
During the removal work, the contract workers used a battery-powered reciprocating saw to cut bolts connecting the nitrogen pressure regulator to its supply piping. One worker saw a small flame at one of the holes in the tank’s roof. In response, all the workers evacuated from the tank and went to a nearby maintenance shop, where they called the control room and notified the operators. About three minutes later, at approximately 10:45 a.m., the tank exploded, fully separating from its base (**Figure 2**). About 3,000 pounds of residual ethylene dichloride were burned in the subsequent fire.

Figure 2. The tank after the explosion. (Credit: Westlake)

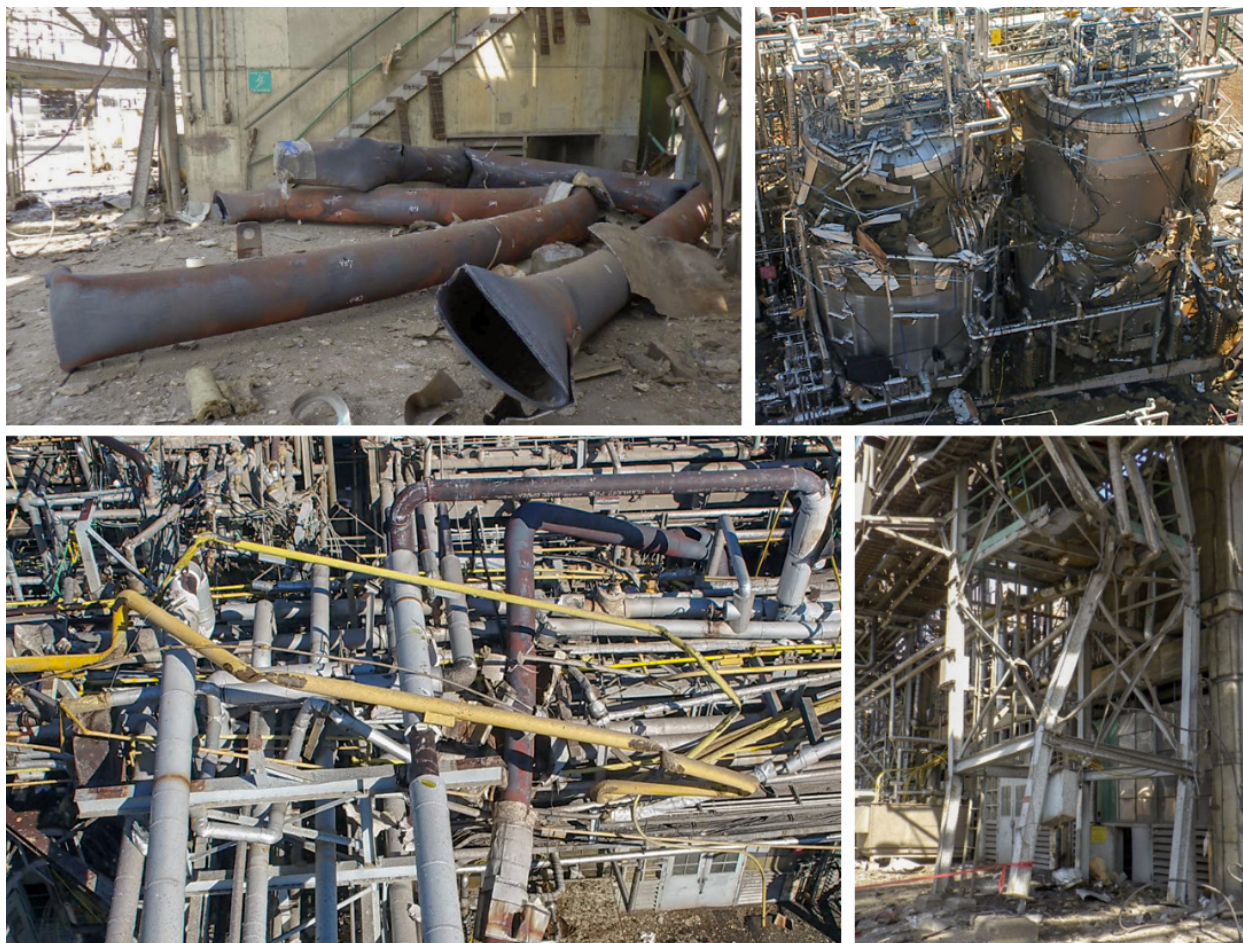
On the day of the incident, an elbow in a section of carbon steel piping that contained steam at 600 psig and 750°F ruptured. The elbow was forcefully ejected, releasing steam from both ends of the pipe. The incident caused extensive damage to the surrounding equipment (**Figure 2**). The area of the facility where the incident occurred was shut down from the loss of steam, and other areas were impacted by the loss of other utility systems, including electrical power, river water, plant air, and instrument air. Additionally, because the steam piping was insulated with asbestos, asbestos fibers were released into the neighboring community as a result of the explosion.

Figure 2. Property damage at Eastman. (Credit: Eastman)

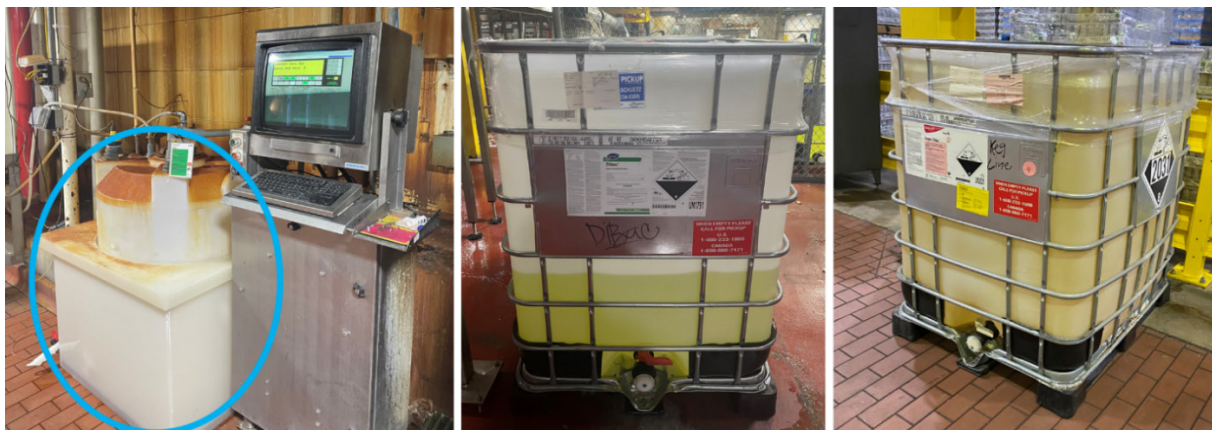
Figure 2. Photos showing the bleach solution tank (blue circle - left), a bleach solution tote (middle), and an acid solution tote (right). (Credit: Blues City Brewery, modified by the CSB)

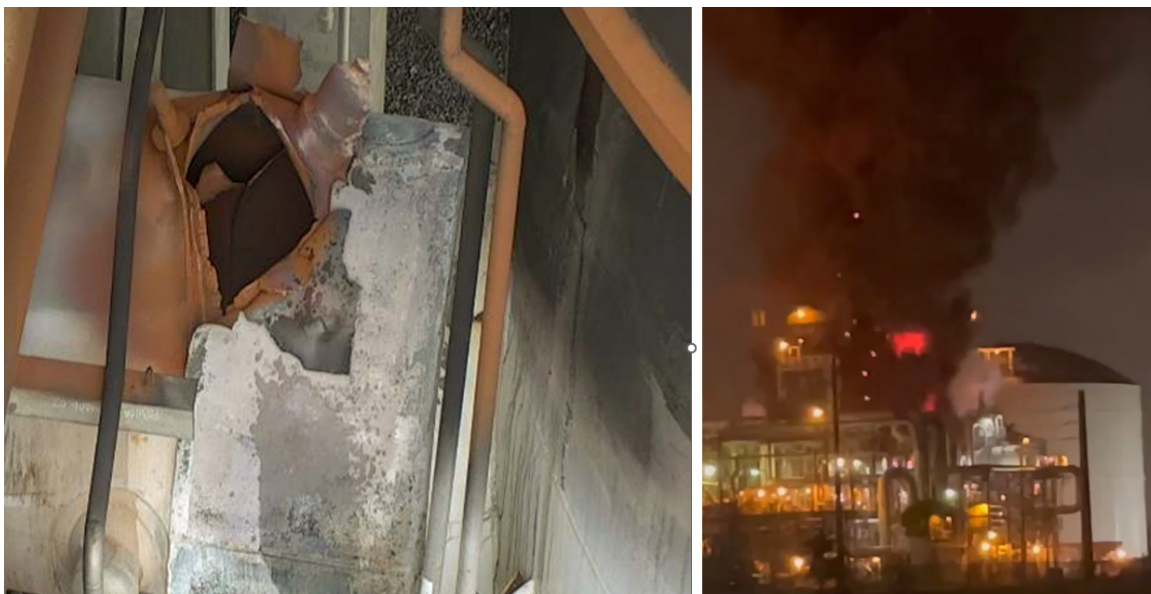
Figure 2. Transition pipe rupture (left) led to a large fire (right). (Credit: Dyno Nobel)

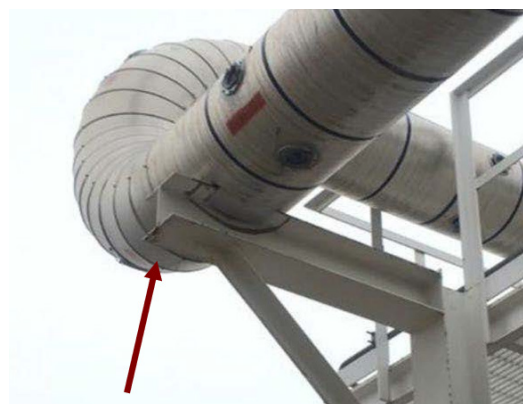
Figure 2. A pre-incident photo showing the approximate failure location. (Credit: ONEOK, modified by CSB)

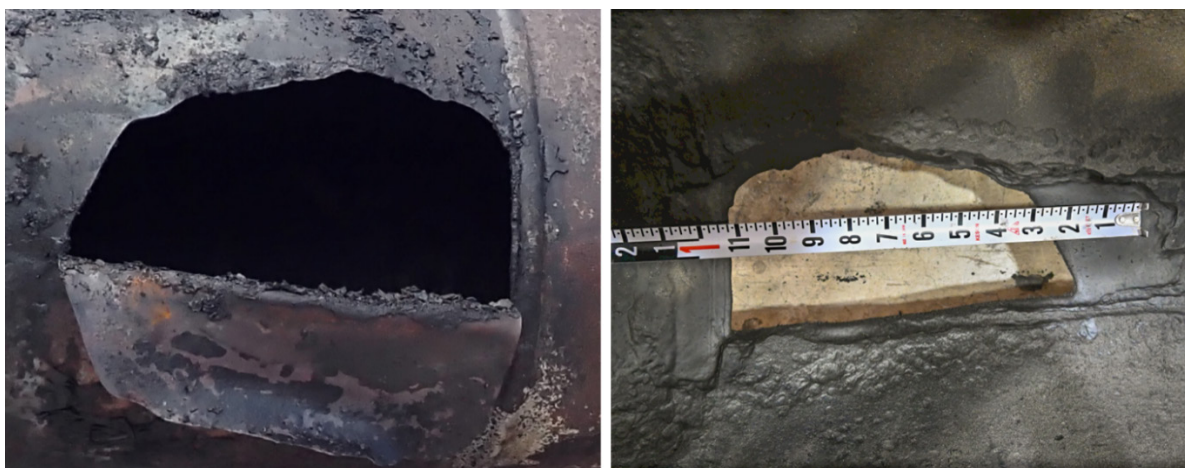
Figure 3. Post-incident photos of the ruptured 12-inch piping. The left image shows the outside, and the right image shows the inside of the piping. (Credit: ONEOK)

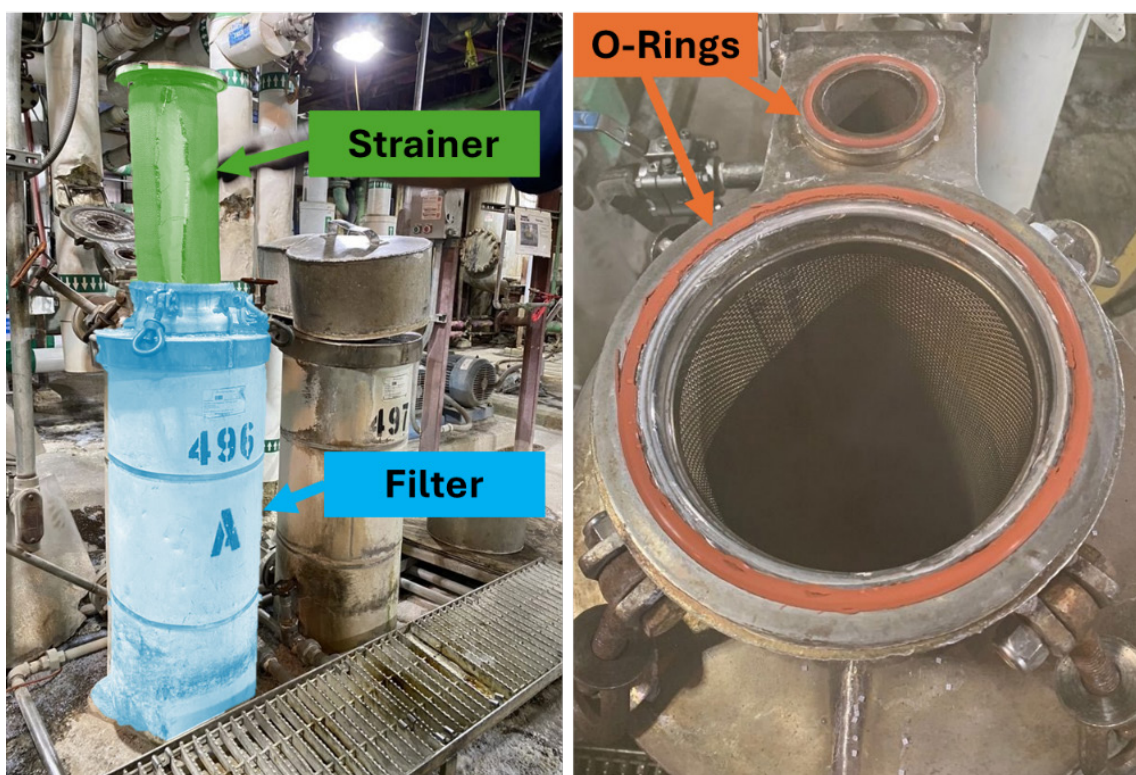
Figure 1. The left image shows a filter housing (blue) and the filter’s bag and strainer (green). The right photo shows the O-rings (orange) at the top of the filter’s opening. (Credit: Advansix, modified by CSB)

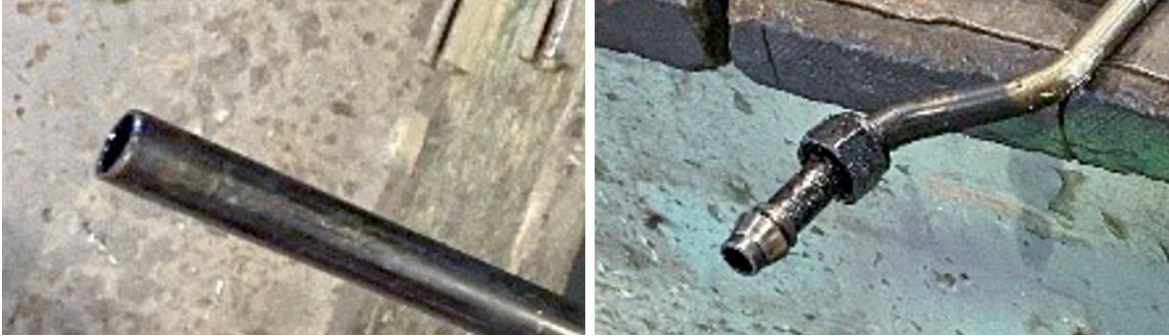
Figure 2. Post-incident photo of the flow transmitter's tubing connections. The left image shows the tube pulled out of its compression fitting. The right image shows the flow transmitter's other tubing with the compression fitting in place. (Credit: HF Sinclair)

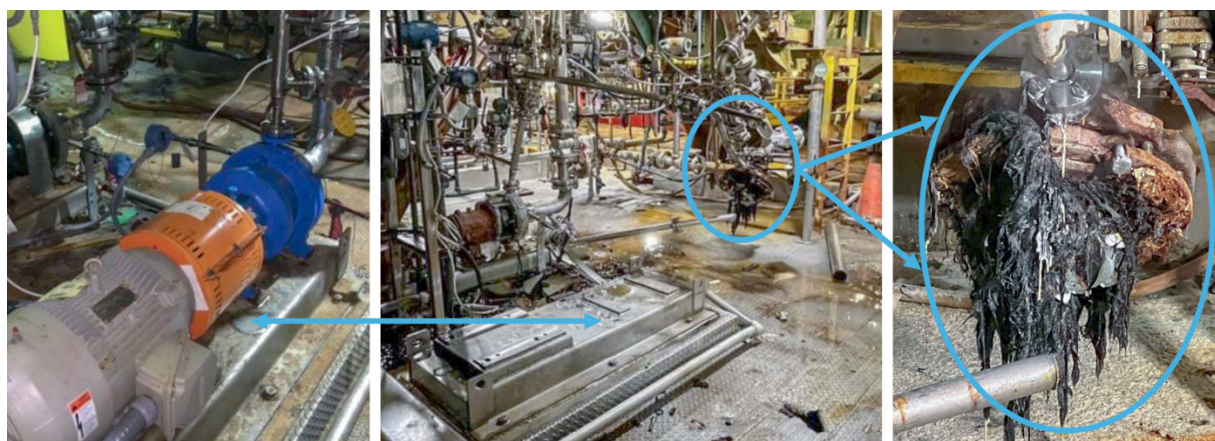
Figure 2. The nitric acid pump before (left photo) and after (middle and right photos) the explosion. (Credit: SABIC)

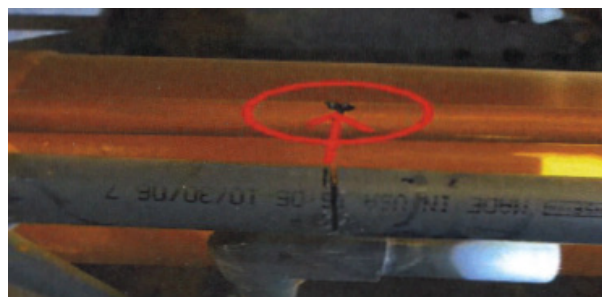
Figure 1. The cuts in the old CPVC pipe and the ½-inch ammonia pipe (Credit: Hilmar)

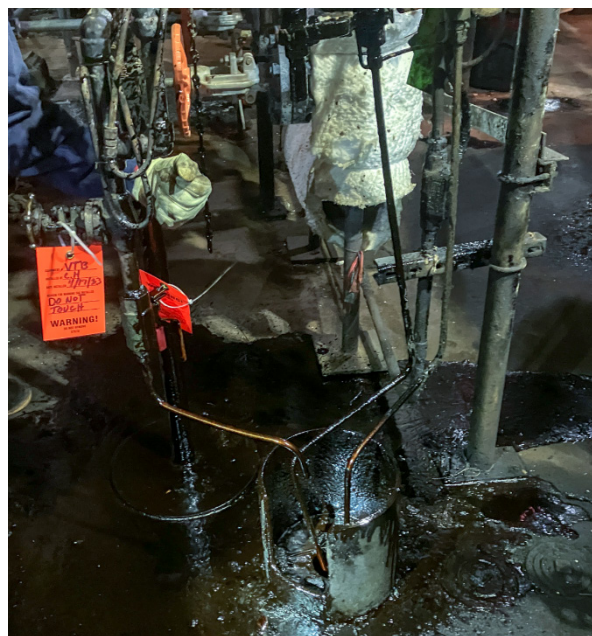
Figure 2. Post-incident image of the VTB release and sampling equipment. (Credit: Delek)

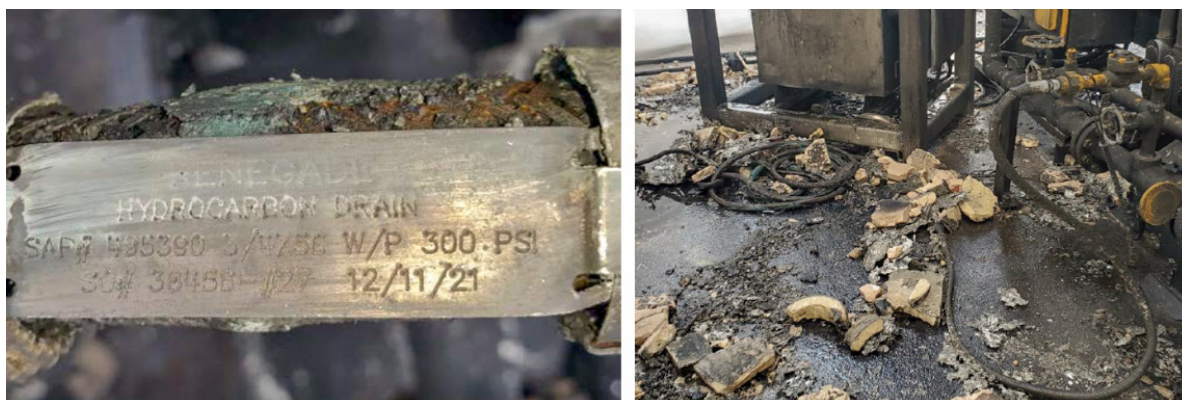
Figure 2. Post-incident image of the tag (left) on the hose to the flare system (right).
(Credit: Valero)

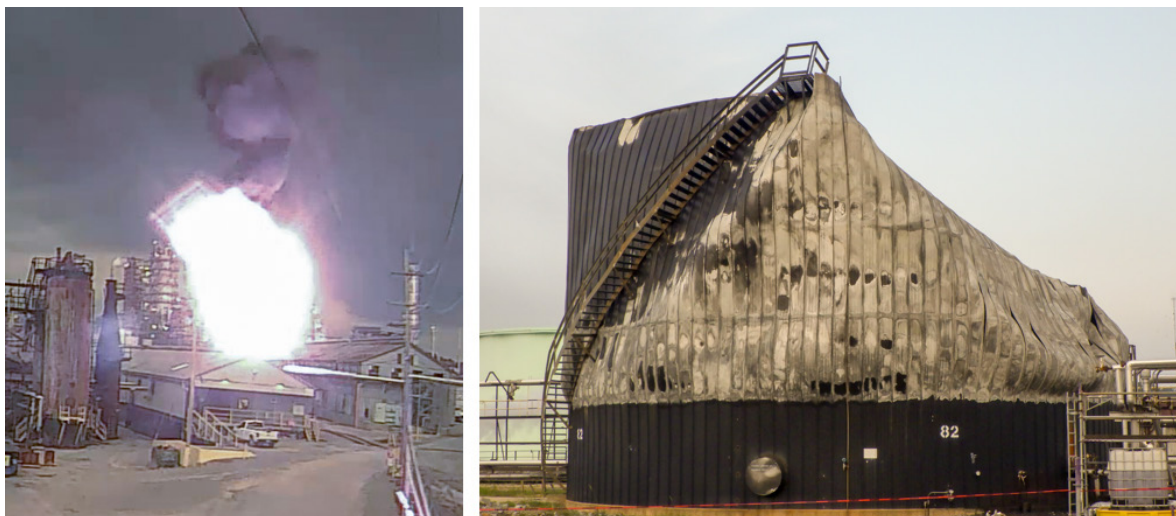
Figure 2. Tank explosion (left) and its post-incident condition (right). (Credit: Delek)

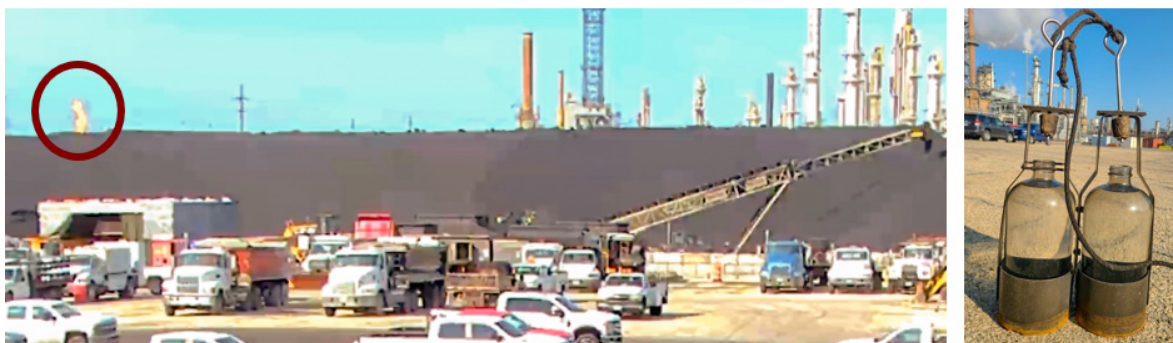
Figure 2. A surveillance video captured the fire (red circle, left) and a picture of the sample device (right). (Credit: CITGO, modified by CSB)

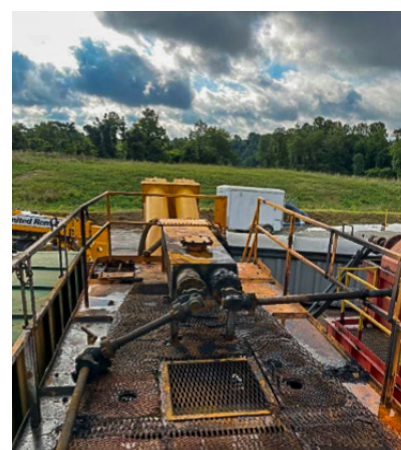
Figure 2. Post-incident image of the return tank. (Credit: Southwestern Energy)

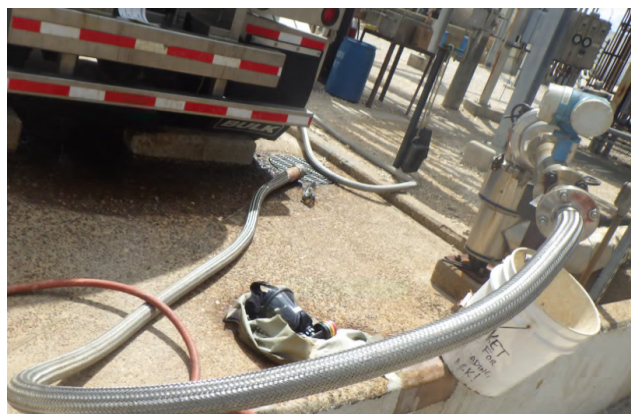
Figure 1. Post-incident image showing the loading hose. (Credit: Dow)

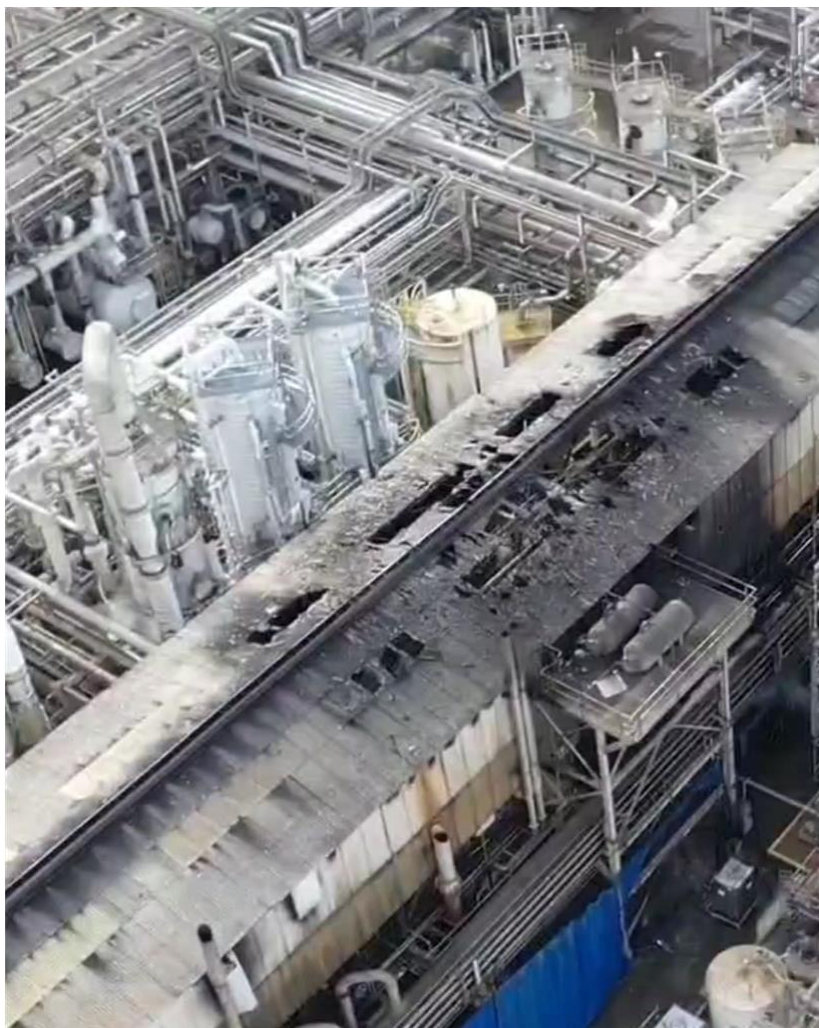
Figure 1. Overview of fire impact. (Credit: Sasol)

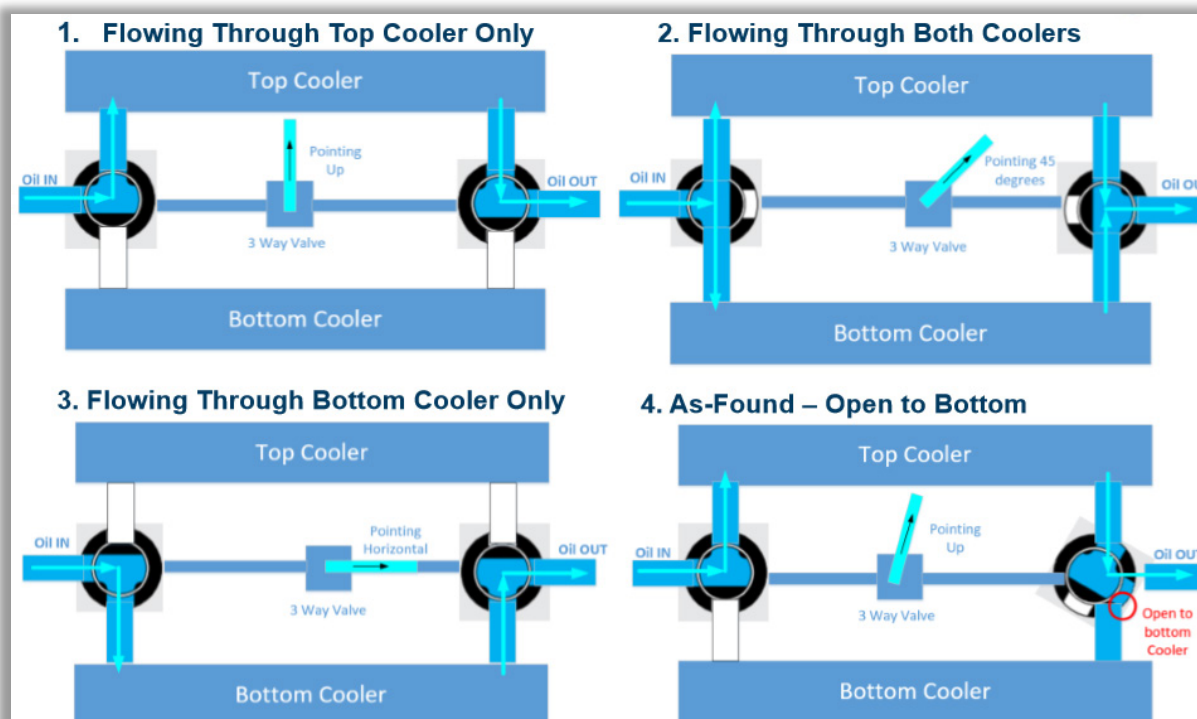
Figure 2. Three-way valve handle positions and “as-found” position (4). (Credit: Sasol)

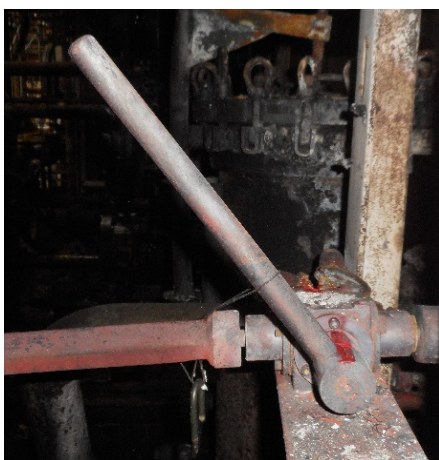
Figure 3. Locked out valve handle position. (Credit: Sasol)
