DATE: JULY 22, 2025

INCIDENT REPORTS

EVENTS REPORTED TO THE CSB UNDER THE ACCIDENTAL RELEASE REPORTING RULE

U.S. Chemical Safety and
Hazard Investigation Board

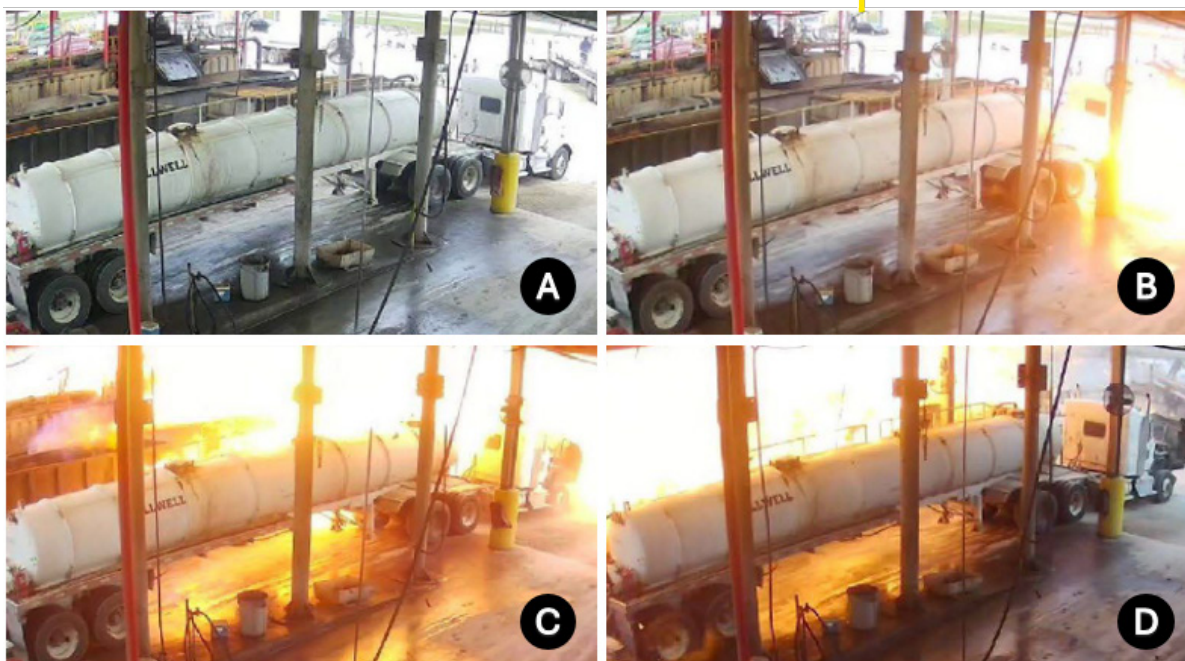
Figure 2. Progression of the fire and explosion at the Advantek facility (Credit: Advantek, modified by CSB)

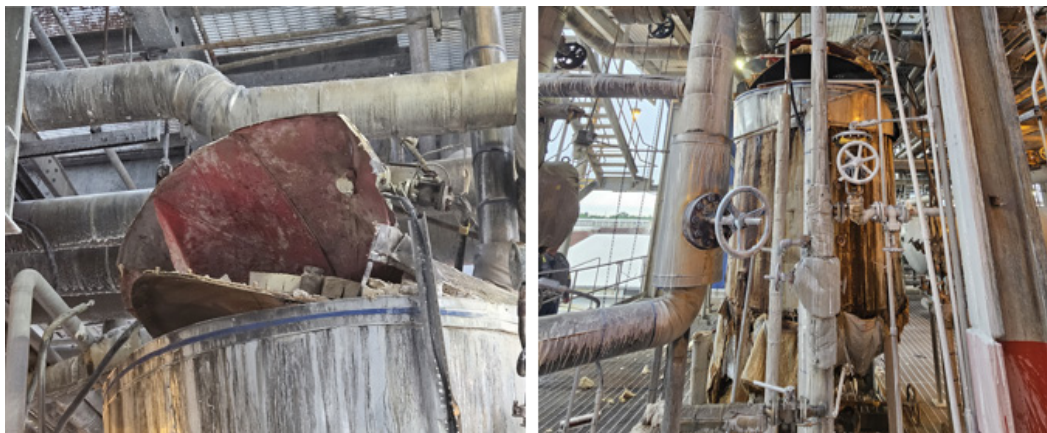
Figure 2. The damaged tank at Cornerstone. (Credit: Cornerstone)

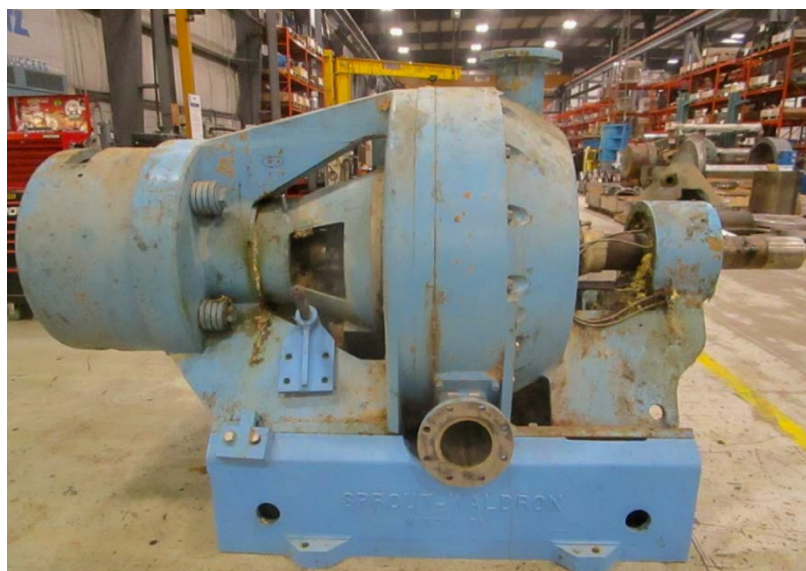
Figure 2. The refiner that leaked (left). (Credit: Georgia Pacific)
