VOLUME: 4

INCIDENT REPORTS

EVENTS REPORTED TO THE CSB UNDER THE ACCIDENTAL RELEASE REPORTING RULE

U.S. Chemical Safety and Hazard Investigation Board

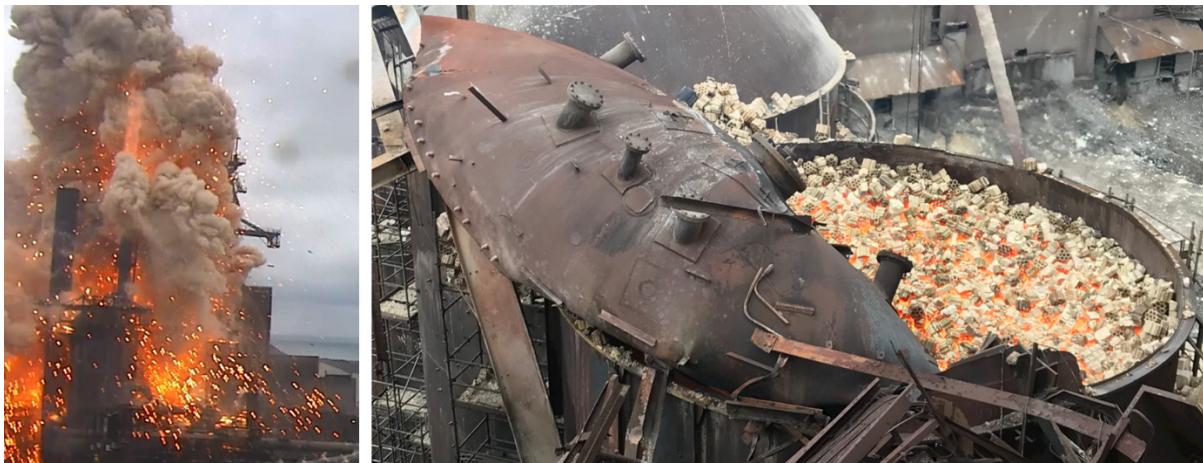
Figure 2. Surveillance video image of the explosion (left) and post-incident picture of the incident stove (right). (Credit: Cleveland-Cliffs)

ArcelorMittal's investigation revealed that the rupture originated at a large repair patch on the stove's dome. The failure initiated where the dome's shell was thinnest due to internal corrosion, measuring approximately one-tenth of an inch. This thickness was only ten percent of the dome's original wall thickness of one inch. The investigation also found that the repair patch in this area was improperly welded and that the repair plate was only 0.25 inches thick, significantly less than the calculated minimum required thickness of 0.56 inches for the dome. The stove's normal operating pressure of 36 pounds per square inch caused the fracture to spread along the welds of the shell.

High-temperature oxidation corrosion had significantly reduced the thickness of the dome's shell over the years it was in operation. Several repair patches were applied throughout the dome's service life to address thinning and weld cracking. ArcelorMittal's investigation concluded that some of these repairs did not conform to the American Society of Mechanical Engineers (ASME) Pressure Vessel Code requirements. In fact, several repair patches were improperly welded, used dissimilar steel grades that did not match the original structural steel, and failed to meet the minimum thickness requirements for this type of pressure vessel. These deficiencies likely compromised the strength of the repaired areas, allowing the crack to propagate along the welds after the initial failure.

Based on ArcelorMittal's investigation, the CSB determined that the probable cause of the explosion was the catastrophic failure of the stove's dome. The dome failed at a repair patch that had been improperly welded and did not provide the minimum thickness needed to contain the dome's operating pressure. The steel mill's mechanical integrity program lacked effective inspection and weld repair practices, contributing to the incident.

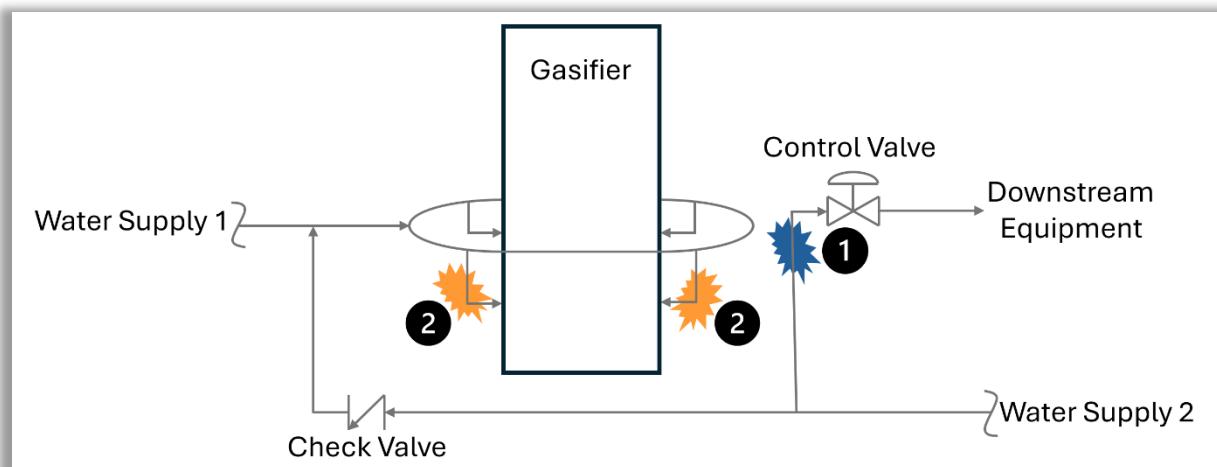
Figure 1. Simplified diagram of the water supply system involved in the incident. (Credit: CSB)

At approximately 6:41 p.m., a pipe support failed near the water supply control valve at location #1, shown in **Figure 1**. This pipe support was welded to the water supply piping, and its failure opened a large hole in the piping, releasing most of the available water supply. Roughly one minute later, two of the four water supply pipes to the gasifier ruptured at location #2, shown in **Figure 1**, releasing hot, flammable product gases that autoignited, resulting in a fire around the gasifier. Eastman operators shut down the gasifier, which stopped the release of product gases, extinguishing the fire.

With Water Supply 2 being released through the breached piping, Water Supply 1 should have been able to provide sufficient water flow to the gasifier. However, the check valve in the water supply piping had been stuck in the open position for an extended period prior to the incident and had not been inspected or otherwise tested. As a result, Water Supply 1 preferentially flowed through the open hole in the piping at location #1 (**Figure 1**).

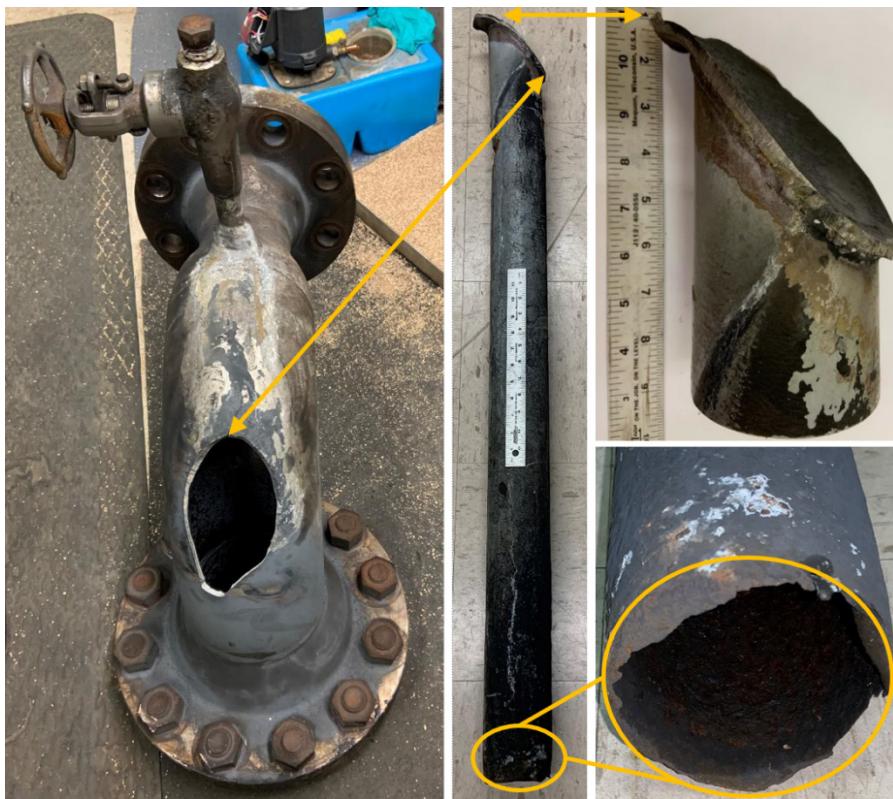
Eastman’s investigation found that fatigue cracking at the pipe support weld caused the initial water supply piping failure (**Figure 2**). The piping support had severely corroded over time and was no longer supporting the pipe, as it had lost contact with the structure. The company’s last visual inspection of this piping system, which occurred in 2018, did not identify any problems with the pipe support.

Figure 2. Hole in water piping at location one (left), the piping support (center), and the top and bottom ends of the piping support (right).
(Credit: Eastman, modified by CSB)

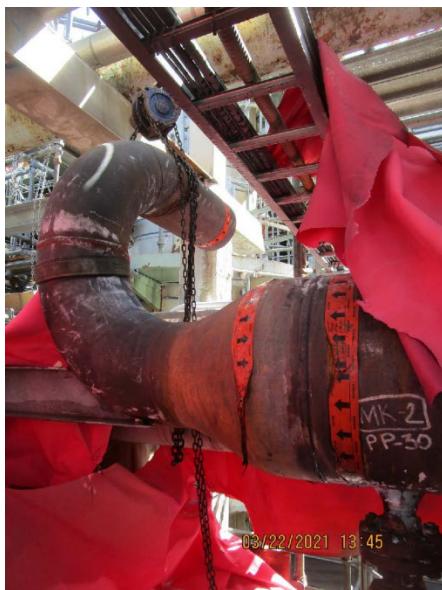
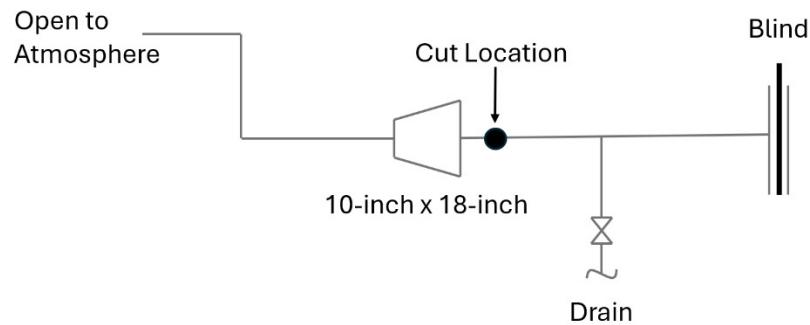
Figure 2. Photo (left) and simplified sketch (right) of the piping. Credit: (Phillips 66 (left), CSB (right))

As the lower portion (from the four to six o'clock position) of the piping was being cut, liquid flowed out, and the worker stopped cutting. The drain piping was unplugged using a wire, allowing the fluid to drain. The contractors contacted Phillips 66's operations personnel to evaluate the piping. The operators rechecked the piping and confirmed that no flammable gas was present. One of the contract workers invoked his stop-work authority and refused to continue cutting on this piping because the liquid smelled like gasoline. One of the operators described the odor as pine and attributed it to the substance used during chemical cleaning. Ultimately, two operators and a contractor supervisor agreed that the liquid was primarily water. At approximately 12:30 p.m., two hours after the work was stopped, another contract worker was sent to finish cutting the pipe. When the worker started the angle grinder, an explosion and fire occurred. The contractor suffered serious burn injuries from the combustion event and was transported and admitted to a hospital for treatment.

Based on Phillips 66's investigation, the CSB determined that the probable cause of the incident was that the piping segment was not effectively flushed and drained before the contract workers were authorized to cut the piping. Not recognizing the presence of flammable gas contributed to the incident.

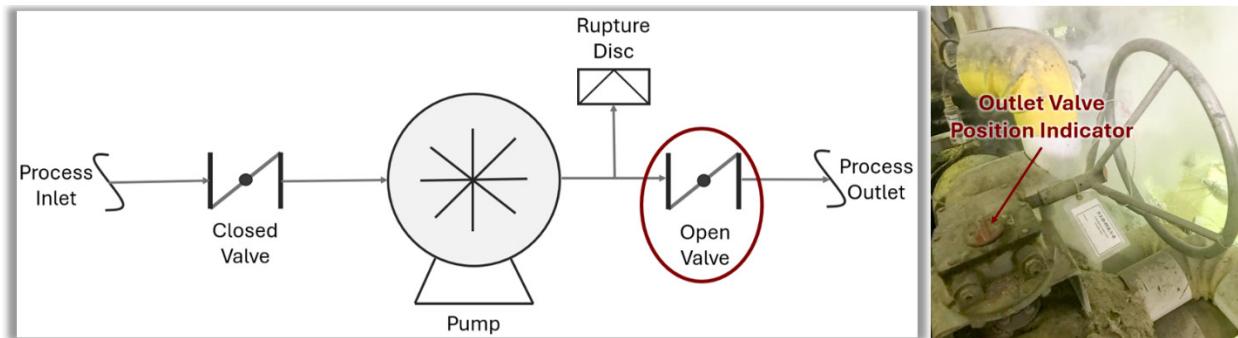
AdvanSix's investigation found that the pump's outlet valve had been incorrectly locked in the open position when it should have been closed (**Figure 2**). On the day of the incident, the AdvanSix employees saw that the inlet and outlet valves had been tagged and locked. However, they did not verify that the valves were closed.

Figure 2. Simplified equipment drawing, highlighting the open outlet valve (left image), and a post-incident picture of the outlet valve's position indicator showing it was open (right image). (Credit: CSB (left), and AdvanSix (modified by CSB, right))

In response to the incident, AdvanSix upgraded the PPE requirements to include aluminized clothing for line opening work on its molten polymer equipment.

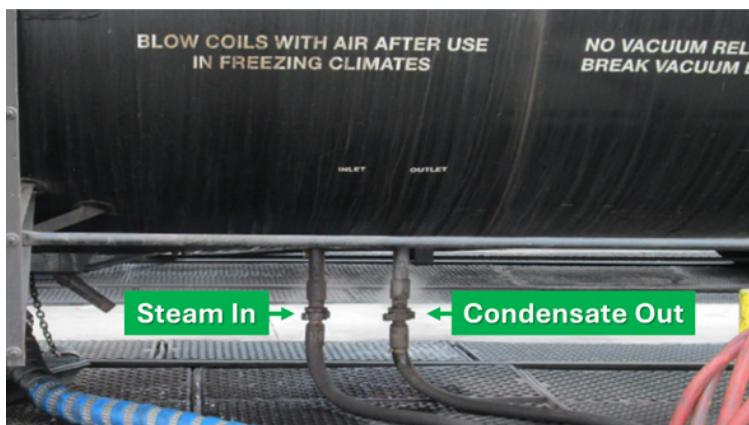
On the day of the incident, a contract worker used steam to heat the contents of a railcar to facilitate its unloading into process equipment. After the railcar was unloaded, the worker needed to remove the steam and condensate hoses from the railcar (Figure 2). The contractor verified that the steam and condensate isolation valves were closed and that steam was no longer draining from the condensate drain valve. While removing the steam hose from under the railcar, the contractor was sprayed with steam and hot condensate. The contractor was transported and admitted to a hospital for treatment.

Figure 2. A photo showing the railcar's steam and condensate hose connections. (Credit: DGD, modified by the CSB)

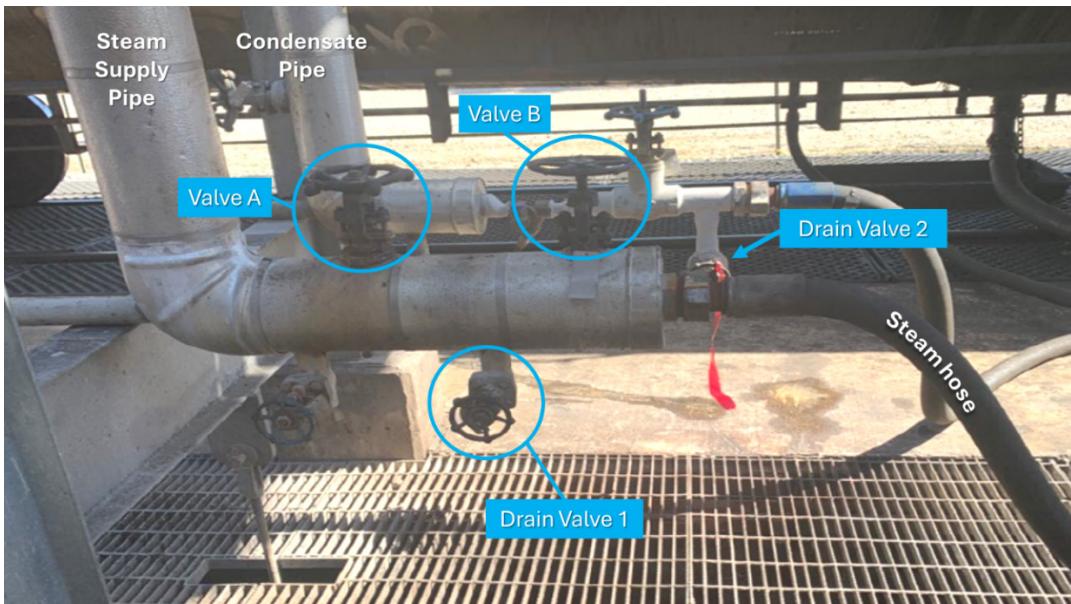
DGD's investigation identified that the typical practice used at the facility to isolate and depressurize the steam hose was to close Valve A (Figure 3) while having Valve B (Figure 3) and Drain Valve 1 (Figure 3) open to allow residual steam to flow out of the hose (Figure 3). However, Valve A was broken in the open position and could not be closed. Instead, the contract worker closed Valve B, left Drain Valve 1 closed, and opened Drain Valve 2 (visually obstructed in Figure 3 by the steam supply hose) to drain both the condensate hose and the steam hose. Because of how the heating coil was configured within the railcar, this configuration trapped condensate in the steam hose.

Figure 3. Valve configuration to isolate and depressurize the steam and condensate hoses.
(Credit: DGD, modified by the CSB)

DGD's investigation found that when workers first identified the broken valve (Valve A), they should have used stop work authority to prevent the unloading equipment from being used until the valve was repaired. The company's investigation also concluded that its written operating procedure did not effectively describe the process of draining steam or hot condensate from the railcar. In addition, the procedure did not explain how to verify that there was no pressure on the steam or hot condensate hoses. No instruments (such as a pressure gauge) or other safeguards were available to warn workers that the steam hose contained a dangerous amount of condensate.

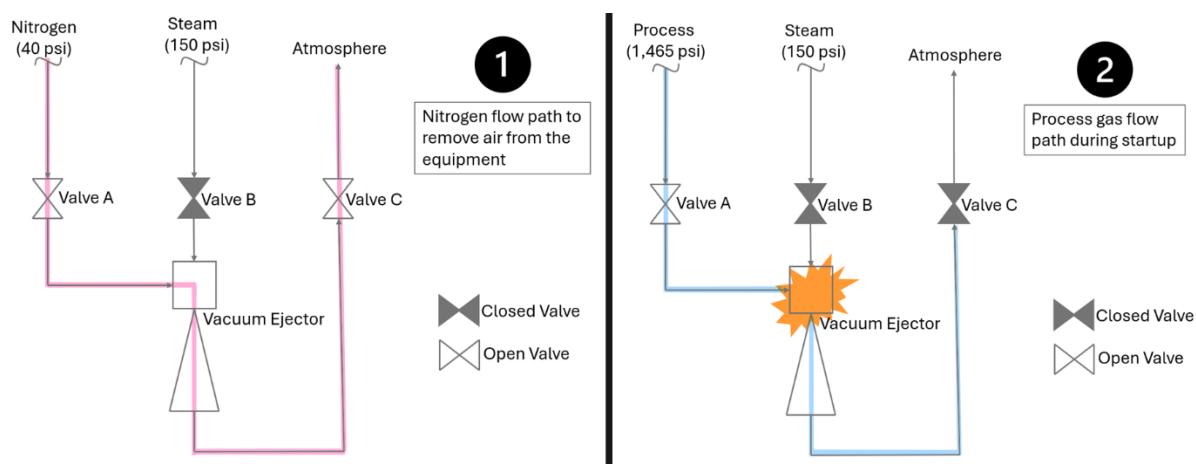
Figure 2. A simplified drawing of the vacuum ejector and relevant valve positions during air removal (1) and startup (2). (Credit: CSB)

Marathon's investigation determined that after the air removal step was completed, an operator closed Valve C, but Valve A remained open. During the startup, this valve alignment allowed process gas to enter and pressurize the vacuum ejector to approximately 1,465 pounds per square inch (psi). The pressure ruptured the vacuum ejector, which had a design pressure of 360 psi. Marathon concluded that the flammable gas was ignited by a spark created when the vacuum ejector ruptured or from static electricity.

Marathon's investigation identified that the startup procedure did not include the necessary actions to protect the vacuum ejector from high-pressure conditions after operators completed the air removal step. In addition, Marathon found that the process hazard analysis had not identified the potential for overpressurizing the vacuum ejector.

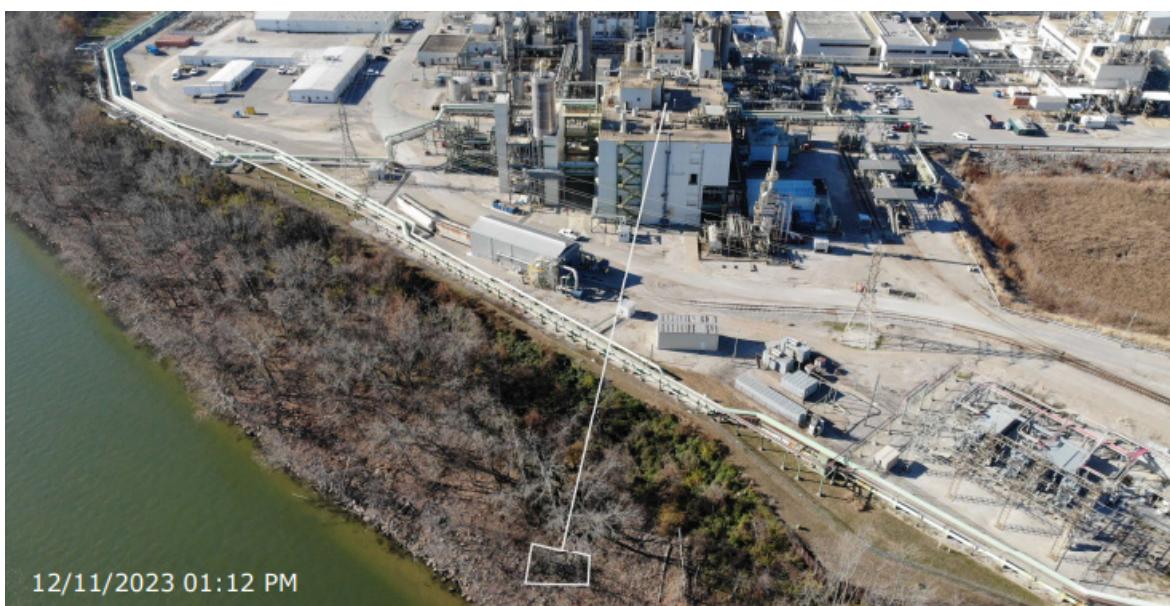
Figure 1. Location of one equipment fragment after the initial explosion. (Credit: SABIC)

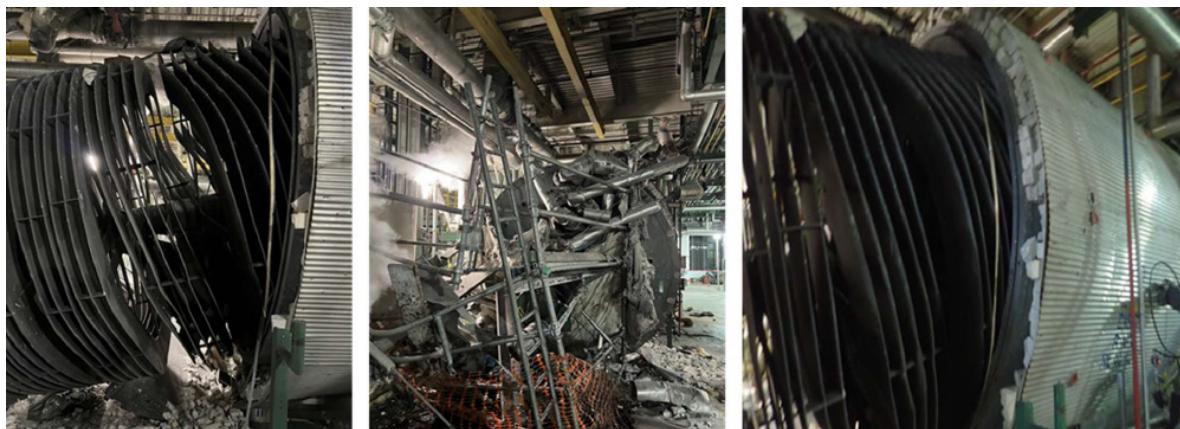
Figure 2. Post-incident images of the damaged reactor. (Credit: SABIC)

SABIC's investigation concluded that the initial explosion in the heat exchanger was caused by the rapid, energetic decomposition of unstable organic peroxide that had formed and accumulated inside the equipment. The second explosion and flash fire, which destroyed the reactor, was caused by heat from the first explosion igniting flammable tetrahydrofuran vapor inside the reactor.

SABIC's investigation found that the company's historical practice of leaving residual hydrocarbon material in the reactor's outlet piping during shutdown created hazards that were neither recognized nor controlled. The reaction of tetrahydrofuran with oxygen produced the explosive organic peroxide. Before the incident, SABIC personnel had assumed that the cooled, solidified material could remain in the reactor's outlet piping because it was not hazardous, creating a false sense of safety.

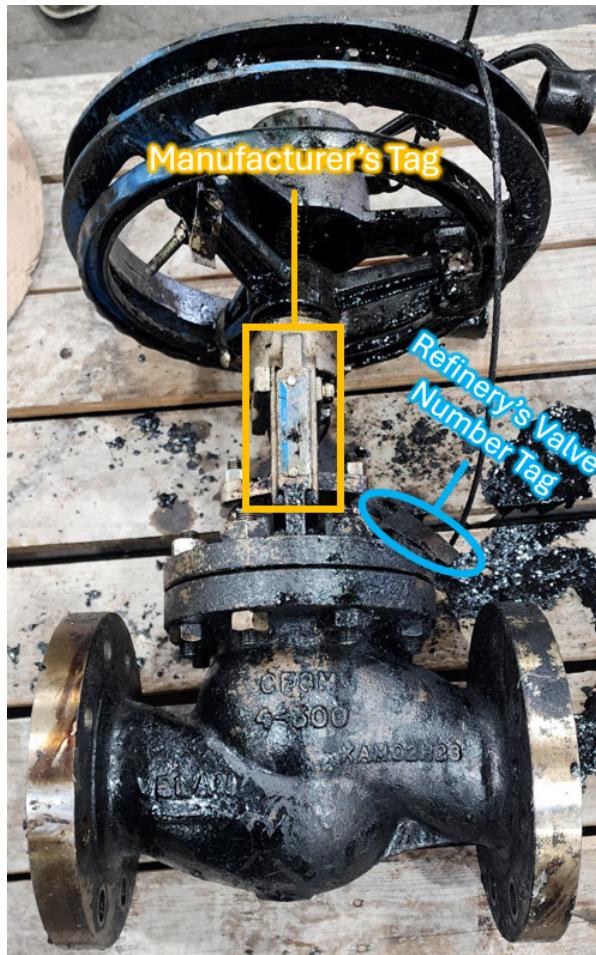
The valve was equipped with two tags that provided conflicting information (**Figure 2**). When PBF Energy ordered the valve from its preferred vendor, the order included the refinery's valve number, which specified a valve that met the process requirements by using graphite for the bonnet gasket and packing material. Teflon was not an acceptable material for this application.

Figure 2. Tags on Incident Valve. (Credit: PBF Energy, modified by CSB)

PBF Energy's preferred vendor did not have this valve in its inventory, so it procured the valve from a third-party supplier. The manufacturer's tag attached to the valve correctly indicated that it was equipped with Teflon components and stated that the valve's maximum operating temperature was 450°F. However, the third-party supplier wired an additional tag stamped with the refinery's valve number to the valve, incorrectly identifying the valve as having graphite components. Refinery personnel accepted and installed the valve based on the order and receipt documentation, along with the valve's size, flange rating, and the refinery valve number.

Based on PBF Energy's investigation, the CSB determined that the probable cause of the incident was the installation of a valve with Teflon components that could not withstand the process temperature. PBF Energy could have prevented the incident by confirming that the manufacturer's tag indicated that the valve was assembled with the proper components and that the valve's design temperature was compatible with the vacuum tower bottoms temperature. Contributing to the incident was the third-party supplier's tag, which incorrectly identified the valve as having graphite components.

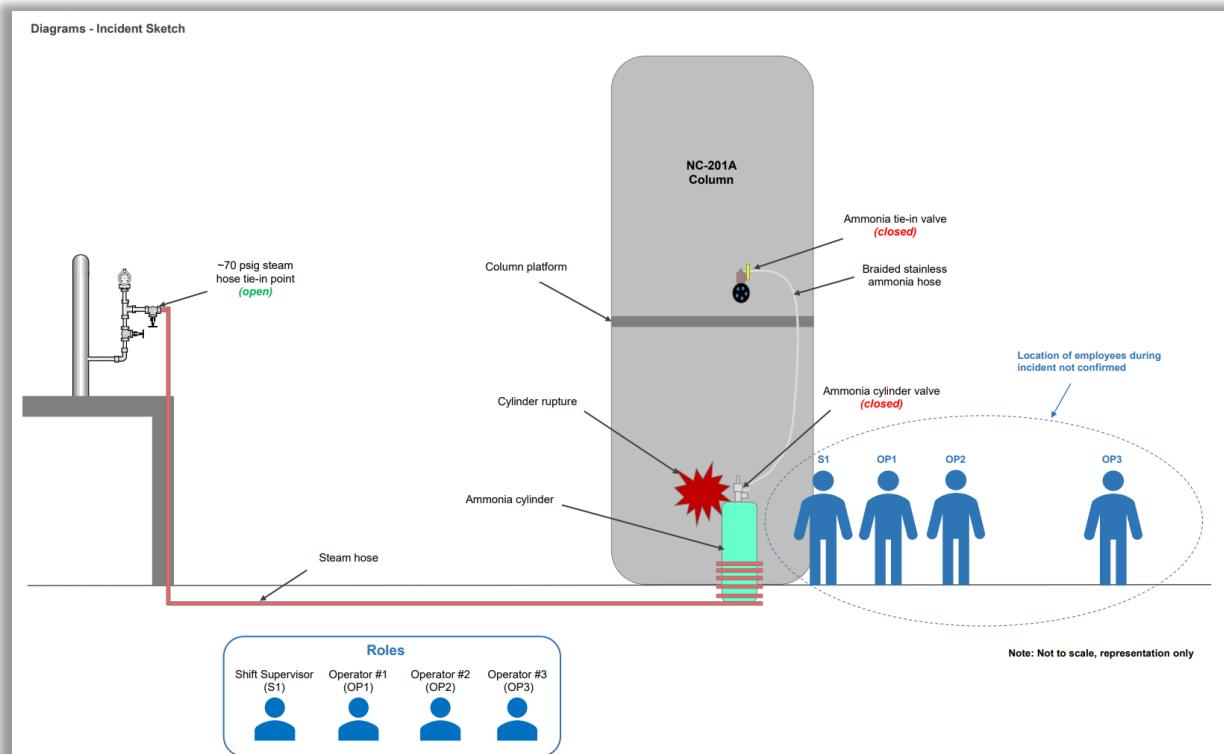
Figure 1. Sketch showing a simplified process diagram and the people injured by the explosion. (Credit: Formosa)

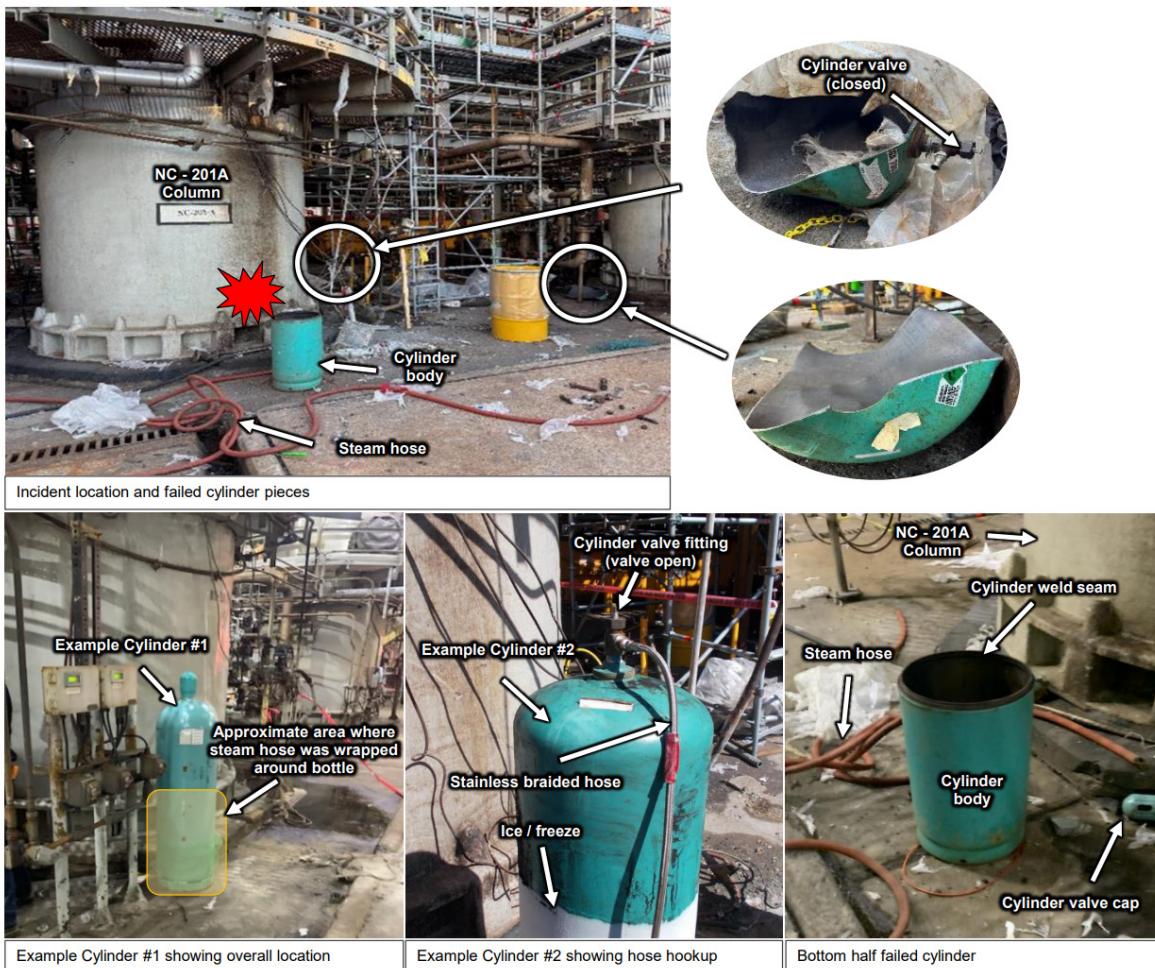
Figure 2. Photos showing damaged and exemplary cylinders. (Credit: Formosa)

Formosa's investigation determined that the procedure used for the chemical treatment did not cover critical safety details, such as not heating the cylinder when its outlet valve was closed. In addition, Formosa found that the cylinder was not protected by a pressure relief device. When the cylinder was heated, the pressure exerted by the liquid ammonia inside the cylinder significantly increased far above the cylinder's service pressure of 480 psi, resulting in a boiling liquid expanding vapor explosion (BLEVE).

Based on Formosa's investigation, the CSB determined that the probable cause of the incident was the uncontrolled external heating of a liquefied compressed gas cylinder without essential safeguards, including an emergency pressure-relief device. The uncontrolled heating generated tremendous internal pressure, causing the cylinder to explode. Formosa's process safety management systems contributed to the incident by not effectively evaluating and controlling the hazards presented by its anhydrous ammonia chemical treatment system.

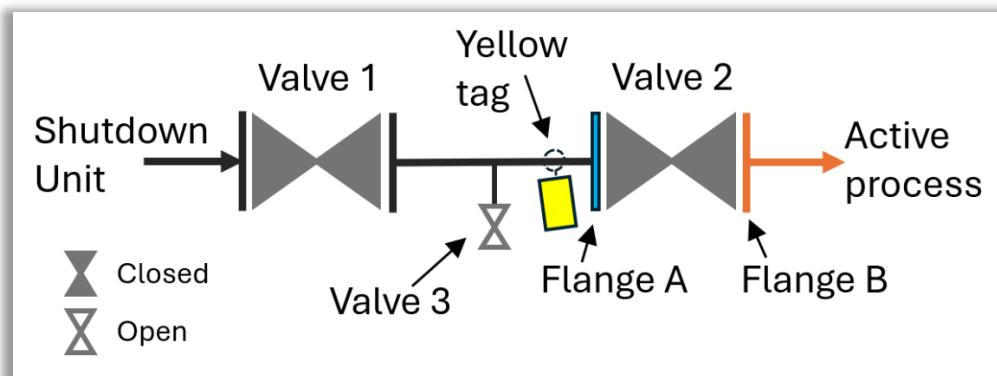
On February 1, 2025, PBF Energy tasked contract workers with installing an isolation blind at Flange A (**Figure 2**) to prepare a catalytic feed hydrotreater unit (“unit”) for turnaround maintenance. A yellow tag was placed between Valve 2 and Valve 3 to indicate the location of the blind installation. After completing a field walkthrough to verify that the piping segment between Valve 1 and Valve 2 was empty, an operator issued a permit to the supervisor of the contractor work crew at 11:30 a.m.

Figure 2. Existing isolation before blind installation (objects not to scale). (Credit: CSB)

PBF Energy's investigation found that the contract workers, hired specifically for the extra tasks during the turnaround, had not received training on the refinery's equipment opening policies and procedures. Consequently, these workers were not aware of PBF Energy's tagging system for identifying which flange should be opened. The company's investigation also revealed that installing this blind should have been treated as a "first break" (as written on the permit) under the refinery's policies, because this was the initial equipment opening for this system. First breaks required a qualified operator to be present during the work to ensure that maintenance workers open the proper equipment. However, because of a miscommunication between the workers, the operator was not present when the contract workers disassembled Flange B.

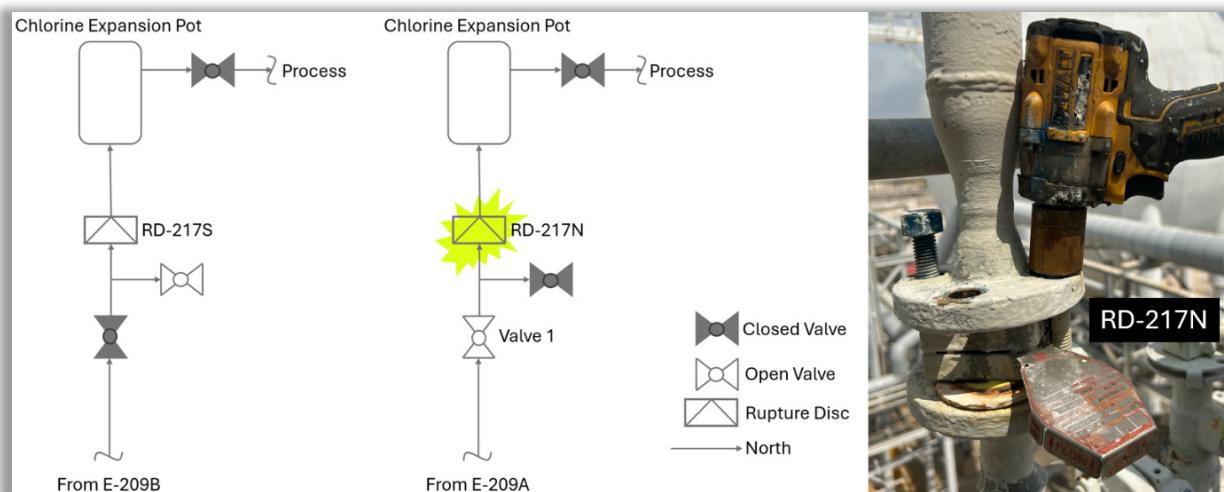
On the day of the incident, Olin planned to replace a rupture disc (RD-217N) in the chlorine liquefaction unit. This safety device protected the E-209A heat exchanger (Figure 2).

Figure 2. Simplified equipment drawing (left) showing the relevant equipment and valve positions before the rupture disc replacement work began, and a post-incident photo of RD-217N (right). (Credit: CSB (left), Olin (right)).

Olin gave two contract maintenance workers the work package and a permit to replace the RD-217N rupture disc. At approximately 8:10 a.m., one of the maintenance workers began disassembling the RD-217N rupture disc holder using a battery-powered impact wrench. In addition to the standard protective equipment, the maintenance worker wore an air-supplying respirator with a 30-minute air bottle. At 8:15 a.m., liquid chlorine at a pressure of 100 pounds per square inch began releasing from the partially disassembled RD-217N rupture disc holder. The maintenance workers evacuated from the area. Alarm horns in the unit were activated after chlorine gas detectors identified the release. Local officials issued a shelter-in-place order for the cities of Clute and Lake Jackson. At 9:03 a.m., emergency responders closed Valve 1 to stop the release.
