Investigation Update

February 2024

On November 19, 2023, at approximately 12:21 a.m., a metal tube ruptured within a reactor charge furnace during a unit startup at the Martinez Renewables facility in Martinez, California. The ruptured tube released renewable diesel and hydrogen, resulting in a fire that seriously injured one Marathon employee (**Figure 1**). This document provides an update on the ongoing CSB investigation of this incident.

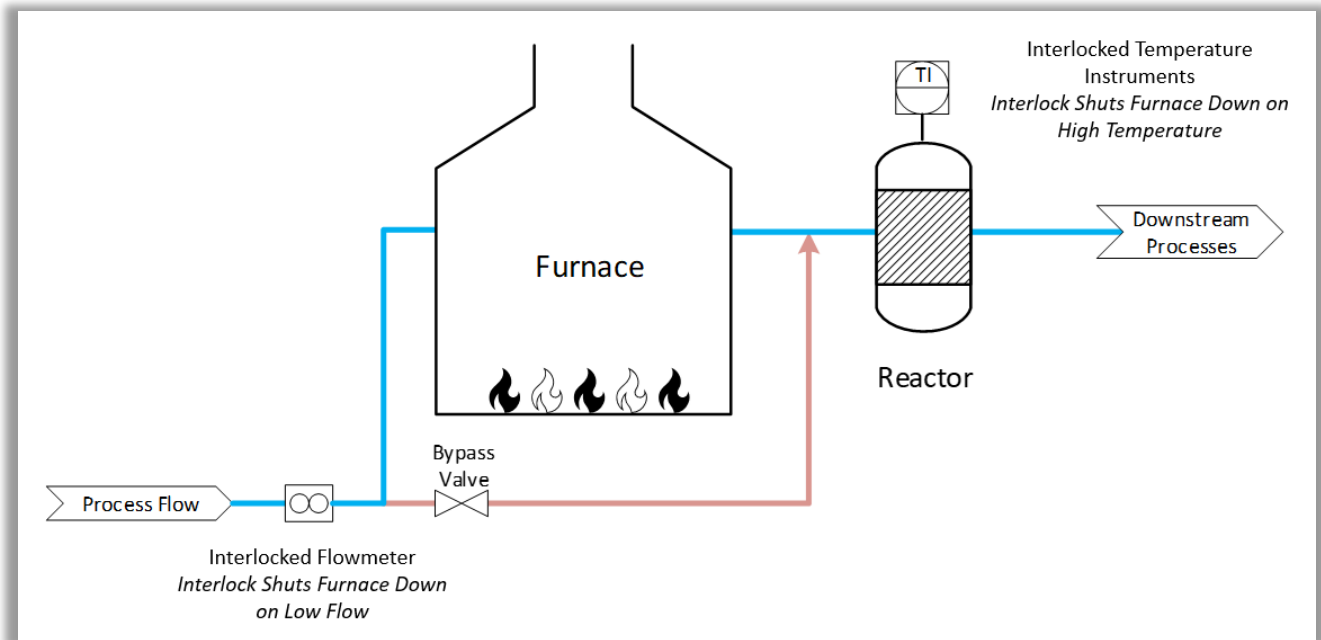
- The morning after the incident, Marathon employees discovered that a normally closed manual bypass valve upstream of the furnace was open (misaligned), which created a potential flow path around the furnace. The flowmeter intended to monitor diesel flow through the furnace was located upstream of the open bypass valve, and had been indicating flow at the time of the incident. Although safety interlocks existed to automatically shut down the furnace during low renewable diesel flow to the furnace and high temperatures downstream of the furnace, none of these conditions were detected by the instrumentation, and the interlocks did not activate (**Figure 2**). Any flow being bypassed around the furnace would have fed back into the process piping upstream of the high temperature safety interlock instrumentation.

Figure 2. Simplified process flow diagram depicting furnace safety interlock instrument configurations relative to the bypass valve found open after the incident. Note: Not all instruments and interlocks are depicted. (Credit: CSB)

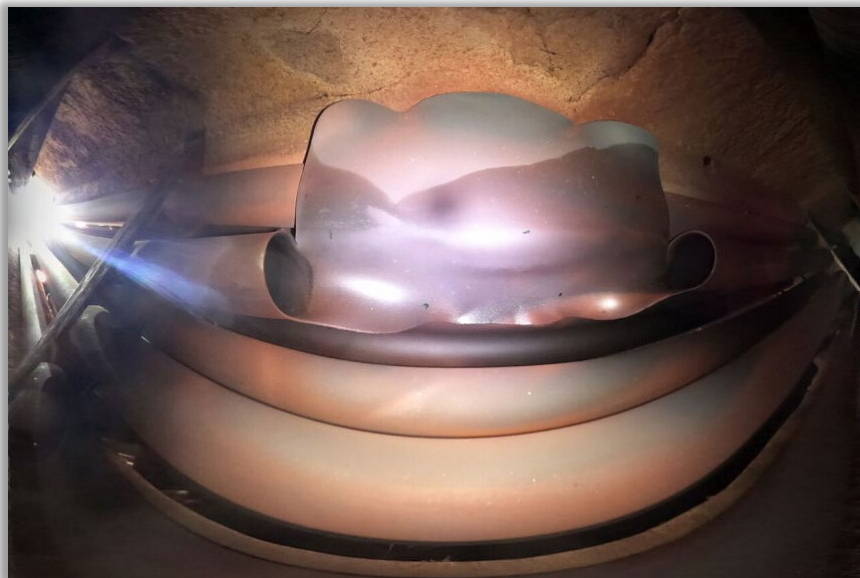
- A post-incident examination of the furnace identified the release point as a ruptured tube in the convection section of the furnace (**Figure 3** and **Figure 4**). Further investigation of the furnace tubes is ongoing.

Figure 3. Post-incident image showing the failed furnace tube from above. (Credit: Marathon)

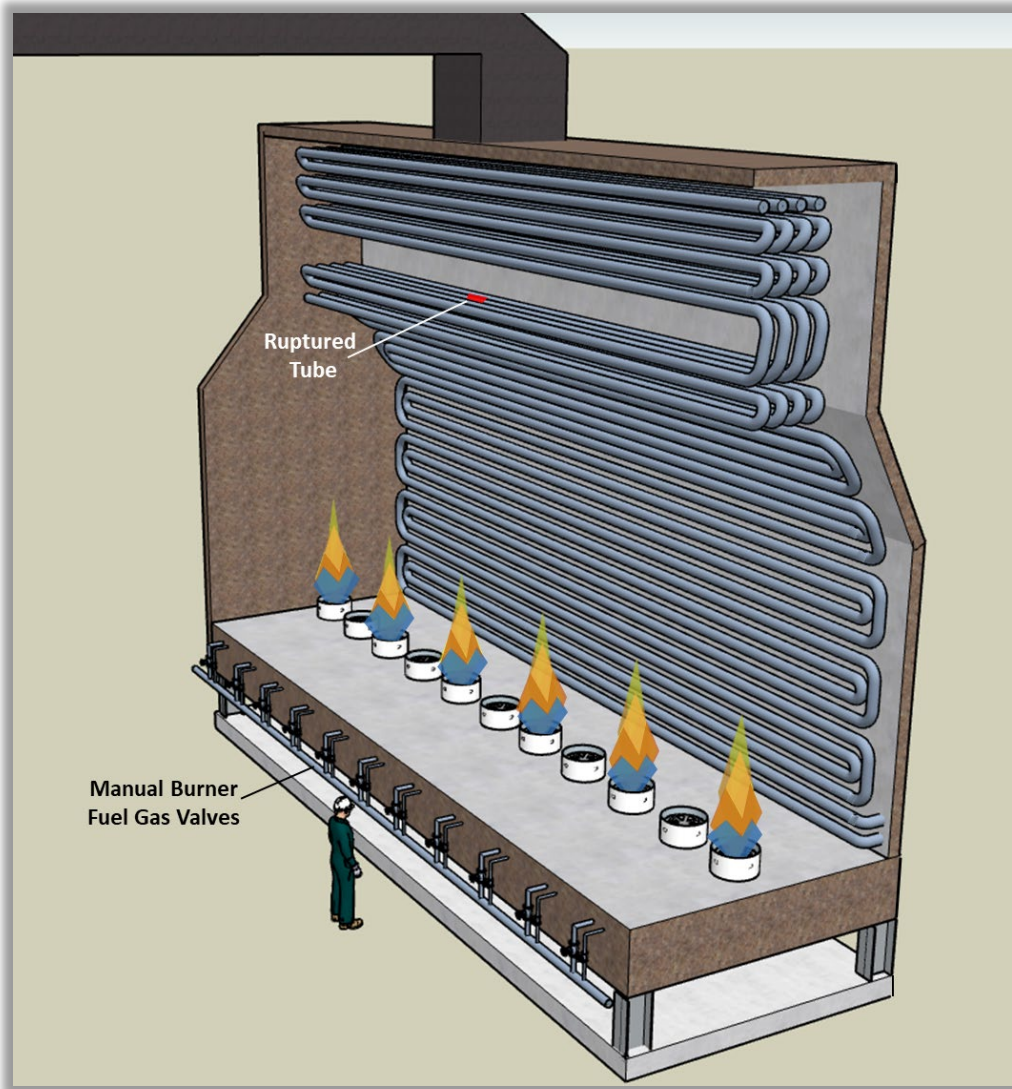
- The HDO unit was designed with a furnace to pre-heat renewable feedstock, recycled renewable diesel, and hydrogen before subsequent processing. Within the furnace, up to eleven fuel-gas fired burners heated the process materials, which flowed through stainless steel tubes inside the furnace (**Figure 4**). During the HDO conversion project, Marathon installed new, reconfigured tubes in the furnace. Documentation indicates that the new tubes were constructed of ASTM A312 Grade 321 stainless steel.

Figure 4. Depiction of the interior of the furnace showing the location of the tube failure. Person shown for scale. The lit burners in the illustration above do not necessarily depict their actual state at the time of the incident. (Credit: CSB)
