## Investigation Update

August 2026

This document provides an update on the CSB's investigation of the May 26, 2026, incident at the Nippon Dynawave Packaging Company, LLC ("NDP") Pulp and Paper Mill in Longview, Washington.

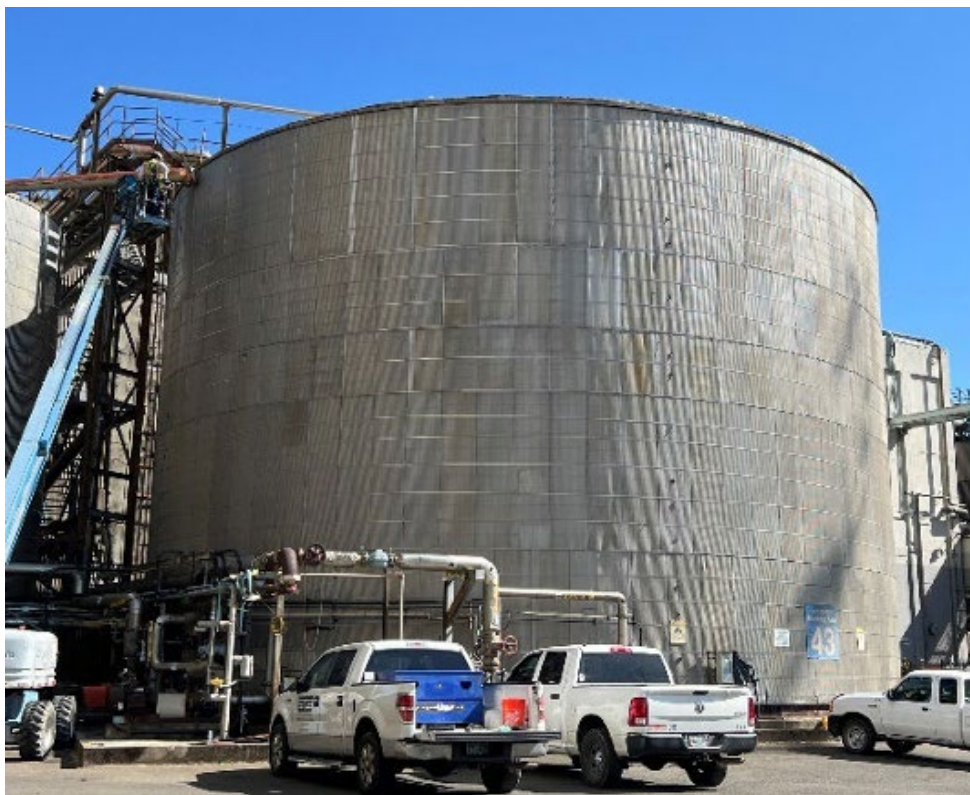
- G Tank, the tank involved in the incident, had a capacity of approximately 1.2 million gallons and was constructed in 1987 (**Figure 2**). The tank was constructed from 40 carbon steel plates welded together in five rings, or “courses,” that made up the outer walls.<sup>b</sup> Each course was made from eight, 26-foot-long plates. The tank was constructed with no secondary containment to capture spills.

**Figure 2.** A pre-incident photo of G Tank. (Credit: NDP)

- G Tank’s first and fourth courses were repaired in 2017 and the tank’s second and third courses were repaired in 2011. Other repairs were made to G tank in 2006, 2002, and 1999.
- G Tank was built in a courtyard surrounded by several buildings that housed boilers, offices, a mechanical maintenance shop, and an electrical maintenance shop (**Figure 3**). A former Weyerhaeuser engineer, who

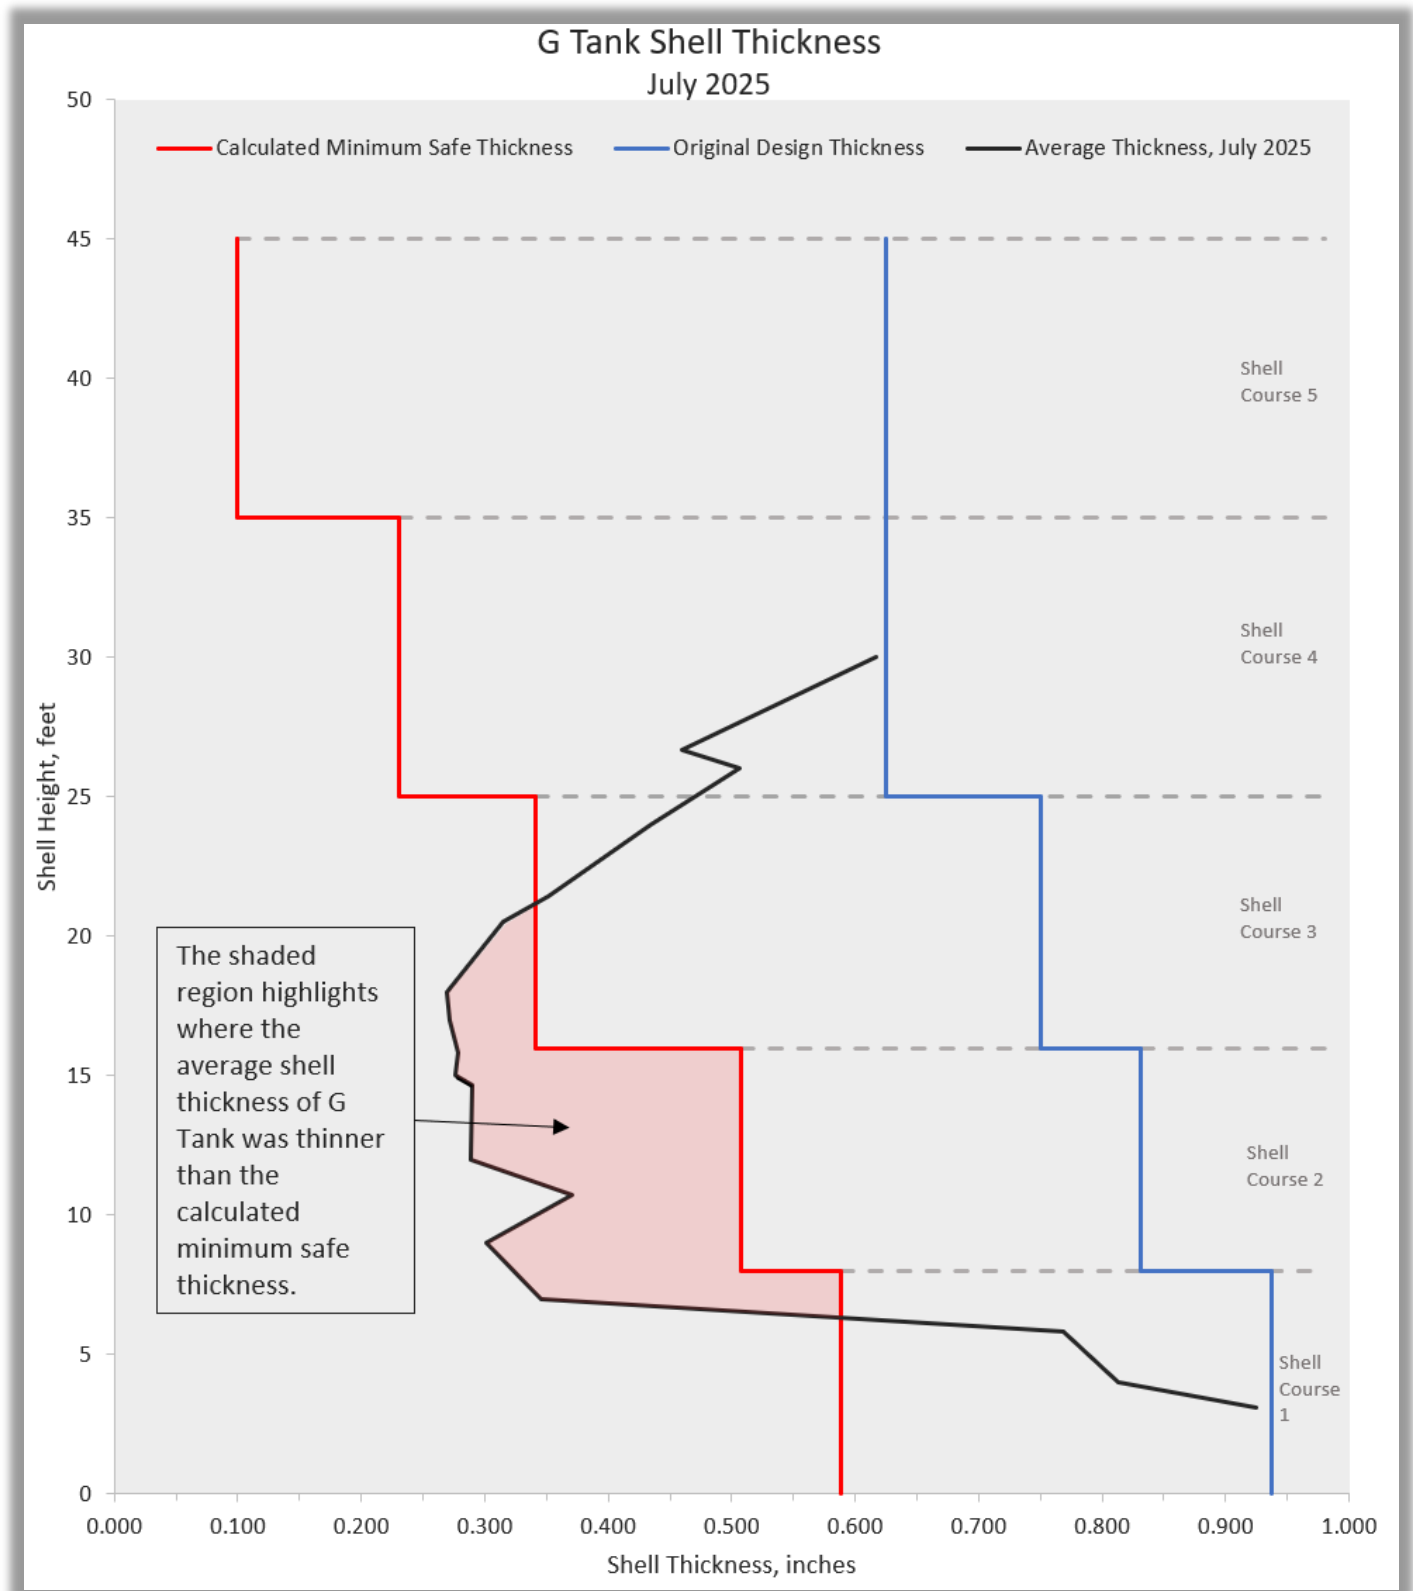
- The ground floors of these buildings contained mechanical and electrical maintenance shops, worker break rooms, and worker locker rooms. NDP maintenance employees typically had a daily meeting in the shops of both buildings shortly after 7:00 a.m.
- In July 2025, 10 months before the incident, NDP had G Tank inspected by performing an external visual inspection and external ultrasonic thickness testing. The results of the inspection showed significant thinning below the minimum safe thickness in the lower regions of the tank,<sup>a</sup> as shown in **Figure 4**.

<sup>a</sup> The minimum safe thickness for an atmospheric storage tank is the required thickness necessary to contain the head pressure of the stored liquid and support the weight of the tank, amongst other factors. It is a calculation which accounts for the tank dimensions, the material of construction, and the stored substance. The calculation is described in API's Standard 653: *Tank Inspection, Repair, Alteration, and Reconstruction* [11, pp. 4-4 - 4-11].

**Figure 4.** A graphical representation of the G Tank shell thickness as measured in July 2025. (Credit: CSB)

- Consequently, NDP's inspection contractor<sup>a</sup> recommended that NDP internally inspect and repair shell courses 1, 2, and 3. The inspection report also stated that G Tank was "[n]ot fit for continued service" unless it was repaired and that there was a "[h]igh likelihood/consequence of failure" (Figure 5).

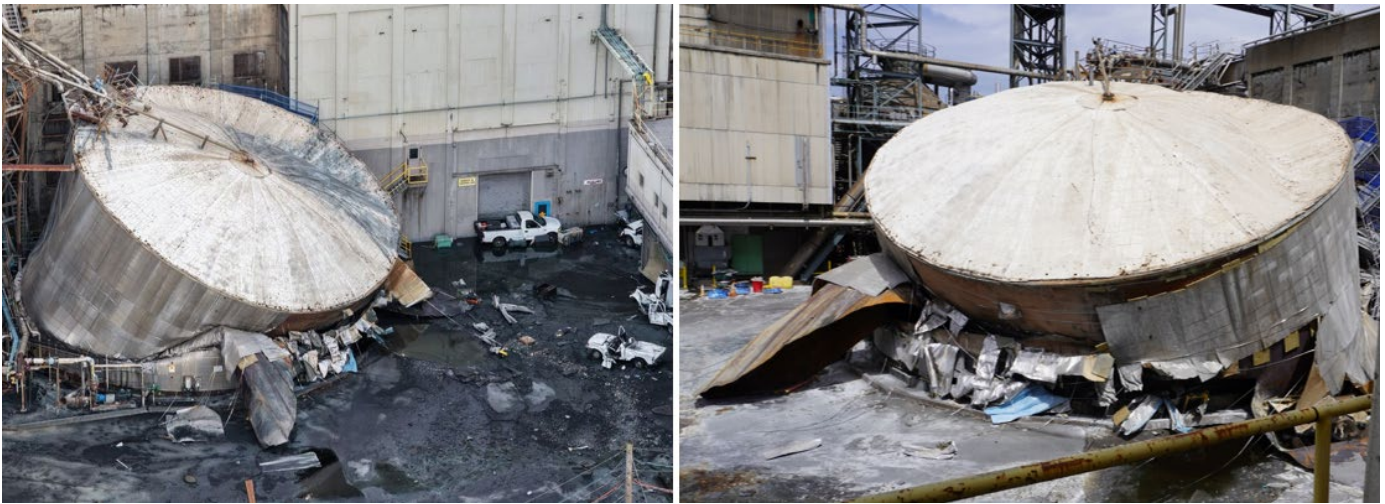
- Although the flow of white liquor from G tank to the digester was stopped, white liquor from the recausticizers continued to flow to G tank at a reduced rate. As a result, G Tank's level began to increase. By about 6:22 a.m., G Tank was approximately 90 percent full.
- Around 7:00 a.m., employees began arriving at work for their upcoming shift. These employees went to the electrical and mechanical maintenance shops and were waiting for their morning meetings to start.
- At approximately 7:09 a.m., G Tank catastrophically failed, releasing approximately 900,000 gallons of white liquor (**Figure 6**).

**Figure 6.** Post-incident photos of the failed G Tank at NDP in Longview, WA. (Credit Left: Seattle Times; Credit Right: CSB)

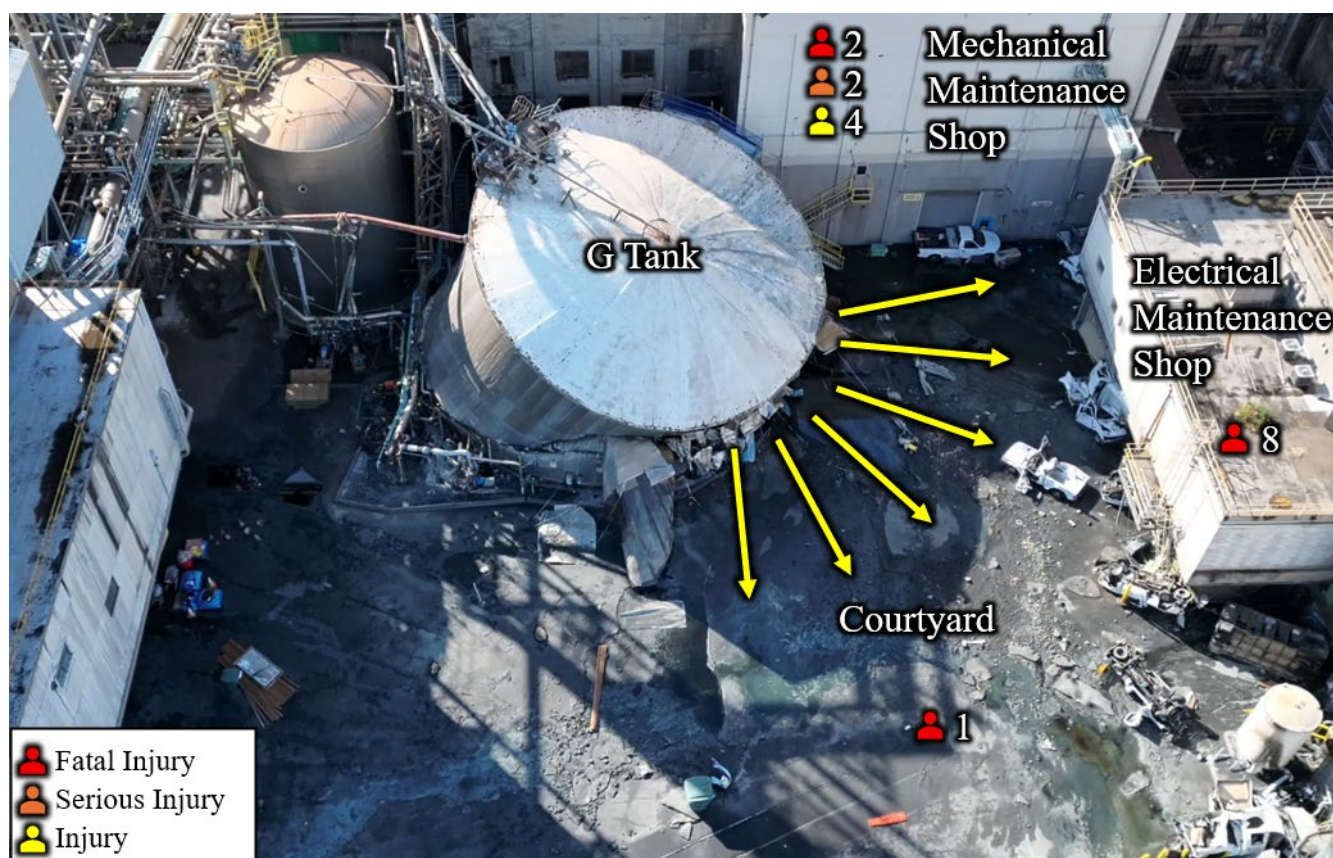
- At the time of the tank failure, 17 employees were present on the ground level. Seven maintenance employees and one foreman were in the mechanical maintenance shop, eight maintenance employees were in the electrical maintenance shop, and one operator was in the courtyard (**Figure 7**).

**Figure 7.** An image of the courtyard where G tank failed. This shows the locations of the buildings and the tank and the direction in which the white liquor flowed. All of the workers depicted in the figure were on the ground floors (Credit: Cowlitz County, annotated by CSB)

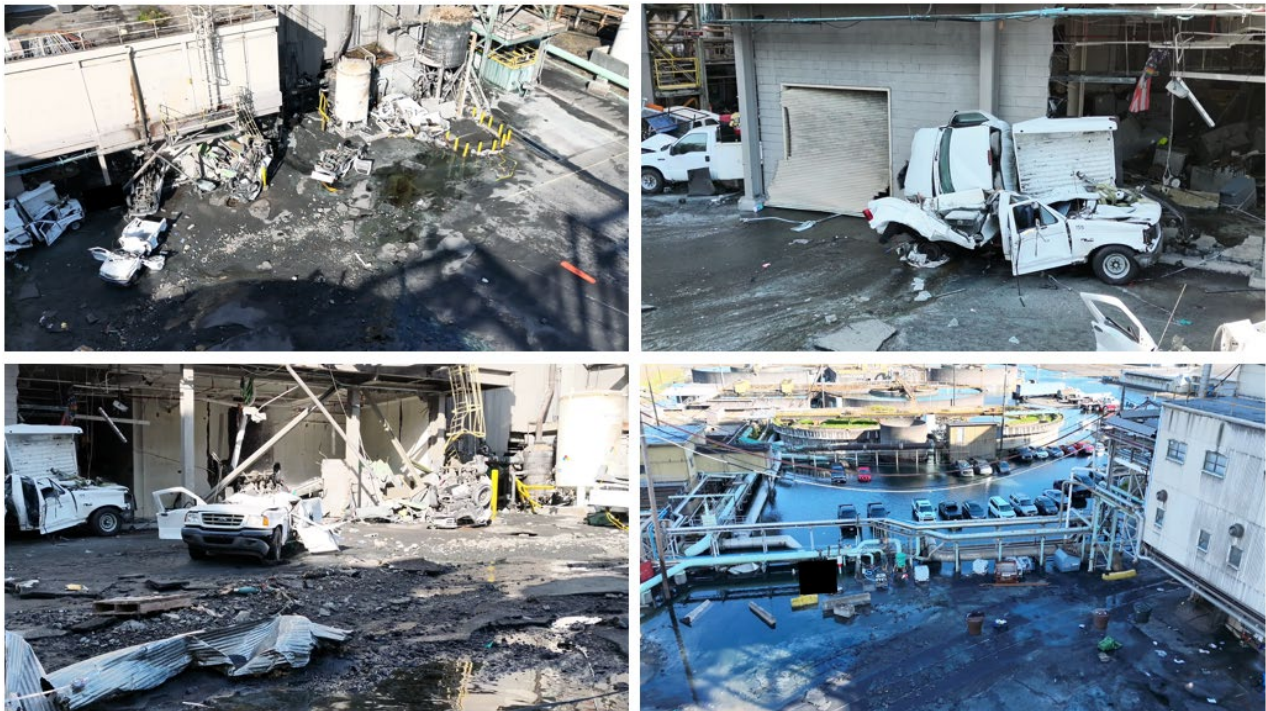
- Most of the tank’s contents were released when it failed, creating a massive “wave” of white liquor that rapidly flooded into the courtyard and towards the buildings. As the white liquor deluged the courtyard, the force of the moving liquid crushed vehicles and destroyed one of the surrounding buildings’ roll-up doors and one of its walls, shown in **Figure 8**. The white liquor entered the lower floors of the buildings through door seals and the destroyed roll-up doors, where the morning meetings were occurring.

**Figure 8.** Damages from the G Tank failure. The images show the courtyard after the event, the crushed vehicles and damaged roll-up door, the destroyed wall, and a nearby flooded parking lot. (Credit Cowlitz County Sheriff, modified by CSB)
