## Investigation Update

August 2026

This document provides an update on the CSB's investigation of the May 26, 2026, incident at the Nippon Dynawave Packaging Company, LLC ("NDP") Pulp and Paper Mill in Longview, Washington.

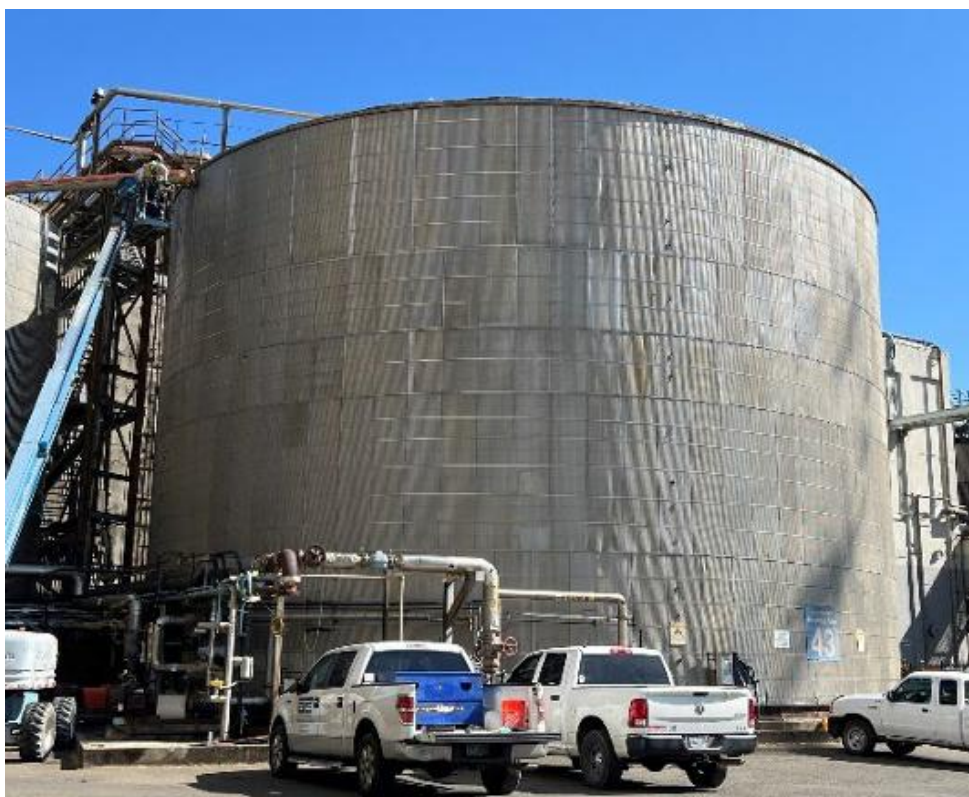
- G Tank, the tank involved in the incident, had a capacity of approximately 1.2 million gallons and was constructed in 1987 (**Figure 2**). The tank was constructed from 40 carbon steel plates welded together in five rings, or “courses,” that made up the outer walls.<sup>b</sup> Each course was made from eight, 26-foot-long plates. The tank was constructed with no secondary containment to capture spills.

**Figure 2.** A pre-incident photo of G Tank. (Credit: NDP)

- G Tank’s first and fourth courses were repaired in 2017 and the tank’s second and third courses were repaired in 2011. Other repairs were made to G tank in 2006, 2002, and 1999.
- G Tank was built in a courtyard surrounded by several buildings that housed boilers, offices, a mechanical maintenance shop, and an electrical maintenance shop (**Figure 3**). A former Weyerhaeuser engineer, who

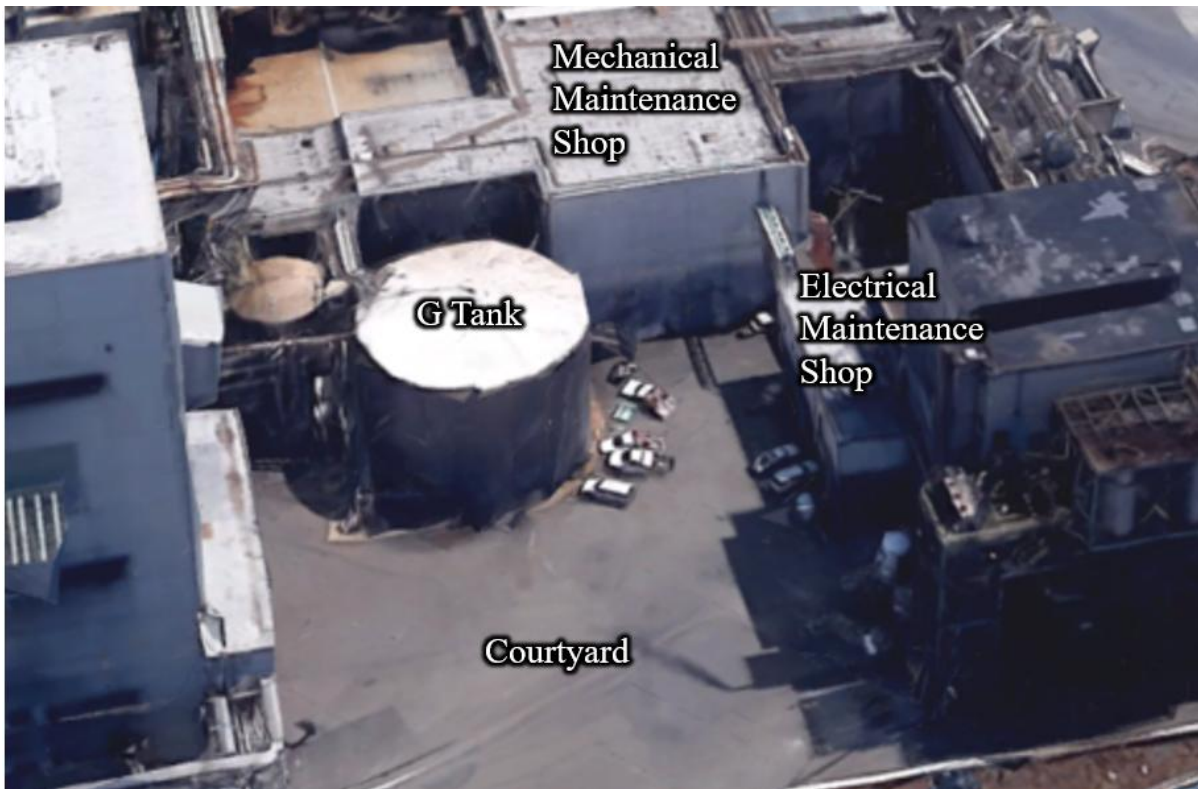
worked on the tank when it was first installed, told the CSB that Weyerhaeuser placed the tank in the courtyard because “that was the available area.”

**Figure 3.** A pre-incident satellite image of the courtyard where G tank was built. (Credit: Google Earth, annotated by CSB)

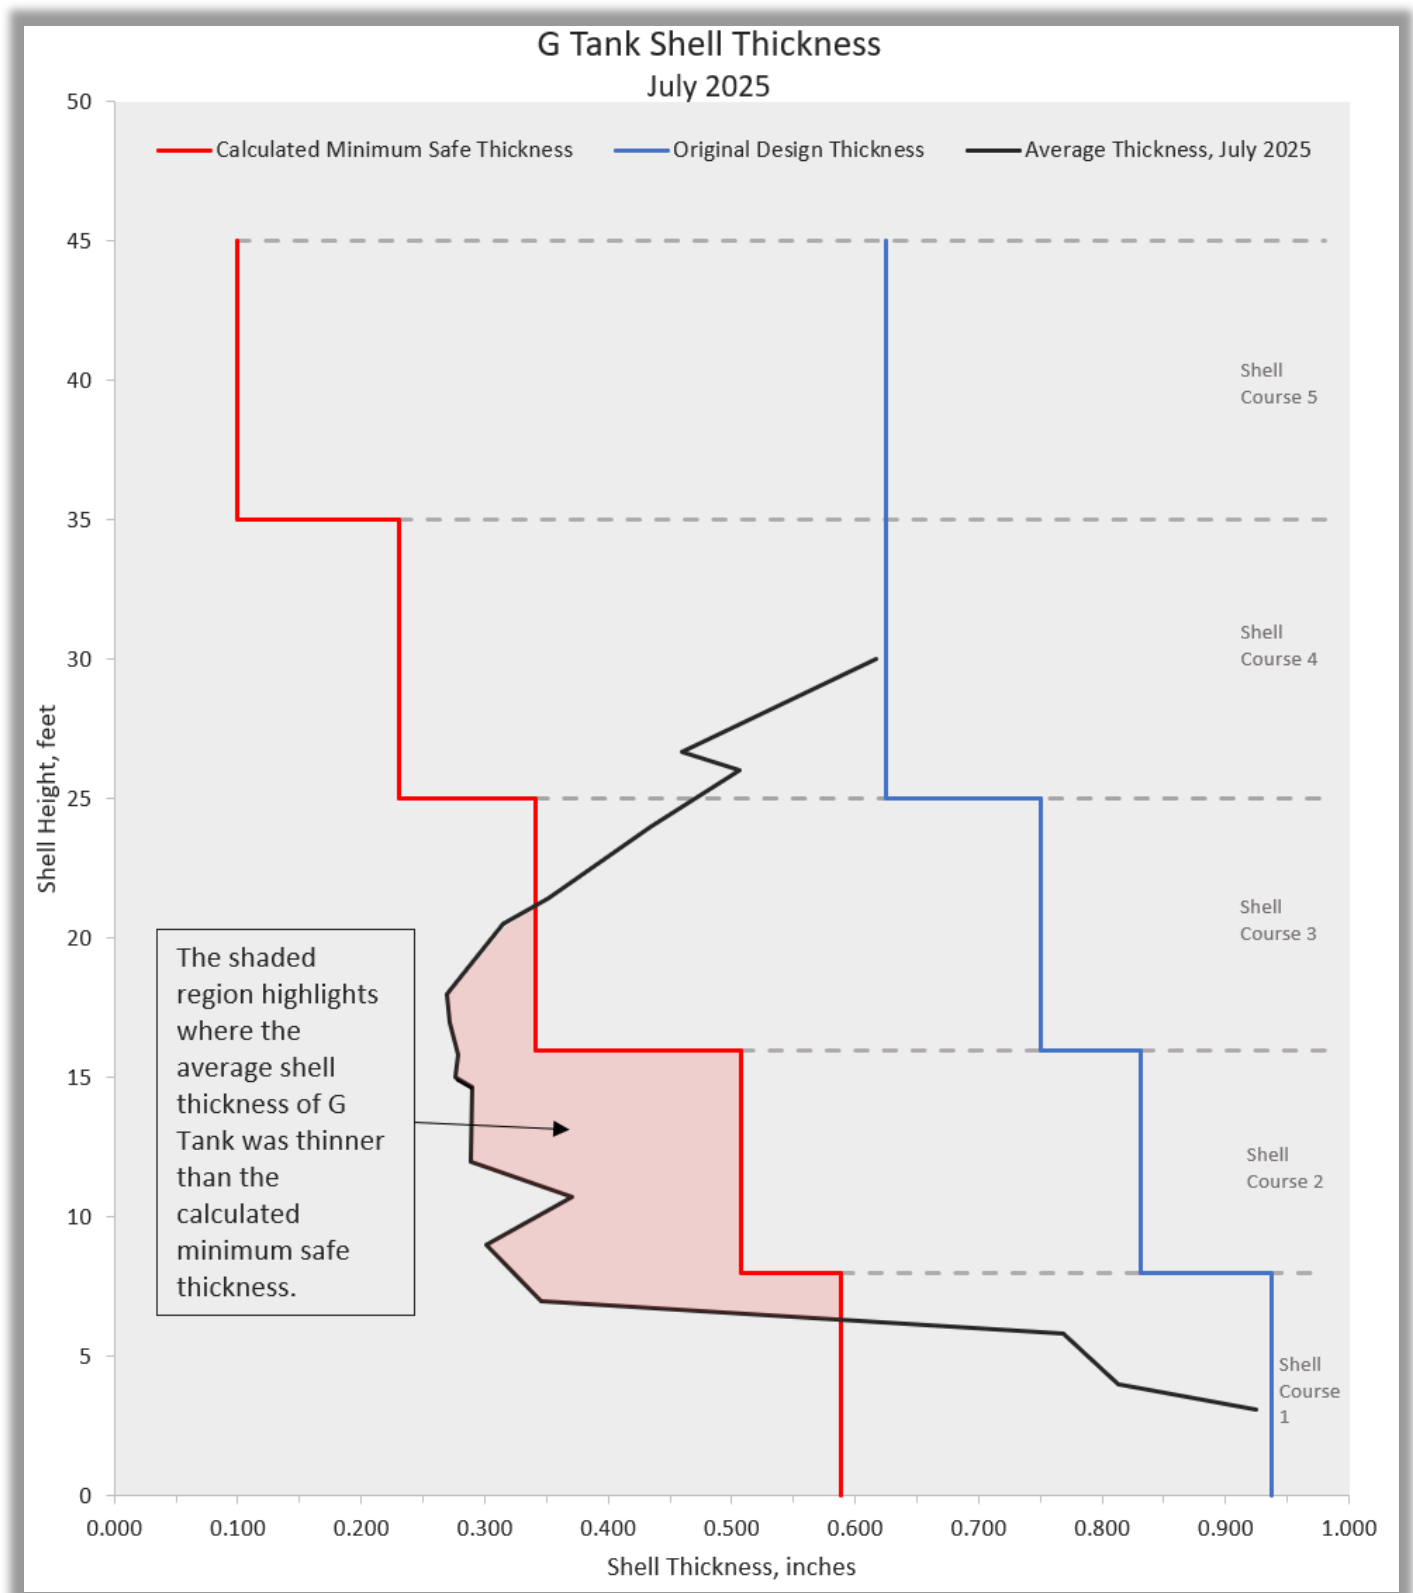
- The ground floors of these buildings contained mechanical and electrical maintenance shops, worker break rooms, and worker locker rooms. NDP maintenance employees typically had a daily meeting in the shops of both buildings shortly after 7:00 a.m.
- In July 2025, 10 months before the incident, NDP had G Tank inspected by performing an external visual inspection and external ultrasonic thickness testing. The results of the inspection showed significant thinning below the minimum safe thickness in the lower regions of the tank,<sup>a</sup> as shown in **Figure 4**.

<sup>a</sup> The minimum safe thickness for an atmospheric storage tank is the required thickness necessary to contain the head pressure of the stored liquid and support the weight of the tank, amongst other factors. It is a calculation which accounts for the tank dimensions, the material of construction, and the stored substance. The calculation is described in API's Standard 653: *Tank Inspection, Repair, Alteration, and Reconstruction* [11, pp. 4-4 - 4-11].

**Figure 4.** A graphical representation of the G Tank shell thickness as measured in July 2025. (Credit: CSB)

- Consequently, NDP's inspection contractor<sup>a</sup> recommended that NDP internally inspect and repair shell courses 1, 2, and 3. The inspection report also stated that G Tank was "[n]ot fit for continued service" unless it was repaired and that there was a "[h]igh likelihood/consequence of failure" (Figure 5).

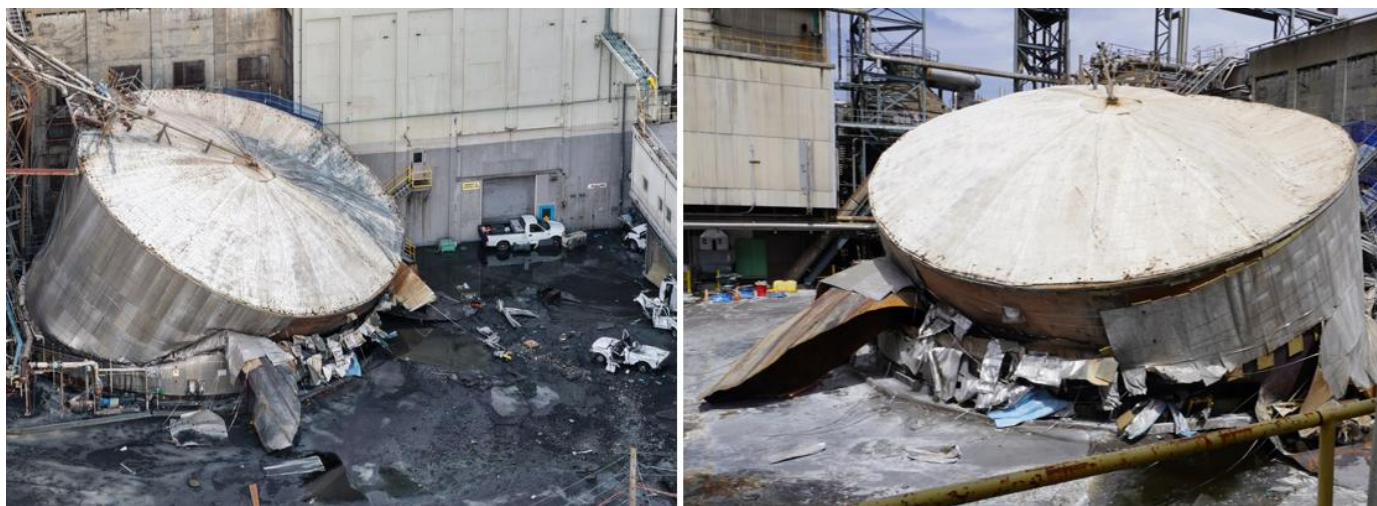
- Although the flow of white liquor from G tank to the digester was stopped, white liquor from the recausticizers continued to flow to G tank at a reduced rate. As a result, G Tank's level began to increase. By about 6:22 a.m., G Tank was approximately 90 percent full.
- Around 7:00 a.m., employees began arriving at work for their upcoming shift. These employees went to the electrical and mechanical maintenance shops and were waiting for their morning meetings to start.
- At approximately 7:09 a.m., G Tank catastrophically failed, releasing approximately 900,000 gallons of white liquor (**Figure 6**).

**Figure 6.** Post-incident photos of the failed G Tank at NDP in Longview, WA. (Credit Left: Seattle Times; Credit Right: CSB)

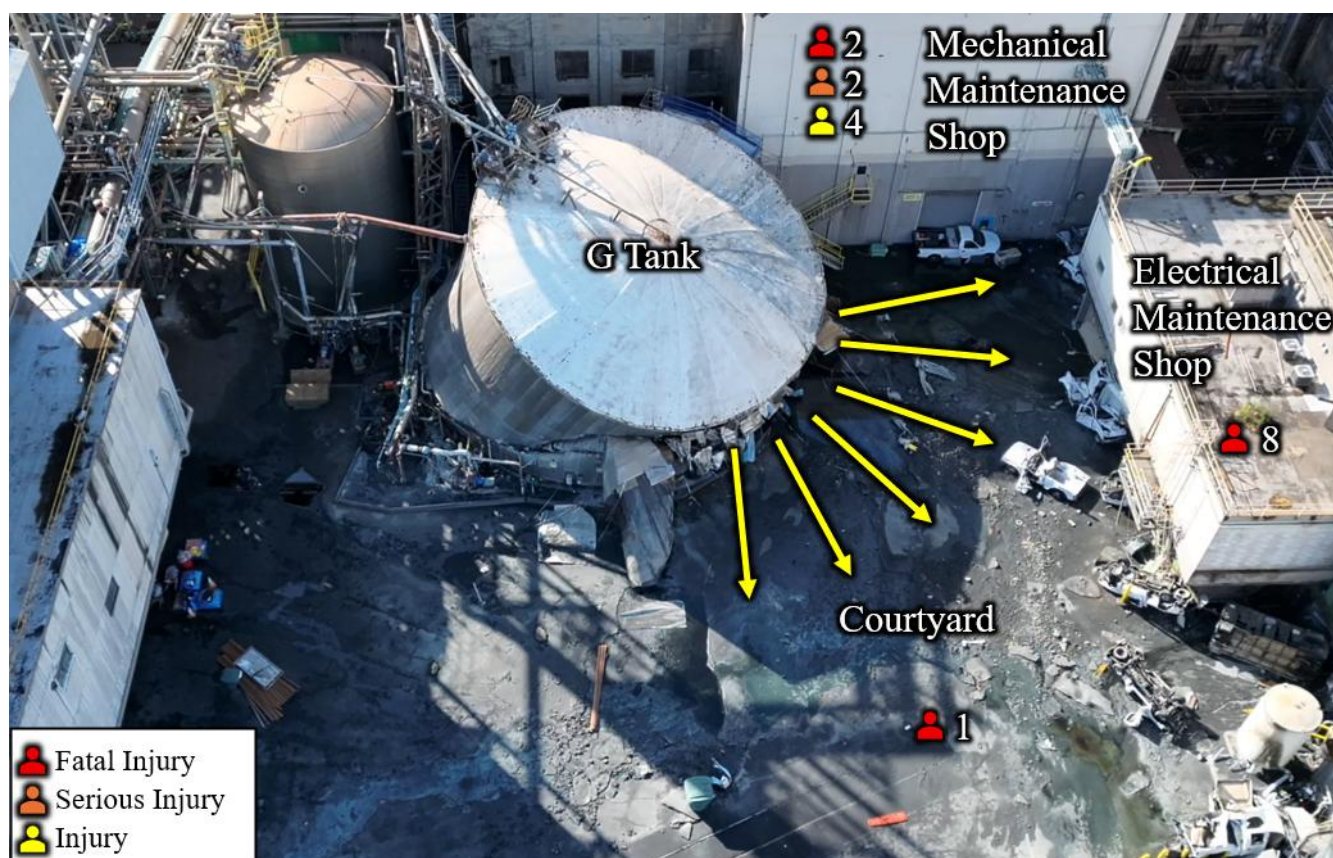
- At the time of the tank failure, 17 employees were present on the ground level. Seven maintenance employees and one foreman were in the mechanical maintenance shop, eight maintenance employees were in the electrical maintenance shop, and one operator was in the courtyard (**Figure 7**).

**Figure 7.** An image of the courtyard where G tank failed. This shows the locations of the buildings and the tank and the direction in which the white liquor flowed. All of the workers depicted in the figure were on the ground floors (Credit: Cowlitz County, annotated by CSB)

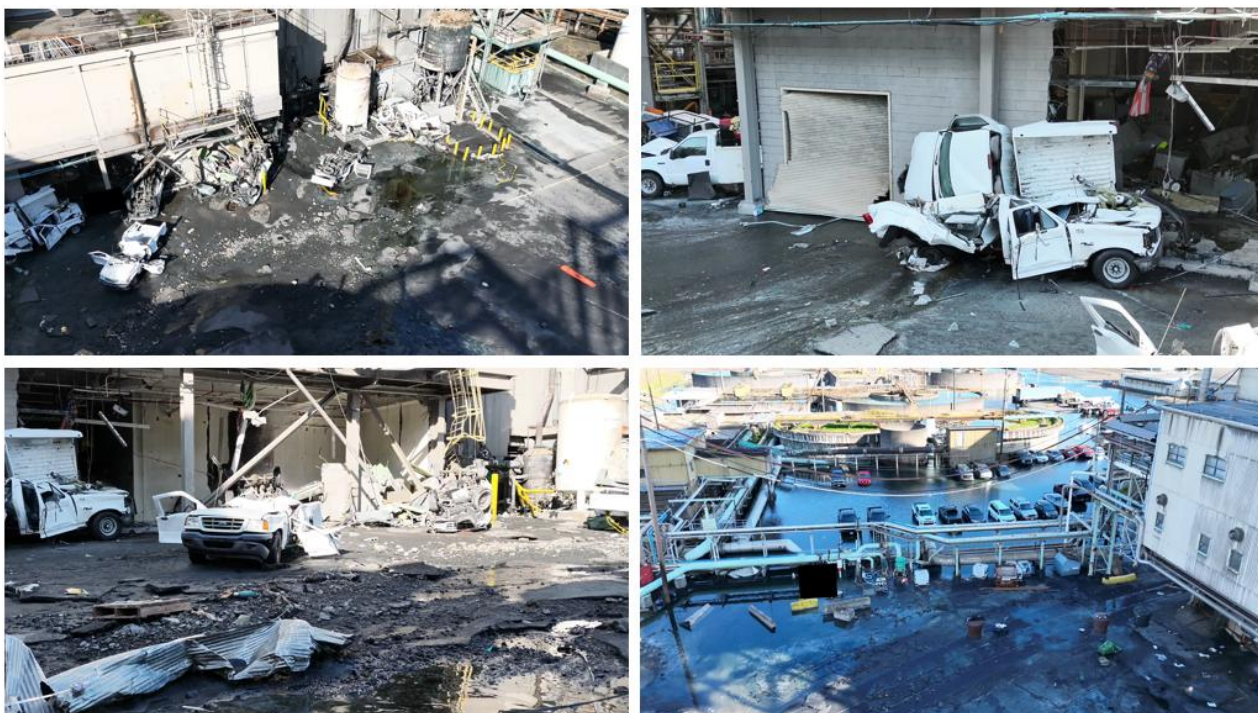
- Most of the tank’s contents were released when it failed, creating a massive “wave” of white liquor that rapidly flooded into the courtyard and towards the buildings. As the white liquor deluged the courtyard, the force of the moving liquid crushed vehicles and destroyed one of the surrounding buildings’ roll-up doors and one of its walls, shown in **Figure 8**. The white liquor entered the lower floors of the buildings through door seals and the destroyed roll-up doors, where the morning meetings were occurring.

**Figure 8.** Damages from the G Tank failure. The images show the courtyard after the event, the crushed vehicles and damaged roll-up door, the destroyed wall, and a nearby flooded parking lot. (Credit Cowlitz County Sheriff, modified by CSB)
