U.S. Chemical Safety and
Hazard Investigation Board

Fatal Hydrogen Sulfide Release at PEMEX Deer Park Refinery

Deer Park, Texas | Incident Date: October 10, 2024 | No. 2024-05-I-TX

Investigation Report

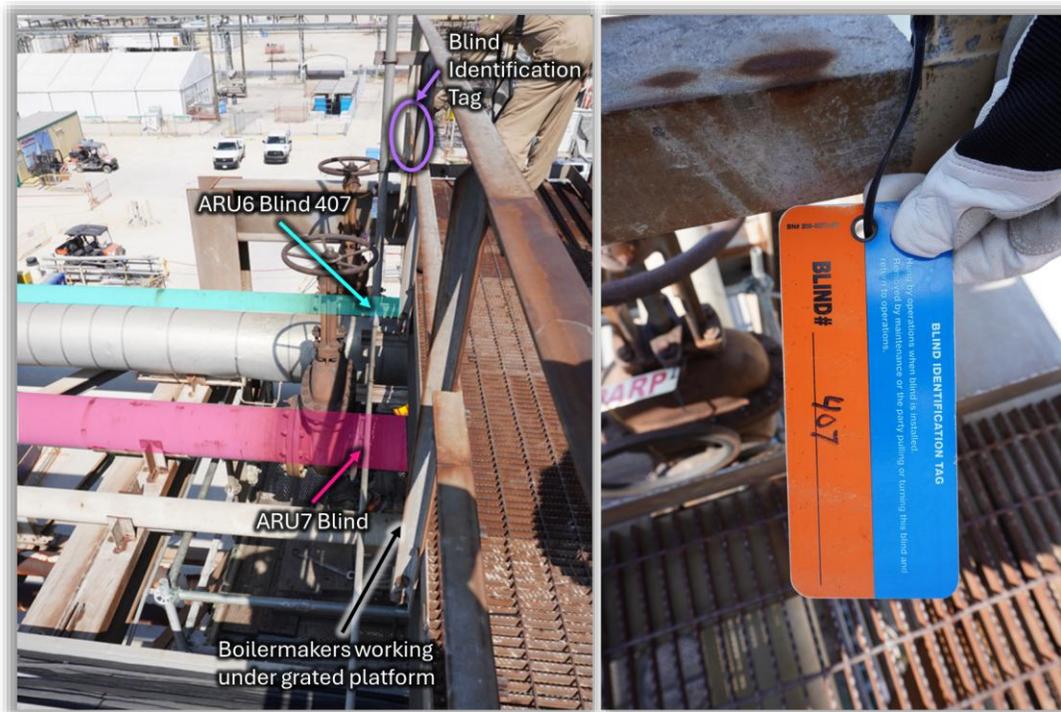
Figure 8. ARU6 Blind 407 could not be easily accessed, so operators hung the blind tag on the railing on the platform above the piping. (Credit: CSB)

The two Repcon boilermakers stated to the CSB that they did not see the orange-and-blue Blind 407 tag that had been fastened to the railing above the blind (**Figure 8**). Instead, the boilermakers observed a flange-locking

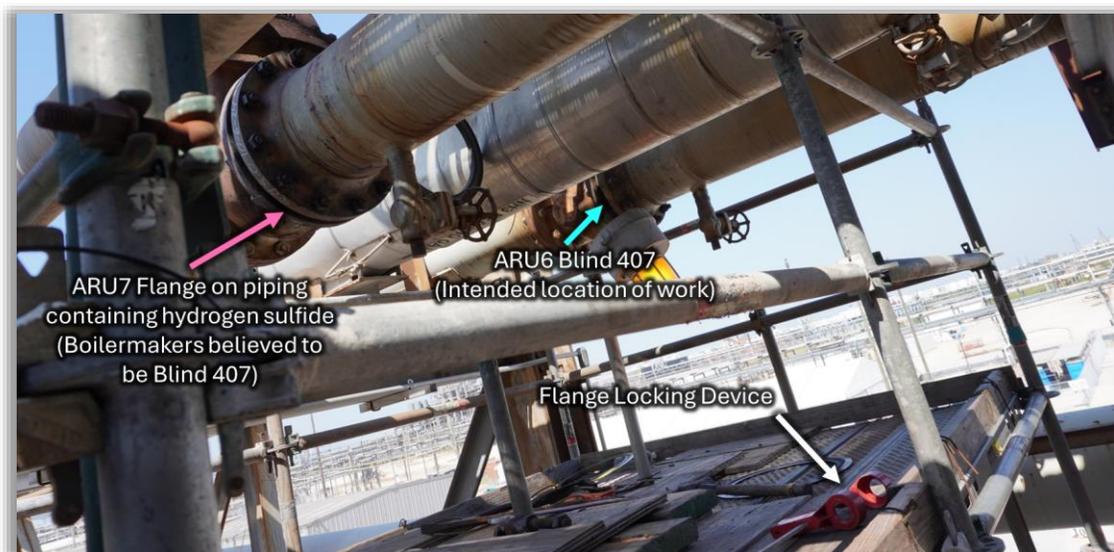
The two Repcon boilermakers at the Blind 407 location encountered two identical piping segments 5 feet apart. The ARU6 piping, which was the intended location of the work, had previously been depressurized, purged, and isolated via closed and locked-out valves. Five feet away, the ARU7 piping segment (**Figure 9**)—which had not been depressurized, purged, and isolated—contained approximately 90 percent hydrogen sulfide gas at a pressure of about 15 pounds per square inch gauge.

Figure 9. Adjacent ARU6 and ARU7 acid gas piping flanges (taken after the incident, when both blinds had been installed in the closed position). A flange-locking device was found on the work scaffold underneath the ARU7 acid gas piping flange. (Credit: CSB)

Believing that they were working on Blind 407, the Repcon boilermakers began removing bolts from the ARU7 flange, which was not covered by the work permit. Moments later, hydrogen sulfide began leaking from the flange. Because they were wearing supplied-air respirators and did not have personal hydrogen sulfide gas detectors, the two Repcon boilermakers did not detect the hydrogen sulfide leak by either air monitoring or odor detection. As a result, they continued to loosen and remove bolts from the ARU7 flange.

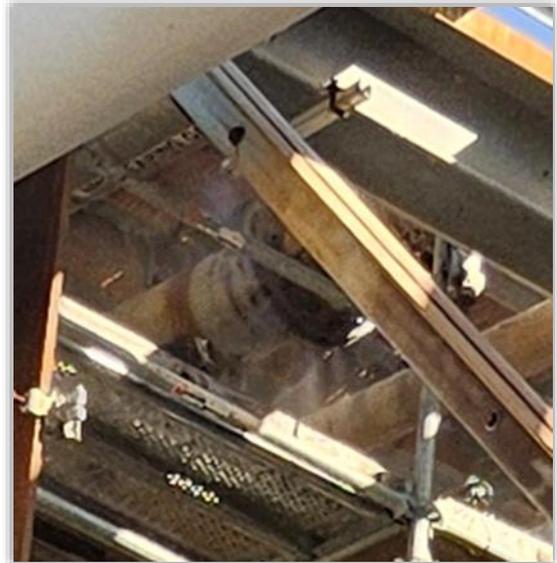
Figure 10. Hydrogen sulfide release from the ARU7 flange. (Credit: PEMEX Deer Park)

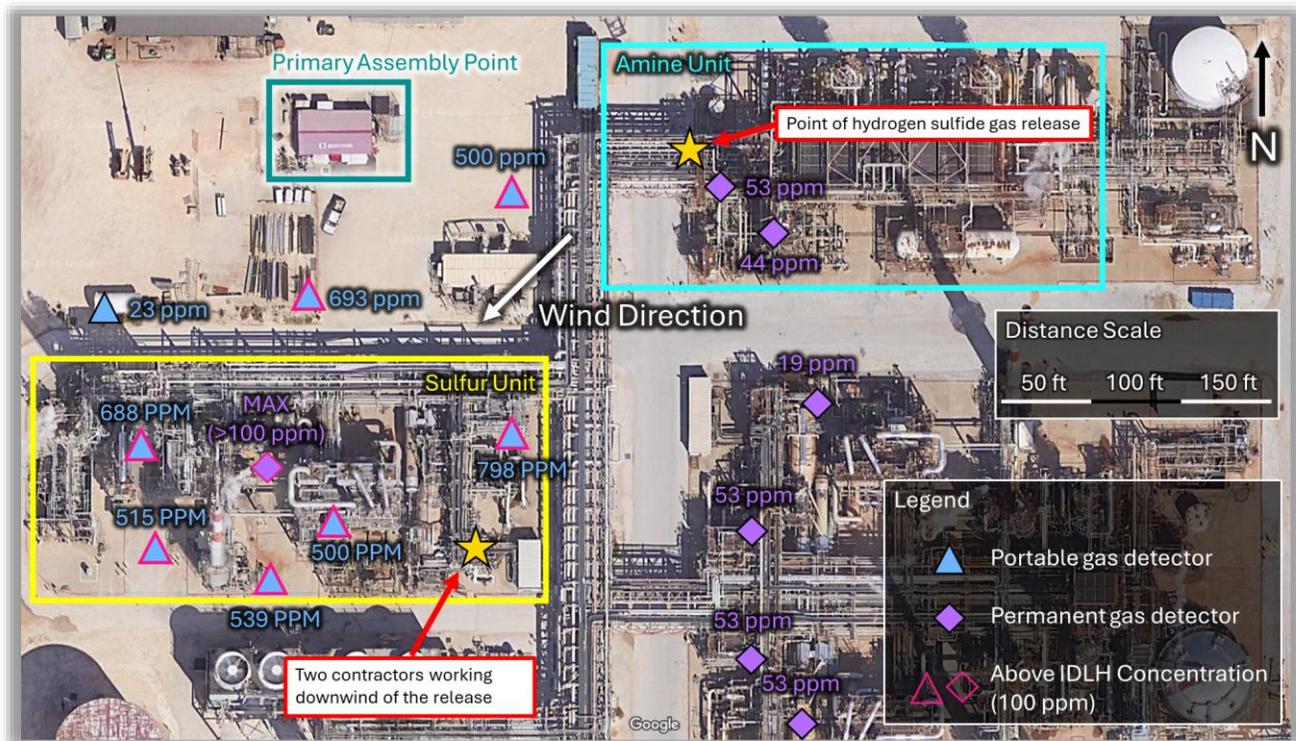
The wind^a carried the released hydrogen sulfide through the nearby Sulfur Unit (**Figure 11**). Less than 1 minute after the flange was opened, at 4:24 p.m., Code Red’s portable gas monitors that were stationed throughout the Sulfur Unit detected the hydrogen sulfide, recording concentrations exceeding 500 ppm and reaching nearly 800 ppm in some areas (**Figure 11**).^b The portable gas monitors began to alarm audibly at the location of each gas detector, and the functioning, permanently mounted alarm at a structure within the Sulfur Unit also started to alarm.

Figure 11. Overhead view of the hydrogen sulfide release location and adjacent units, with gold-colored stars indicating the approximate location of the fatally injured. The numerical values depict the maximum hydrogen sulfide concentration (ppm) at each location over the course of the incident. (Credit: Google Maps, annotated by CSB)

Two ISC contract workers (Section 1.4.3) were working on Sulfur Unit equipment about 250 feet away and downwind from the release (**Figure 11**). Because the ISC workers were within a deinventoried turnaround area, PEMEX Deer Park did not require them to wear respiratory protection for their permitted work, and they did not have escape respirators.

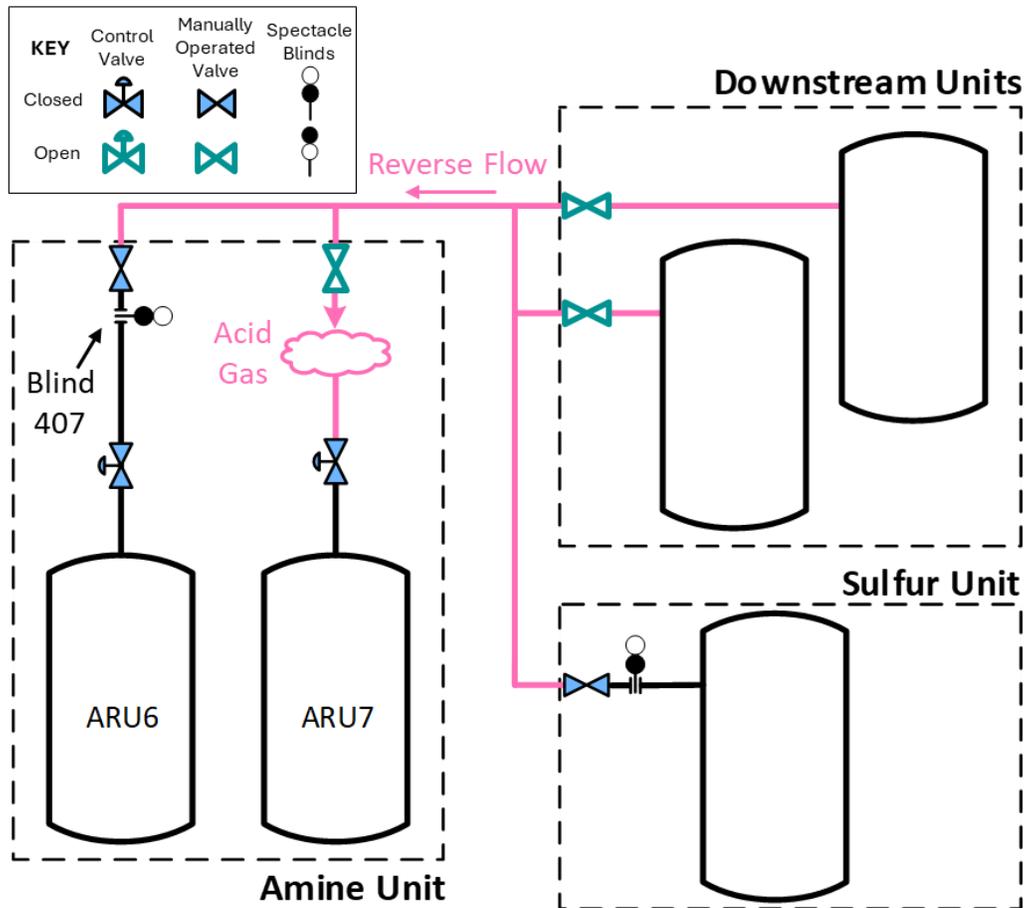
At 4:49 p.m., 26 minutes after the release began, a console operator closed a remotely operated control valve upstream of the release and redirected upstream acid gas flow to the emergency flare system. However, pressurized acid gas flowed back from the downstream processes through open manual valves (**Figure 12**), and the release continued.

Figure 12. Reverse flow of acid gas during the release. (Credit: CSB)

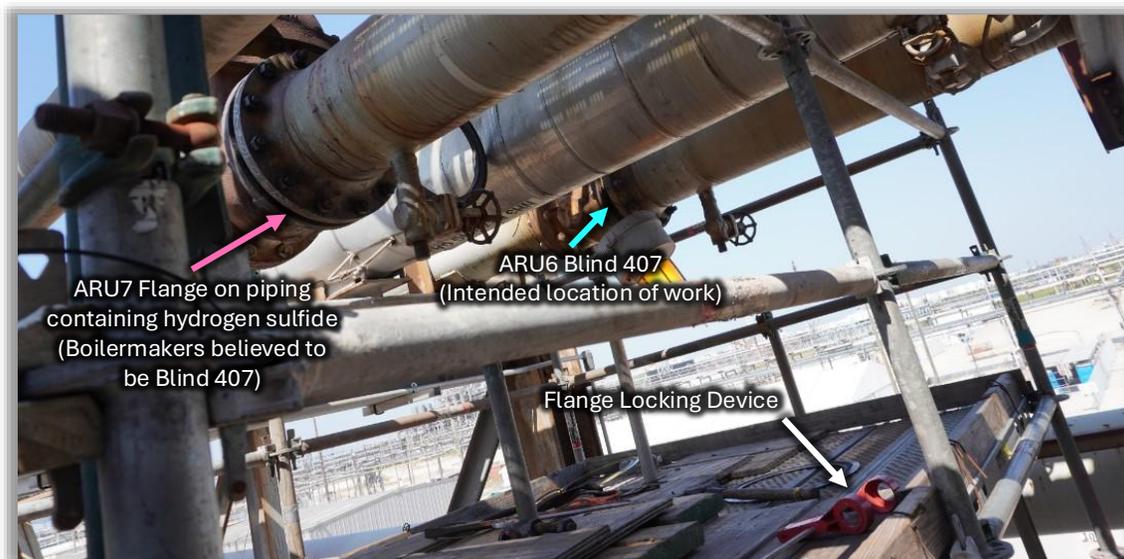
Flange-locking devices (**Figure 14**) were commonly placed on flanges during the Sulfur Unit turnaround to secure a blind installation. PEMEX Deer Park did not instruct Repcon to install these flange-locking devices for the Amine Unit maintenance task, however. Nevertheless, the surviving Repcon boilermakers told the CSB they located the isolation blinds in the Amine Unit primarily by looking for unlocked flange-locking devices because the flange-locking devices were used in the Sulfur Unit. As the Repcon boilermakers removed the blinds, they collected the flange-locking devices, as shown in **Figure 15**. As detailed in Section 2.2, when the boilermakers attempted to locate Blind 407, they found an unlocked flange-locking device on the ARU7 piping, which informed their decision to open the piping, believing it was the location of Blind 407. After the incident, the CSB found the flange-locking device under the ARU7 piping, as shown in **Figure 16**.

Figure 16. Adjacent ARU6 and ARU7 acid gas piping flanges (taken after the incident, when both blinds had been rolled to the closed position). A flange-locking device was found on the work scaffold underneath the ARU7 acid gas piping flange. (Credit: CSB)

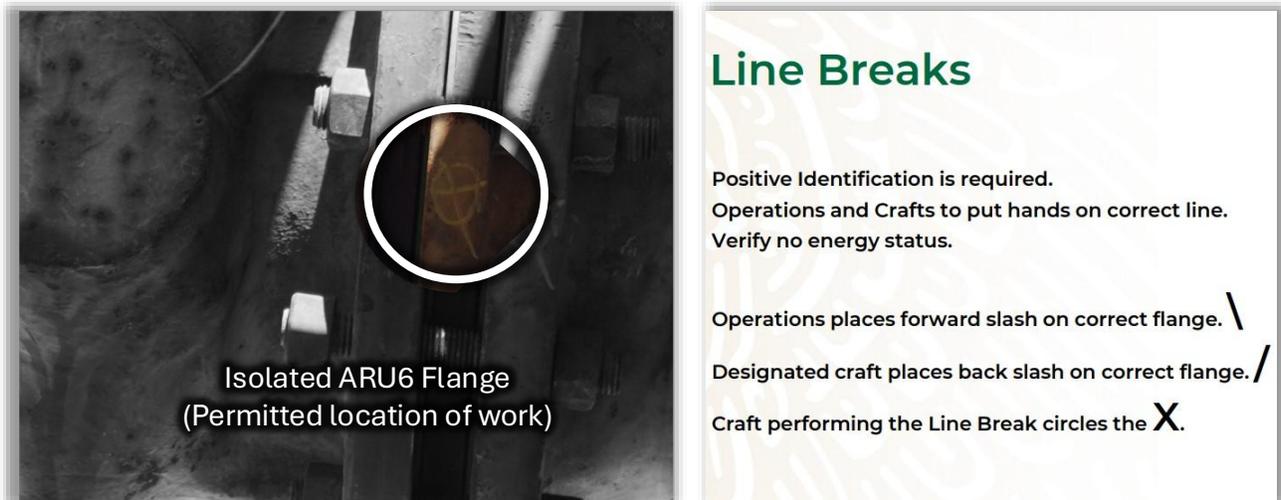
Improvised equipment identifiers can add unnecessary confusion, resulting in errors when selecting equipment to open. Standardized markings with verification requirements ensure that all parties understand which equipment should be opened before the work begins.

Figure 17. ARU6 Blind 407 piping flange with markings circled in white (left). (Credit: CSB) Onboarding training slide describing the marking practice for the identification of equipment openings during a turnaround (right). (Credit: PEMEX Deer Park)

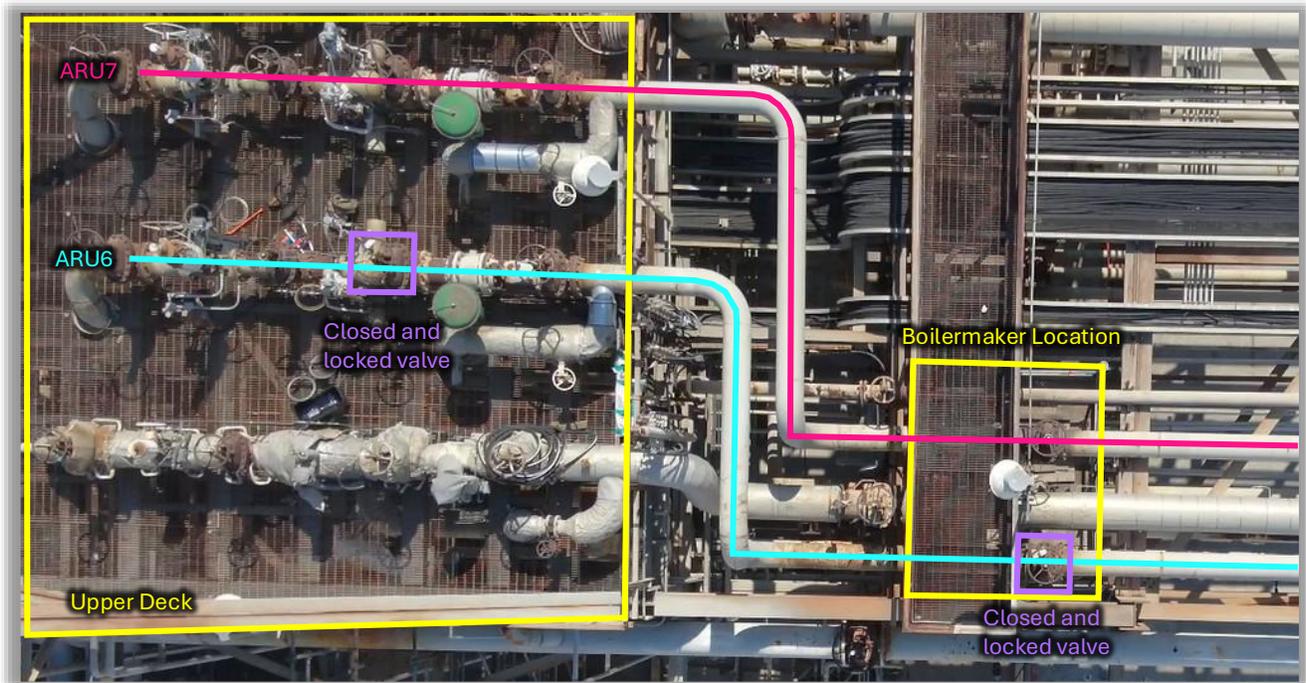
From the boilermakers' perspective at the location of Blind 407, the upstream locked-out valve on ARU6 appeared to align with the downstream ARU7 acid gas piping (**Figure 18**). As shown in **Figure 18**, the Amine Unit's pipe bends are not immediately noticeable and would require tracing out the piping segment from the upper deck to differentiate the two piping systems.

Figure 18. Overview of the Amine Unit piping configuration near the location of the boilermakers. (Credit: CSB)

The CSB recommends that PEMEX Deer Park label all piping in ARU6 and ARU7 in accordance with ANSI/ASME A13.1 *Scheme for the Identification of Piping Systems*.

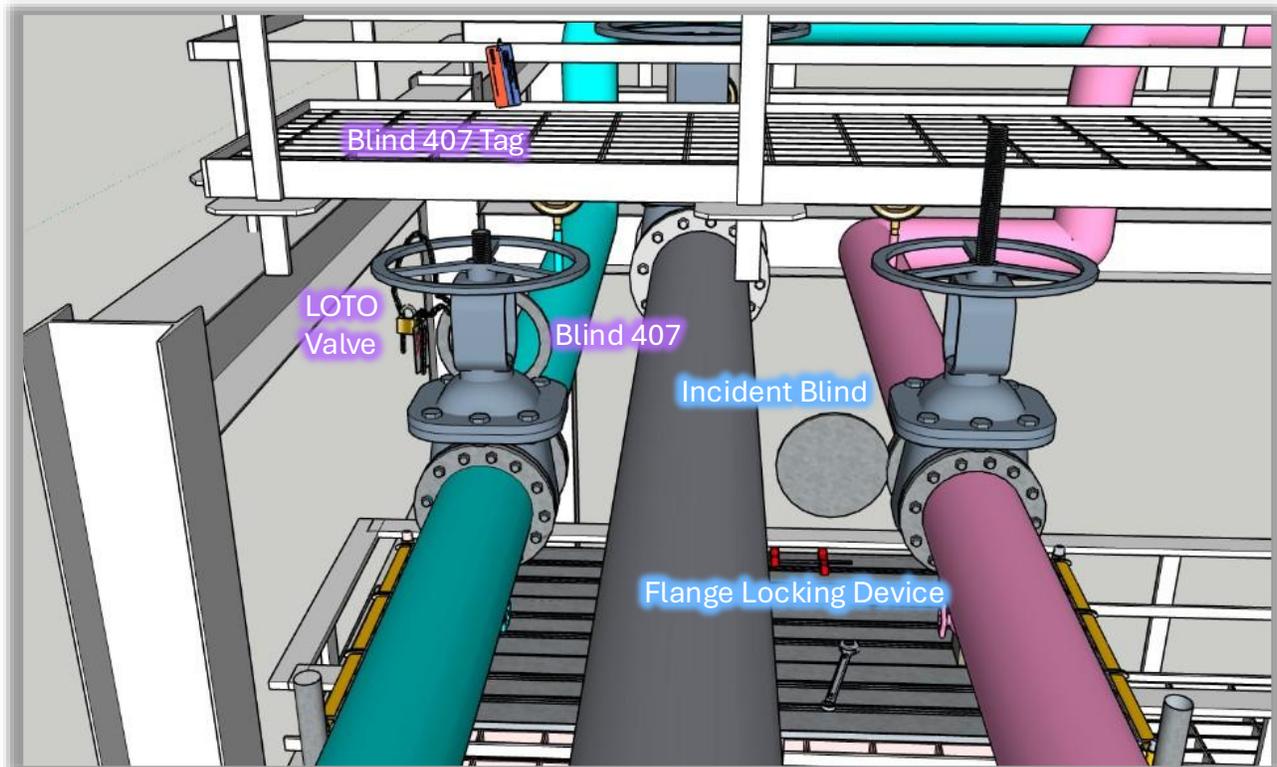
At the time of the incident, there were additional visual cues that could have been used to determine the status of the Amine Unit's piping systems. PEMEX Deer Park expected that the boilermakers would visit the locked-out downstream ARU6 block valve or have the Repcon foreman communicate this isolation point to them. Additionally, the orientation of the spectacle blinds for both ARU6 and ARU7 could have indicated the status of the two piping systems. As shown in **Figure 4** and **Figure 19**, the ARU7 blind was in the "open" position during the incident and could have been an indication that the ARU7 acid gas piping was operational. However, the boilermakers did not consider the locked-out block valve or the ARU7 spectacle blind position because they were not looking for them.

Figure 19. Overhead perspective of the Amine Unit's acid gas piping showing the equipment identifiers for ARU7 (highlighted blue) and the equipment identifiers for ARU6 (highlighted purple). (Credit: CSB)

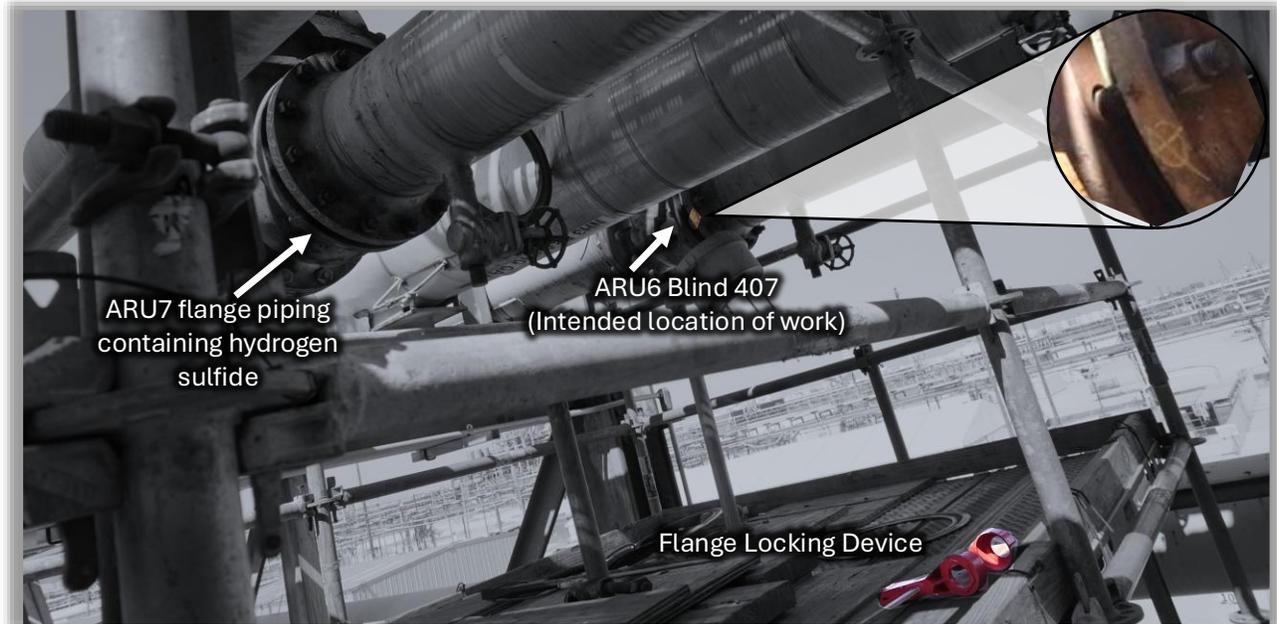
Figure 20 shows the incident location from the boilermaker’s perspective by highlighting the equipment identifiers in place—the flange-locking device and the Circle-X marking. Because the boilermakers were not looking for locked-out valves or spectacle blind positions, the flange-locking device directed them to work on the ARU7 piping.

Figure 20. ARU6 and ARU7 acid gas piping segments as found after the incident. (Credit: CSB)
