# Fatal Coke Oven Gas Explosion at U.S. Steel Clairton Coke Works

Clairton, Pennsylvania | Incident Date: August 11, 2025 | No. 2025-03-I-PA

## Investigation Report

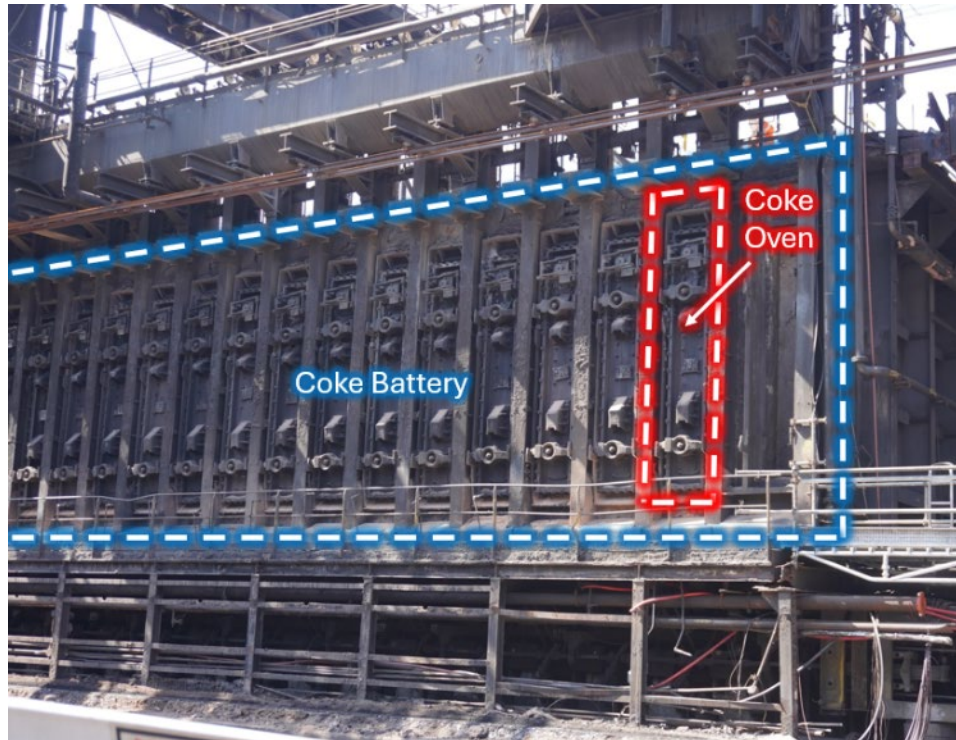
**Figure 2.** Post-incident picture of one of U.S. Steel’s coke batteries. (Credit: CSB)

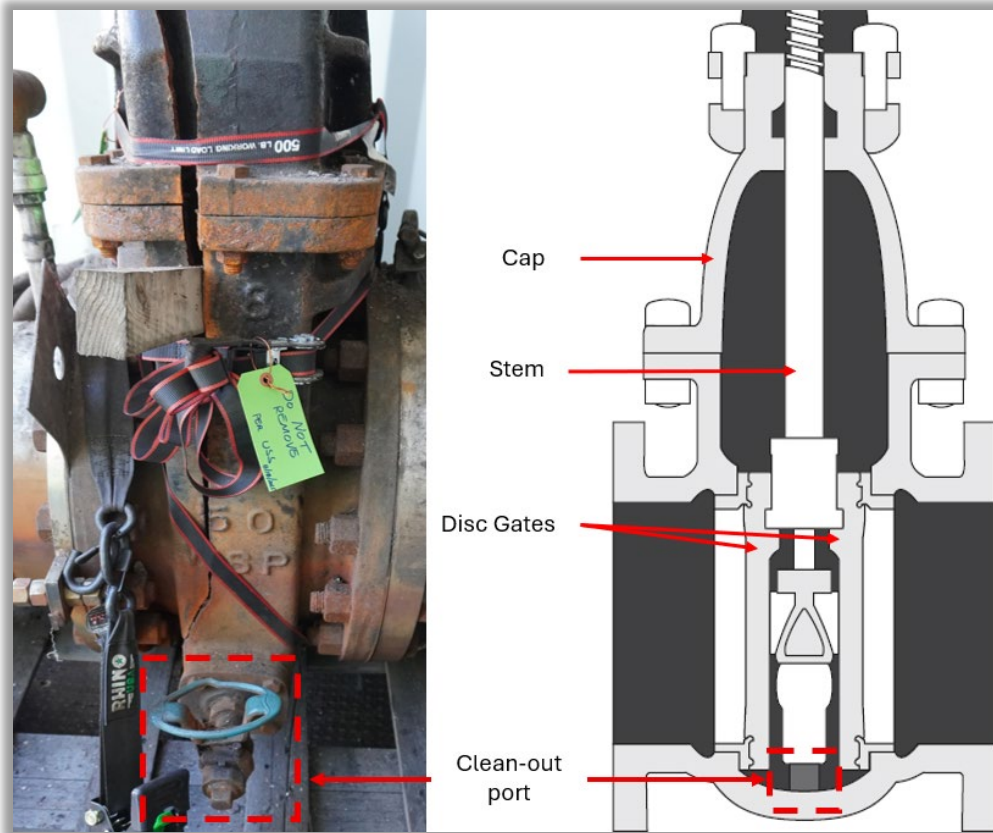
<sup>b</sup> Maintenance records show that U.S. Steel last sent the valve to a local vendor for repair in 2013. At that time, both gates in the valve were found cracked, and they were subsequently replaced.

**Figure 7.** Post-incident photo of the isolation valve involved in the incident (left) and a diagram of the valve internals (right). (Credit: CSB)

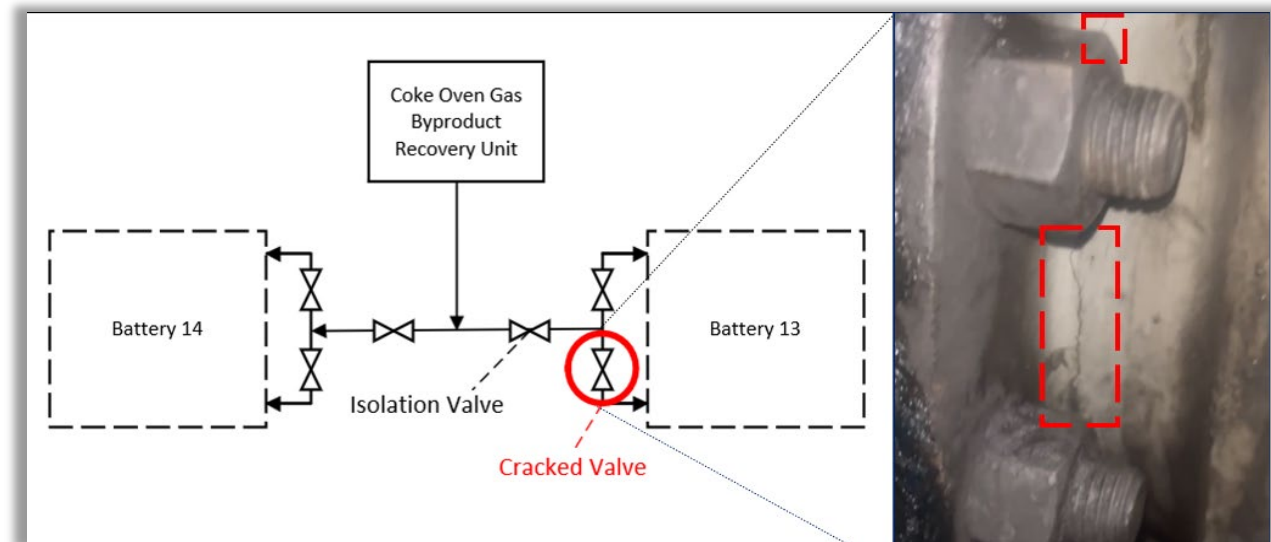
On July 8, 2025, five weeks before the incident, a U.S. Steel employee identified a coke oven gas leak from a valve downstream of the Battery 13 isolation valve. The company found that the valve had a hairline crack near one of its flanges (**Figure 9**). U.S. Steel applied a metal repair composite onto the crack as a temporary repair. Subsequent monitoring by U.S. Steel determined that coke oven gas had stopped leaking from the temporarily repaired valve. As a precaution, U.S. Steel placed air movers<sup>a</sup> near the valve, intended to exhaust air outside to prevent the accumulation of flammable gas in the basement.

**Figure 9.** Cellphone photograph of cracked valve, with diagram showing valve’s relative position in the coke oven gas piping. (Credit: Photo by U.S. Steel, diagram and annotations by CSB)

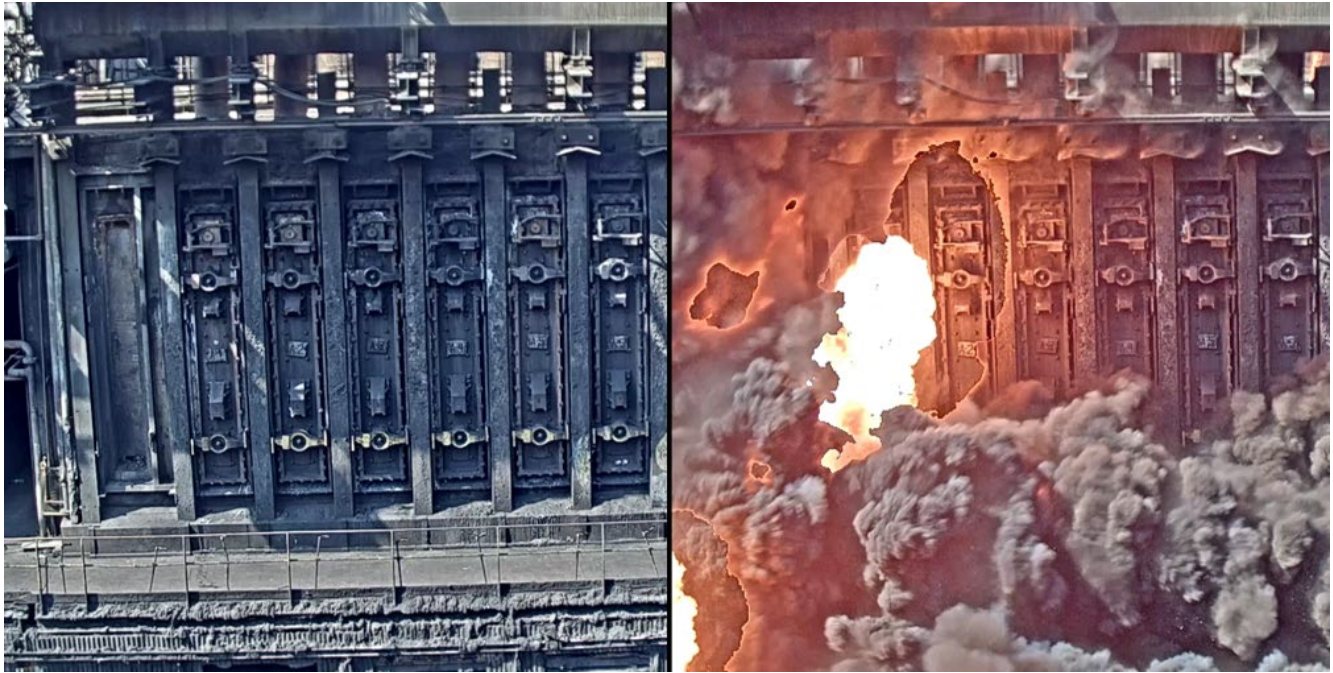
ran toward the Battery 13/14 transfer area instead of away from it. Twenty-four seconds after the radio evacuation call, at 10:47 a.m., the released coke oven gas ignited and exploded (**Figure 11**).

**Figure 11.** Surveillance images showing Battery 14 immediately before and after the ignition of the coke oven gas leaking from the basement. (Credit: U.S. Steel)

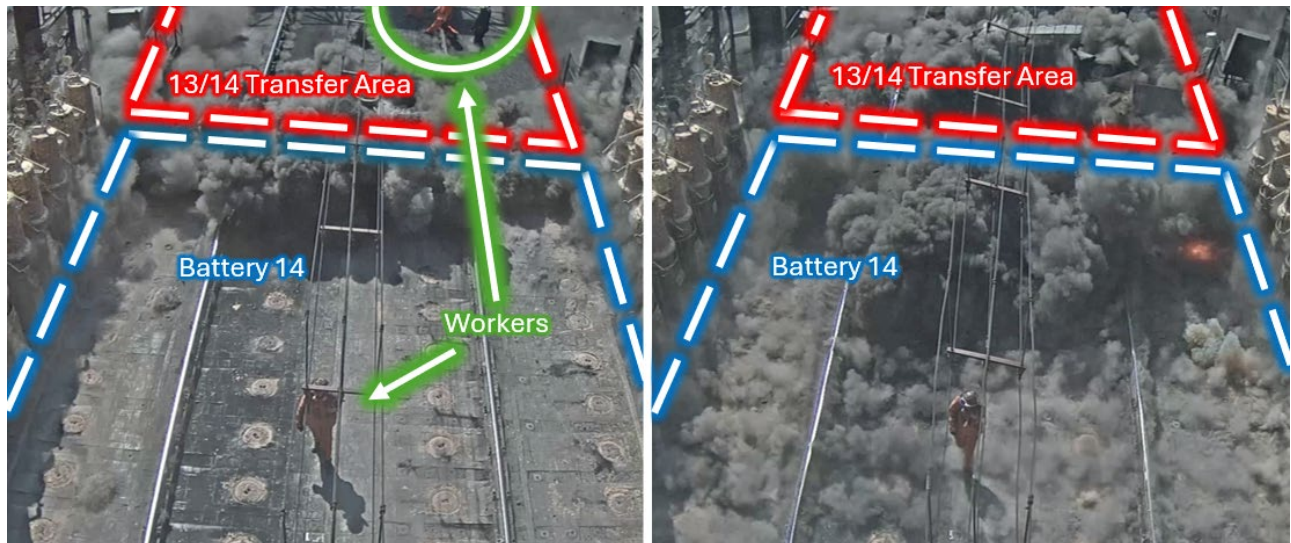
At the time of the explosion, four workers were still on top of the transfer area (**Figure 12**).

**Figure 12.** Surveillance images of the initial moments of the explosion, overlooking the top of Battery 14 and the Battery 13/14 transfer area. (Credit: U.S. Steel, annotated by CSB)

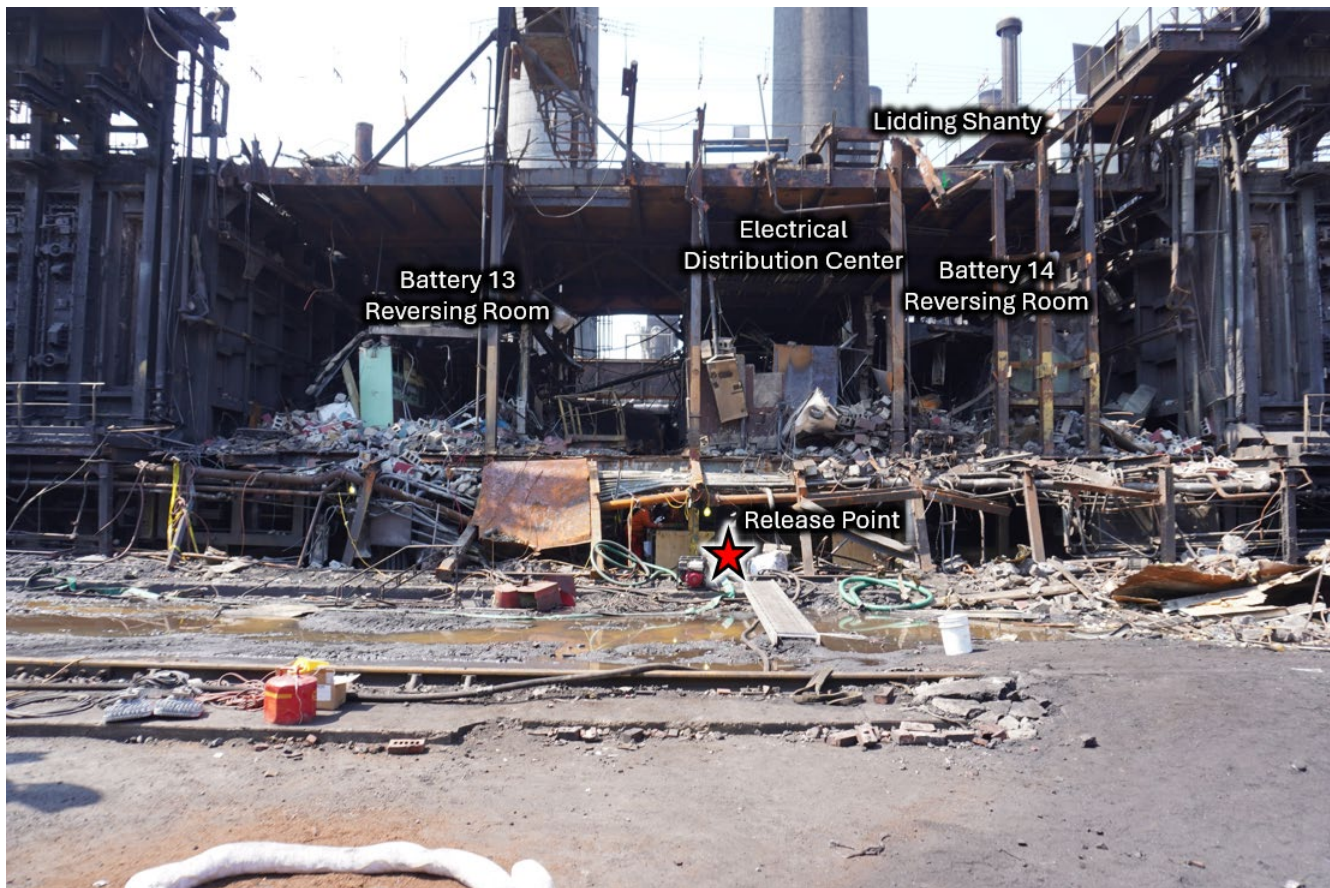
The incident at the U.S. Steel Clairton facility resulted in two fatalities, five serious injuries, six other injuries, and an estimated \$52.5 million in property damage.<sup>a,b</sup>

**Figure 13.** Post-incident photo, showing the damage to the Battery 13/14 transfer area. (Credit: CSB)

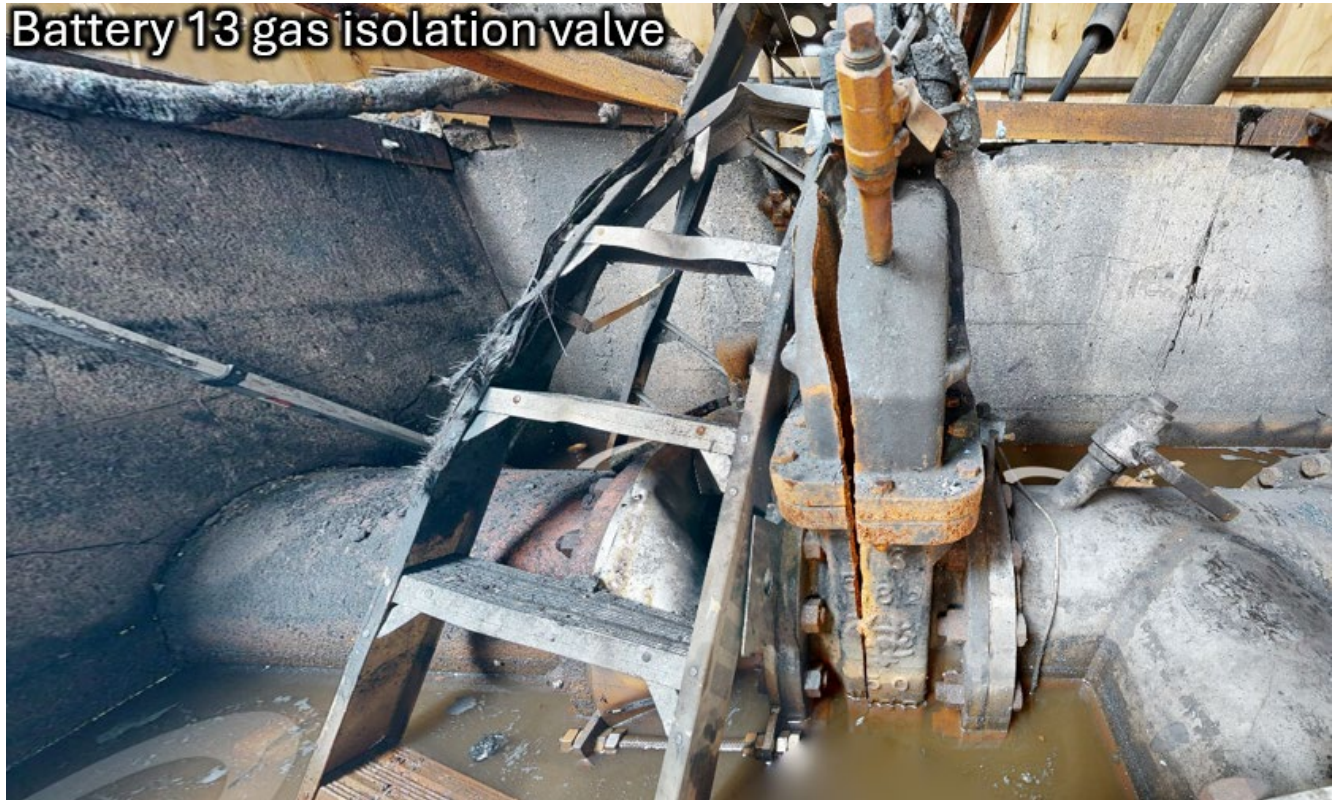
After the incident, the Battery 13 coke oven gas isolation valve was found to have failed catastrophically (Figure 14).

**Figure 14.** Photo of the Battery 13 gas isolation valve, as found after the incident. (Credit: Allegheny County Fire Marshal, annotated by CSB)

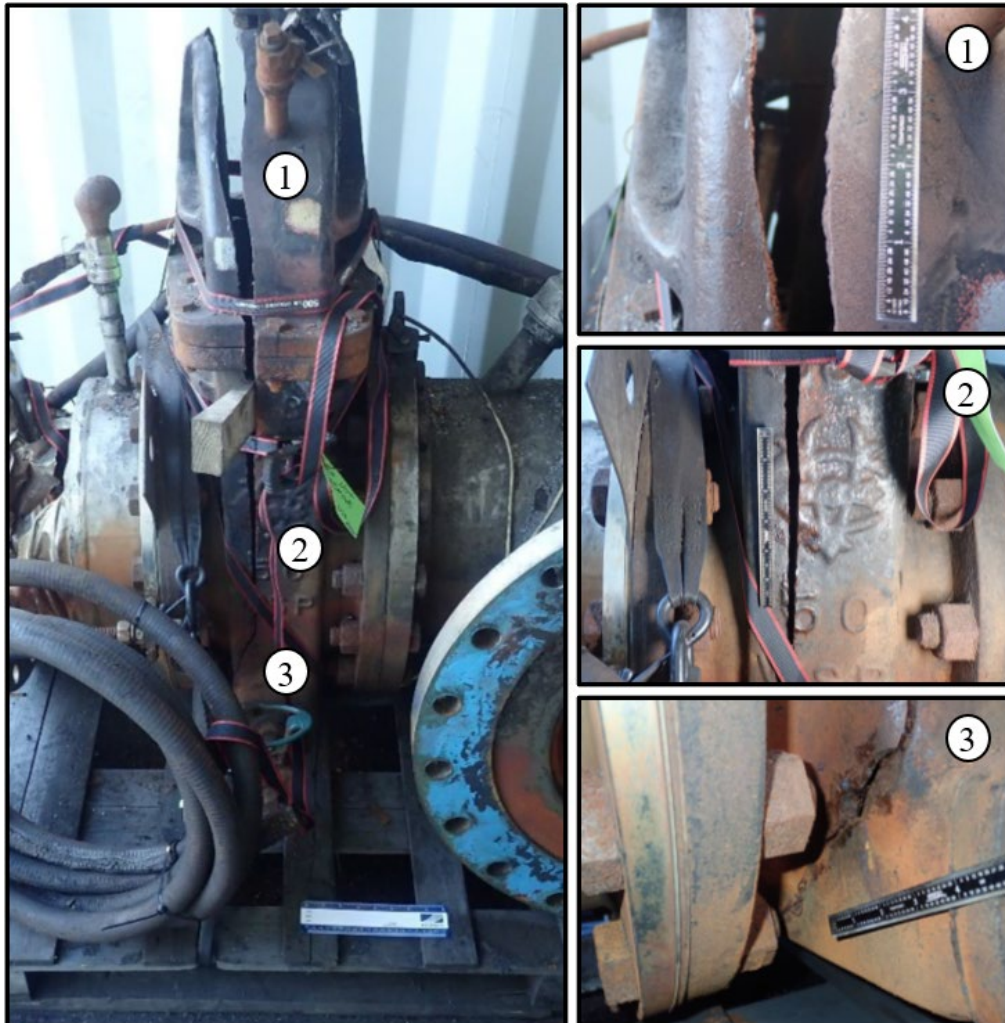
External visual examination determined that the crack in the body of the Battery 13 gas isolation valve was fully circumferential, and was visually consistent with sudden, brittle fracture (**Figure 15**). Internal visual examination confirmed that the double gates of the valve were in the fully lowered or nearly fully lowered position.

**Figure 15.** Photos of the Battery 13 coke oven gas isolation valve, taken during post-incident examination. (Credit: CSB)

Visual examination of the valve determined that the failure was consistent with overpressurization of the valve body and cap. The CSB concludes that the Battery 13 coke oven gas isolation valve was subjected to internal pressures greater than the valve was designed to withstand, causing it to catastrophically fail.

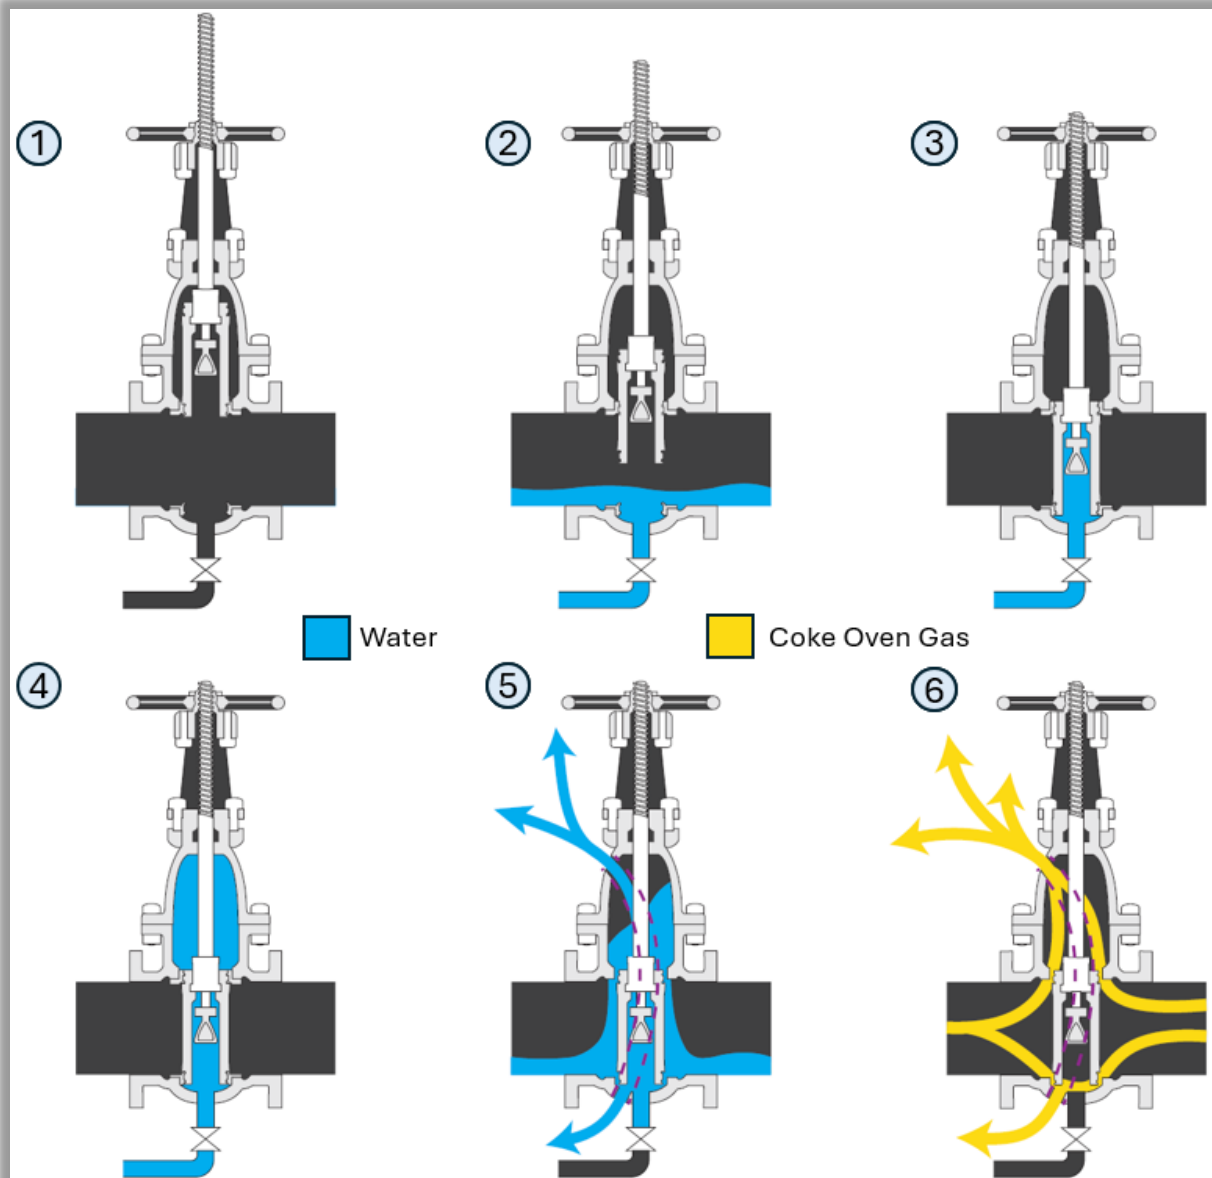
**Figure 16.** Diagram illustrating the likely incident sequence. (Credit: CSB)

1. The valve exercising operation began with the valve gates fully open.
2. Workers partially lowered the gates. Then workers began applying water to the valve seats through the cleanout port. Workers began further lowering the valve's gates.
3. The gates reached the fully closed, or nearly fully closed position, while water was still being pumped into the valve. The cleanout port was positioned directly between the valve's two gates. With the gates closed, water began filling up the space between the two gates.
4. Water continued filling the inside of the valve into the cap and increased the pressure on the inside of the valve body and cap.

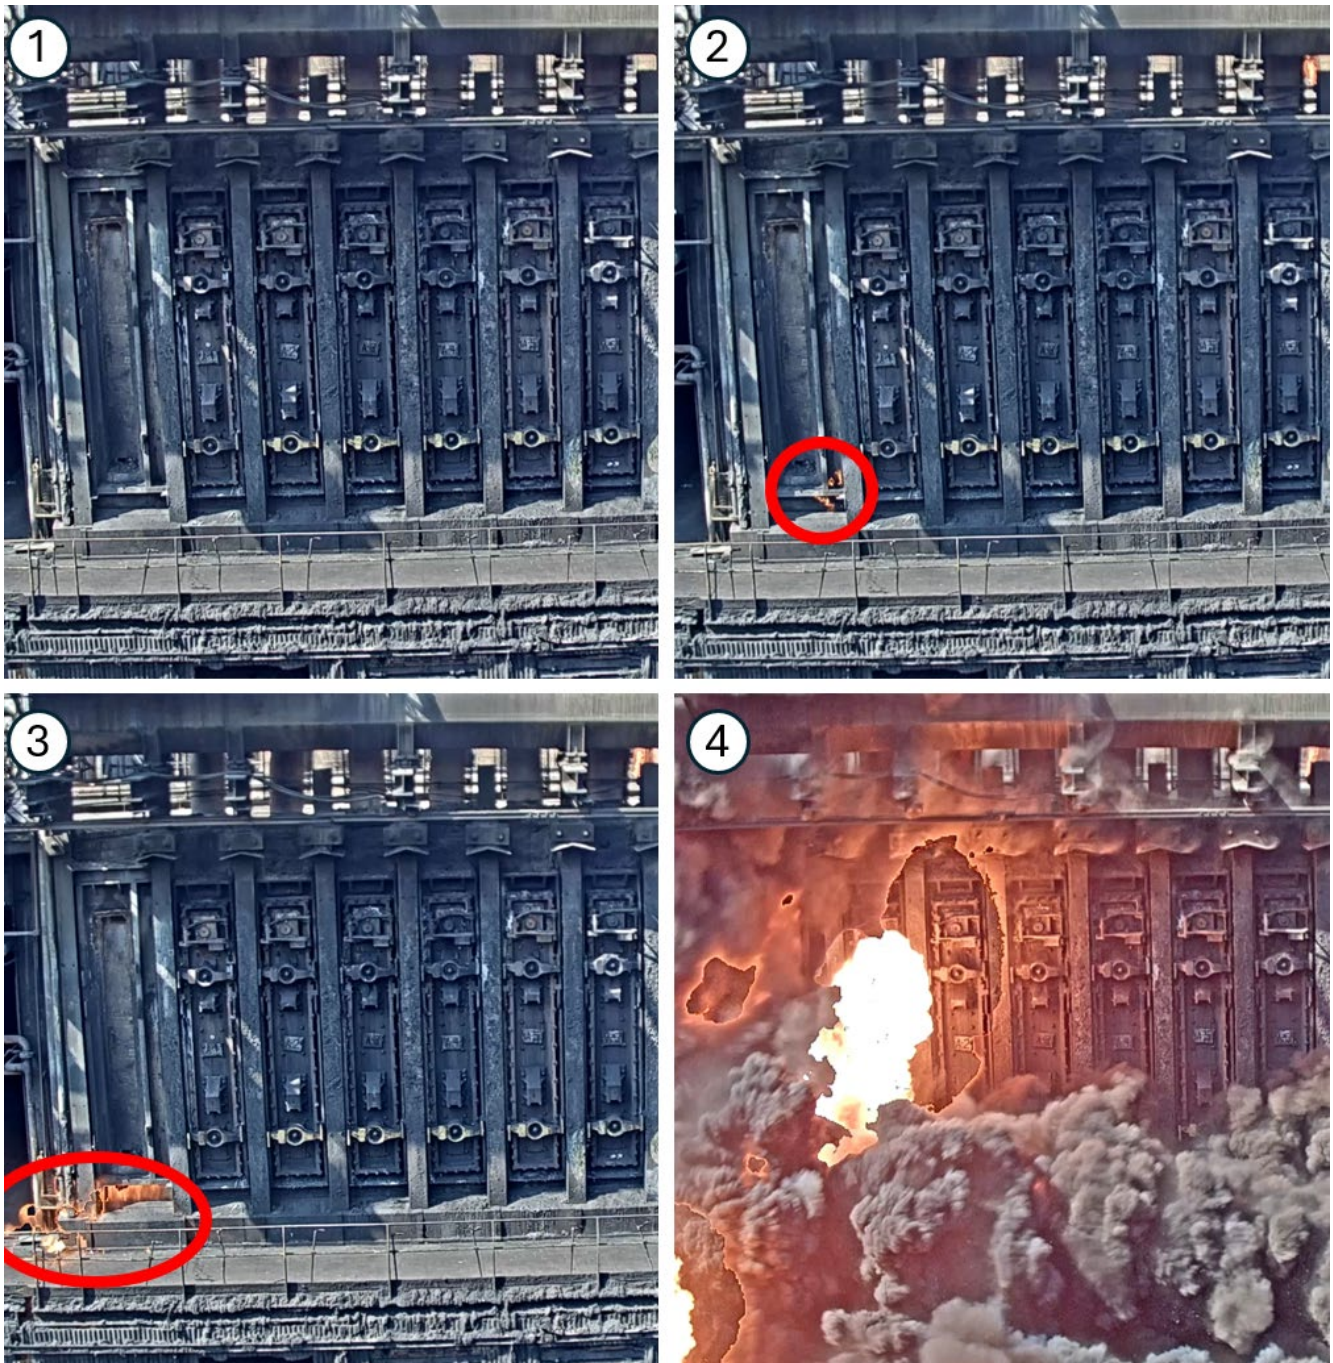
**Figure 17.** Frame-by-frame surveillance images showing the ignition of the coke oven gas cloud. (Credit: U.S. Steel, annotated by CSB)

The CSB concludes that the coke oven gas cloud ignited at or near the Battery 14 coke oven closest to the transfer area.

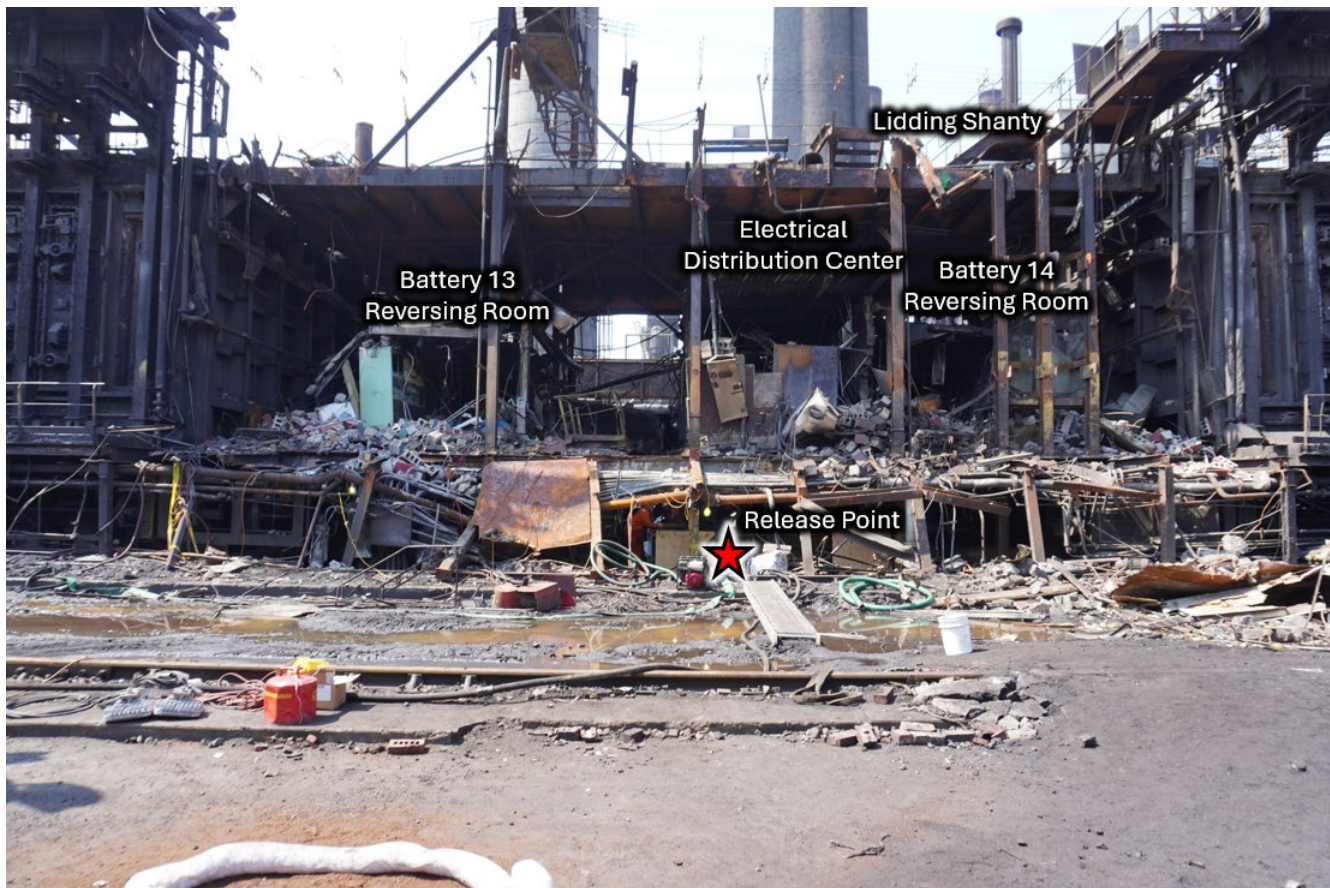
**Figure 21.** Post-incident photo of the 13/14 transfer area. The break room was located behind the EDC and the Battery 14 reversing room. (Credit: CSB)

Before the explosion, four U.S. Steel employees were inside the buildings in the 13/14 transfer area. One employee was in or near the Battery 13 reversing room, one in or near the Battery 14 reversing room, and two in the break room.<sup>a</sup> The two workers in or near each of the reversing rooms were both fatally injured. One of them was propelled by the force of the explosion and was found underneath rubble by emergency responders on the ground level adjacent to the coke batteries. The other fatally injured worker was buried in debris and was found by an urban search and rescue team roughly nine hours after the explosion.

Conduct a siting evaluation for all occupied and potentially occupied buildings at the Clairton Coke Works facility. Utilize the guidance contained in the Center for Chemical Process Safety's *Guidelines for Evaluating Process Plant Buildings for External Explosions, Fires, and Toxic Releases*, the American Petroleum Institute's Recommended Practices 752, 753, and 756, and other industry good practice guidance documents.

Using the results from the evaluation performed in **2025-03-I-PA-R1**, ensure that all documented facility siting hazards are mitigated in accordance with the guiding principles contained in the American Petroleum Institute's Recommended Practices 752, 753, and 756.

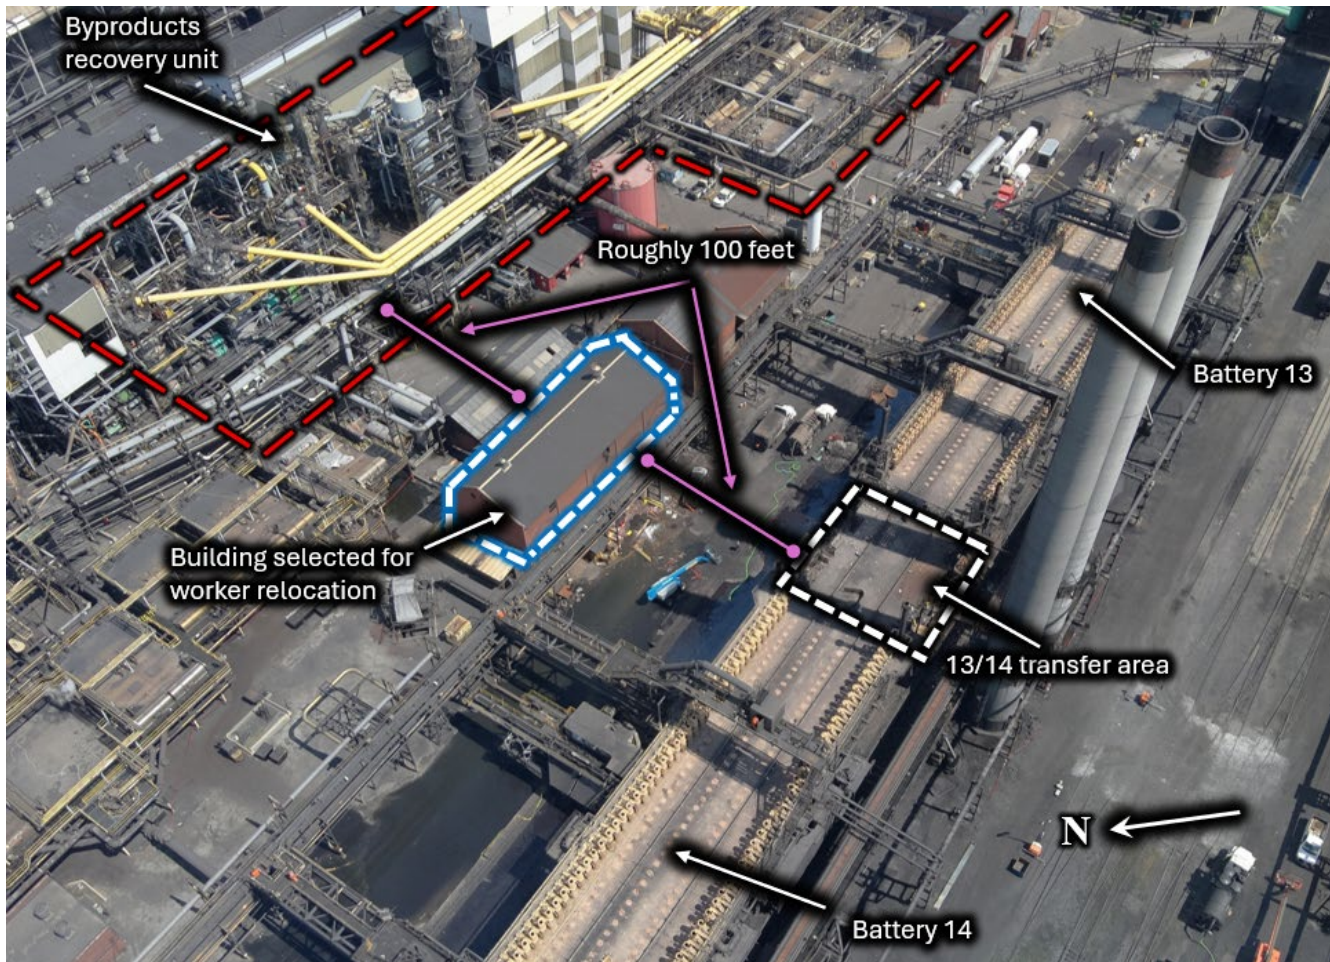
**Figure 22.** Aerial drone photograph of a portion of the U.S. Steel Clairton facility. The building to which the company is relocating workers is close to processes containing raw and processed coke oven gas. (Credit: Allegheny County Fire Marshal, annotated by CSB)
