Report No. 5005.3434 C

November 6, 2018

**LABORATORY EVALUATION OF SAMPLES FROM THE  
BRAZED ALUMINUM PLATE-FIN HEAT EXCHANGER H-3059 INVOLVED IN  
THE JULY 27, 2016 FIRE AT ENTERPRISE PRODUCTS OPERATIONS,  
MOSS POINT, MS**

Customer Authorization: CSB-16-0030

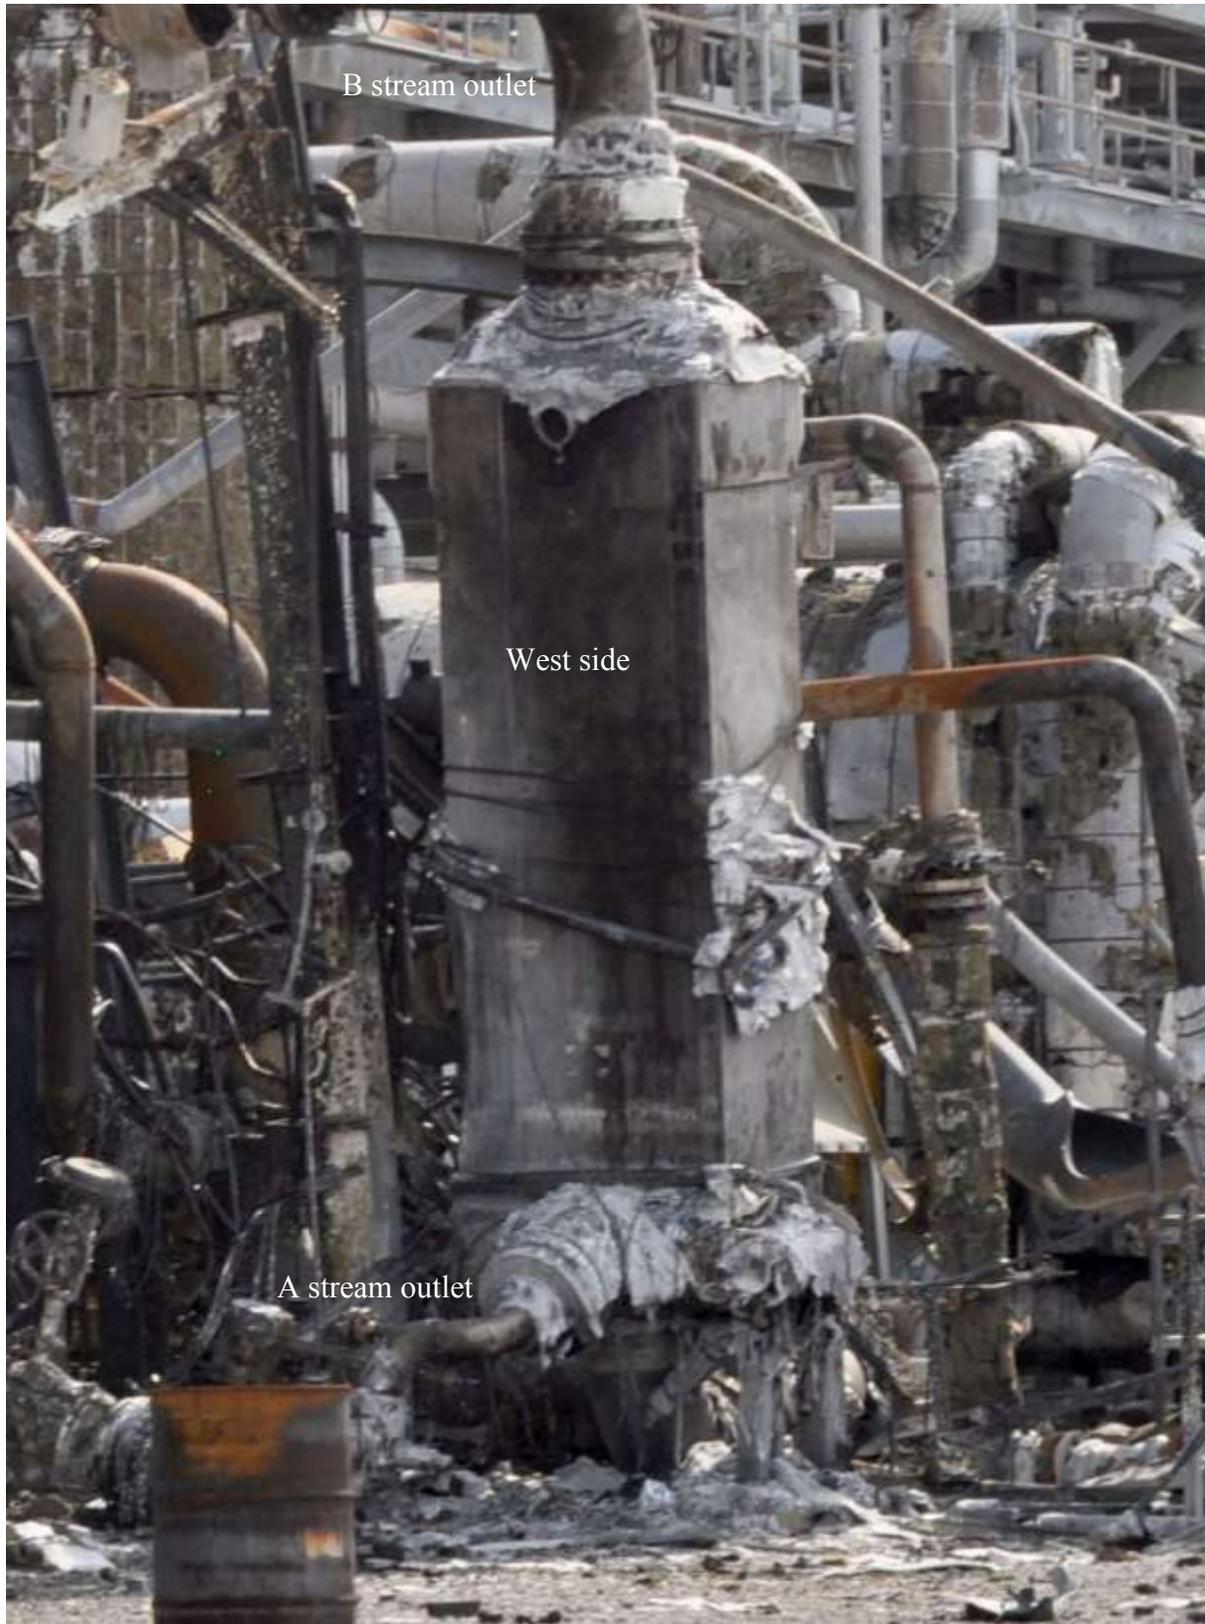
Figure 2 Photograph of the ACSR, viewed from the south west.

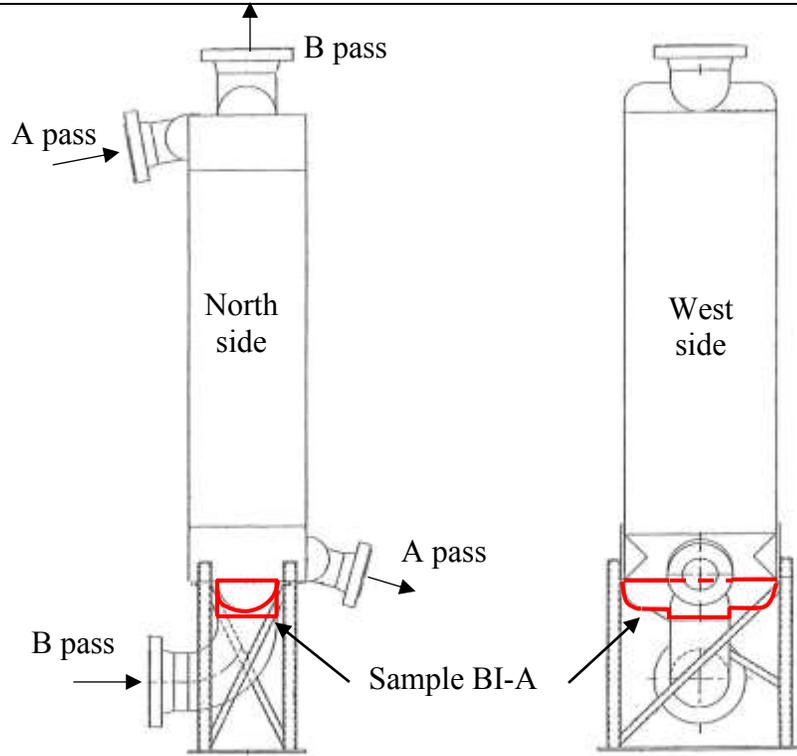
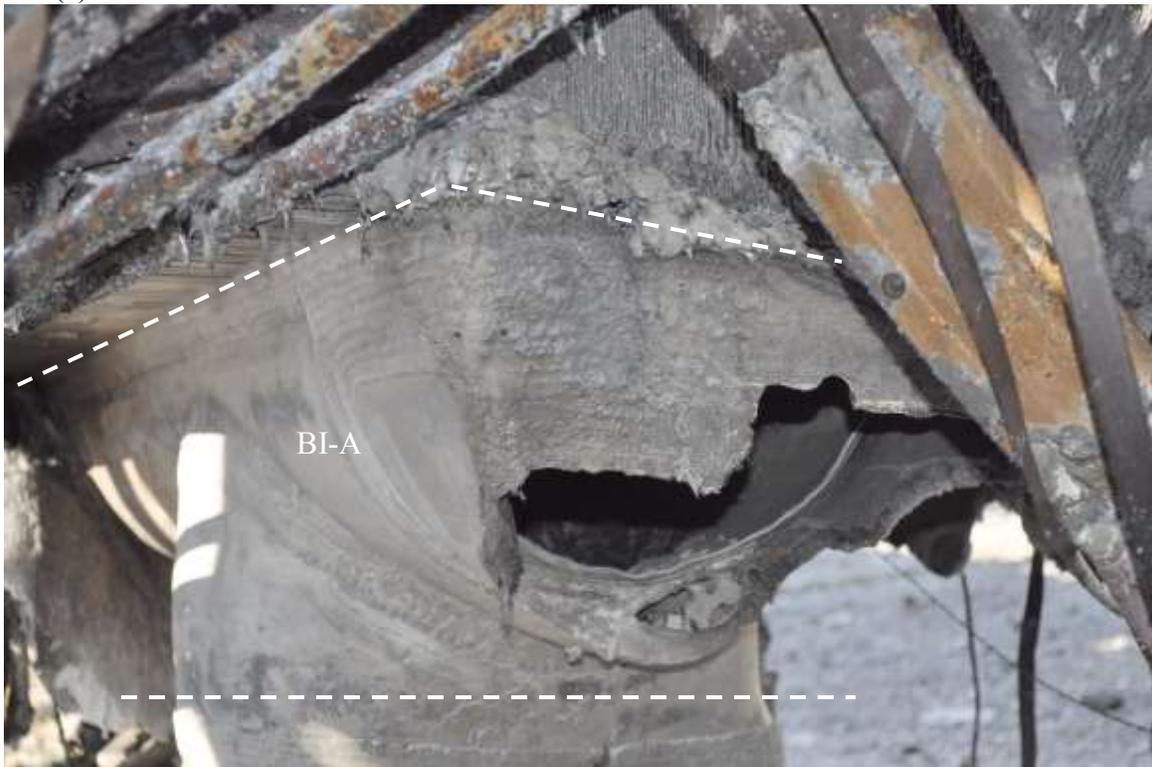
The location of the B pass inlet header sample BI-A on the ACSR is shown in a simplified drawing along with a photograph in Figure 9. The sample is shown as-received in Figure 10. The configuration of transverse header welds indicated the header had been cut open at some point after manufacture, and re-welded. Cutting open headers is typically done as part of a core leak testing or repair. Seams in the perforated plate located between the header and the core matched up with the header repair welds. The perforated plate had likely been cut after the header was opened to allow access to the end of the core. The plate had been re-welded to the header.

Figure 9 Simplified drawing of the ACSR with the location of the B pass inlet header sample indicated and a photograph of the header taken after the fire with the ACSR still in place. Dashed lines in (b) indicate where the header was cut from the core and nozzle.

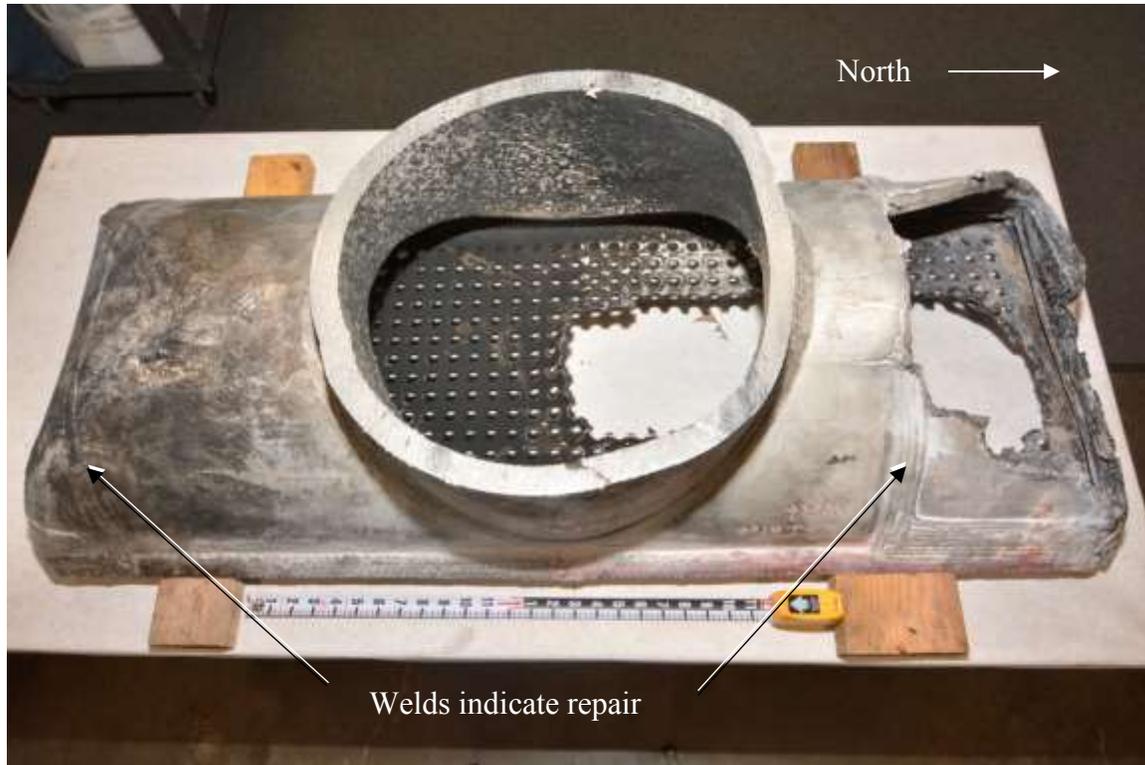
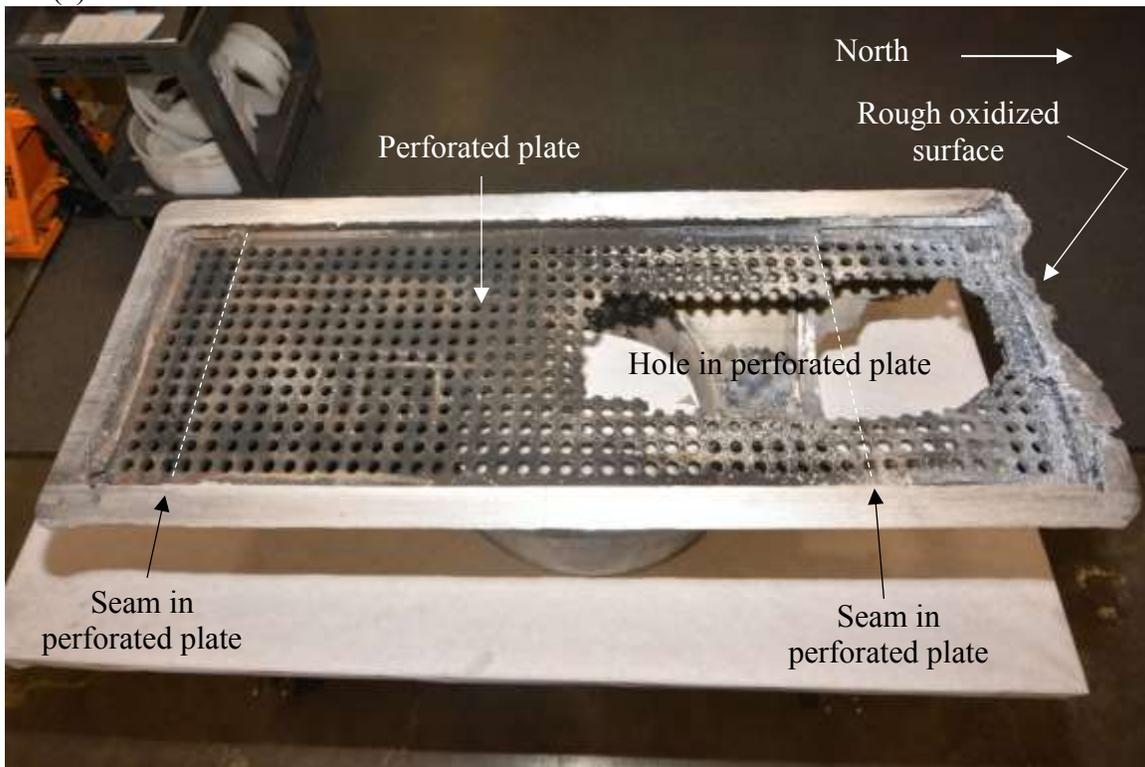
A large hole was present in the north end of the header, which extended from the repair weld to the weld that joined the end of the header to the core. At the north end, the header had been separated from the core by partial melting, evidenced by a rough oxidized surface. Had this section of weld been intact when the sample BI-A was cut from the core, a saw cut surface would have been present in this location. A hole in the perforated plate corresponded with the hole in the header. Edges of the hole in the plate were curved toward the inlet nozzle. Fragments of the plate had been found at the top of a pile of melted and re-solidified aluminum located at the base of the ACSR after the fire, prior to removal from the site. This indicated the hole in the perforated plate was caused by partial melting from the heat for the fire, after the hole in the header was created.

Figure 10 Photographs of the B stream inlet header BI-A cut from the ACSR.

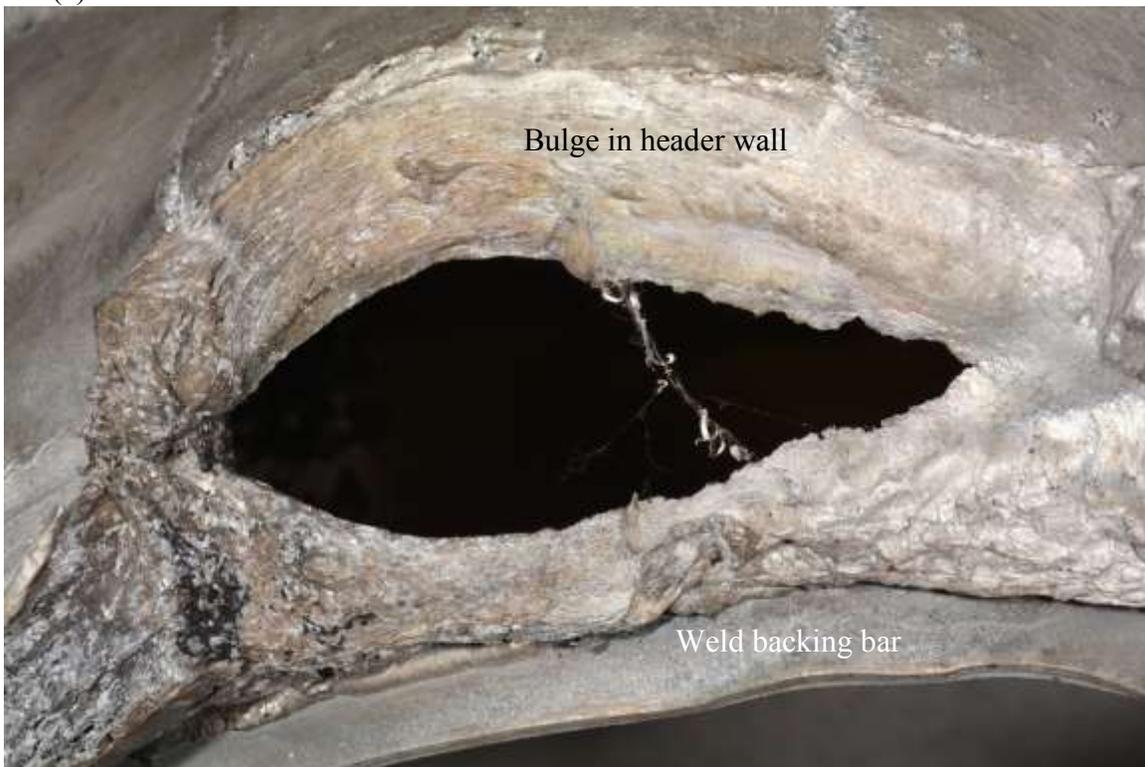
Key details of damage to the header are indicated in Figure 11 and Figure 12. A bulge in the header wall located along the edge of the hole parallel to the header repair weld indicated partial melting. Sag in the north end header to core weld coincided with the region of separation from the core caused by partial melting. Wide cracks in the header, header to nozzle weld, and small section of nozzle that was continuous with sample BI-B indicated partial melting.

Figure 12 Photographs of the header, boxed regions in Figure 11a.

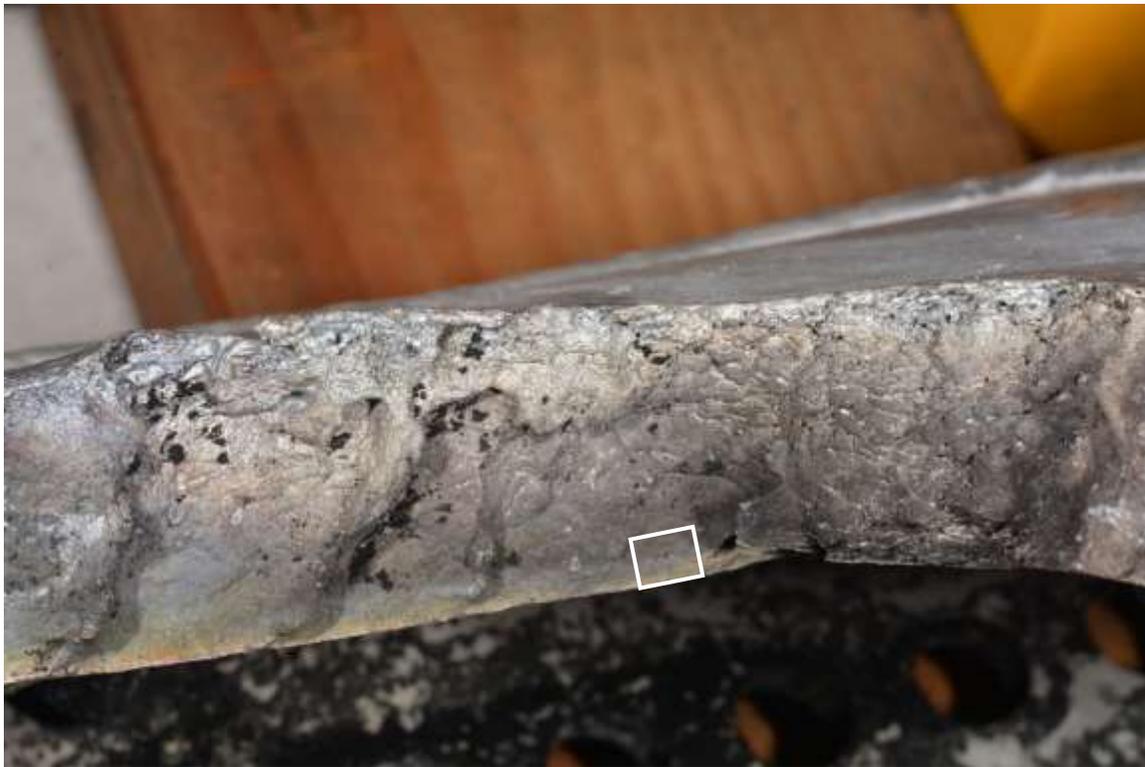
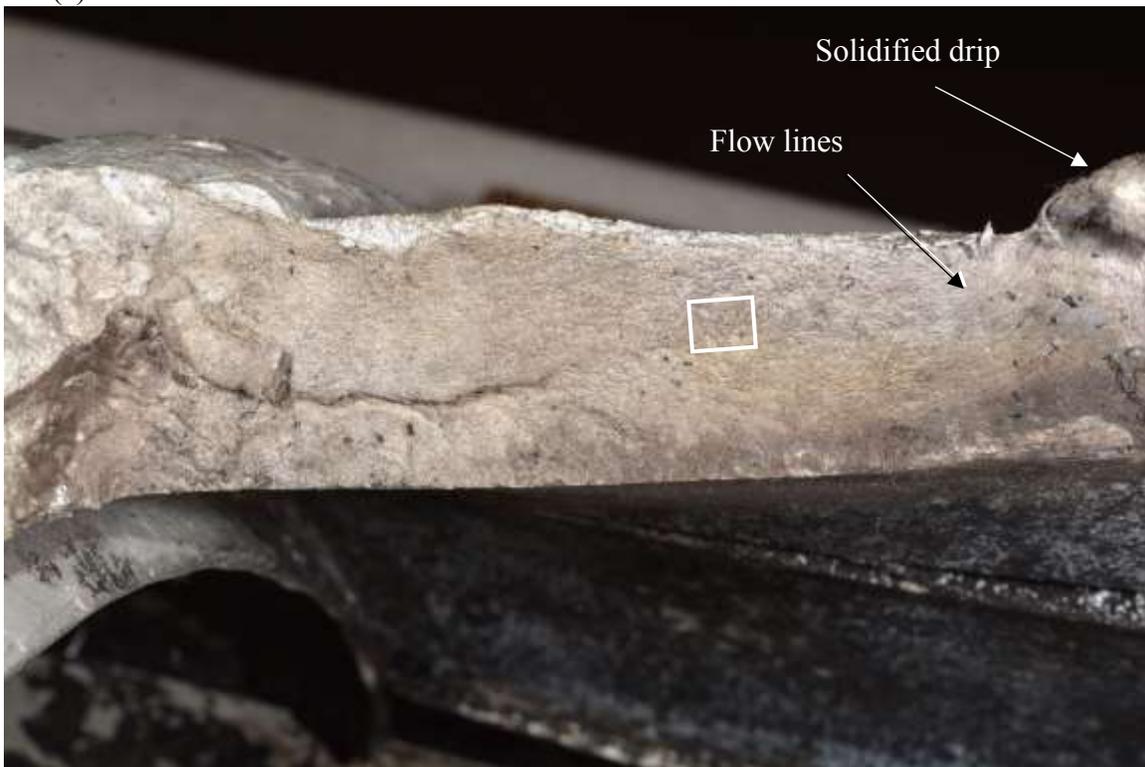
Although much of the hole in the B pass inlet header had evidence of partial melting, a few locations appeared more like fracture surfaces. Two of those regions are shown in Figure 13. Representative SEM micrographs from the boxed locations in the figure are shown in Figure 14 and Figure 15. Examination by SEM indicated a re-solidified morphology, evidenced by rounded inter connected features and thick, wrinkled surface oxide. The SEM results indicate that if a mechanism other than heat damage, such as fatigue or repair weld defect, caused the header hole prior to the fire, evidence of that mechanism was destroyed by the fire.

Figure 13 Photographs of the header sample, from the locations indicated in Figure 11a. The boxed region in (a) is shown in Figure 14, and the boxed region in (b) is shown in Figure 15.

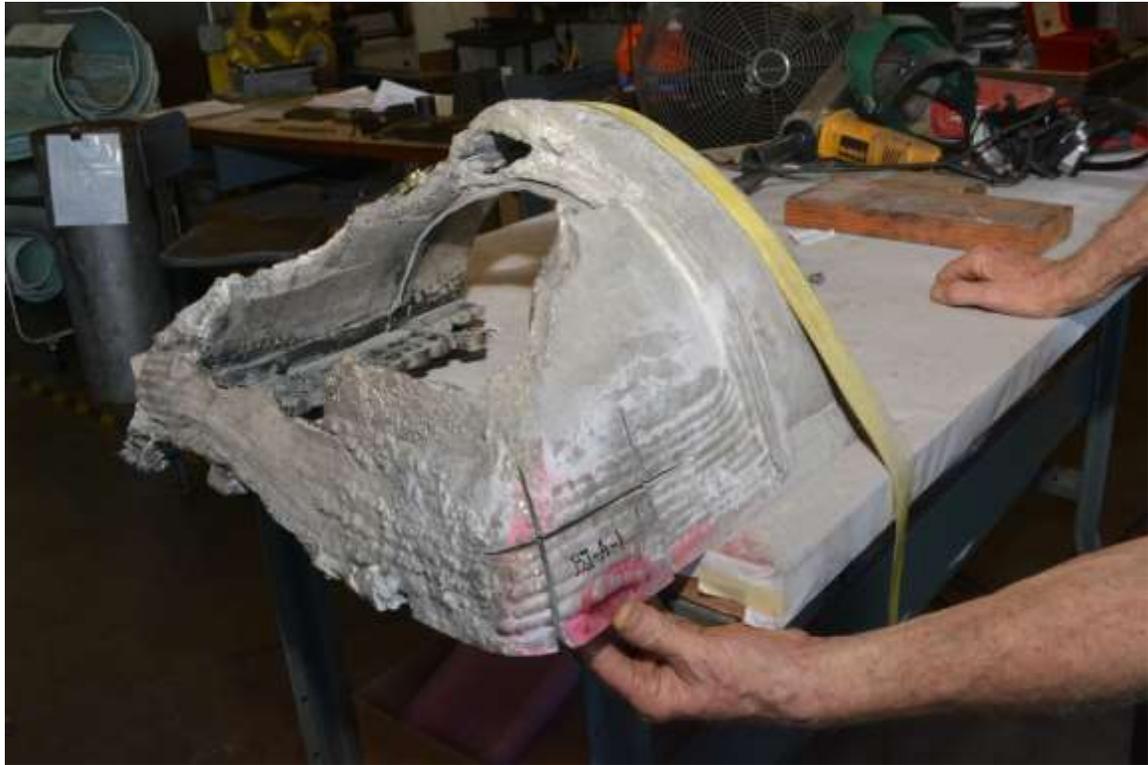
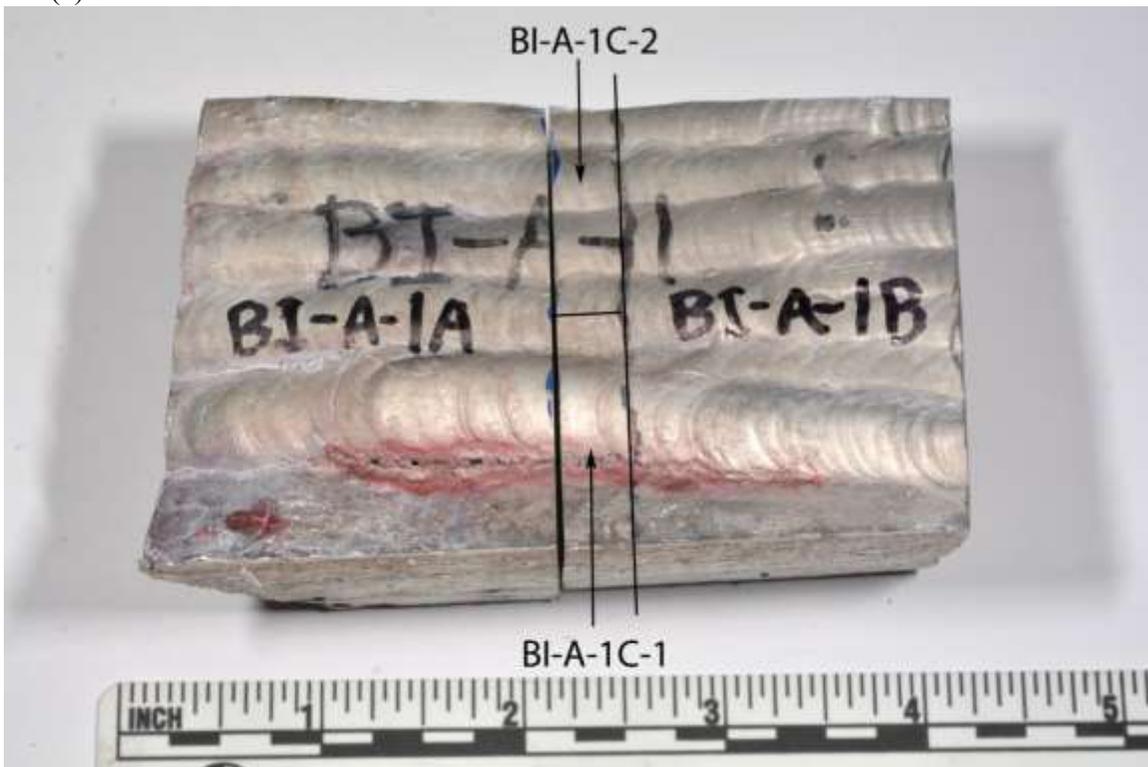
Metallography was performed on sections cut from the north end header to core weld. A representative section cut from the sample is shown in Figure 16. Specimens were embedded in clear epoxy, and polished through 0.05-micron colloidal silica using standard techniques for preparation of specimens for metallography. The specimens were examined as-polished and after etching with 5% HF. In the as-polished condition, numerous interpass weld cracks indicative of partial melting were visible. Photographs of specimen BI-A-1C-1 are shown in Figure 17.

Figure 16 Photographs of the sample BI-A1, with cut lines indicated.

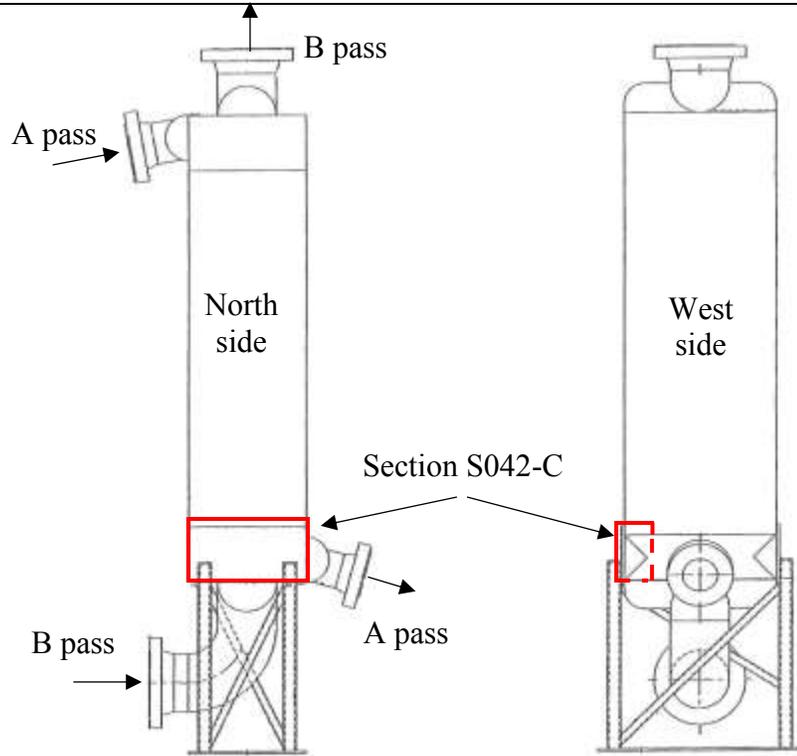
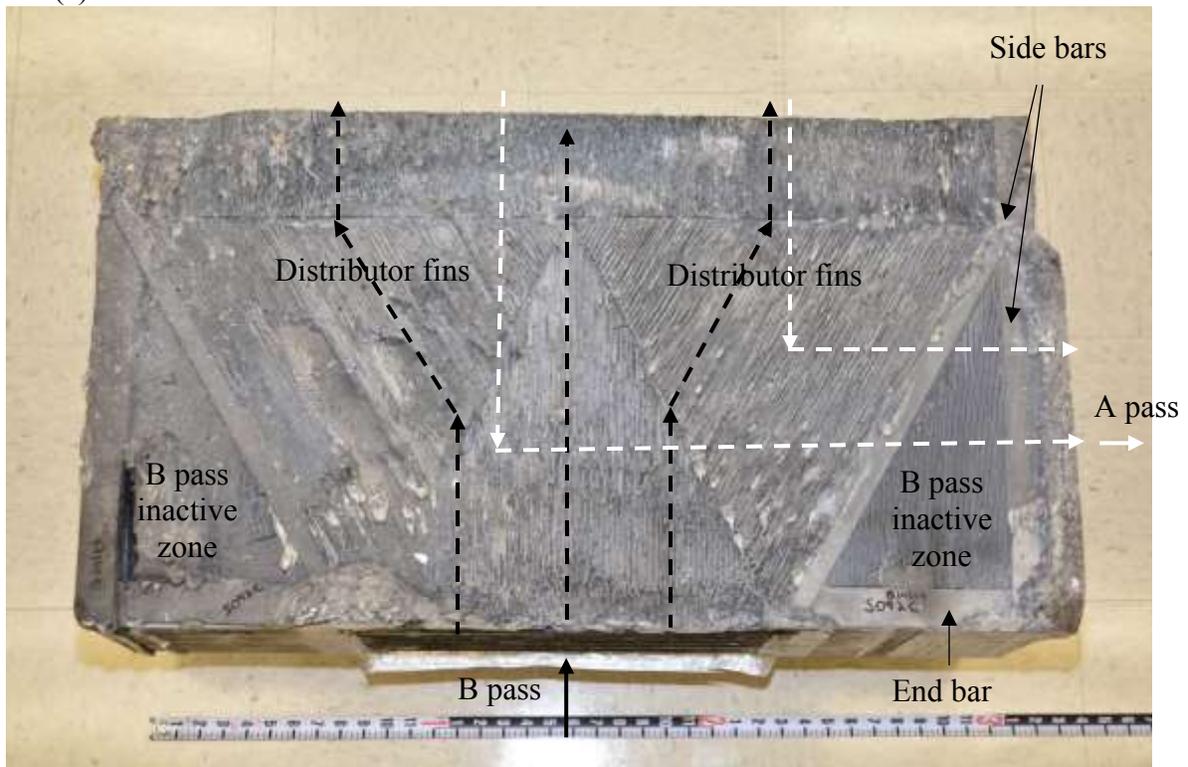
Sample S042-C was cut from the north side of the ACSR just above the B pass inlet header. A simplified drawing of the reboiler and a photograph of sample S042-C are shown in Figure 23. The sample included the full width of the ACSR, extended slightly past the height of the attachment plate, and was eighteen layers thick. After the fire, the attachment plate and the cap sheet were missing in this region. As a result, the layer 99 fins, side bars, and end bars were exposed. The fin orientation revealed flow direction in the B pass, indicated in Figure 23b, along with the flow direction of the A pass in underlying layers. Inactive zones of the B pass layer are also noted in the figure. These zones are created by the angled side bars that channel flow from the inlet header into the full width of the B pass layers. Inactive zones were vented into square channels that are designed to be open to atmosphere through drains. A bulge and partially visible void were present in the lower east corner of the sample.

Figure 23 Simplified drawing of the ACSR and photograph of section S042-C. After the fire, the attachment plate and cap sheet were missing in this region, leaving the B stream layer 99 fins exposed. Black dashed arrows indicate flow in the B pass layers and white dashed arrows indicate flow in the A pass layers.

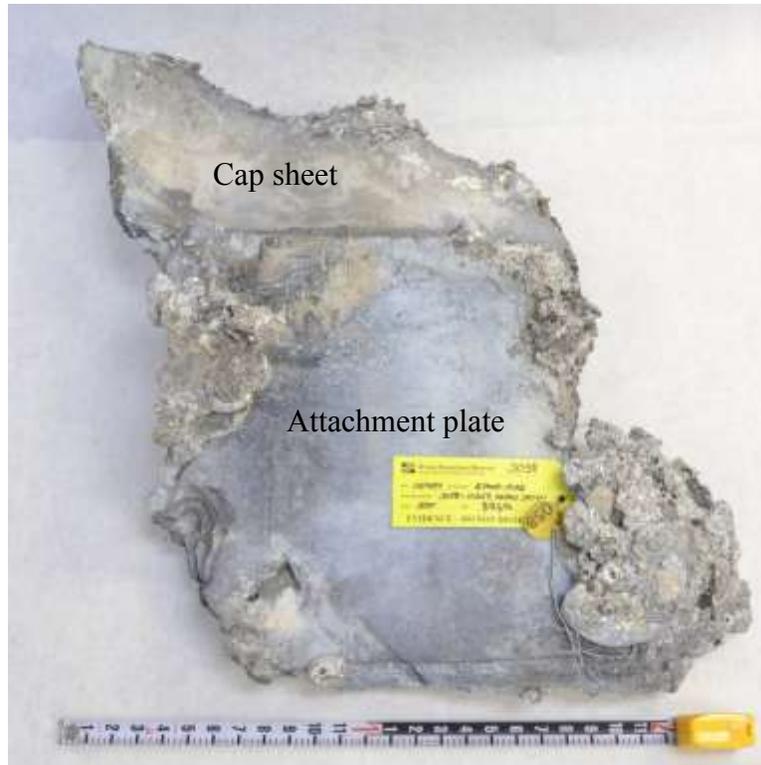
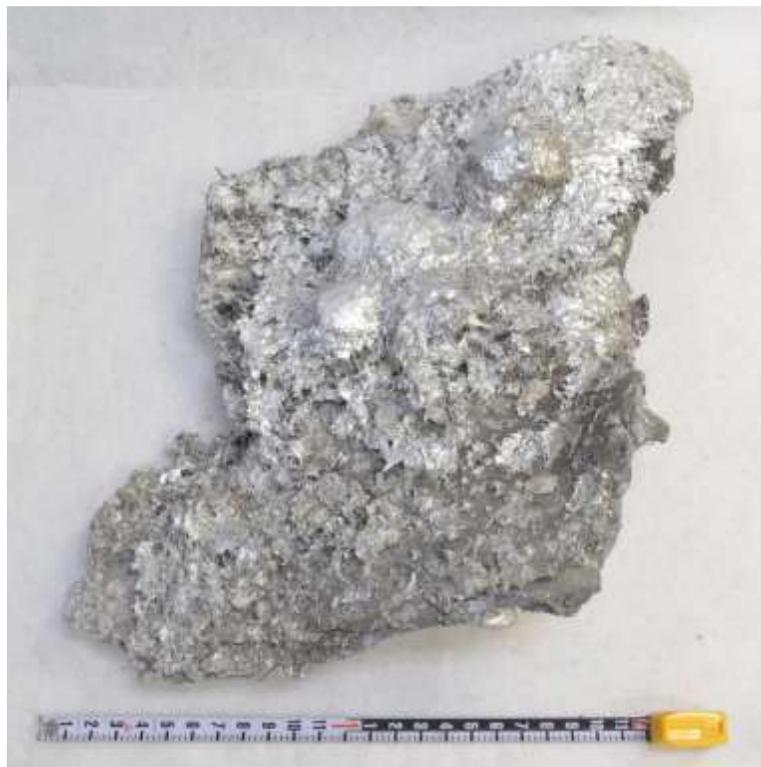
Solidified drips of aluminum and oxidized fins on the layer 99 surface indicated extensive heat damage. A fragment of the cap sheet and attachment plate, labeled S058, was found on the ground beside the ACSR, covered in aluminum that had melted during the fire. The outside surface of the attachment plate was toward the ground, and the molten aluminum was on the layer 99 side of the cap sheet. No metallurgical evidence of the mechanism by which the fragment separated from the reboiler was detected on the fragment, shown in Figure 24.

Figure 24 Fragment of the ACSR attachment plate and cap sheet found on the ground beside the reboiler. The side shown in (b) was facing up and was mostly covered with aluminum that had melted in the fire.

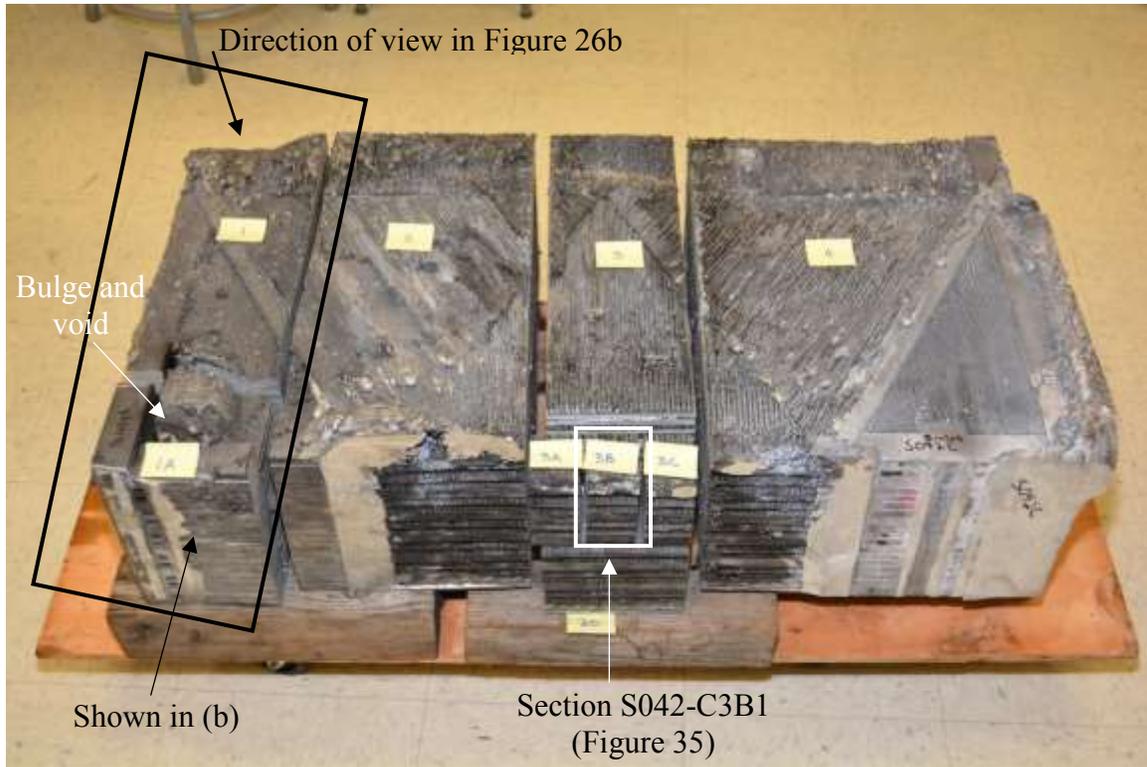
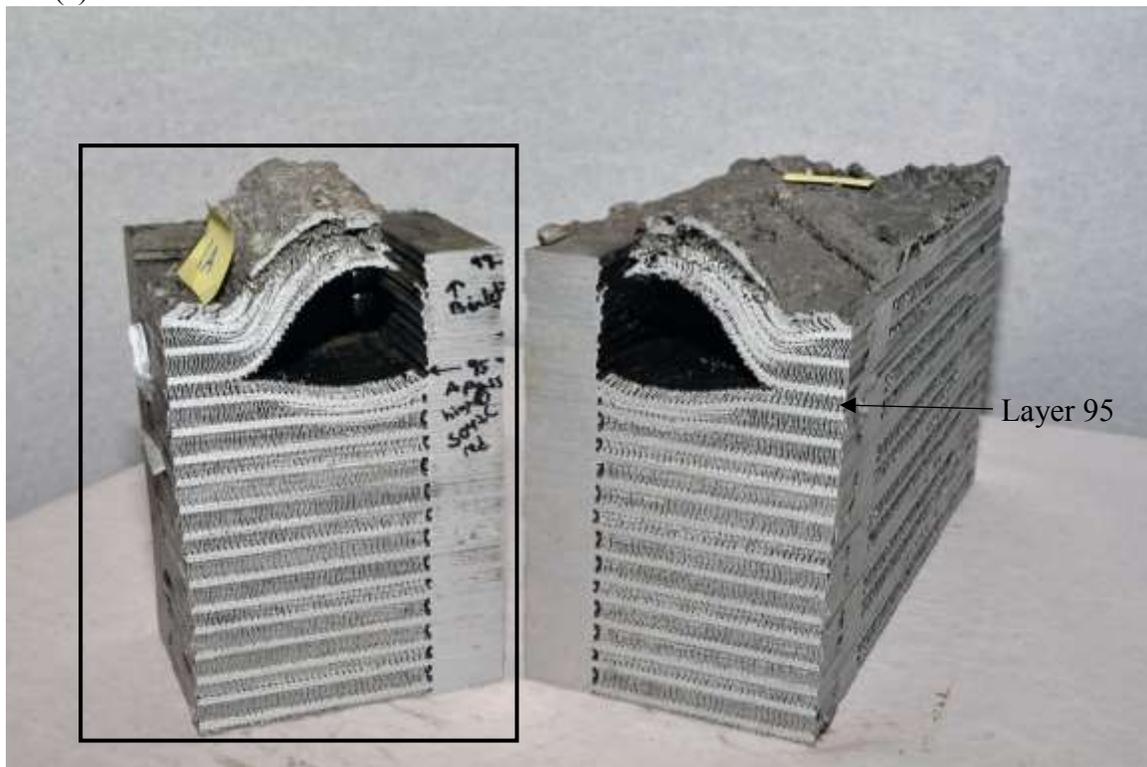
Sample S042-C was cut into smaller sections using a horizontal band saw. The resulting subsamples are shown in Figure 25a. The corner bulge, shown in Figure 25b, was caused by fin fracture in A pass layer 95. Fin compression was visible in layers 93, 94, 96, and 97. However, the remaining fins in layer 98 were not compressed. Furthermore, the bulge projected beyond the plane of the side and end bars. Therefore, the cap sheet and attachment plate had detached from the core before the bulge occurred.

Figure 25 Photographs of section S042-C after cutting. Localized rupture in layer 95, A pass, was investigated.

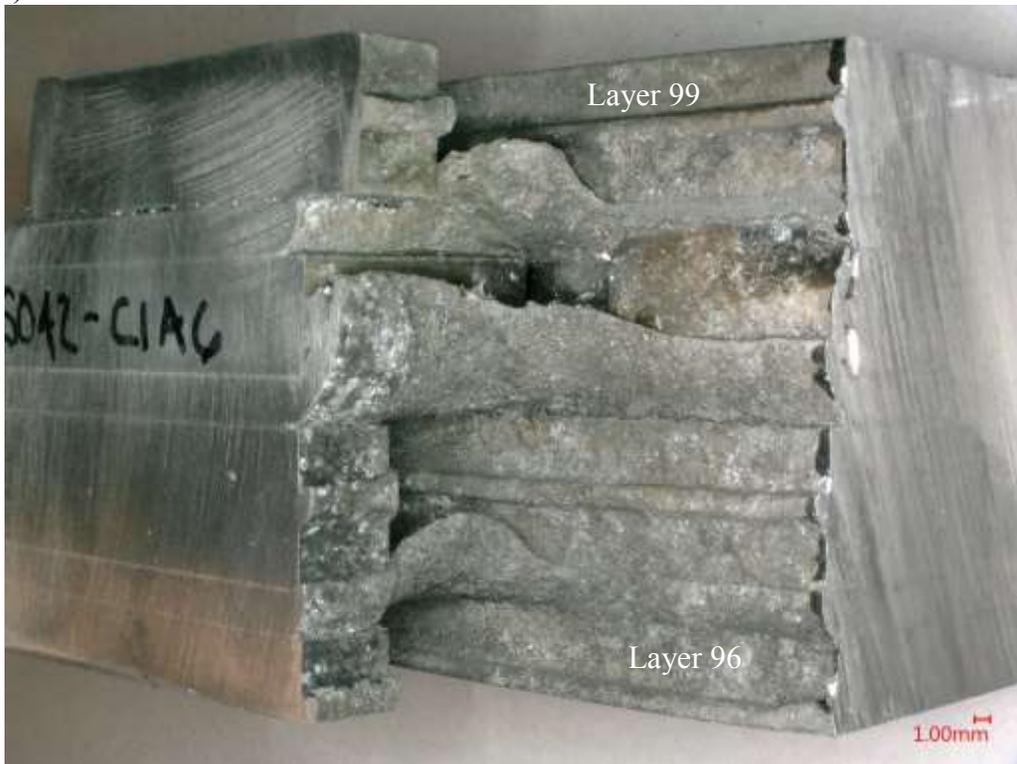
The side bars and end bars around the bulge were cut from the sample, shown in Figure 27. Thick oxide was present on the fractured parting sheet edges. The image in Figure 27b was taken after cleaning with acetone, followed by scrubbing with a soft bristle brush and soapy water.

Figure 27 Images of side bar and side bar section from sample S042-C, indicated in Figure 26. Thick oxide covered fractured parting sheets and side bars.

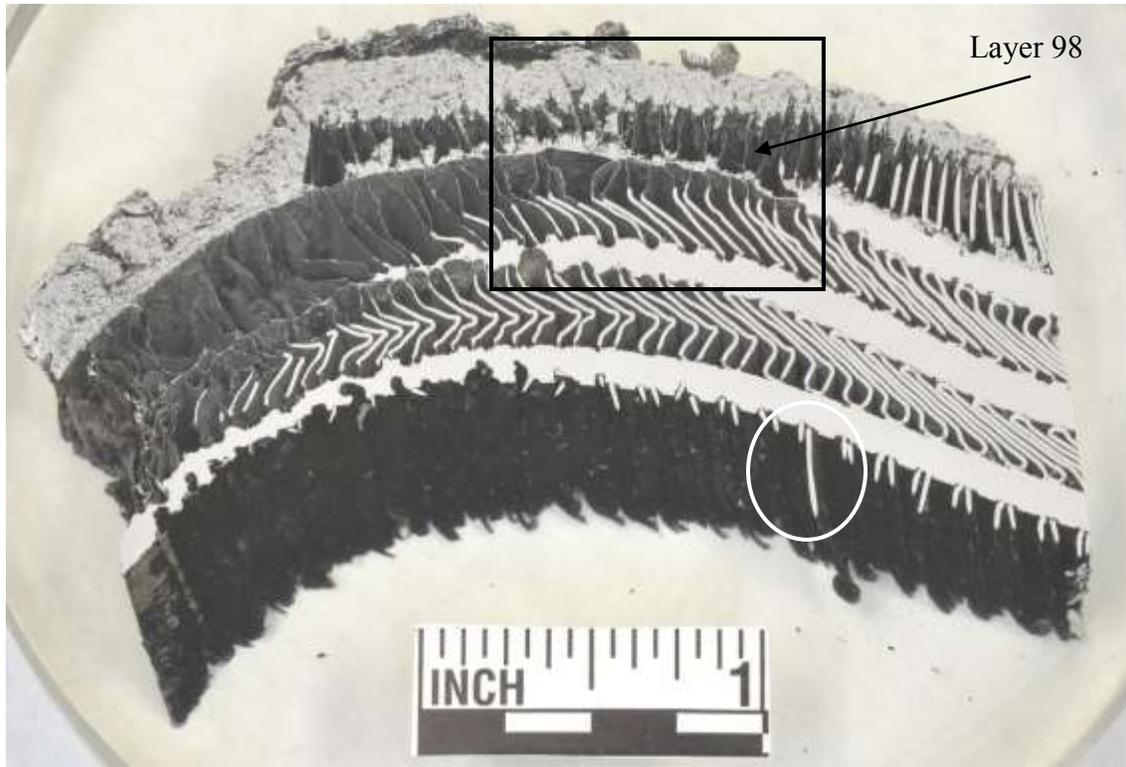
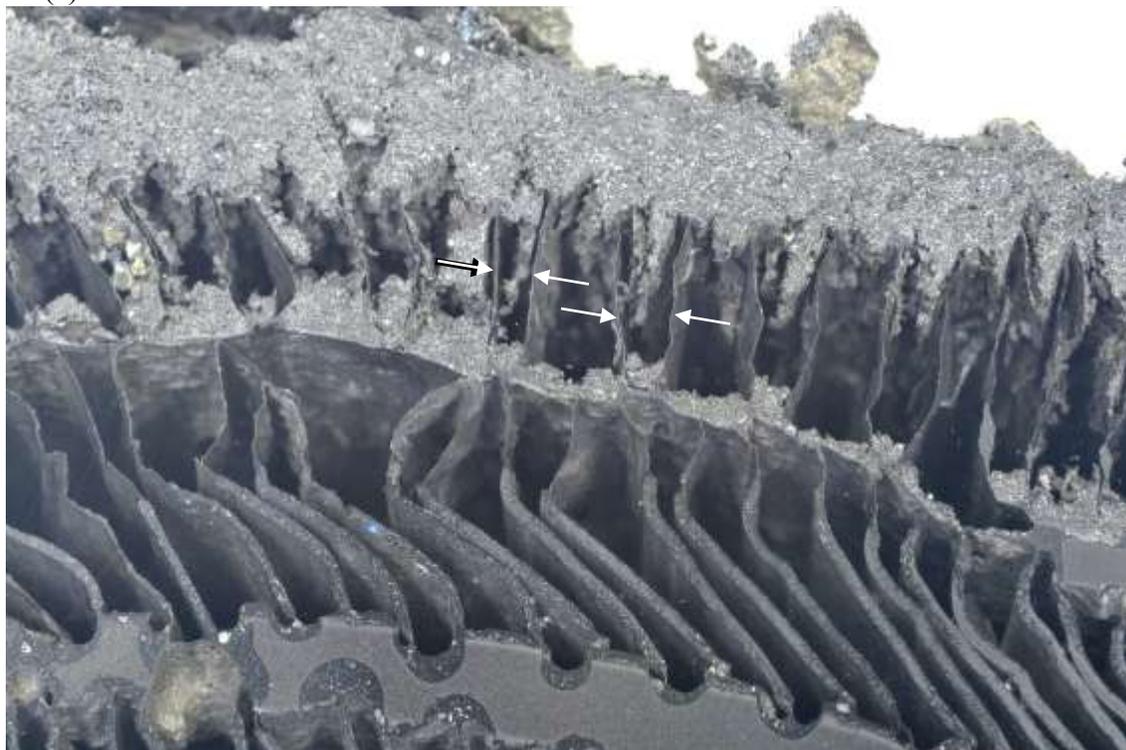
A section through the bulged layers, indicated in Figure 26a, was prepared for metallography. Although significant fire damage had occurred to the outer layers, lack of buckling in the layer 98 fins was clearly visible, indicating the bulge happened after the cap sheet and attachment plate had detached from the core. Ductile fracture and incipient melting of layer 95 fins was detected. Loss of fin root at the parting sheet likely occurred by erosion of molten 4004 braze that mixed with the 3003 fins during the fire. A photograph of the section and representative micrographs are shown in Figure 31 and Figure 32.

Figure 31 Images of section S042-C1A7, indicated in Figure 26a. Circled region in (a) is shown in Figure 32. In (b), arrows point to examples of fins that were heat damaged but not buckled.

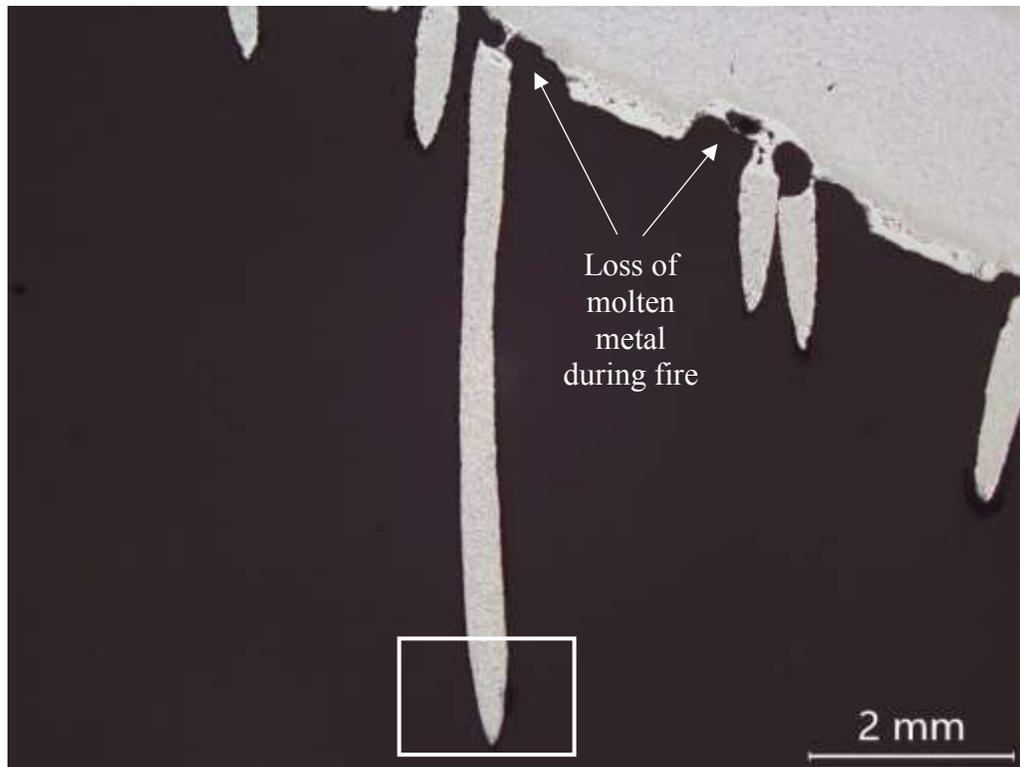
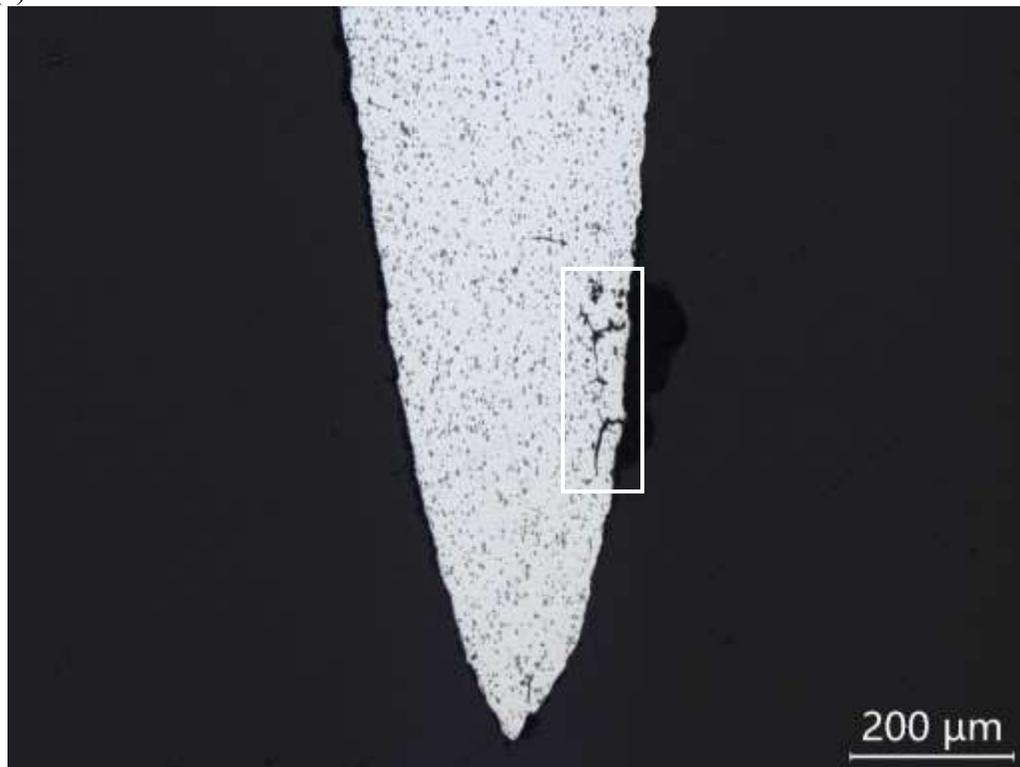
Figure 32 Images of section S042-C1A7 from the circled region in Figure 31a. The boxed region in (b) indicates evidence of incipient melting.

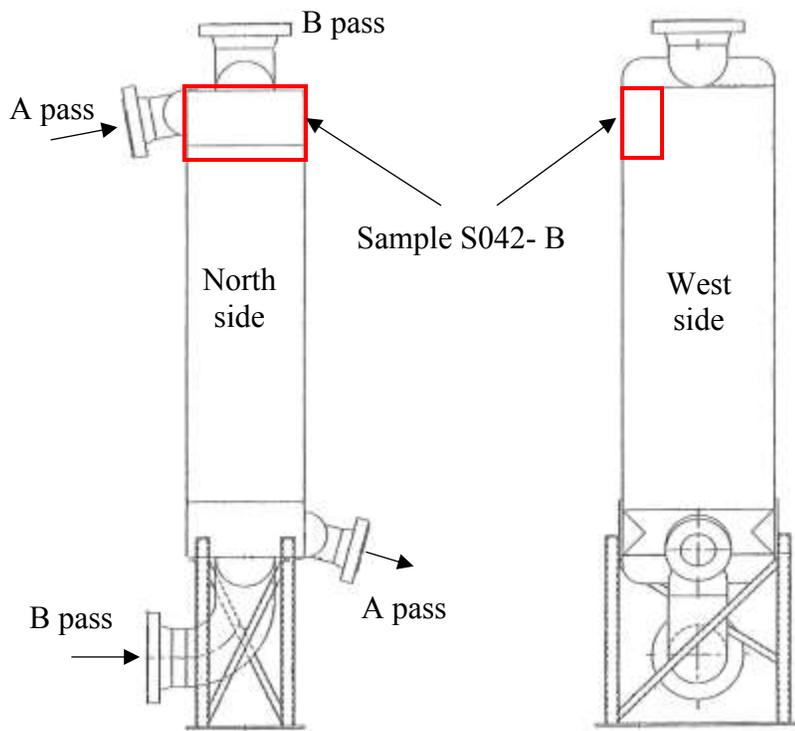
Sample S042-B was sectioned from the upper north side of the ACSR. A drawing with the sample location indicated, and a photograph of the sample are shown in Figure 37. The majority of the attachment plate had melted off the section during the fire. Remnants of the attachment plate were removed from the sample by cutting approximately 0.5-inch inside the attachment plate edge with a carbide tipped circular saw, and the entire sample was cut with a large horizontal band saw along the dashed lines indicated in Figure 37b. A wide through-cap sheet crack parallel to the inner edge of the side bar was present under the remnants of attachment plate. At the ends of the crack, depressions in the cap sheet were present, consistent with large scale plastic deformation. The crack and depressions are shown in Figure 38.

Figure 37 Simplified drawing of the ACSR with the location of sample S042-B indicated, and a photograph of the sample. Most of the attachment plate had been melted. Dashed lines indicate cuts made with a horizontal band saw. Boxed region is shown in Figure 38.
