Report No. 5005.3434 C

November 6, 2018

**LABORATORY EVALUATION OF SAMPLES FROM THE  
BRAZED ALUMINUM PLATE-FIN HEAT EXCHANGER H-3059 INVOLVED IN  
THE JULY 27, 2016 FIRE AT ENTERPRISE PRODUCTS OPERATIONS,  
MOSS POINT, MS**

Customer Authorization: CSB-16-0030

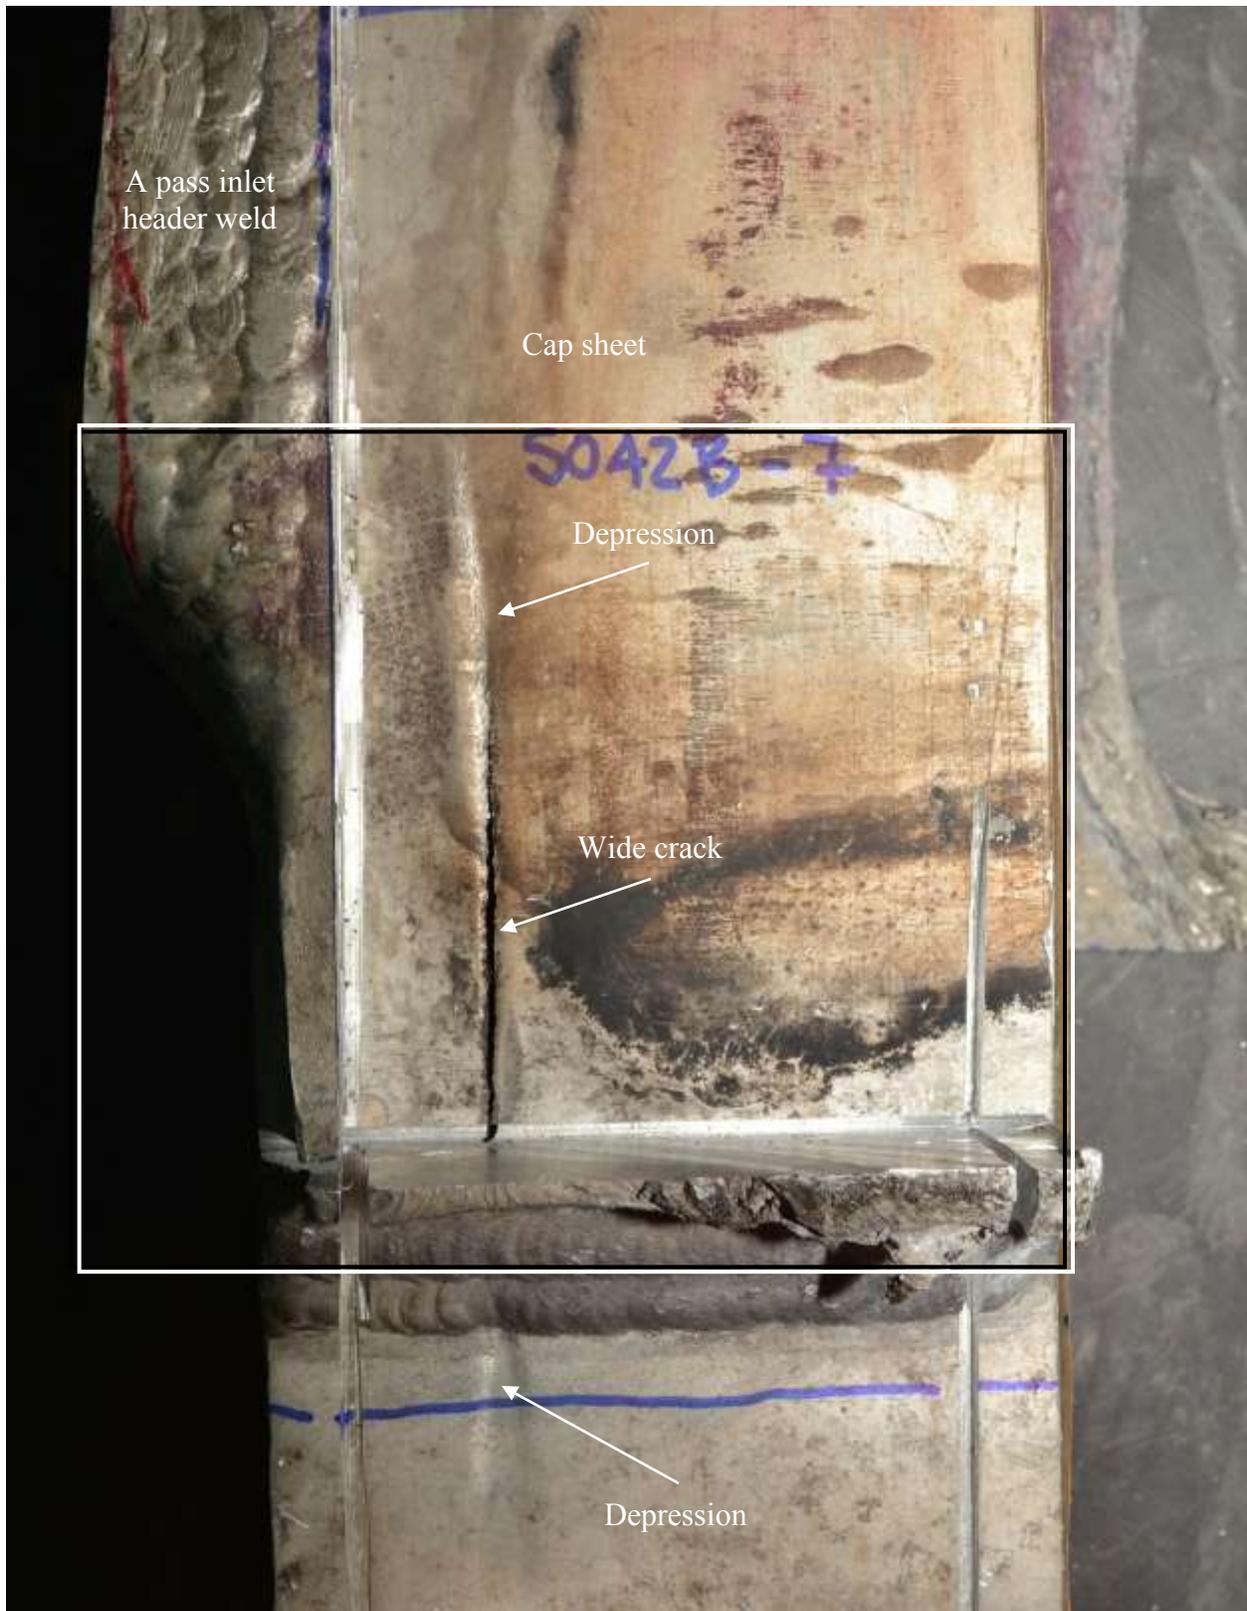
Sample S042-B was sectioned from the upper north side of the ACSR. A drawing with the sample location indicated, and a photograph of the sample are shown in Figure 37. The majority of the attachment plate had melted off the section during the fire. Remnants of the attachment plate were removed from the sample by cutting approximately 0.5-inch inside the attachment plate edge with a carbide tipped circular saw, and the entire sample was cut with a large horizontal band saw along the dashed lines indicated in Figure 37b. A wide through-cap sheet crack parallel to the inner edge of the side bar was present under the remnants of attachment plate. At the ends of the crack, depressions in the cap sheet were present, consistent with large scale plastic deformation. The crack and depressions are shown in Figure 38.

Figure 38 Photograph of S042-B after remnants of the attachment plate had been removed and the sample was cut into three pieces. Area shown is boxed region in Figure 37. A wide through-cap sheet crack and depressions at the ends of the crack are indicated.

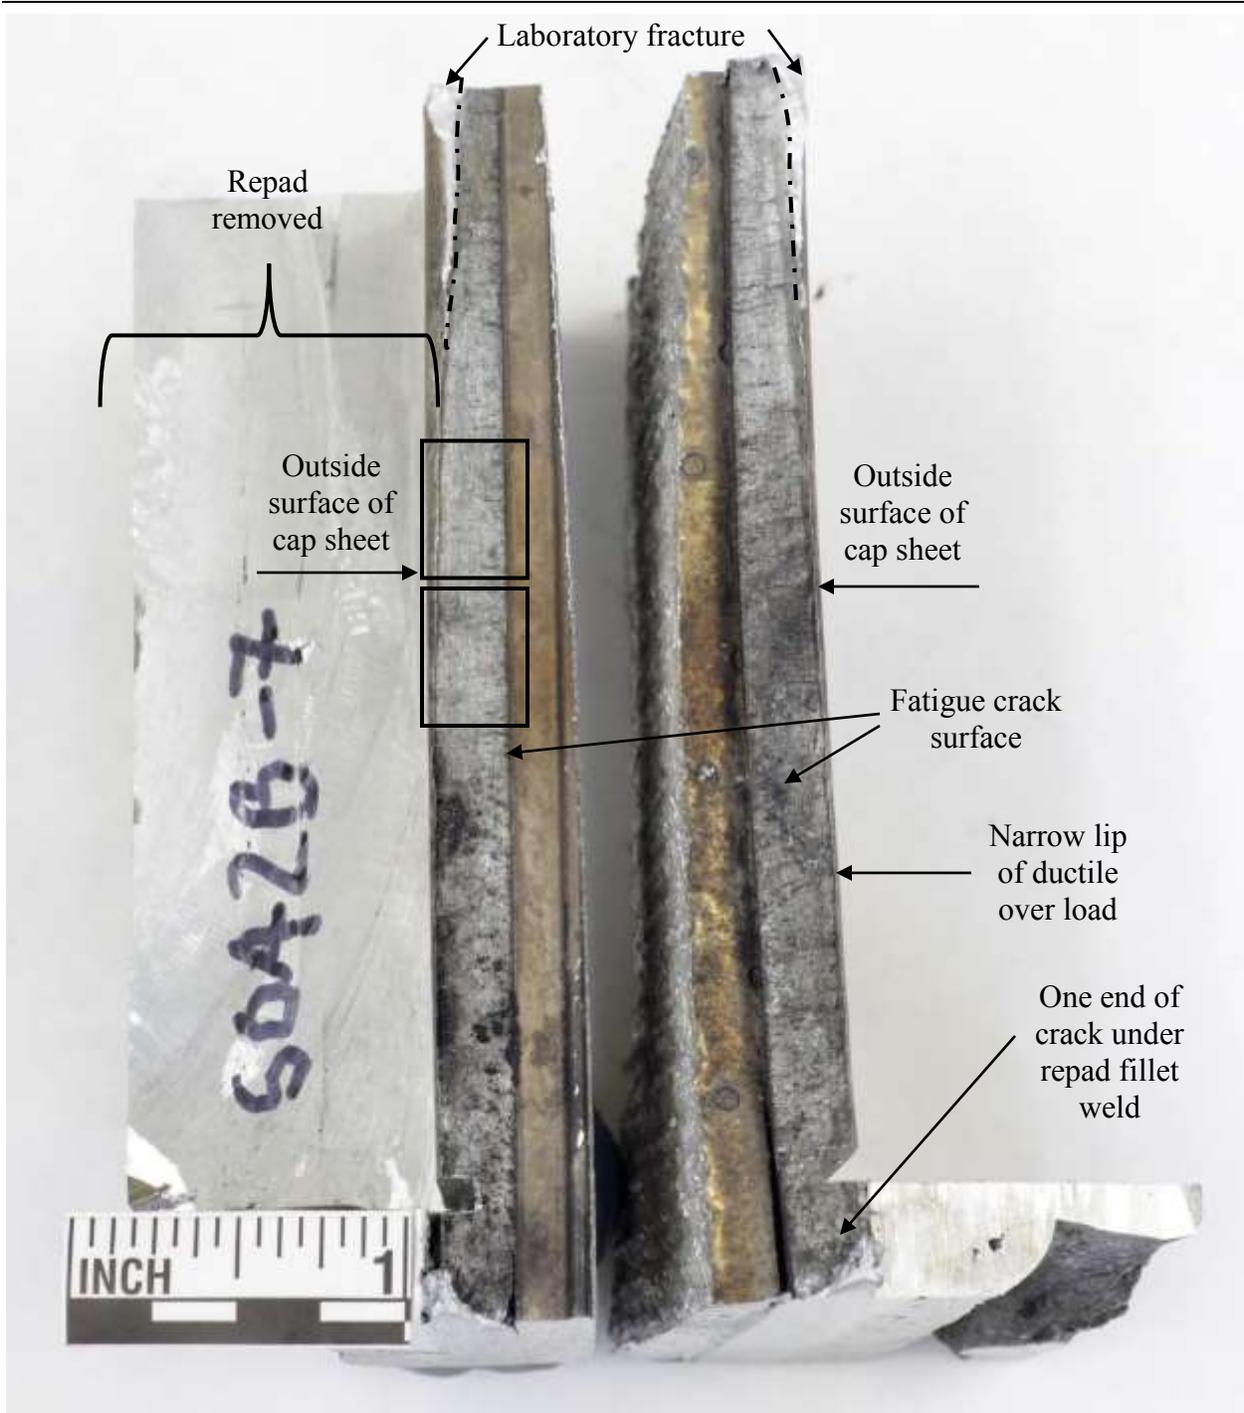
The cracked section of cap sheet was cut from the sample through layer 99 and the crack was isolated by additional cuts near the crack tips. A remaining cap sheet ligament was broken by hand to reveal the crack surfaces. The crack morphology was macroscopically brittle with the exception of a narrow lip along the outside edge that had fractured by ductile overload. One end of the crack was located under the attachment plate fillet weld. A photograph of the mating crack surfaces is shown in Figure 39. The crack was examined with a stereomicroscope, which revealed a brittle, stepped morphology with progression marks indicative of fatigue crack growth. The crack had initiated on the inside surface of the cap sheet at numerous sites, evidenced by ratchet marks and the local curvature of progression marks, and grown toward the outside surface. Representative low-magnification images are shown in Figure 40. Cap sheet depressions at the ends of the crack and the lip of ductile overload at the outside surface indicated a large plastic strain event, likely the fire, widened the crack. It is possible the crack was not open to the surface beneath the attachment plate until the heat of the fire caused sufficient thermal strain to open the crack.

Figure 39 Photograph of the sample S042-B-7 cap sheet mating crack surfaces. Cut from the boxed region in Figure 38.

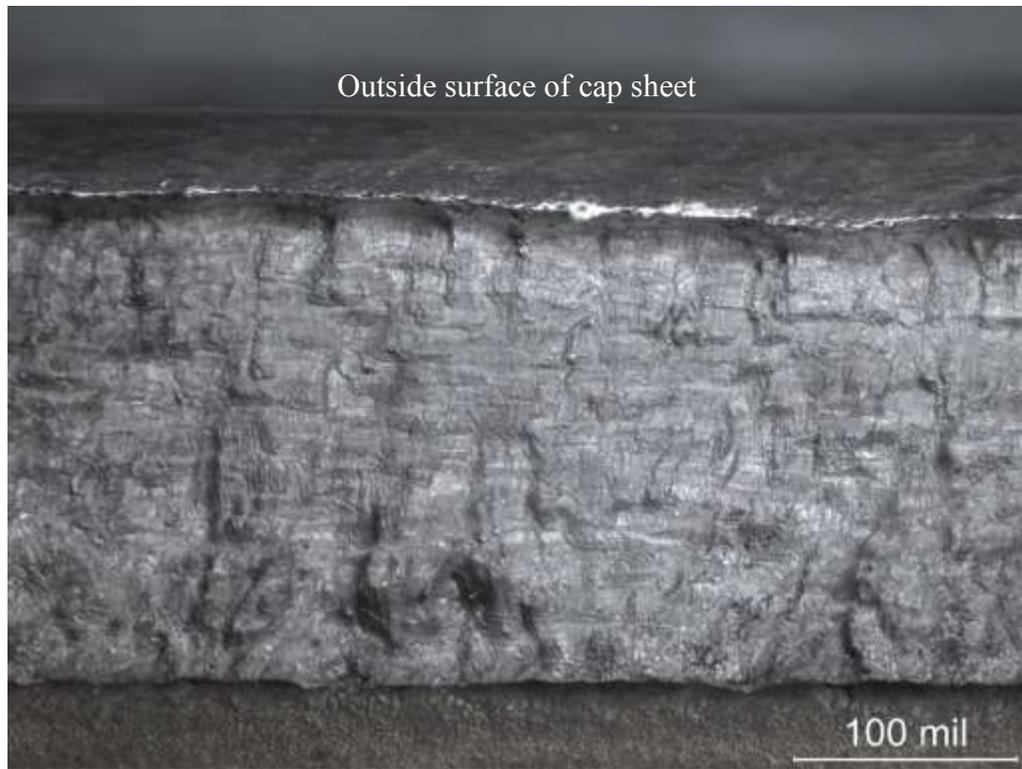
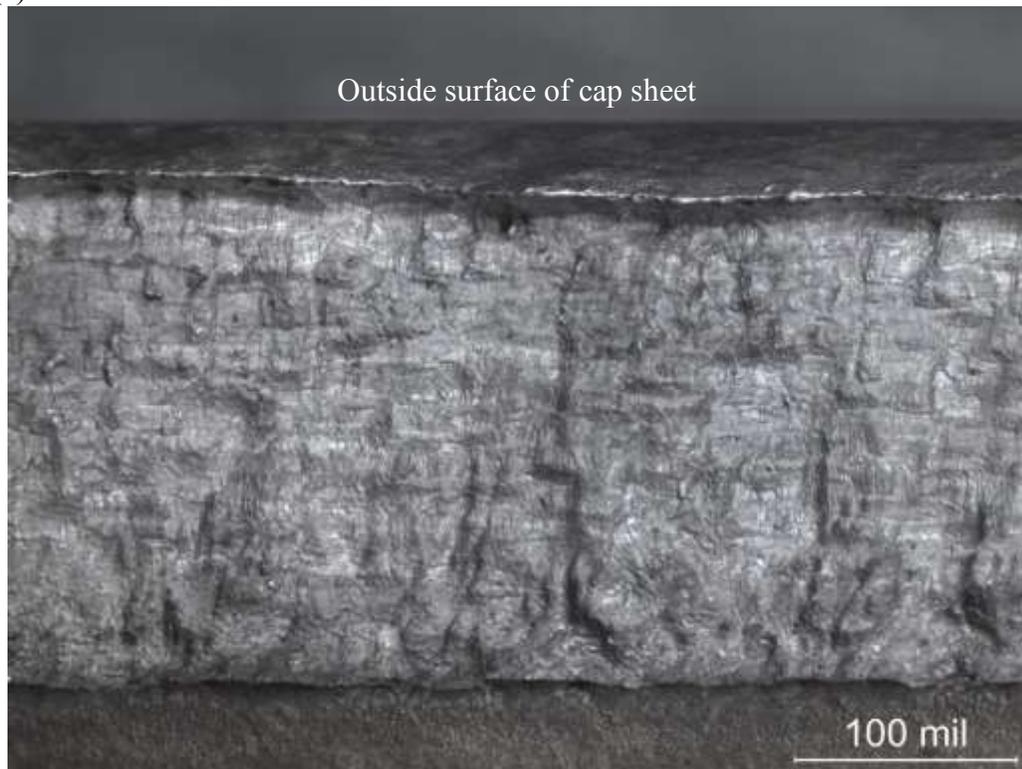
Figure 40 Images of the sample S042-B-7 cap sheet crack taken from the boxed locations in Figure 39. The specimen was rotated 90° from the orientation in Figure 39.

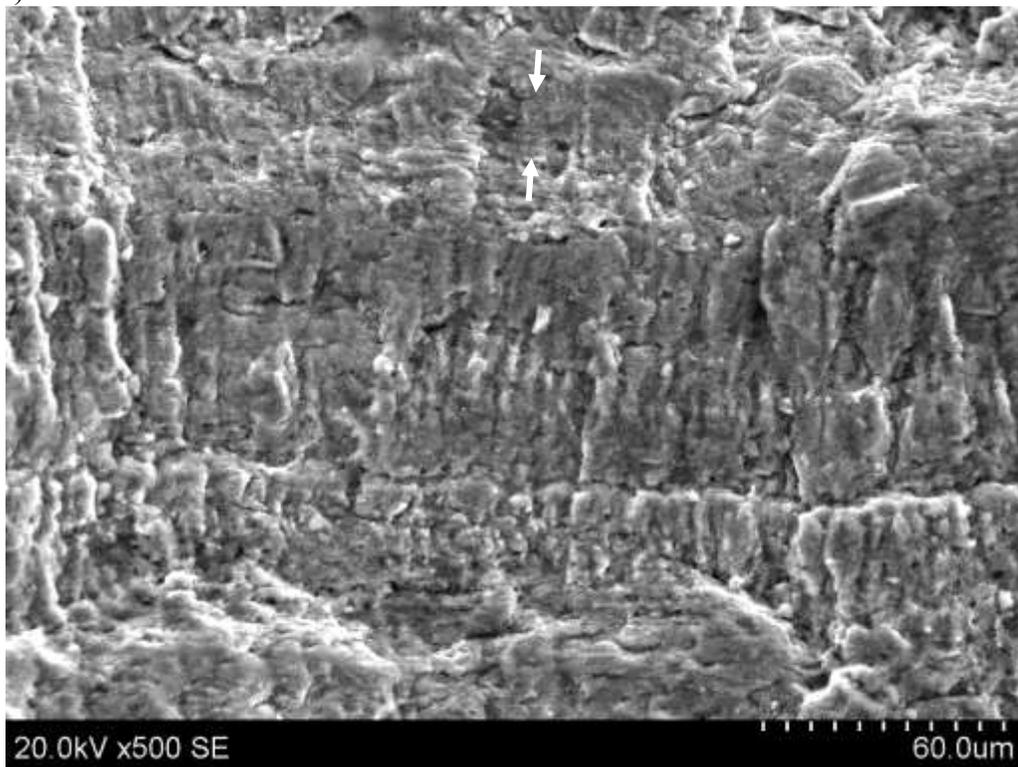
Sections of the through-cap sheet crack and the layer 98/99 parting sheet crack were examined by SEM. Both cracks were covered with oxide, likely as a result of the fire, that reduced the image quality. However, progression marks and remnants of striations caused by fatigue were present on both crack faces. Fine detail of the fatigue striations was predominantly obscured or destroyed by the oxide. Progression marks are features that indicate the position of the crack front at different points in time.

Figure 42 SEM micrographs of the fatigue crack surface in the sample S042-B-7 cap sheet. In (a), arrows point to examples of progression marks. In (b) arrows bracket striations degraded by oxide layer.

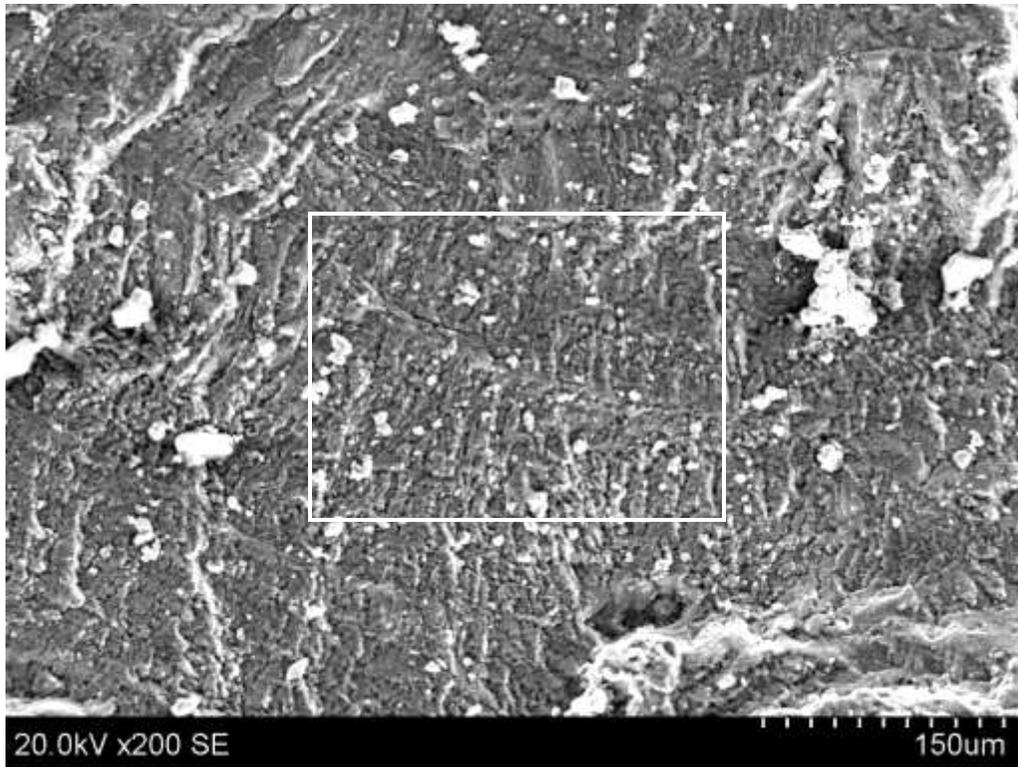
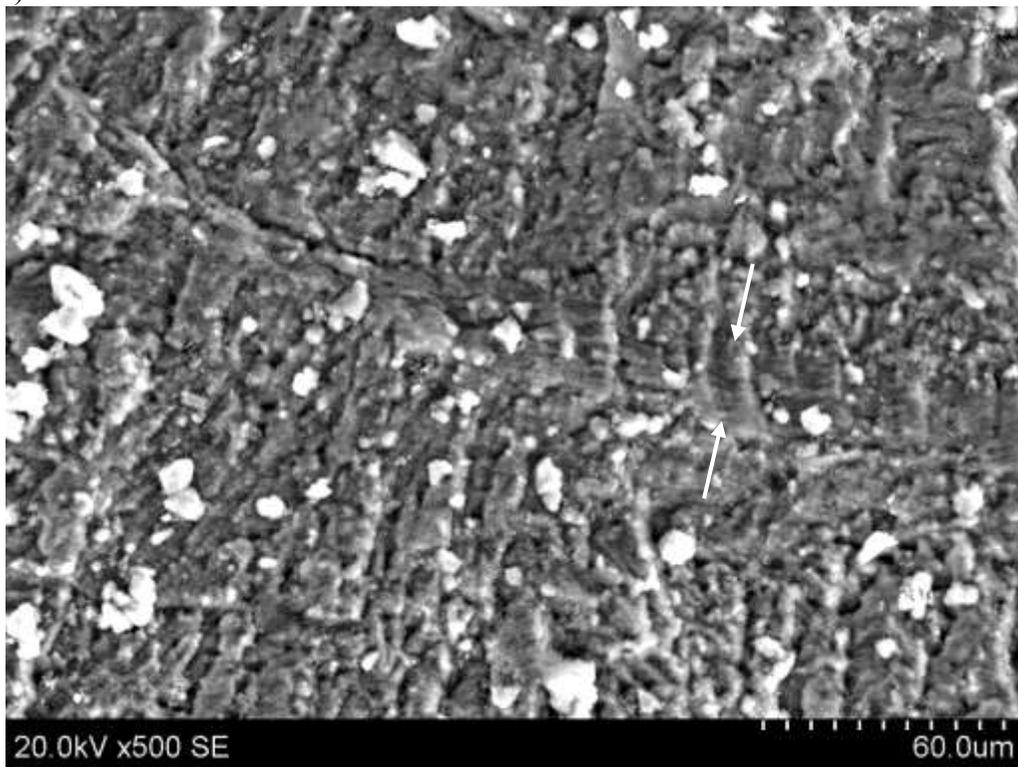
Figure 43 SEM micrograph of the S042-B-7 parting sheet crack that initiated on the layer 99 side. Arrows in (b) bracket approximately ten fatigue striations.

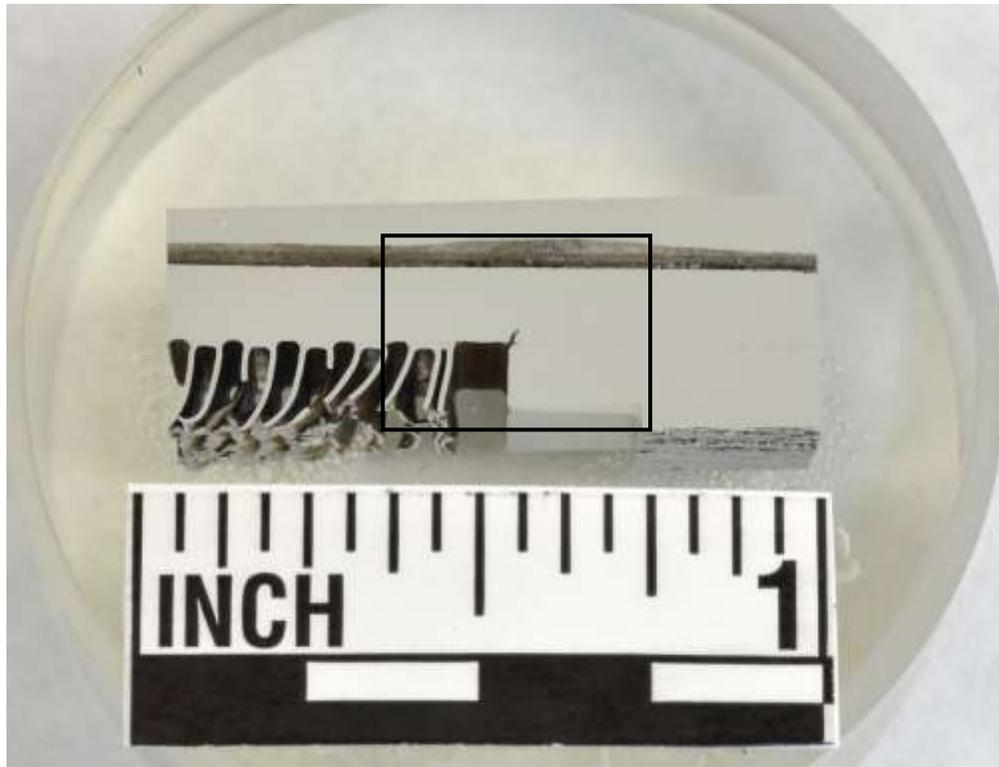
Low-power optical microscopy of the layers 97/98 parting sheet indicated a crack in the layer 97 side, located in the corner formed by the side bar. To investigate the indication, a section through the region was prepared for metallography and a small crack was found. Similarities in location between the small crack and larger cracks examined by SEM, indicated the crack was caused by fatigue. The crack was wide, indicating large plastic strains were applied after the crack had grown to the length shown. Narrow crack branches indicate the likely width of the main crack before it was widened (blunted) by plastic strains. Photographs and micrographs of the section are shown in Figure 44.

Figure 44 Images of section S407-B-7 parting sheet between layers 97 and 98 prepared for metallography.

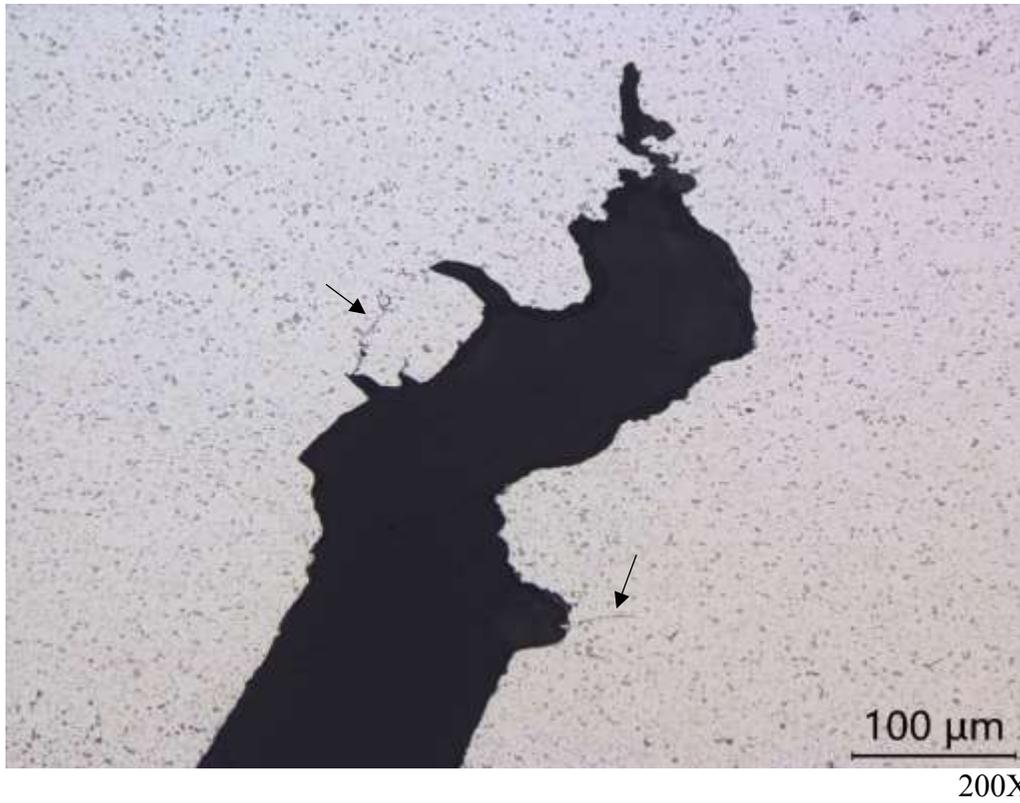
Figure 45 Optical micrographs of crack in sample S042-B-7 parting sheet between layer 97 and 98, boxed region in Figure 44b. Arrows indicate small crack branches that were not opened when the main crack was blunted by plastic strains.

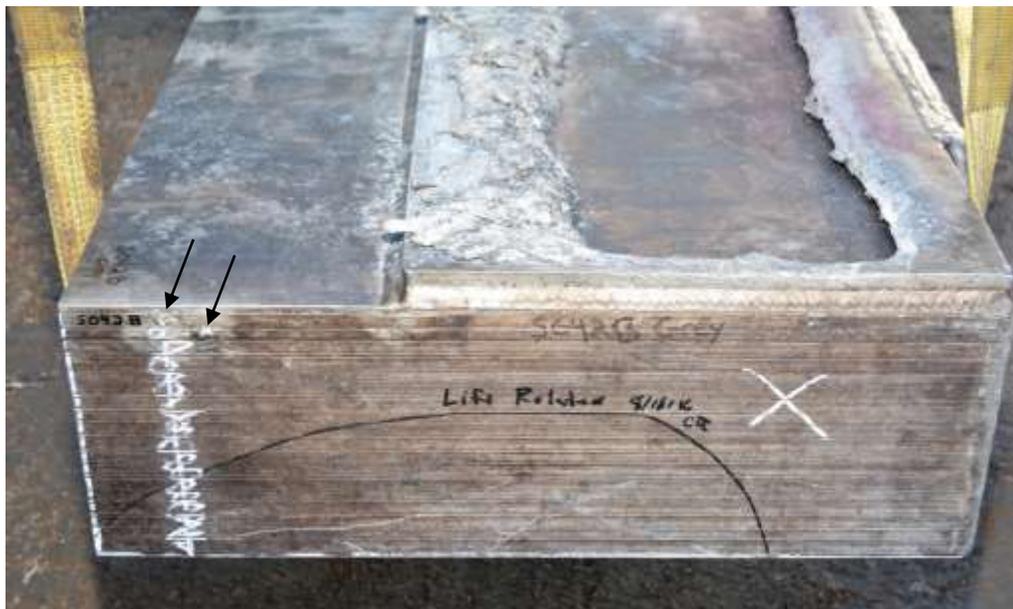
Two spot welds were present on the west side of sample S042-B. The spot welds were cut from the larger sample, shown in Figure 46. Sections through the spot welds demonstrated that holes had been drilled in sidebars to layers 98 and 99, and the holes had been spot welded closed. These types of holes can be made for a number of reasons, one of which is leak testing whereby the hole is monitored for gas introduced into an adjacent layer. A photograph and micrographs of a specimen through the layer 98 spot weld prepared for metallography are shown in Figure 48 and Figure 49. The spot weld had a dendritic structure typical of weld metal and semi-quantitative energy dispersive x-ray spectroscopy indicated the composition of the weld metal was consistent with alloys used to weld 3003 aluminum.

Figure 46 Photograph of the west side of sample S042-B. Arrows point to two spot welds located on side bars of layers 98 and 97.

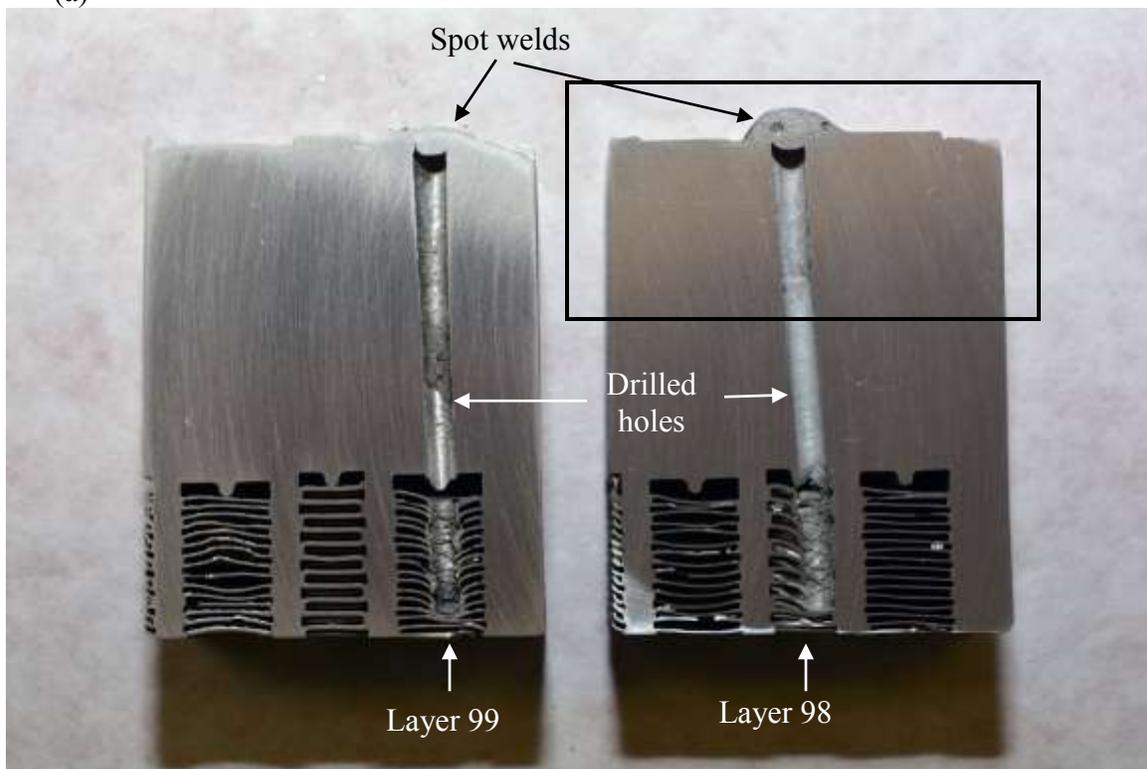
Figure 47 Photographs of the S042-B spot welds and sections through the spot welds. Boxed region in (b) was prepared for metallography.

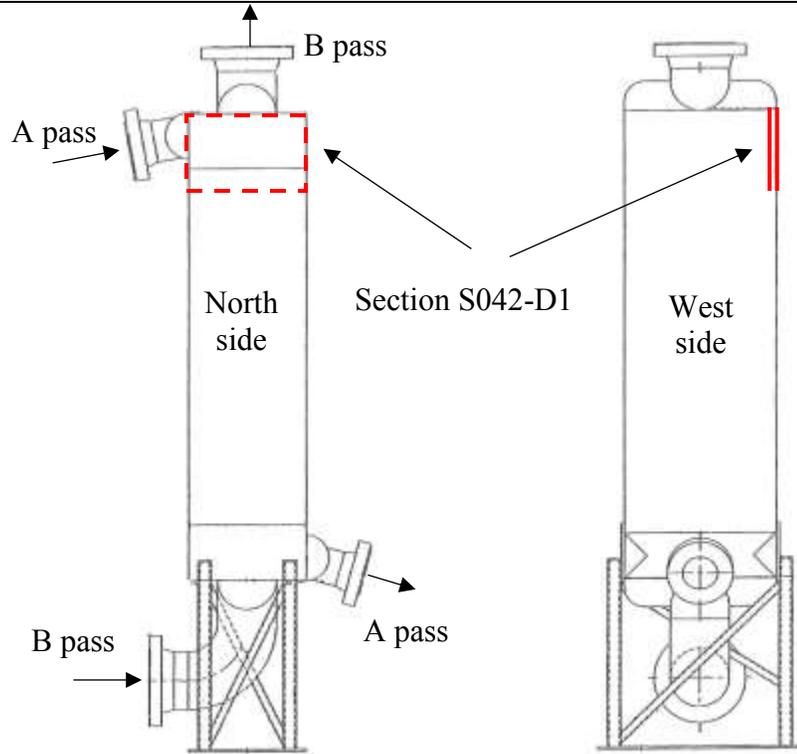
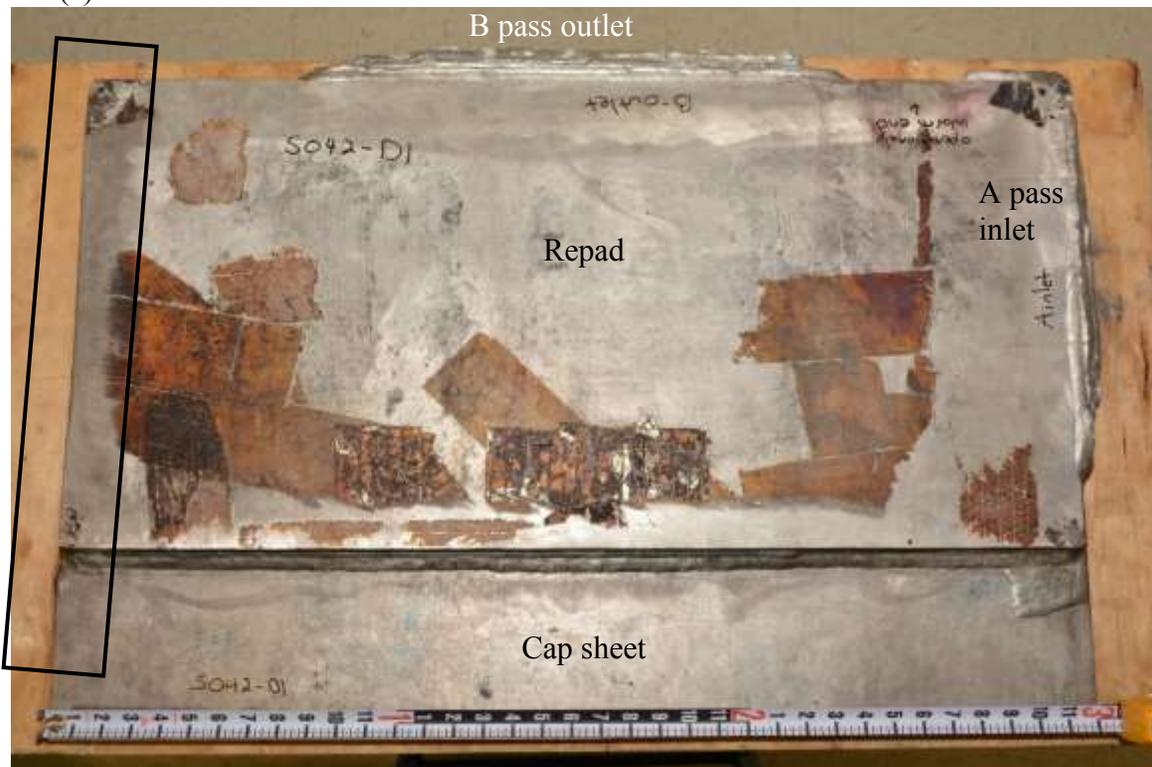
Sample S042-D1 was cut from the top, south side of the ACSR. The sample included the full width of the reboiler, extended from the B pass outlet header weld to approximately 6-inches below the attachment plate, and contained the layer 1/2 parting sheet, cap sheet, and attachment plate. A simplified drawing with the location of sample S042-D1 indicated, and a photograph of the sample are shown in Figure 50. The sample was in good condition visually. The CSB reported that during leak testing before the reboiler was cut into samples, an interpass leak had been detected between layers 1 and 2. The leak location was marked on the outside of the sample, shown in Figure 51, although the leak itself was internal.

Figure 50 Simplified drawing of the ACSR and photograph of sample S042-D1-1D. The boxed region in (b) is shown in Figure 51.

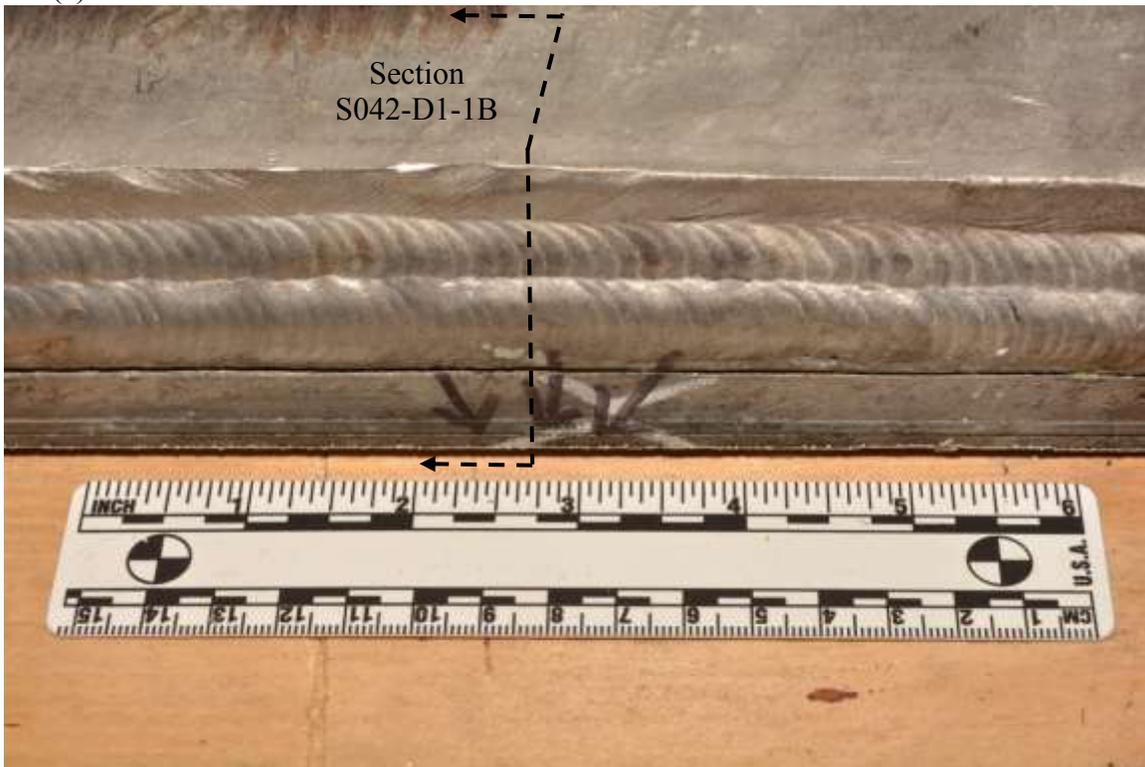
Figure 51 Photograph of Boxed region in Figure 50a. Layer 1 to 2 internal leak location, indicated by arrows, was reported by the CSB to have been detected during leak testing prior to cutting the ACSR. Dashed lines in (b) indicate where the section shown in Figure 54 was cut.

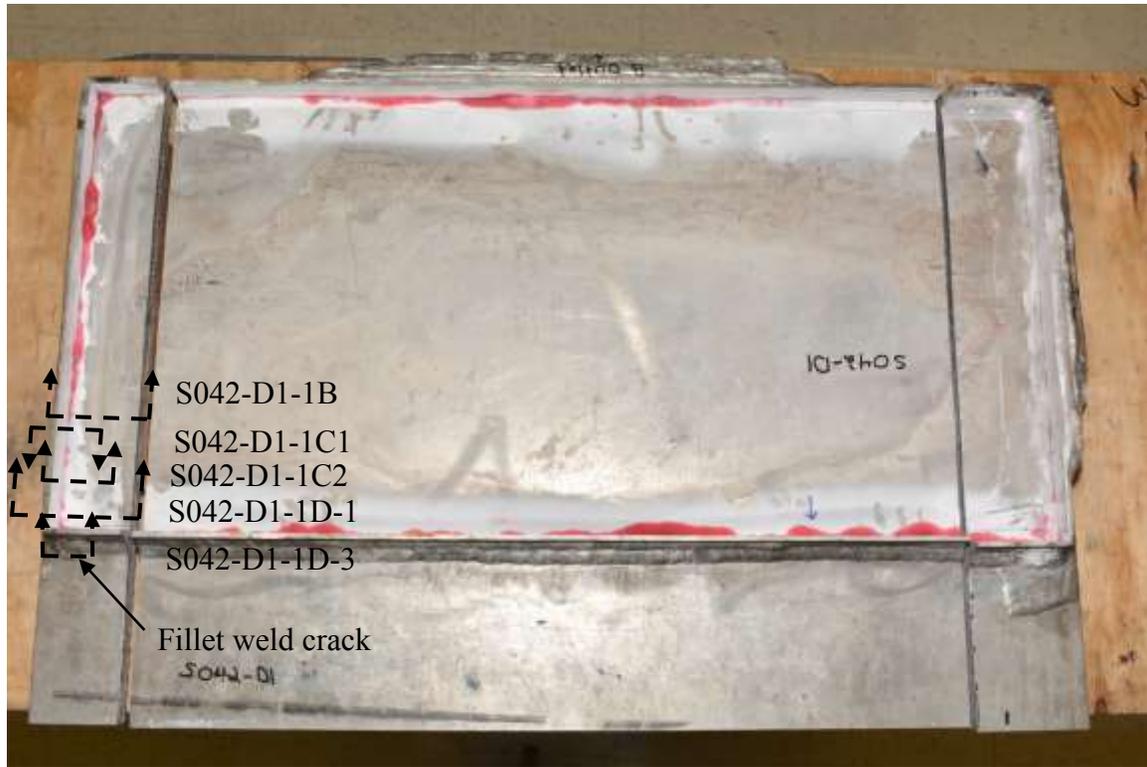
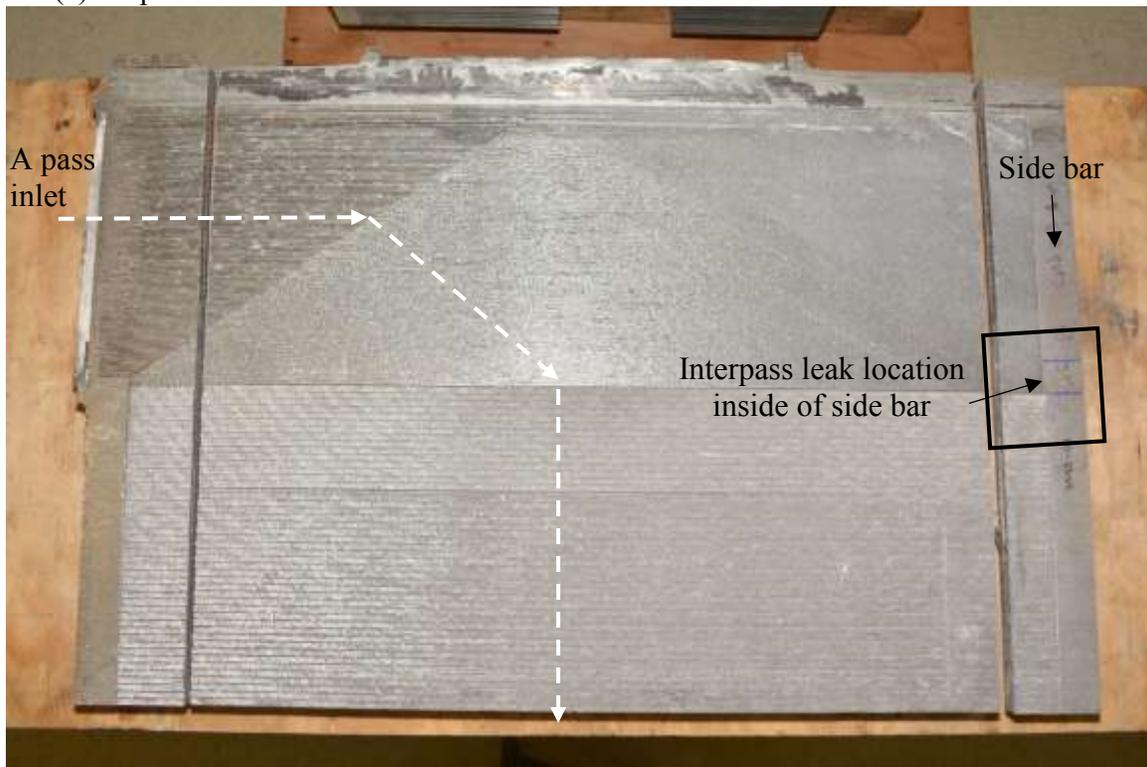
The attachment plate was removed from sample S042-D1 by milling a continuous slot approximately 0.5-inch inside of the edge of the attachment plate. With the attachment plate removed, visual examination and visible dye penetrant testing (PT) was performed on the cap sheet. No crack indications were detected. Both sides of the sample were cut approximately 4-inches inboard of the outer edges with a band saw. Visual examination of the layer 2 side of the parting sheet was performed where gaps in the fin sheets exposed the parting sheet. A crack in the corner formed by the west side was found that corresponded to the interpass leak location, indicated in Figure 52. The visible crack path tended to follow interdendritic regions of the parting sheet braze alloy. Low-power optical images of the crack are shown in Figure 53.

Figure 52 Photographs of sample S042-D1. In (a), the sample is shown after the attachment plate had been removed and a visible dye penetrant test had been performed on the cap sheet. In (b) the sample is viewed from the layer 2, A pass, fin side, and the A pass flow direction is indicated.

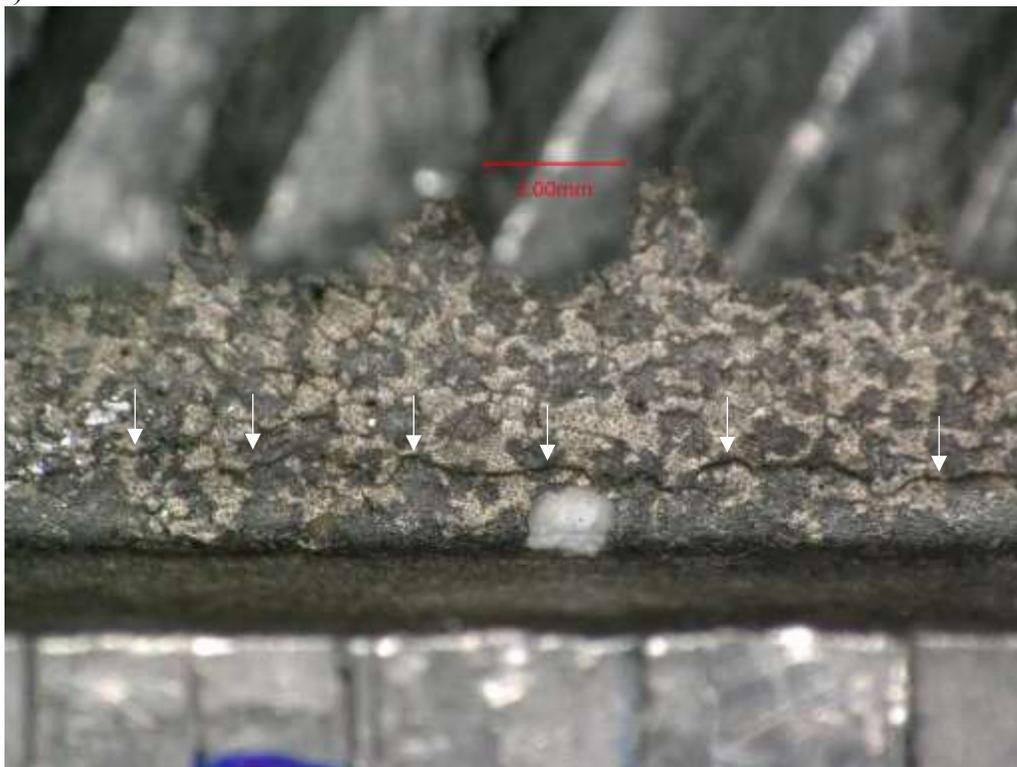
Figure 53 Images of the interpass crack between layers 1 and 2, viewed from the layer 2 side. Arrows point to the crack.

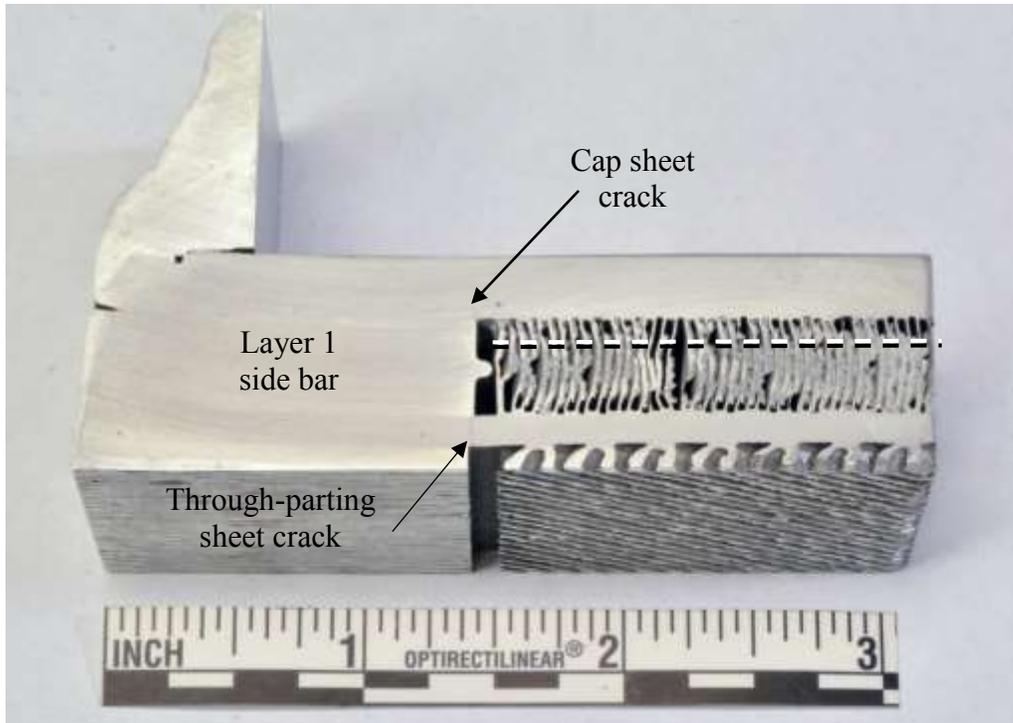
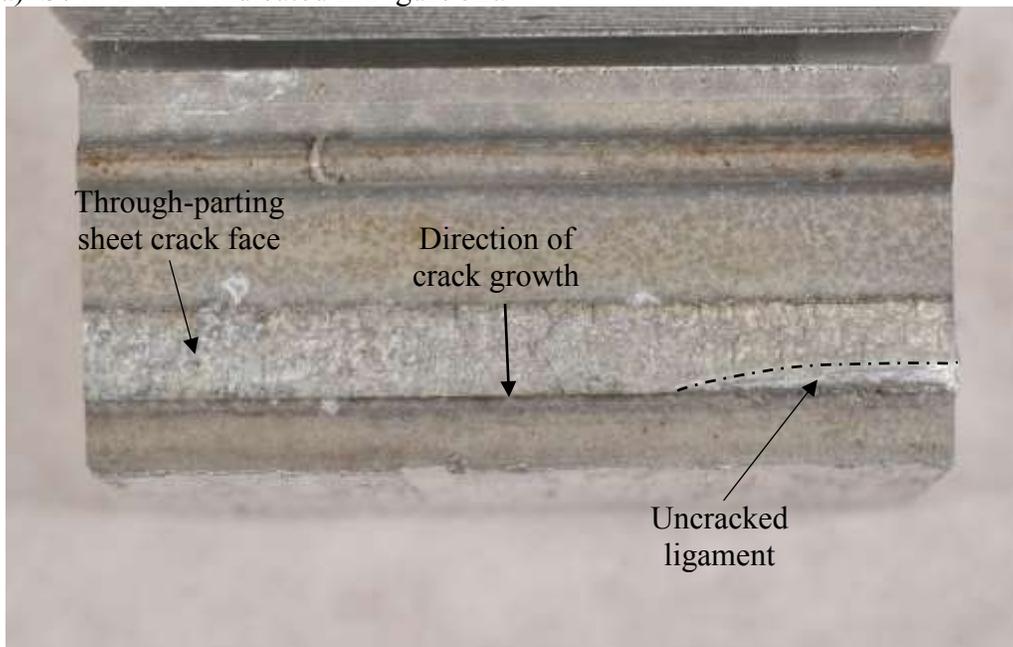
A transverse section through the visible crack was ground wet through 600-grit silicon carbide metallurgical paper. A through-parting sheet crack was visible in the section, and a small cap sheet crack was also present. The through-parting sheet crack face was exposed by cutting the layer 1 fins just below the cap sheet and easily breaking a small remaining ligament of the parting sheet by hand. Images of the section and exposed parting sheet crack surface are shown in Figure 54. The crack face was examined with low-power optical microscopy and found to have a brittle morphology with progression marks indicative of fatigue cracking and multiple crack initiation sites on the layer 1 side of the parting sheet. Oxide coated the crack surface, and was resistant to scrubbing with a soft bristle brush and soapy water. Images of the crack face are shown in Figure 55.

Figure 54 Photographs section S042-D1-1B, indicated in Figure 52a, through the interpass crack, and of the crack face. To expose the crack face, the layer 1 fins were cut along the dashed line in (a) and a small ligament of uncracked parting sheet was easily broken by hand. The cut location for this section is indicated in Figure 51b and Figure 52a.

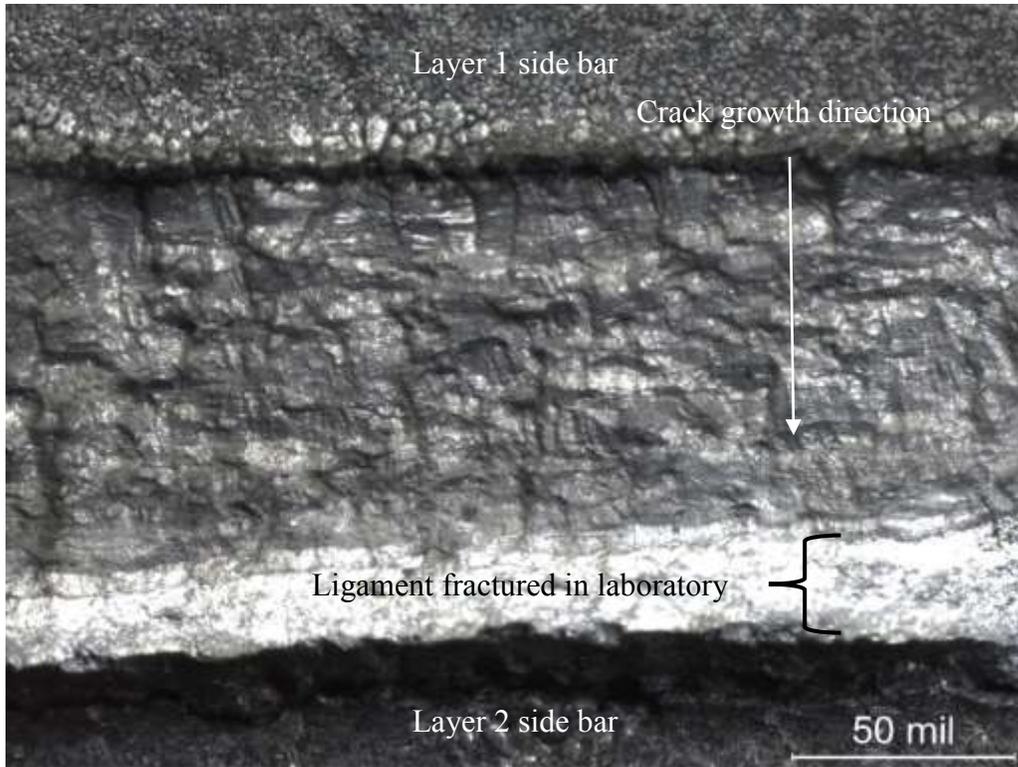
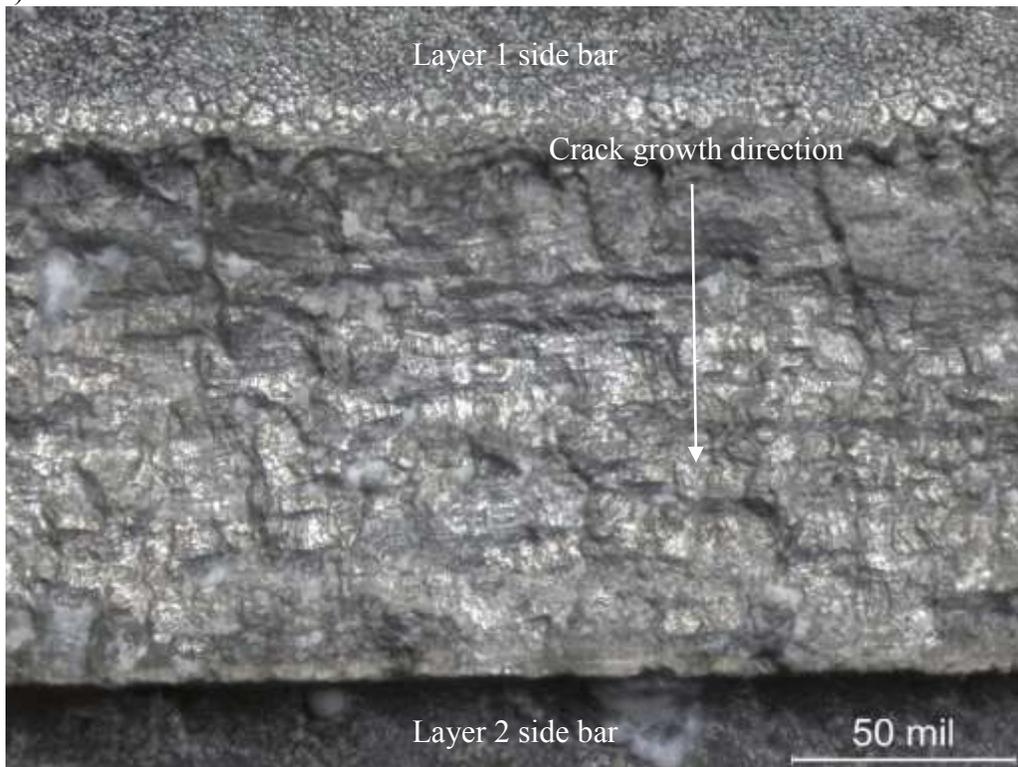
Figure 55 Images of the S042-D1-1B through-parting sheet crack face.
