Report No. 5005.3434 C

November 6, 2018

**LABORATORY EVALUATION OF SAMPLES FROM THE  
BRAZED ALUMINUM PLATE-FIN HEAT EXCHANGER H-3059 INVOLVED IN  
THE JULY 27, 2016 FIRE AT ENTERPRISE PRODUCTS OPERATIONS,  
MOSS POINT, MS**

Customer Authorization: CSB-16-0030

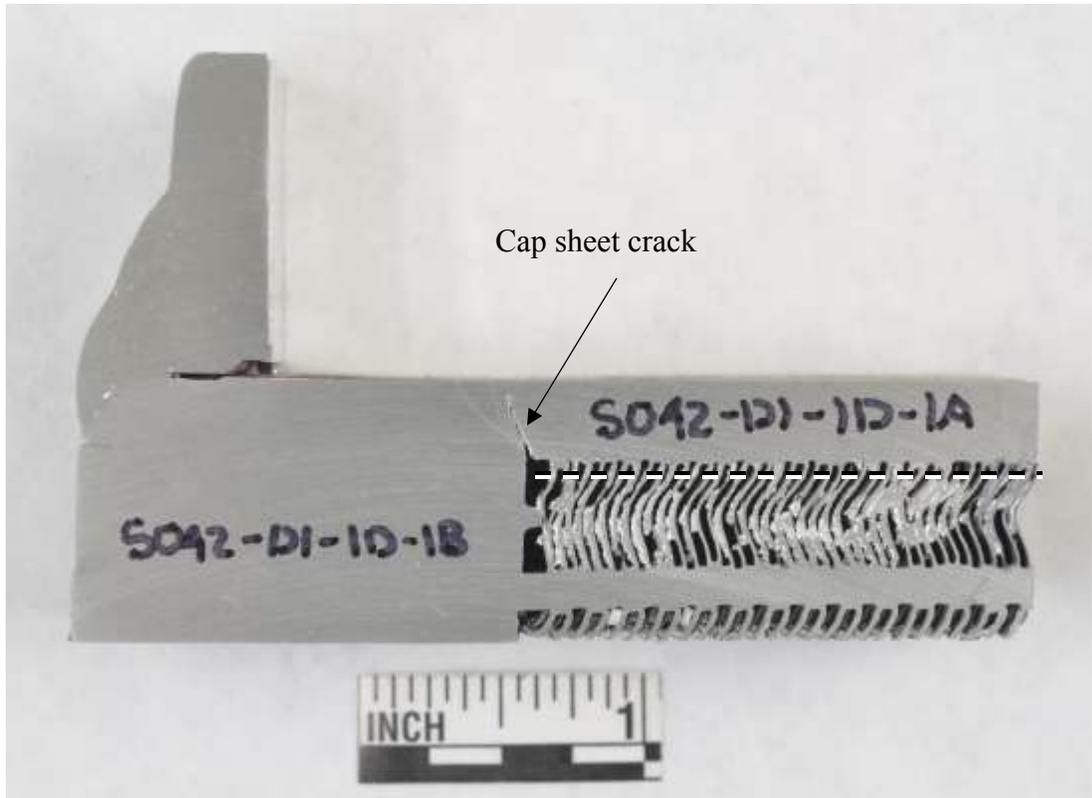
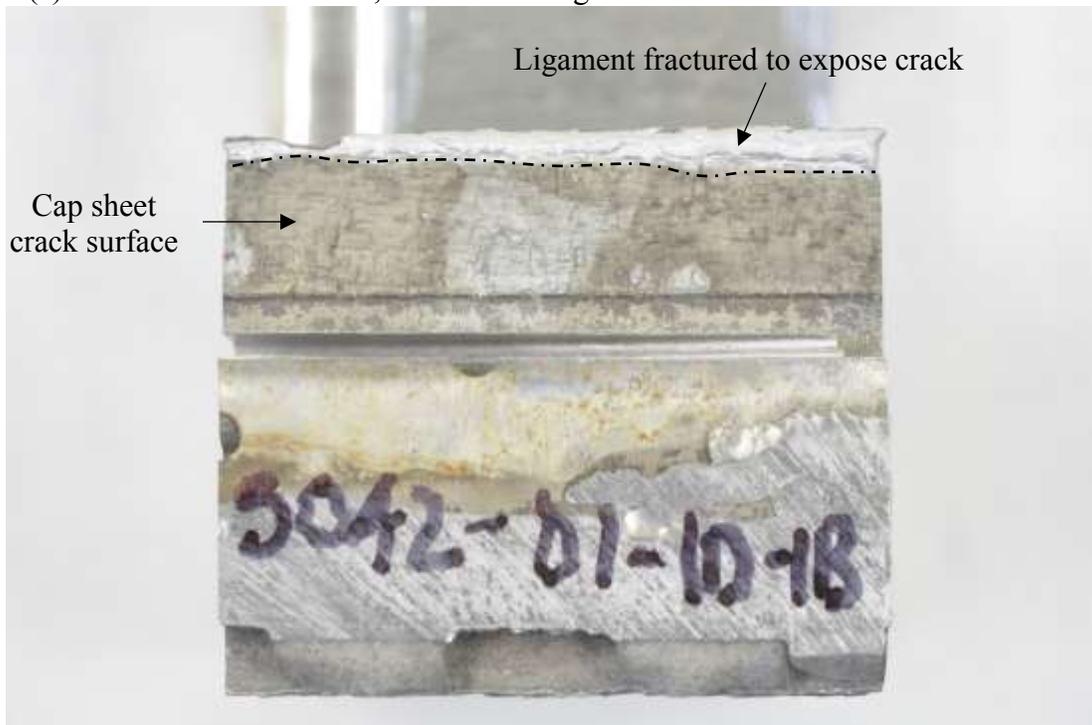
A shallow depression on the outside surface of the cap sheet, aligned with the inside edge of the west side bar was investigated by cutting a transverse section. A near through-cap sheet crack that had initiated on the inside surface was found in the section. The crack surface was exposed by cutting through the layer 1 fins and breaking the remaining ligament by hand. The crack morphology was brittle, with progression marks and ratchet marks that indicated fatigue cracking had initiated at numerous locations on the inside surface of the cap sheet. Oxide was present on the crack surface, and was resistant to scrubbing with a soft bristle brush and soapy water. Images of the section and crack surface are shown in Figure 56 and Figure 57.

Figure 56 Photographs of Section S042-D1-1D-1, indicated in Figure 52a, and of the cap sheet crack surface in that section. Dashed line in (a) indicates where fins were cut to expose crack surface. Dashed line in (b) indicates the remaining cap sheet ligament broken by hand to expose the crack surfaces.

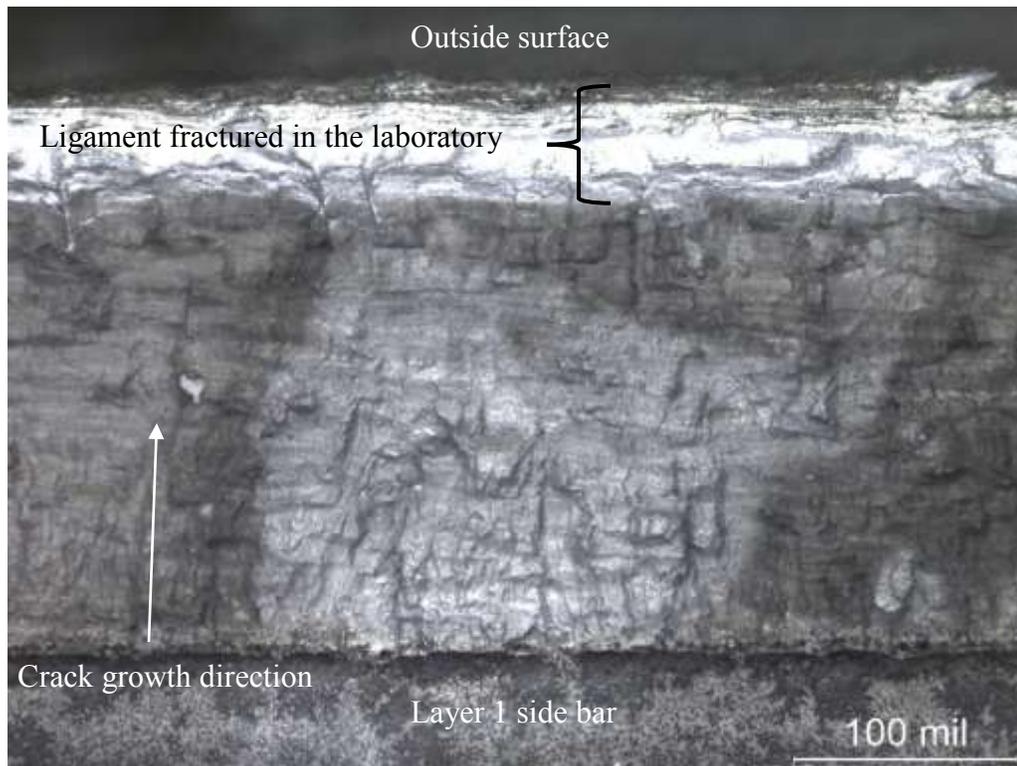
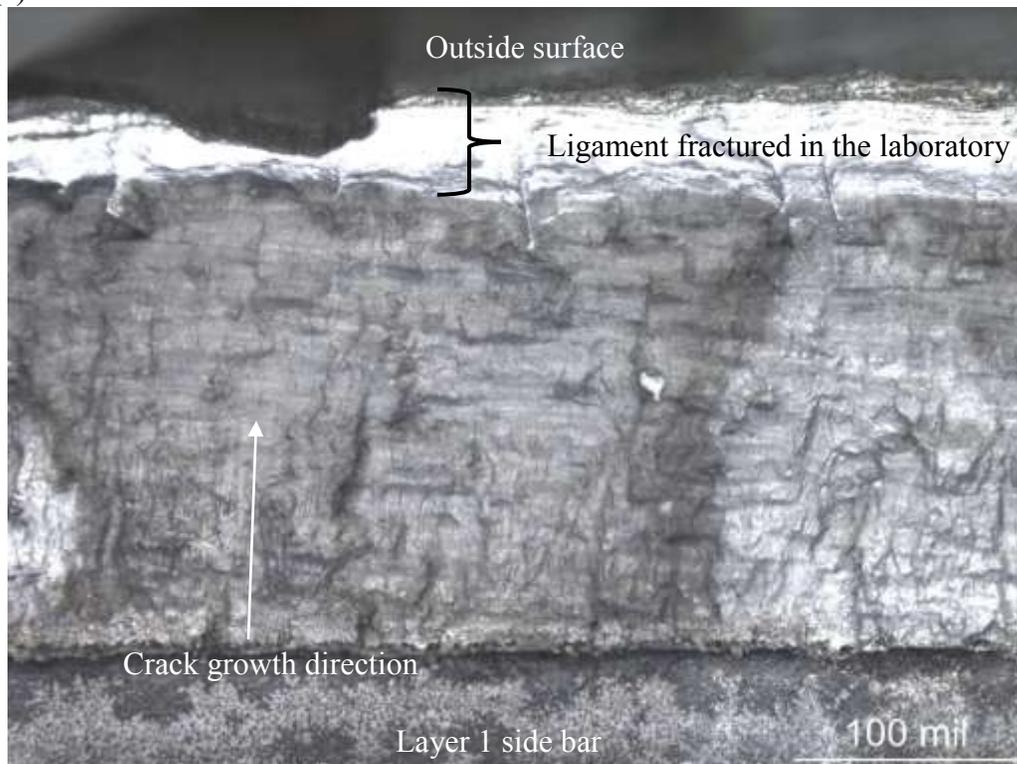
Figure 57 Images of the section S042-D1-D1-1 cap sheet crack surface.

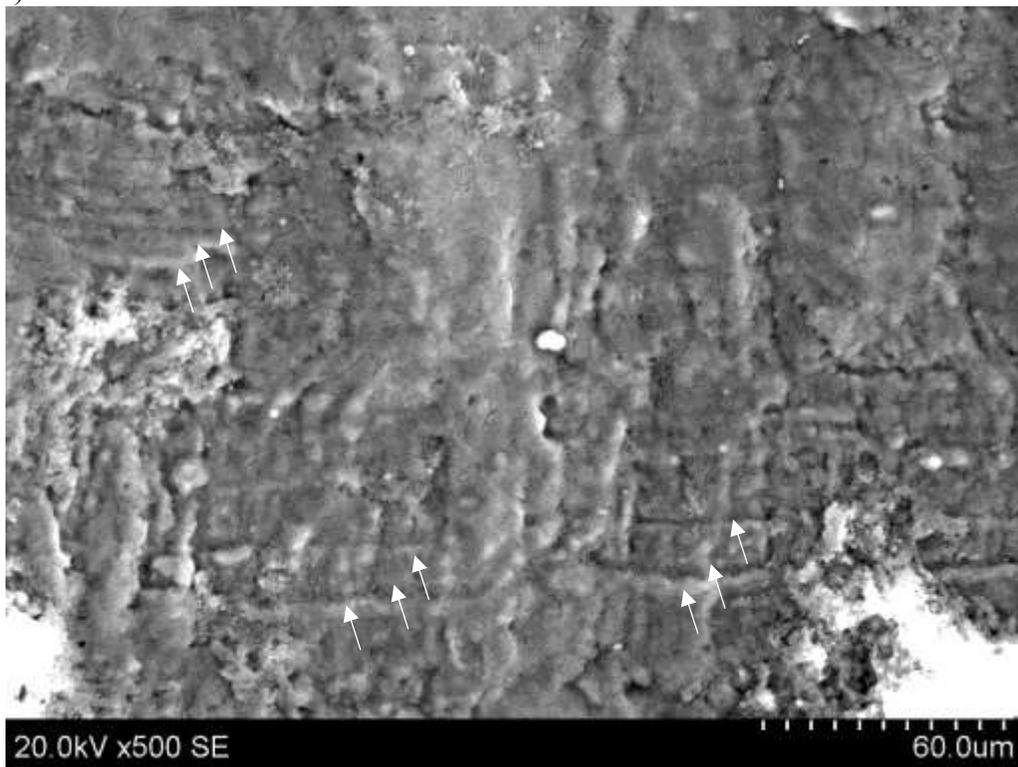
Figure 59 SEM micrographs of the sample S042-D1 interpass leak parting sheet crack face. Arrows in (b) indicate oxidized fatigue striations.

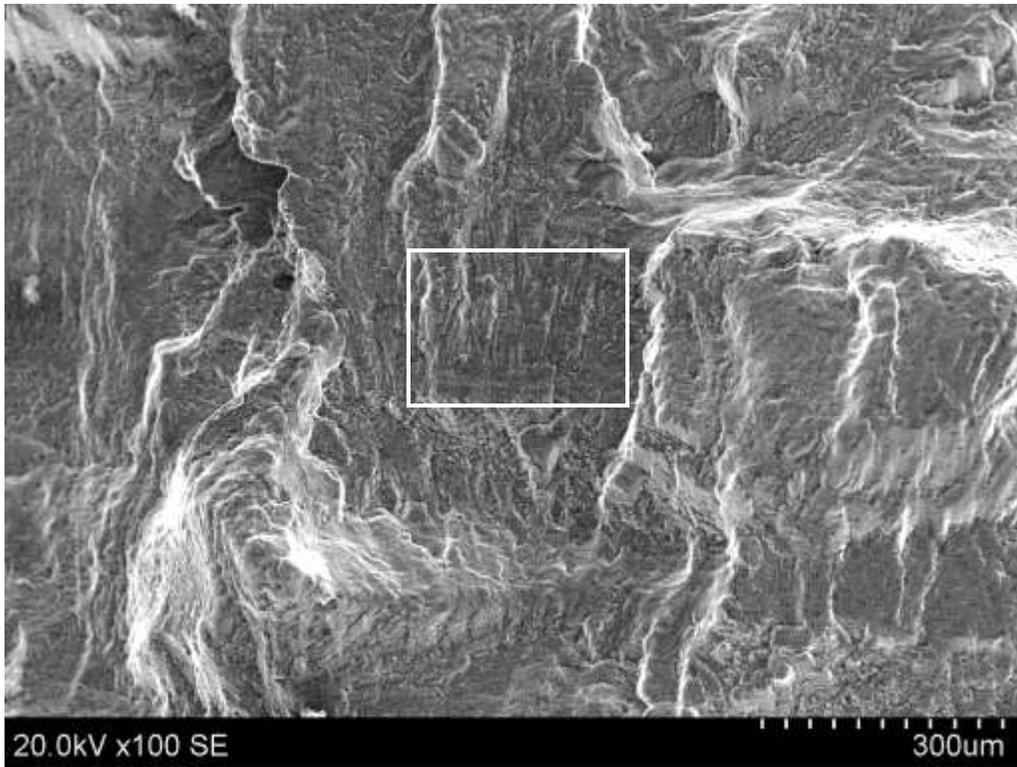
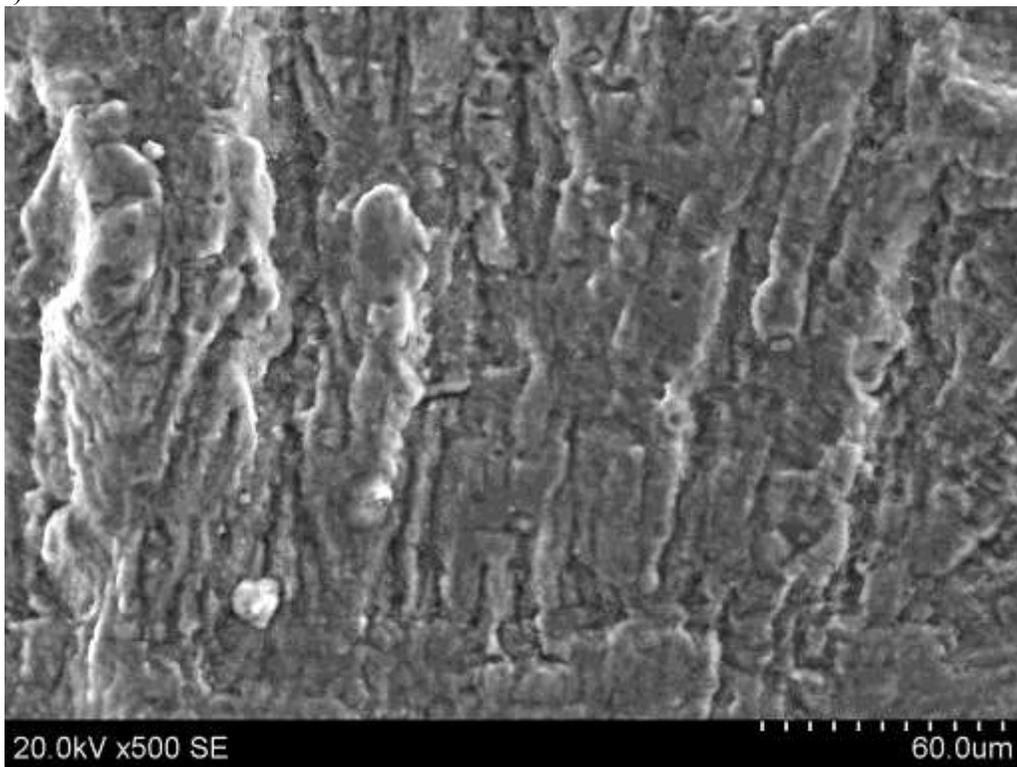
Figure 60 SEM images of the cap sheet crack face.

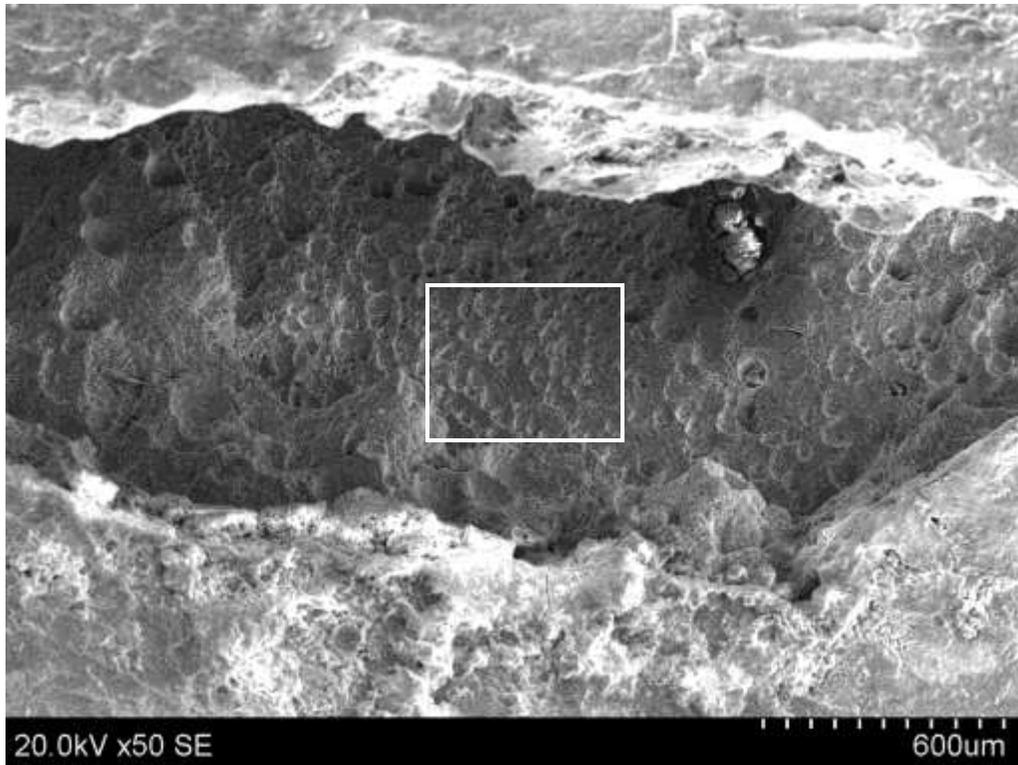
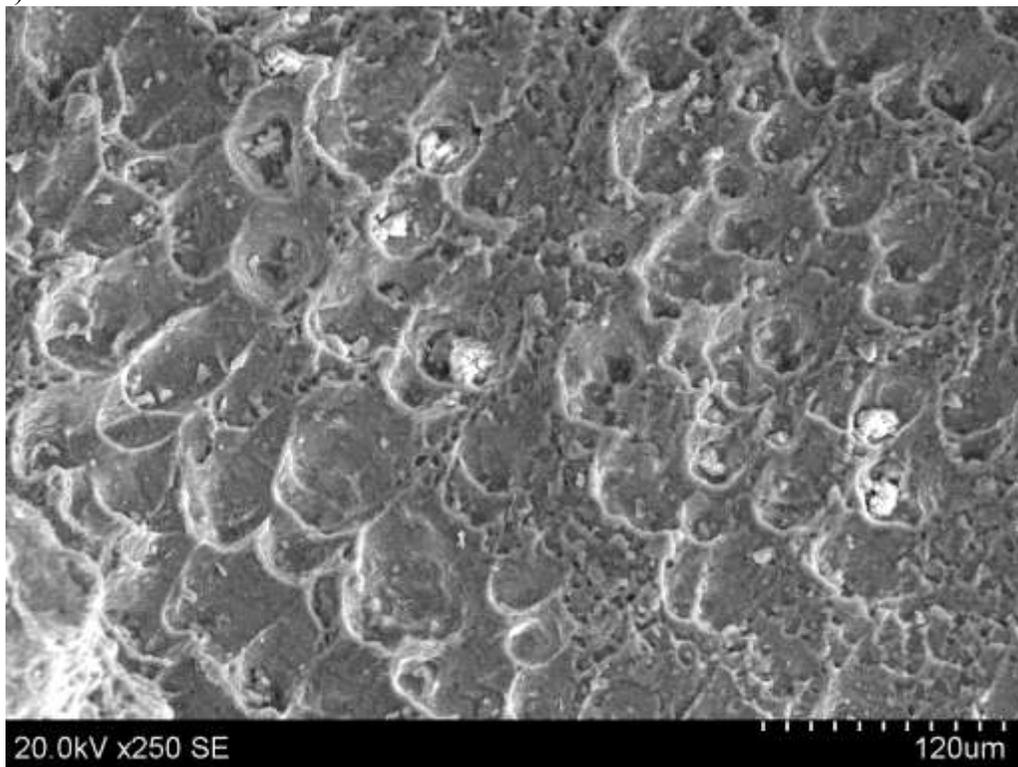
Micrographs of a section through the attachment plate fillet weld revealed elongated dimples consistent with the SEM micrographs of the same crack. The overload crack intersected the cap sheet crack, which created a leak path from the B pass layer 1 to atmosphere. However, it is possible that this leak path only existed after the large strain event that created the weld crack. A photograph and micrographs of the weld crack specimen are shown in Figure 66.

Figure 61 SEM micrographs of the S042-D1 attachment plate fillet weld crack, taken through the open crack. Elongated dimples indicate ductile shear overload crack growth.

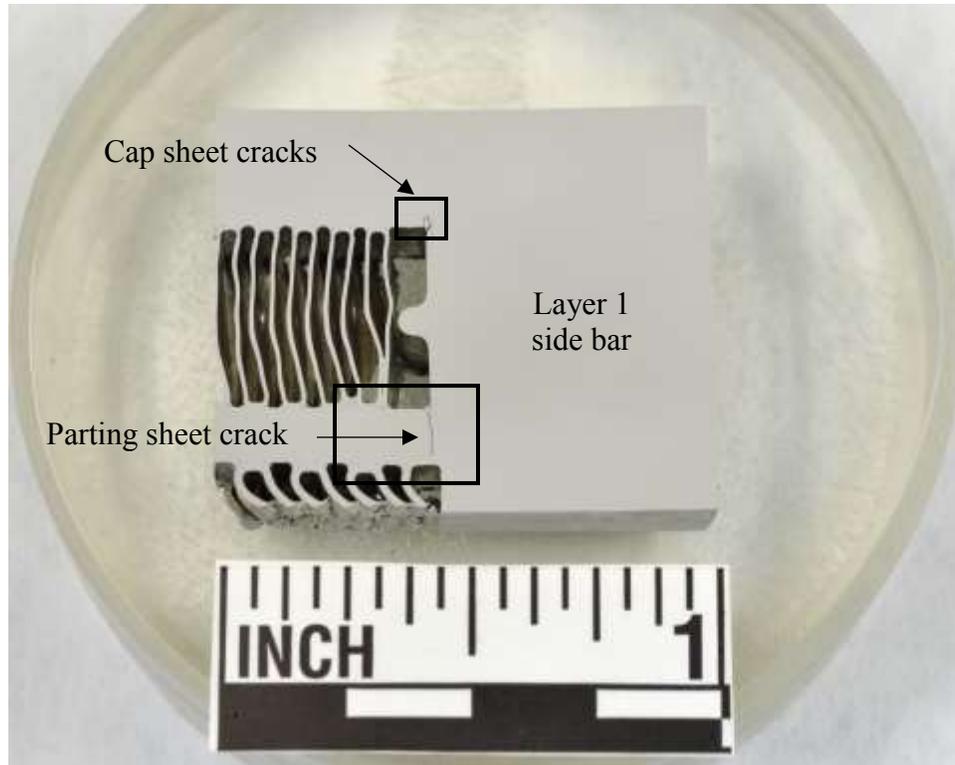
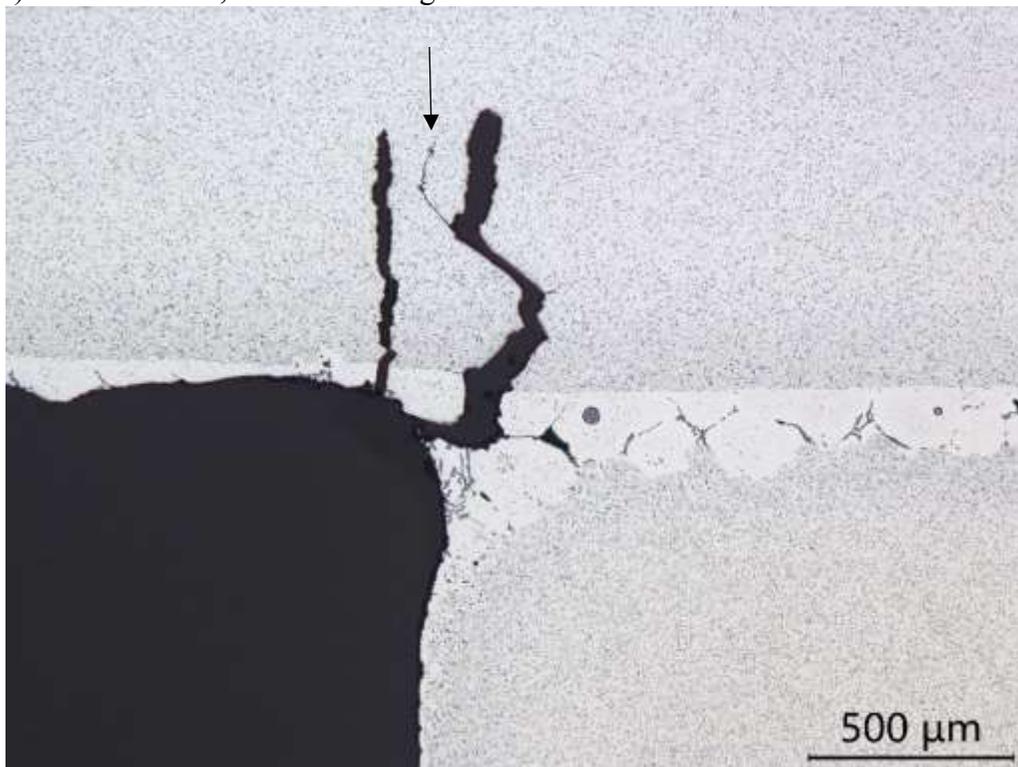
Photographs and micrographs of the sections are shown in Figure 62 through Figure 65. All of the main cracks in these sections had been widened (blunted) by plastic strain. The predominantly uniform width of the individual cracks, indicated that a single strain event was responsible for the widening. Crack branches and cracks that were outgrown by neighboring cracks were narrow, consistent with high cycle fatigue cracks. These narrow cracks represent the character of the wide cracks before the plastic strain event, most likely the fire, caused larger than normal stresses and strains in the ACSR.

Figure 62 Photograph and micrograph section S042-D1-1C1 cap sheet crack. In (b) the arrow points to a narrow crack that represents the condition of the other two cracks before they were blunted by plastic deformation.

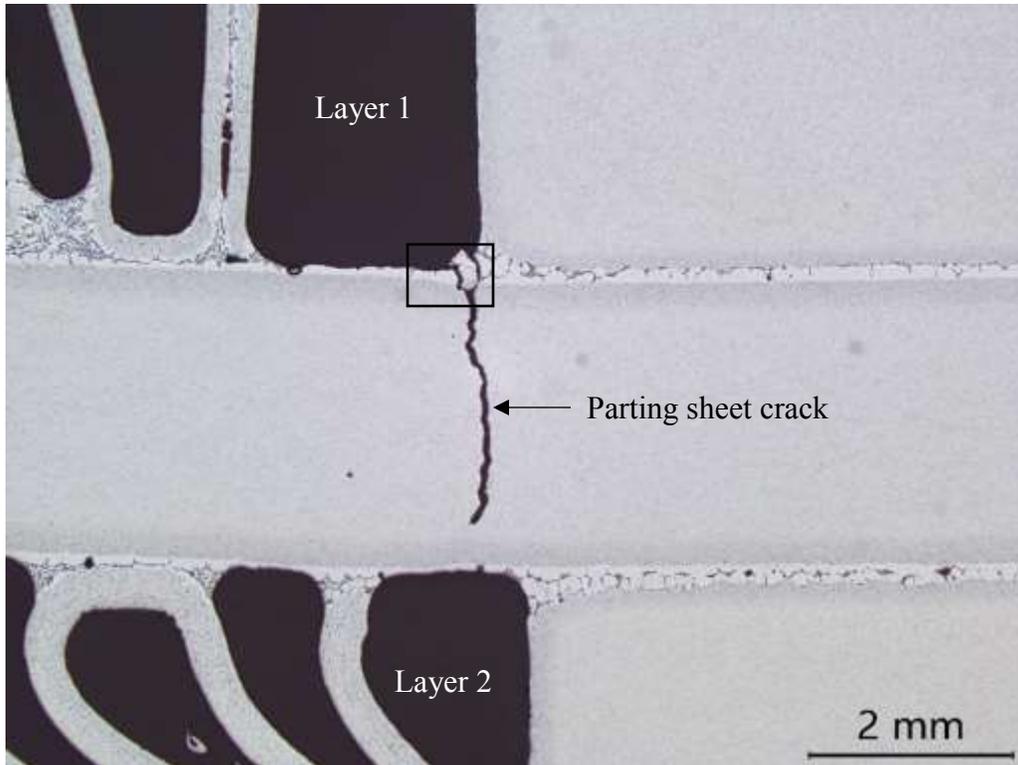
Figure 63 Optical micrographs of a layer 1 and 2 parting sheet crack, specimen S042-D1-1C1. In (b), arrows indicate a small, narrow crack next to the large blunted crack.

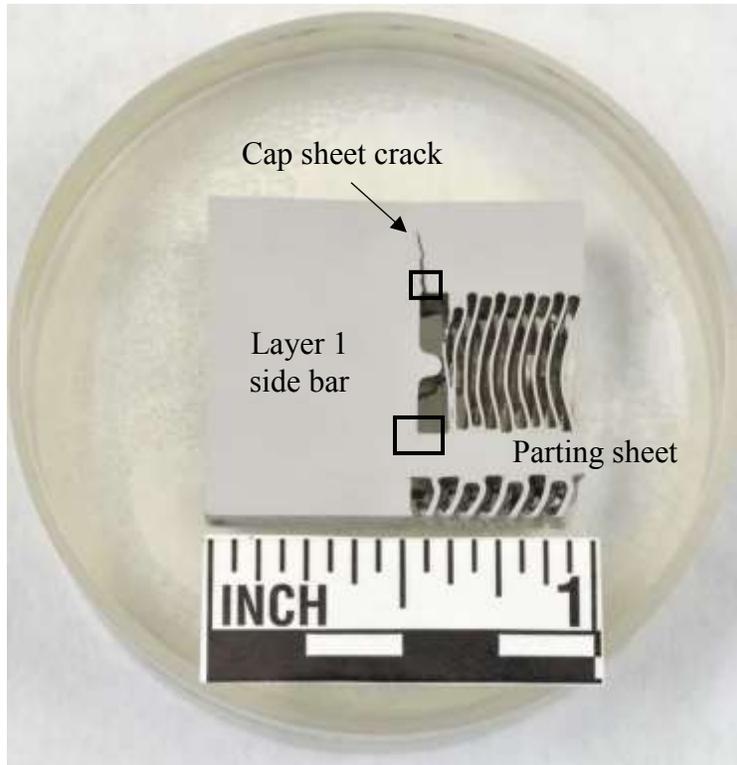
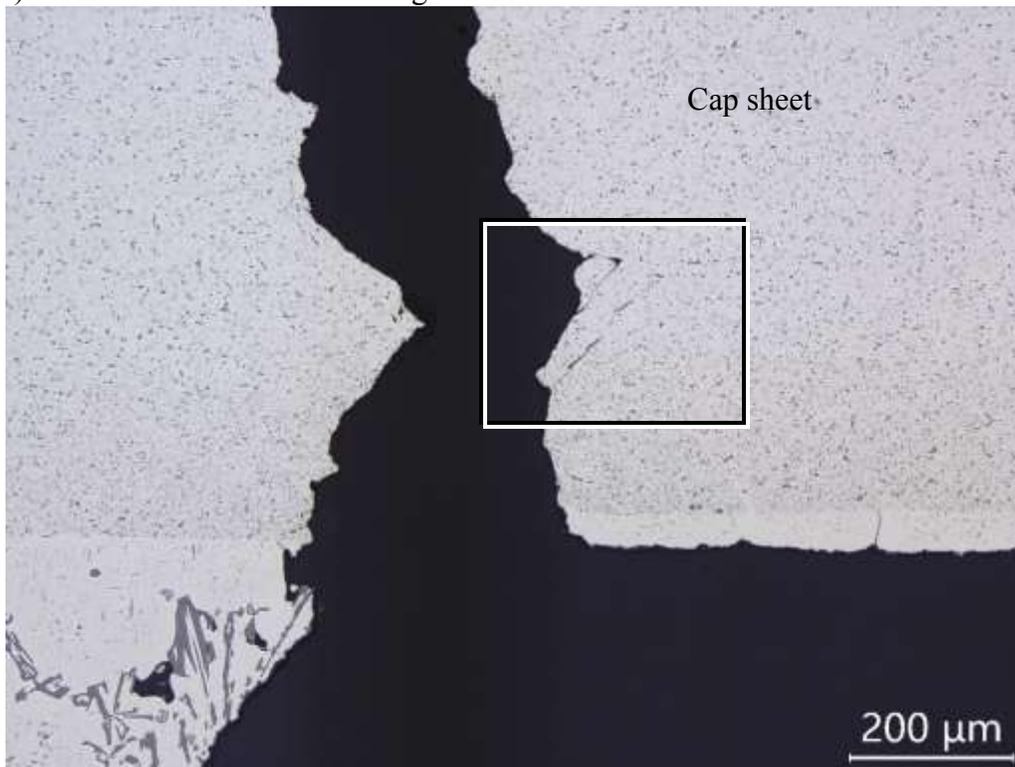
Figure 64 Photograph and micrograph section S042-D1-1C2 indicated in Figure 52a. The cap sheet crack initiated on the inside of the cap sheet and the parting sheet crack initiated on the layer 1 side of the parting sheet.

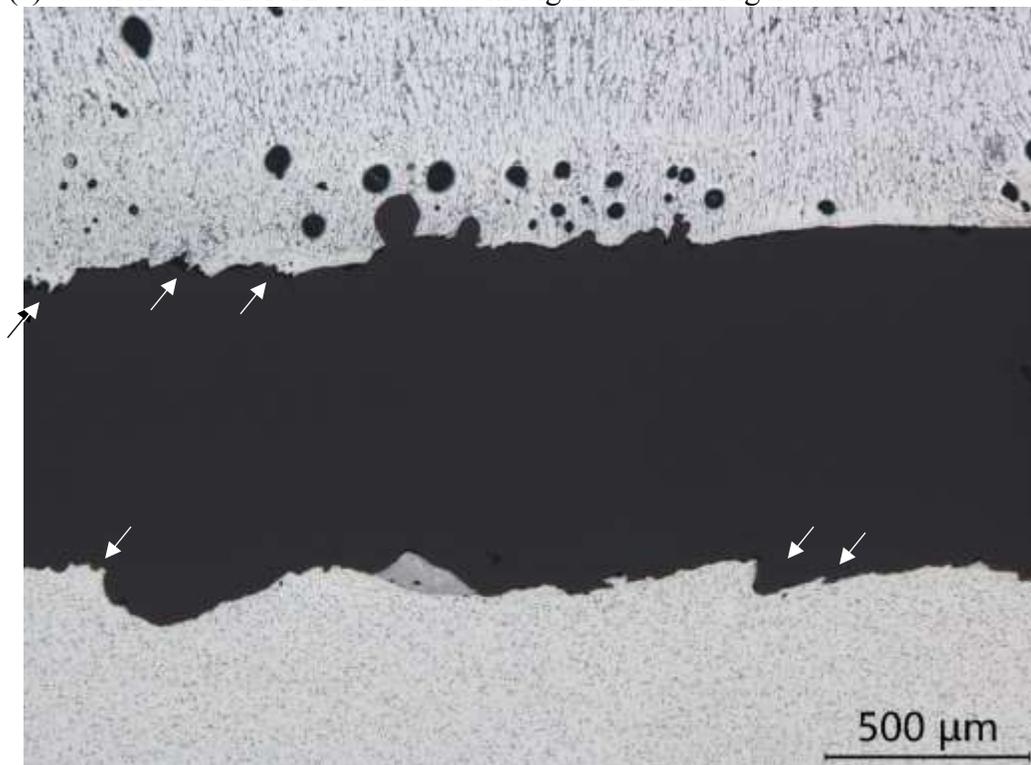
Figure 66 Photograph and micrograph section S042-D1-1D-3, cap sheet crack and attachment plate fillet weld crack. Section indicated in Figure 52a and Figure 58b.

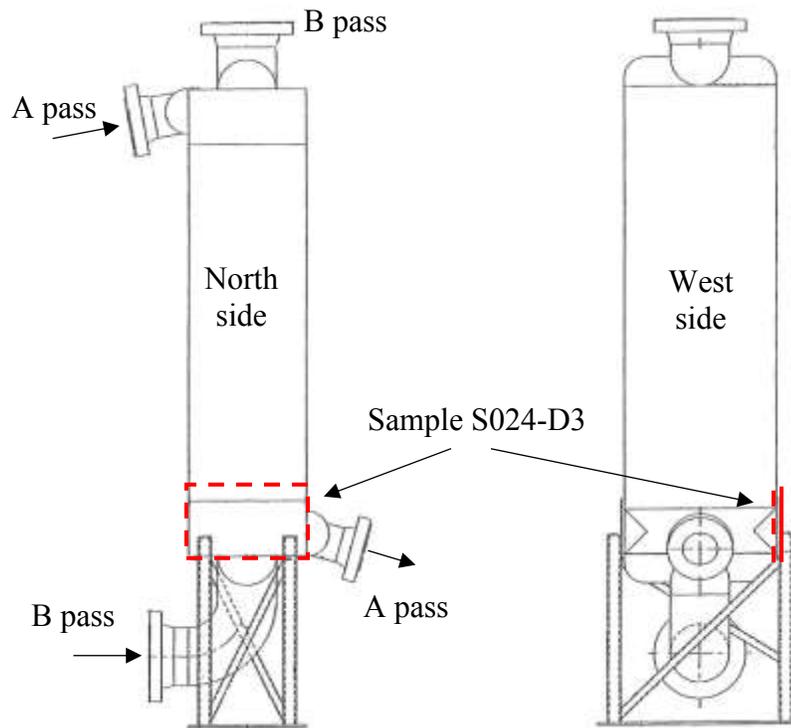
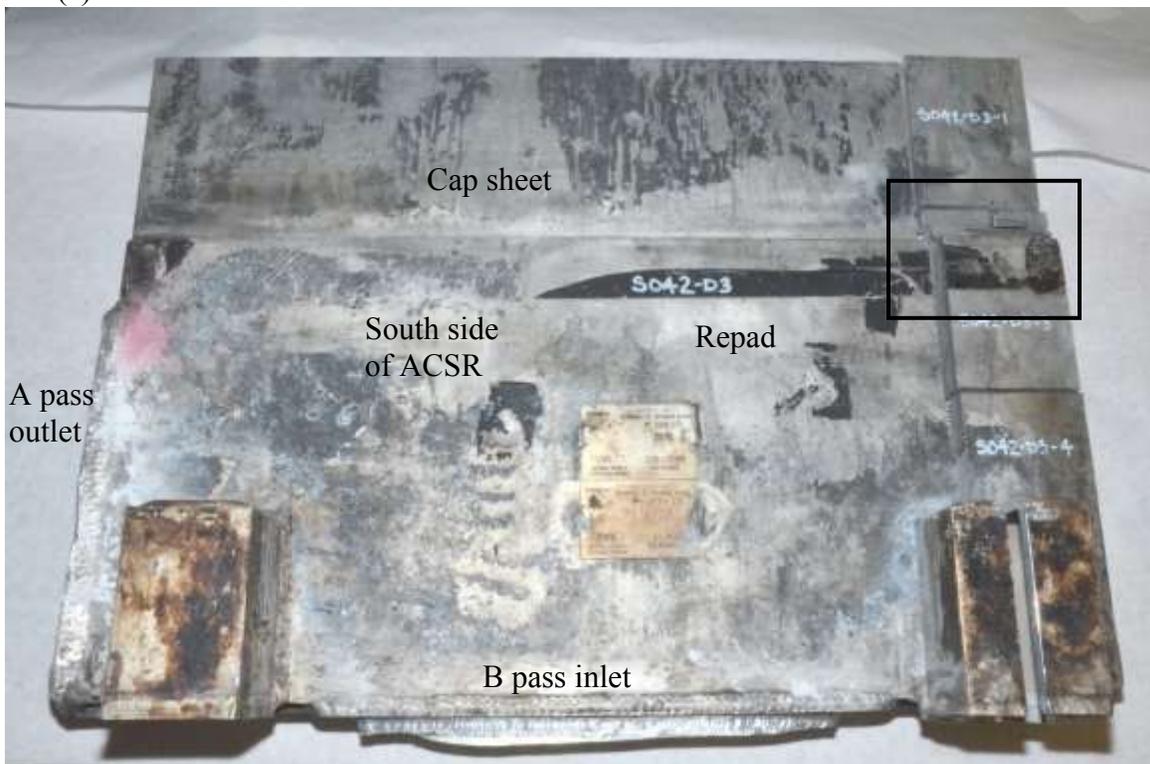
Figure 67 Simplified drawing of the ACSR annotated with the location of sample S042-D3, and a photograph of the sample.

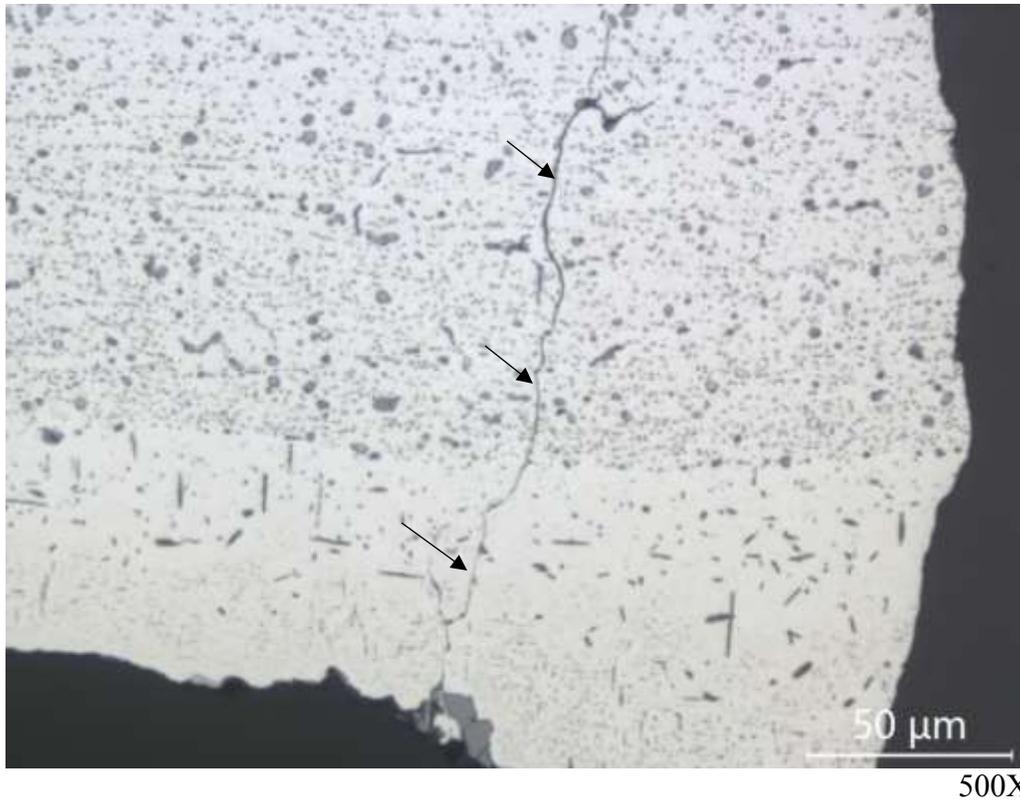
Section S042-D3-2, indicated in Figure 68a, was prepared for metallography using the same techniques as described in previous sections of this report. A photograph and micrographs of the section are shown in Figure 69 and Figure 70. A short, wide crack that had initiated on the inside surface of the cap sheet was present under the depression visible on the outside surface. A shorter, narrow crack was present next to the larger wide crack. Based on the examination of other similar crack faces, the two cracks initiated and grew by fatigue. The narrow crack indicates the two cracks initiated at the same general time, but the larger crack grew faster, eventually shielding the smaller crack from cyclic stresses. When a large strain/stress event occurred, likely caused by the fire, the longer crack blunted, but because the smaller crack was shielded by the larger crack, it remained narrow. Therefore, the smaller crack represents the typical width of fatigue cracks that grew in the ACSR during normal service conditions.

Figure 70 Micrograph of a narrow crack next to the larger wide crack in the section S042-D3-2, from the boxed region in Figure 69b. Arrows indicate the crack.
