Structural Performance and Collapse Sequence

Didion Corn Mill Facility – Cambria, Wisconsin
Grain Dust Explosions – Event of May 31, 2017
CSB Investigation 2017-07-I-WI

Prepared by **Atlas Engineering, Inc.**
551A Pylon Drive, Raleigh, NC 27606
Report date: May 12, 2023

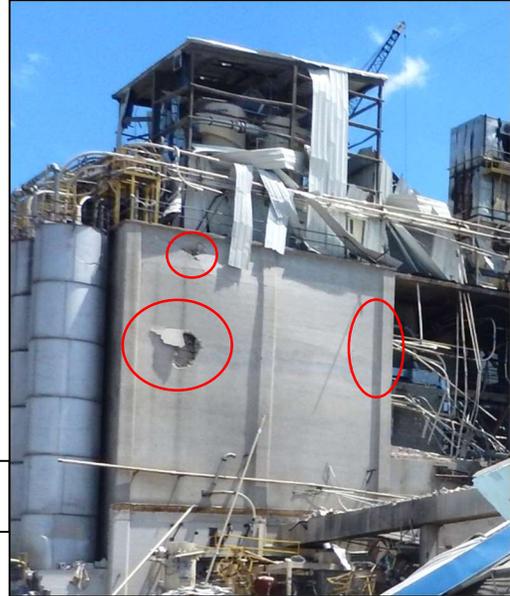
A-Mill remained standing and largely intact. There were isolated areas of severe damage at the west exterior wall, at levels 4A and 5A, where the cast-in-place concrete wall fractured and bulged outward between pilaster columns.

At level 4A, the wall tore loose from its monolithic connection with the floor slab. The damage appears consistent with a powerful interior blast at levels 4A and 5A.

West side of A-Mill. Circles show holes and bulges at the west wall. (photo by CSB)

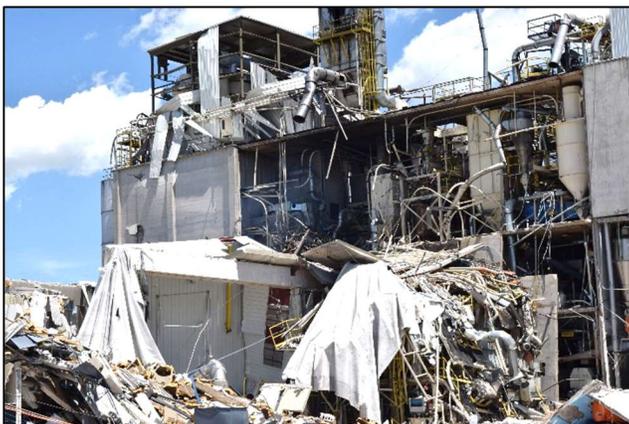
B-Mill - Interior blasts at B-Mill left its cast-in-place columns and floor slabs standing but damaged or destroyed almost all its exterior tilt-up wall panels. Most of the lower-tier panels at levels 1B-3B were buttressed by adjacent buildings (Multi-Purpose, C-Mill, and F-Mill). These panels bulged outward or fractured at their connections to the building but remained roughly in place. The lower-tier 1B-3B wall panels that were not buttressed or braced by adjacent buildings were blown clear of the building.

*West side of B-Mill.
(photo by Atlas)*

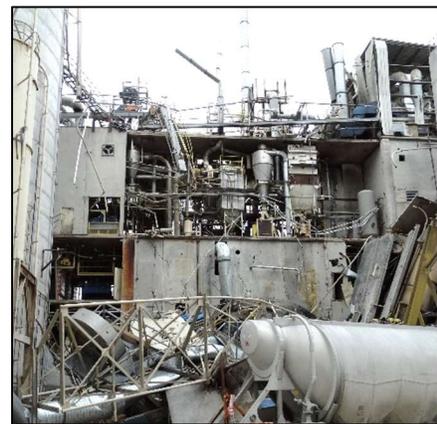
*East side of B-Mill.
(photo by Atlas)*

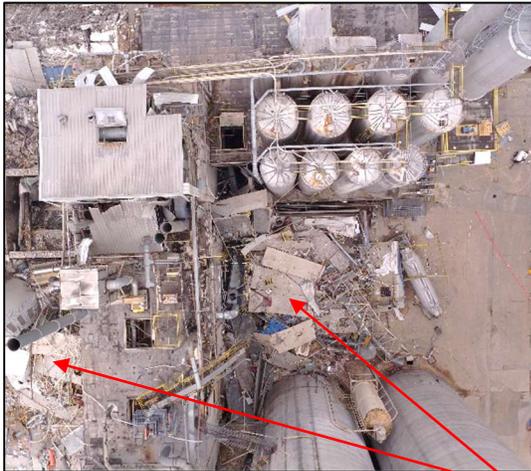
B-Mill (cont.) - All the upper-tier wall panels at 4B broke free and landed on top of the collapsed debris of the adjacent Multi-Purpose Building, C-Mill, and F-Mill. At the northern end of level 4B, the airshaft that it shared with levels 1B-3B (and possibly with A-Mill’s airshaft) was fractured and bulged outward, damage consistent with high blast pressure inside the airshaft.

Overview of B-Mill. Arrows show wall panels from 4B atop C-Mill (left) and F-Mill debris (right). (photo by CSB).

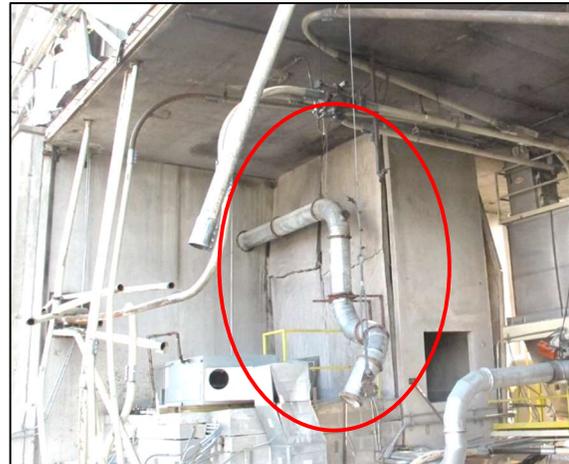
North end of 4B, west side. Circle shows fractured walls of airshaft. (photo by CSB)

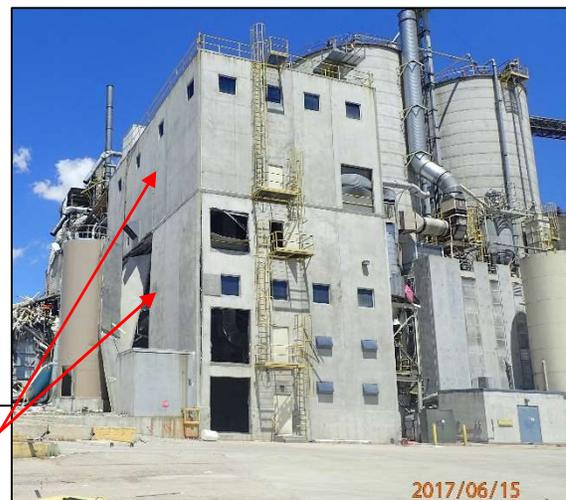
D-Mill remained standing but its lower-tier tilt-up wall panels were damaged, with panels at the west and south sides breaking partially free from the building and bulging outward. Two panels at the west side fractured, broke free and fell away from the building.

In contrast, the upper tier of wall panels at D-Mill appeared undamaged.

D-Mill, view looking northeast. Partial failure at lower tier wall panels; upper tier appeared undamaged. (photo by Atlas)

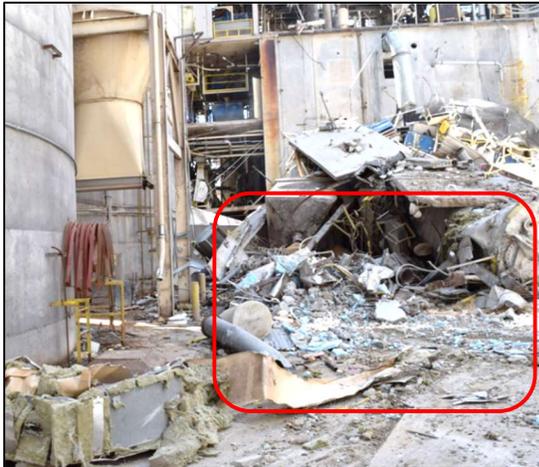
F-Mill collapsed entirely. Most of its debris landed inside its original footprint. Most of the **Boiler Building** collapsed. Part of its debris field fell to the east of its original footprint.

*F-Mill debris, under wall panel from 4B
(photo by CSB)*

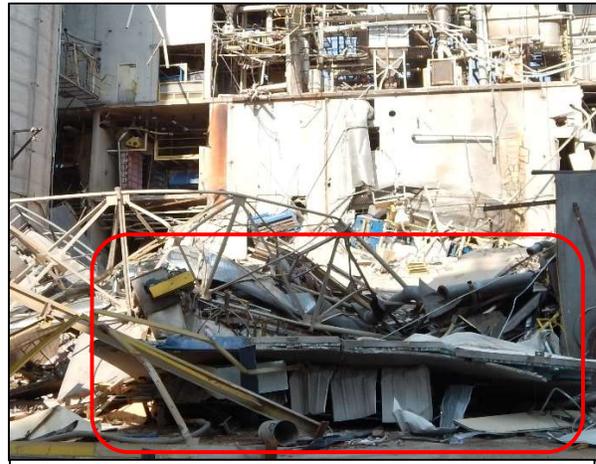
*Boiler Building debris.
(photo by Atlas)*

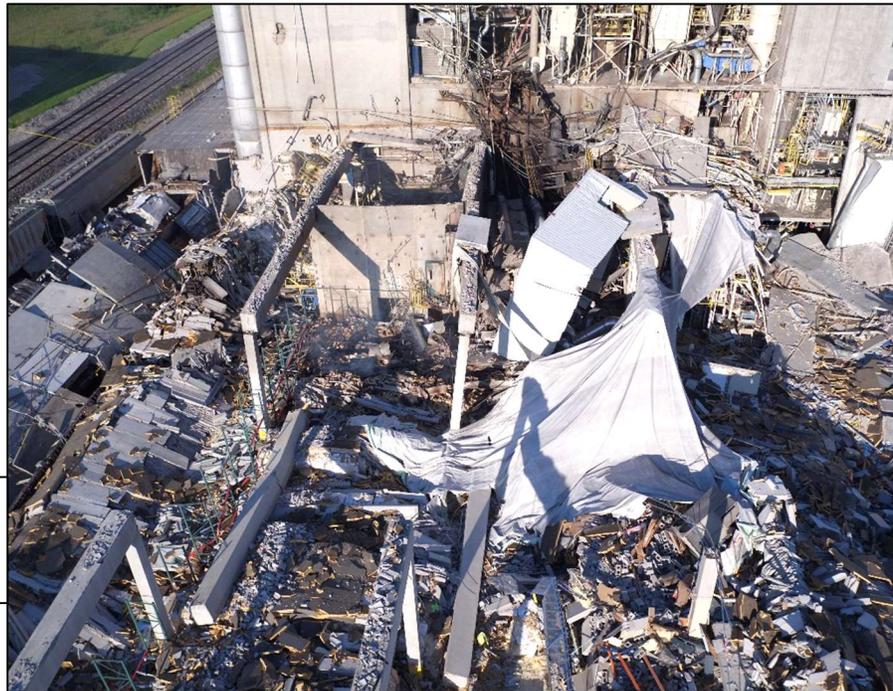
The **Multi-Purpose Building's** tilt-up exterior wall panels and precast roof panels collapsed, along with three girders and one column. The roof panels fell within the building's footprint, while the exterior walls toppled over outwards.

*Collapse of Multi-Purpose Building,
looking east.
(photo by CSB)*

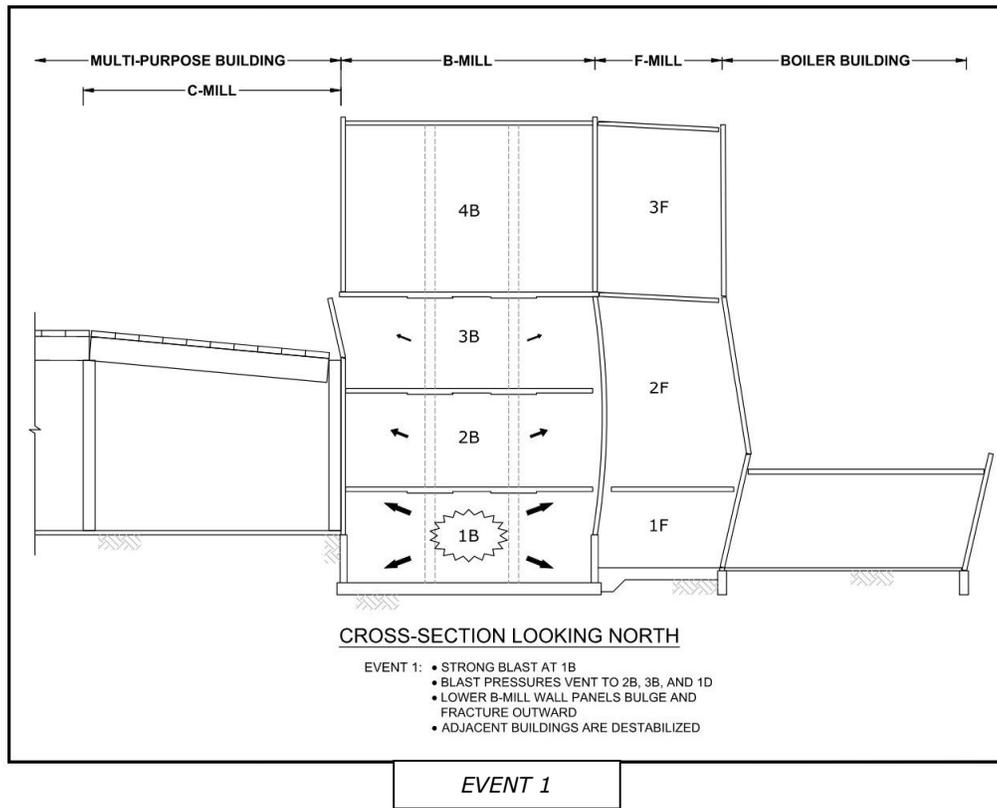
Event 1

Fire and deflagration broke out inside process equipment. Burning product and hot gases erupted into B-Mill at level 1B, when an inlet filter was blown off a product transport pipe, causing process materials and fugitive dust, already present at 1B, to loft and ignite. The blast generated a flame front and high interior pressure, which –

- Vented into the B-Mill airshaft, A-Mill, and D-Mill’s lower stories. D-Mill’s lower-tier wall panels partially detached and bulged outward; B-Mill’s lower-tier wall panels bulged outward, shifting and destabilizing the adjacent tilt-up structures -
 - C-Mill’s 2C floor level and interior wall panels displaced west and fell off their bearings, initiating the collapse of C-Mill; a roof girder at Multi-Purpose fell off its column, dropping all its tributary roof panels
 - At F-Mill, the 2F floor slab shifted east several inches, pushing F-Mill’s eastern wall off its bearing at the west wall of the Boiler Building, initiating the collapse of F-Mill and the Boiler Building
- The lower-tier wall panels at 1B-3B that were not blocked by C-Mill or F-Mill blew completely off the building; this vented the remaining interior pressure at B-Mill and D-Mill

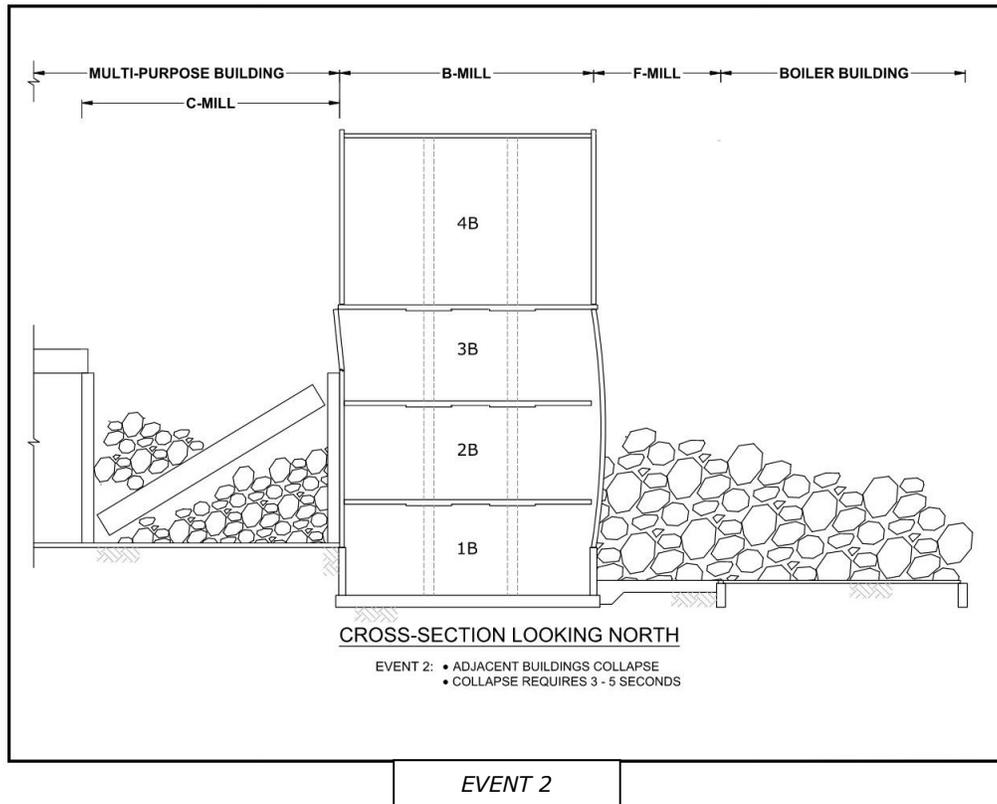
Event 2

C-Mill, parts of the Multi-Purpose Building, F-Mill, and the Boiler Building collapsed.

- It took three to five seconds for connections and members to break apart and for the broken pieces to fall to the ground.
- With the collapse of F-Mill, the eastern 4B wall panels were no longer braced by F-Mill's upper stories

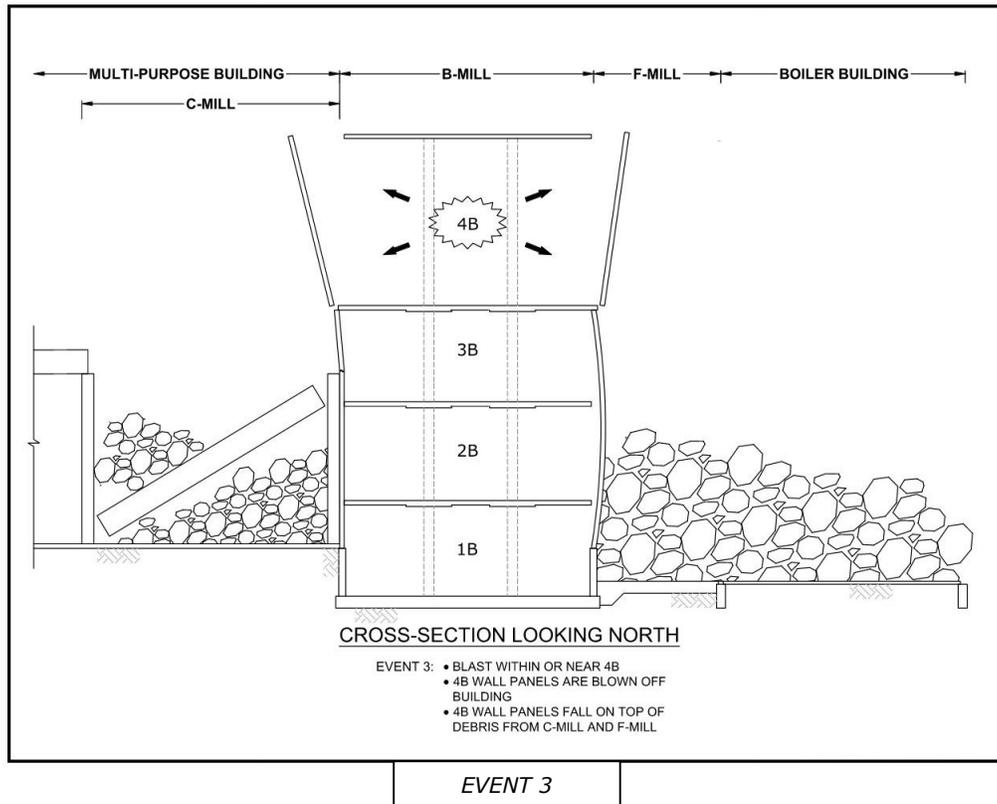
Event 3

Sometime after the collapse of C-Mill, the Multi-Purpose Building, and F-Mill, a secondary blast pressurized the 4B interior. The blast pressure inside 4B–

- Blew all the 4B wall panels off the building; the panels readily detached at a relatively low interior pressure, due to weak and missing wall panel connections
- The prompt loss of 4B's wall panels effectively vented the interior pressure, minimizing damage at the upper level of D-Mill
- The 4B wall panels fell on top of the C-Mill and F-Mill debris piles on either side, largely intact; little damage was seen along their connection lines, indicating poor connection performance

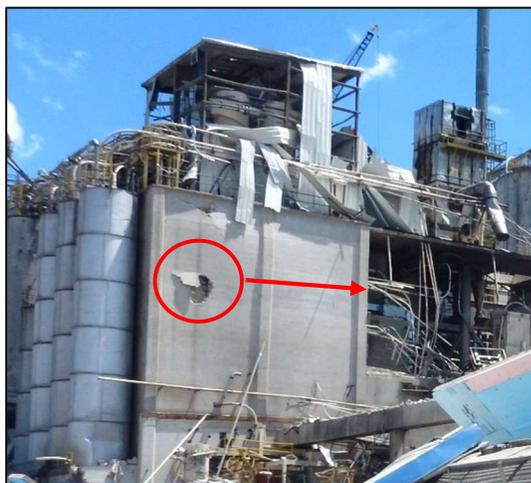
Nearby, there was clear evidence that a powerful blast occurred at 4/5A, at a location just north and at the same elevation as the damaged 4B airshaft. The west wall of A-Mill was blown through at 4/5A, and nearby parts of the wall ripped free of A-Mill's floor slabs and bowed outward, as shown in the photos below.

Severe damage at A-Mill west wall (circle) is at same elevation as fractured airshaft at 4B (arrow). (photo by Atlas)

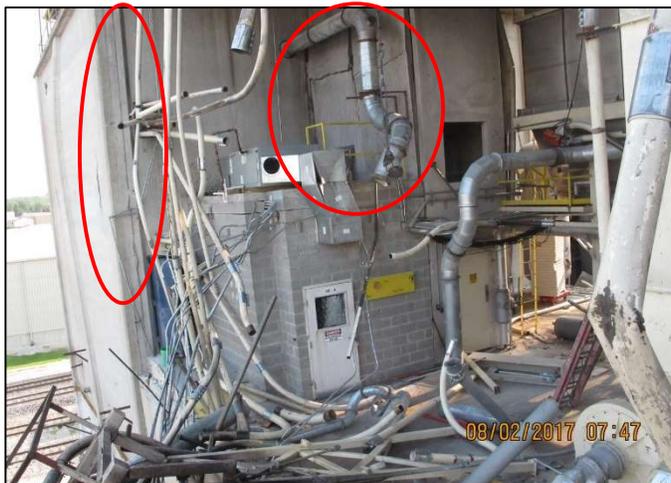
There were signs that fire and blast pressure emanated from the 4B level airshaft, at the building's north end. The airshaft walls were broken outward and there were scorch marks at the north end of the 4B level.

NW corner of 4B, showing fractured airshaft walls (circle at right). Note bulged and cracked wall at A-Mill, just a few feet away (circle at left). (photo by CSB)

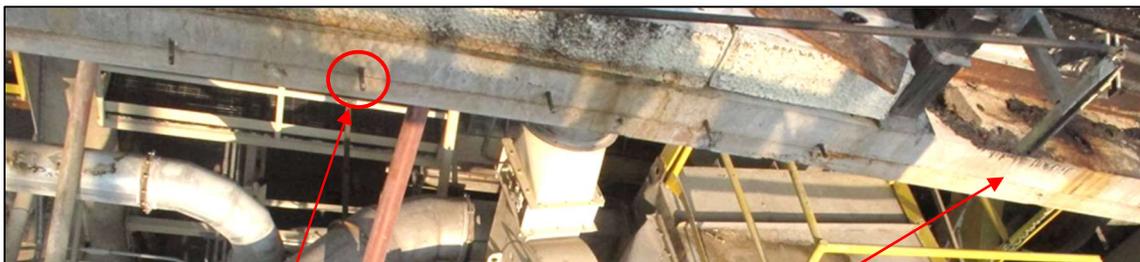
Where panels separated from the buildings, post-blast photos show the dowels still embedded in the floor and roof slabs. This means the connections failed at the epoxy connections at the wall panels.

*Undamaged, clean dowels at 4B east roof edge. Adjacent slab edge - missing dowels
(photo by CSB)*

In post-blast photos, the exposed dowels show no signs of yielding. The exposed bars are relatively clean of epoxy residue or concrete debris. Photos show no pattern of concrete damage at the panels along the lines of the dowel holes, either at the panels that fell off 4B, or at the 1B-3B panels that bulged outward from the building.

These observations indicate that the epoxy connections failed well below their specified capacity. The most common cause for substandard connection performance in epoxy connections is poor workmanship. Successful epoxy connections require careful cleaning, measuring, mixing, and curing at the right temperature. In-field tensile proof-testing of epoxy connections is essential for reliable load capacity. Based on a 2017 interview with Didion’s Construction Manager, no regular testing program was in place during the construction of the mill buildings.

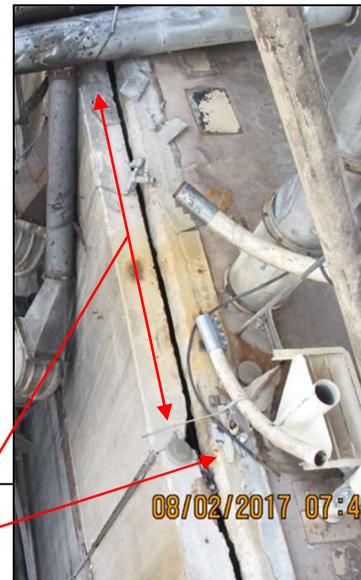
Photos show that top-edge connections existed along the east 1B-3B panels. These consisted of 1/2" bars spaced about 24" on-center. However, photos show no signs of top-edge connections at three 1B-3B panels along the west side of the mill, where the top part of the panel fractured outward, exposing the panel’s top edge. These observations indicate that connections installed along the top and bottom edges of the 1B-3B panels were widely spaced at some locations and entirely missing at others.

*Top edge of 1B-3B panels at west side,
showing lack of any connections to 4B slab
(photo by CSB)*

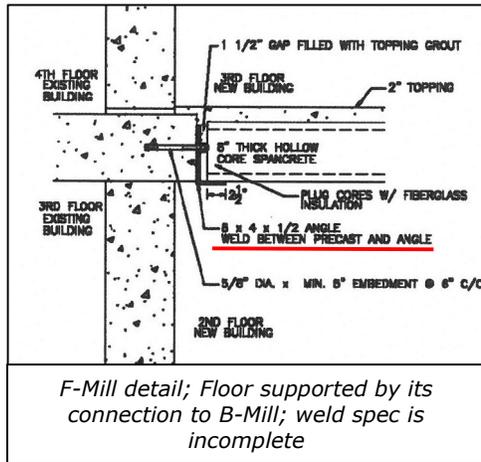
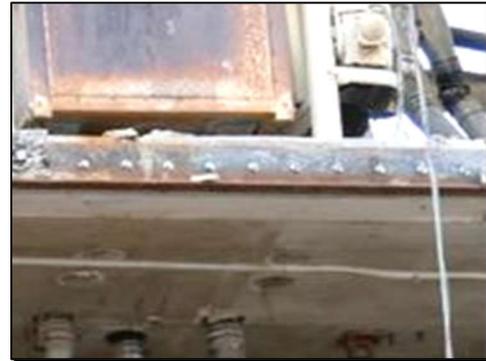
Post-blast photo shows shelf angle intact at B-Mill floor slab; no signs of broken welds. (photo by CSB)

This is significant, because without effective and properly-sized welds, the floor panels would be liable to fall off their bearings under blast loading. Post-blast photos show the complete collapse of F-Mill. The steel shelf angles that supported F-Mill's floors were left intact along B-Mill's 1B-3B east panels. The shelf angles show no sign of damage – if the connections had included any welds at all, they were too small to damage the shelf angles when the pre-cast planks fell away.

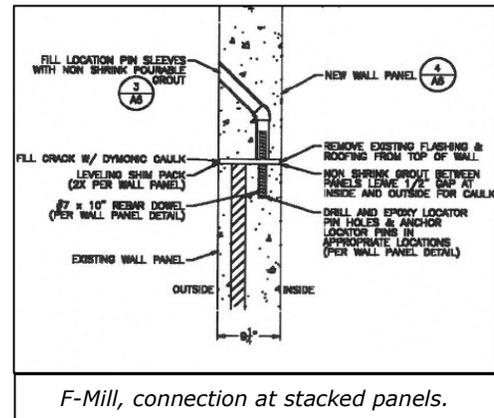
Where F-Mill's wall panels were stacked atop each other, or on top of the Boiler Building's west wall panels, the plans called for an unusual and difficult-to-construct dowel connection.

The design requires installation of drilled and epoxied dowels in the lower panel that must line up precisely with PVC sleeves cast into the upper wall panel. Even if successfully installed, no more than two connections are called for per panel width.

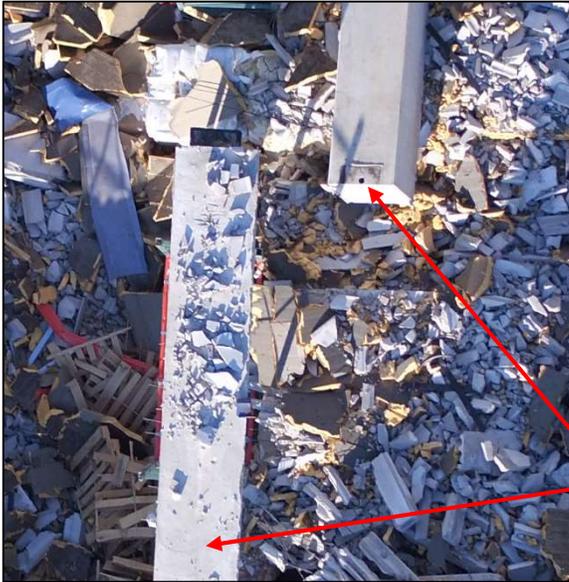
Post-blast photos show that the column-to-girder connection consisted of a vertical dowel bar cast into the column, that engaged a receiver hole in the girder. Normally, the receiver hole would be grouted to complete the connection, but photos show the connections to be ungrouted and incomplete.

The Multi-Purpose Building's hollow-core roof planks rested on the girders, but had no actual connection to them.

Multi-Purpose girders
UngROUTED bearing hole at a fallen girder.
At an erect girder, no sign of structural attachments for roof panels.
Roof panels simply rested atop the girders.
(photo by CSB)
