U.S. Chemical Safety and
Hazard Investigation Board

Explosions, Fires, and Toxic Ethylene Oxide Release at Dow Louisiana Operations

Plaquemine, Louisiana | Incident Date: July 14, 2023 | No. 2023-03-I-LA

Investigation Report

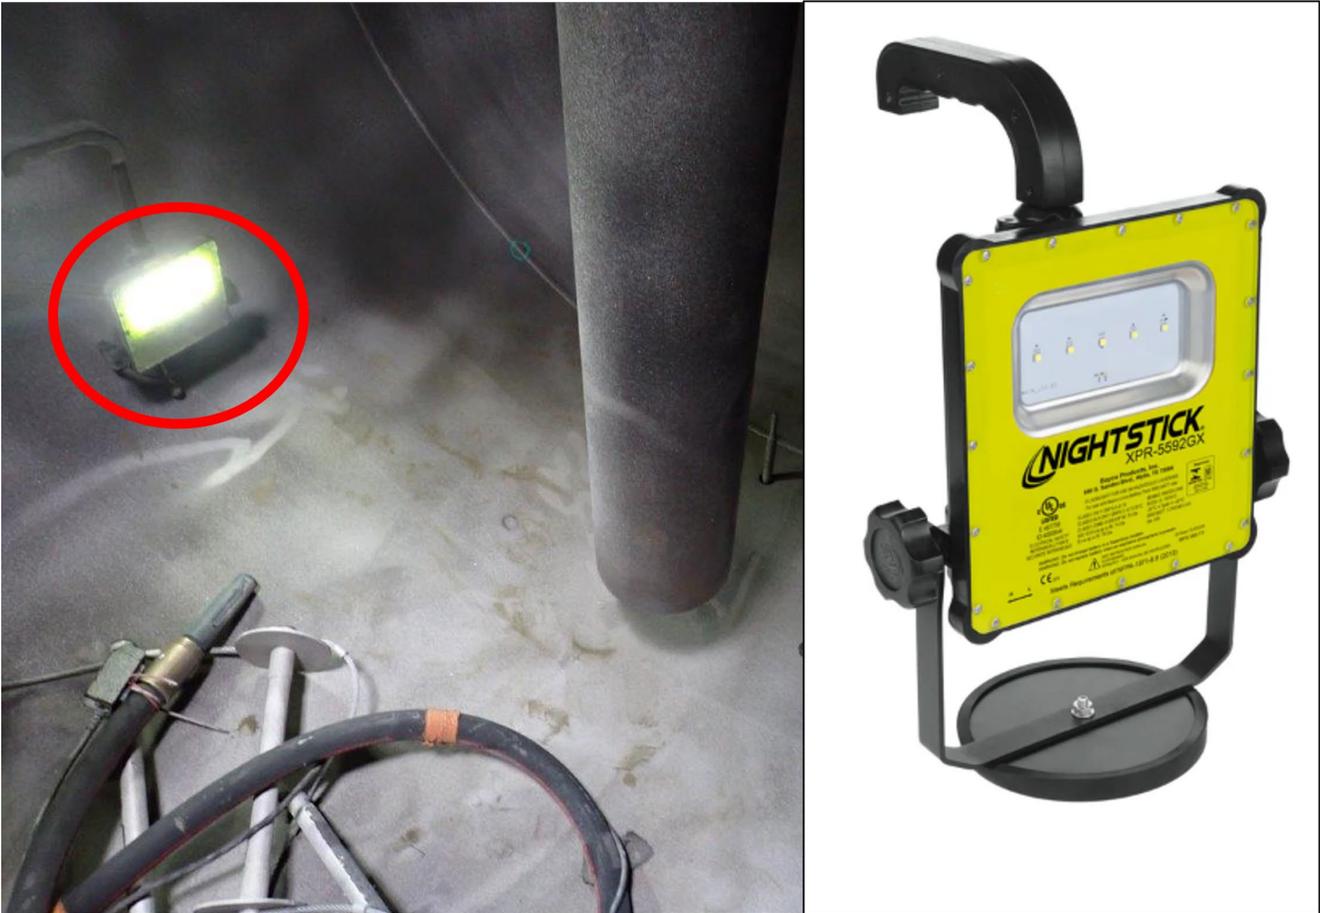
In May 2023, the Glycol II unit underwent a turnaround. One of the turnaround activities included cleaning out and performing an internal inspection of the reflux drum. The work order for this activity included tasks to “install low voltage lights” prior to the work beginning and “remove internal low voltage lights” after the work was completed inside of the reflux drum.^a According to the work order, these tasks were to be performed by contractor electricians and were executed under a confined space entry (CSE) permit. Portable work lights with magnetic bases were checked out during this turnaround, but five of these lights were never returned following the turnaround. **Figure 5** shows one of the portable work lights inside the reflux drum during the May 2023 turnaround.

Figure 5. Photo of the inside of the reflux drum during the May 2023 turnaround, with highlighted portable work light (Credit: Dow) and the portable work light, NightStick XPR-5592 (Credit: Bayco Products, Inc. [9])

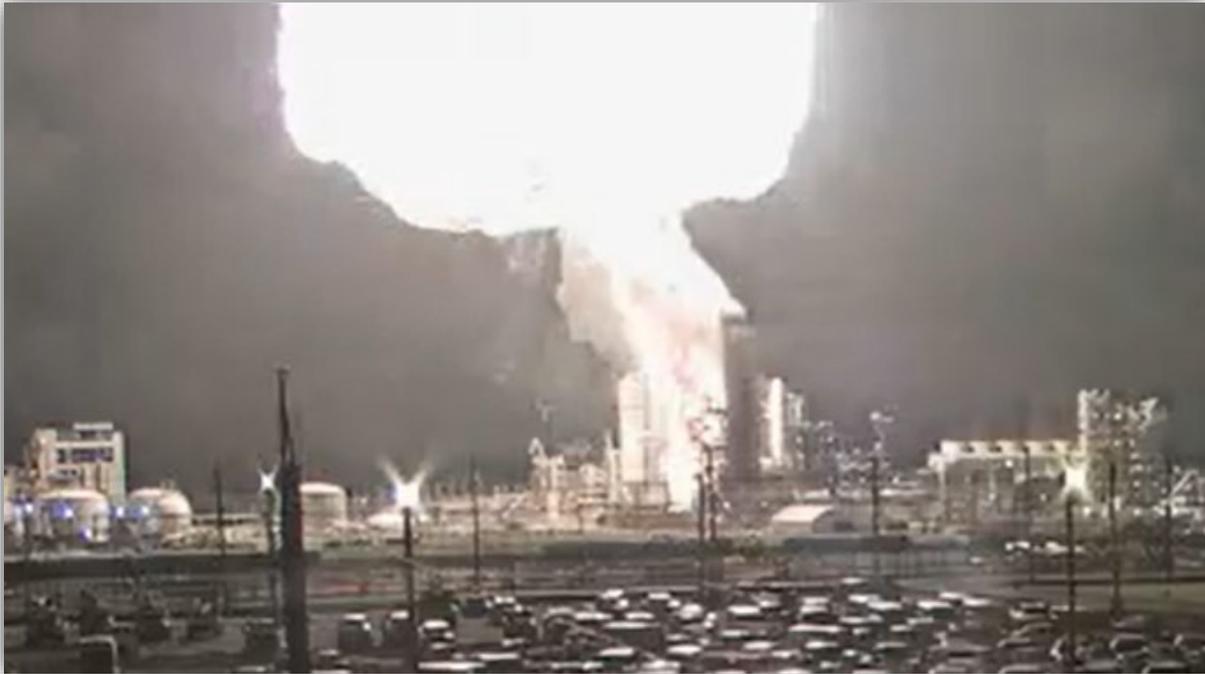
Figure 6. Surveillance footage of the explosion at approximately 9:17 p.m. (Credit: Dow)

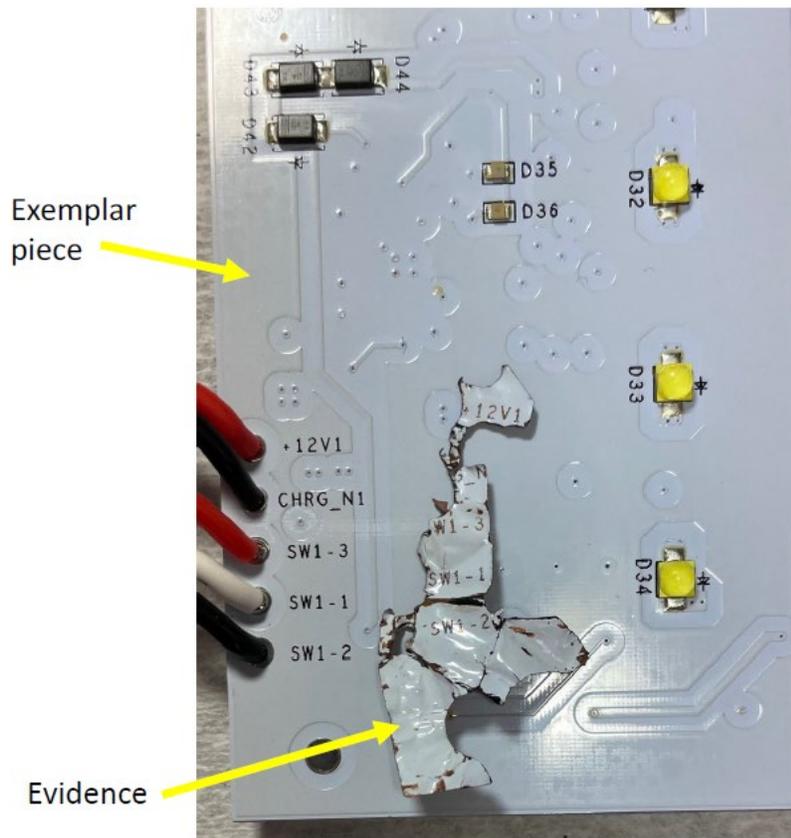
As shown in the figure above, the incident began when work lights were left in the reflux drum after maintenance work and the lights degraded when ethylene oxide was reintroduced to the drum. Following the incident, foreign material consistent with the work lights was discovered inside multiple pieces of equipment in the Glycol II unit. Multiple pieces of rubber and metal debris, including metal fragments, plastic pieces, and batteries, were discovered after the explosion in and around the reflux drum, inside the reflux pump, and in one of the product coolers' heads. The recovered debris from these areas is consistent with components of the portable work lights that were used in the reflux drum during the May 2023 turnaround. For instance, degraded circuit board pieces were found inside the product cooler, which were identical to exemplar pieces from other

portable work lights (**Figure 8**). The metal portions were also consistent with the metal found embedded in the failed rupture disc.

Figure 8. Metallic debris found with process equipment post-incident, along with portable work light exemplar circuit board (Source: Dow)

The presence of debris from the portable work lights in the reflux drum and in other downstream equipment indicates that at least three portable work lights used in the May 2023 turnaround were not removed from the reflux drum before returning it to service. The condition of some of the portable work lights' parts indicates that the reaction of the work lights with the pure ethylene oxide in the reflux drum likely caused the parts to deteriorate, breaking them into smaller pieces of debris.

The presence of debris from portable work lights in the reflux pump and the product cooler also indicates that some of this debris was carried from the reflux drum into process equipment further downstream. This debris likely caused the pump vibrations that occurred in the unit prior to the explosion, as the debris worked its way from the reflux drum through the pumps. As pieces of the work lights impacted the internal components of the pump, they likely caused the pump vibrations to increase, setting off the high-high vibration pump alarms.

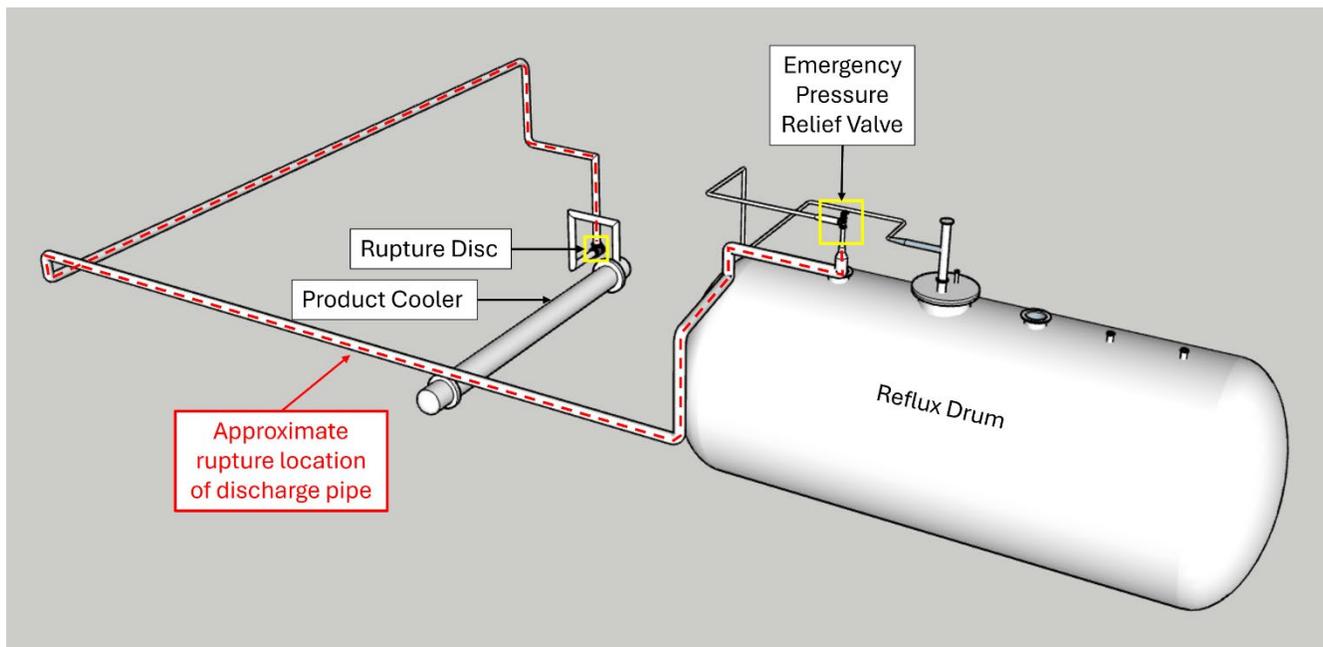
Figure 9. Schematic of product cooler and its emergency pressure-relief system components in relation to the reflux drum, with highlighted approximate location of the product cooler’s emergency pressure-relief rupture disc discharge piping rupture. (Credit: CSB)

The first mechanical failure in the chain of events leading to the fire and explosion was the failure of the product cooler rupture disc (shown in **Figure 9** above). This allowed the ethylene oxide to enter the pressure relief piping which contained air and ignite. After the incident, the rupture disc was tested and analyzed by Dow to understand its part in the incident. Initial inspection determined that the rupture disc had partially opened and would have allowed flow into the pressure relief piping (see **Figure 10**). The pressure transmitter located on the pressure relief piping system showed increased pressure immediately prior to the explosion, which indicates the rupture disc opened immediately before the reflux drum failed.

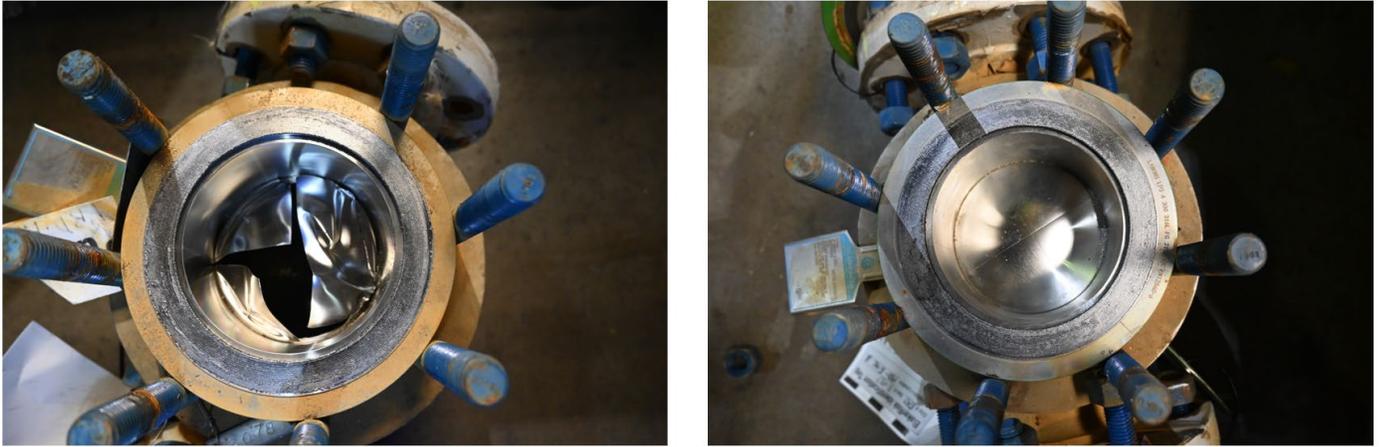
Figure 10. Damaged product cooler’s rupture disc (left), compared to an intact product cooler’s rupture disc which did not open during the incident^a (right), both photos post-incident. (Credit: Dow)

Metallurgical testing and post-incident analysis determined that the rupture disc did not fail in the designed and intended manner as it would in a regular overpressure event. Rupture discs are designed to open in the event of a pressure event in a symmetrical fashion and with minor deformation (**Figure 11**). A “normal” rupture disc opening would have all four portions of the rupture disc open in a symmetrical pattern. The asymmetry of the rupture disc involved in this incident indicates that it likely did not burst from a consistent pressure increase inside the product cooler, but opened through a different mechanism.

Post-incident metallurgical testing of the rupture disc identified small pieces of corroded carbon steel embedded in the rupture disc body. The presence of these small pieces of debris, together with the manner in which the rupture disc opened, indicates that a small hard piece of metal debris likely impacted the rupture disc, causing a hole in the surface of the rupture disc, which resulted in the partial opening of the disc. As the rupture disc was designed for liquid ethylene oxide service and was not intended to withstand metal debris, it most likely failed below the design burst pressure.

The corroded carbon steel embedded in the rupture disc was the same material as some of the work light debris found in the reflux drum and product cooler, indicating that the metal embedded in the rupture disc likely came from portable work lights that were inadvertently left in the reflux drum after the May 2023 turnaround.

The CSB concludes that the product cooler rupture disc opened in a non-intended manner below its burst pressure and allowed ethylene oxide to reach the pressure relief piping due to impact from metal debris.

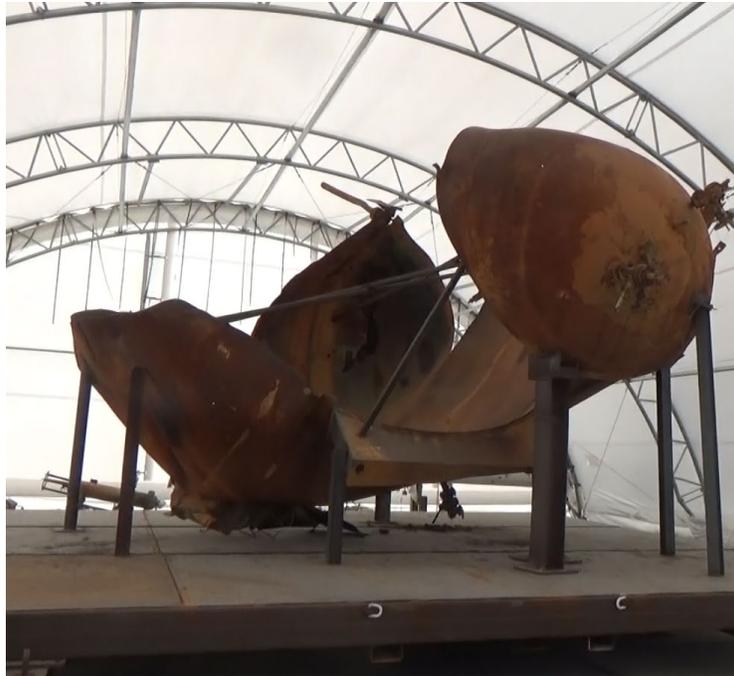
When the ethylene oxide and associated combustion gas flame front reached the reflux drum, which contained liquid and vapor ethylene oxide, it caused the ethylene oxide within the drum to heat and begin to decompose, and the pressure quickly rose faster than it could be relieved, causing the reflux drum to fail catastrophically (**Figure 12**).

Figure 12. Reflux Drum, post-incident.^a (Credit: CSB)

The CSB concludes that the ethylene oxide ignited within the pressure relief piping and propagated toward the PRV, which lifted, and the hot ethylene oxide and combustion products then initiated a reaction in the vapor phase of the reflux drum, causing the drum to overpressure catastrophically.

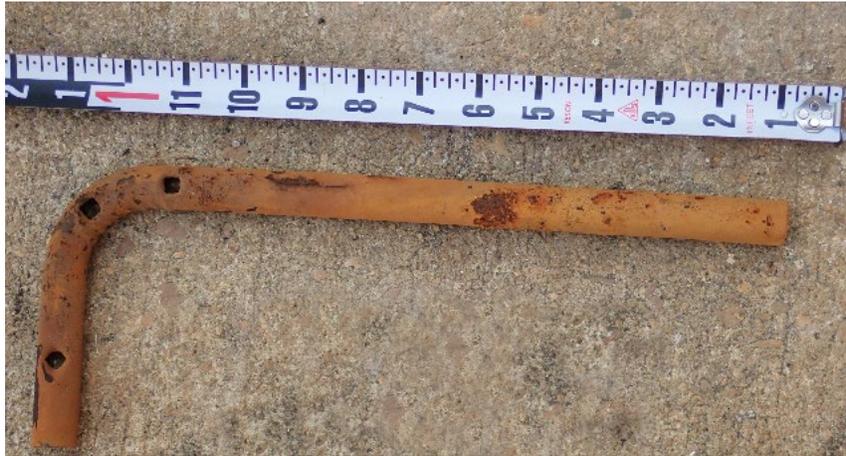
Figure 13. Debris from a portable work light found in the reflux drum post incident with scale showing inches (Source: Dow edited by CSB)

As discussed in Section 3.1, portable work lights were left in the reflux drum after the May 2023 turnaround work in the drum had concluded. Debris consistent with the work lights was found in the reflux drum, the downstream pumps, the product cooler, and the rupture disc after the incident (**Figure 13**).

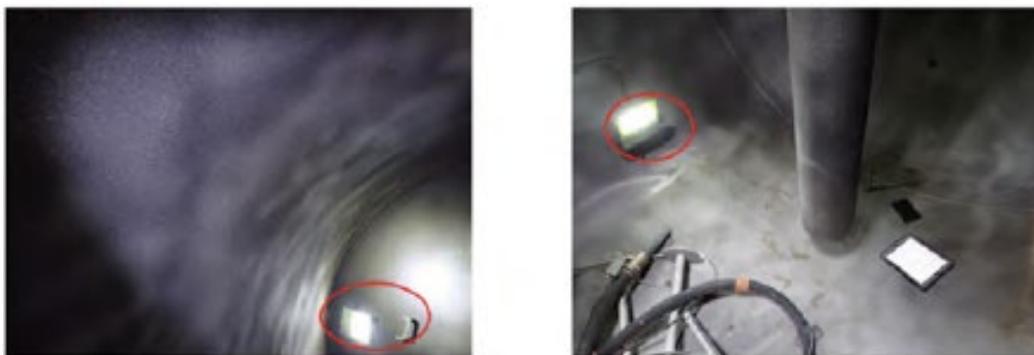
The work done inside the reflux drum during the May 2023 turnaround constituted multiple confined space entries into the vessel. Dow required that all confined space entries “have adequate lighting” present, and the work lights were placed in the drum to meet this requirement during the turnaround. Light installation was the first step of the work order for the reflux drum after it was safe for entry and a ladder was installed inside. Removal of the lights was also the last step in the work order prior to signing the vessel closure form and sealing the reflux drum back up. **Figure 14** shows the work lights in the reflux drum during the turnaround.

Figure 14. Portable work lights within the reflux drum during the turnaround (Source: Dow)

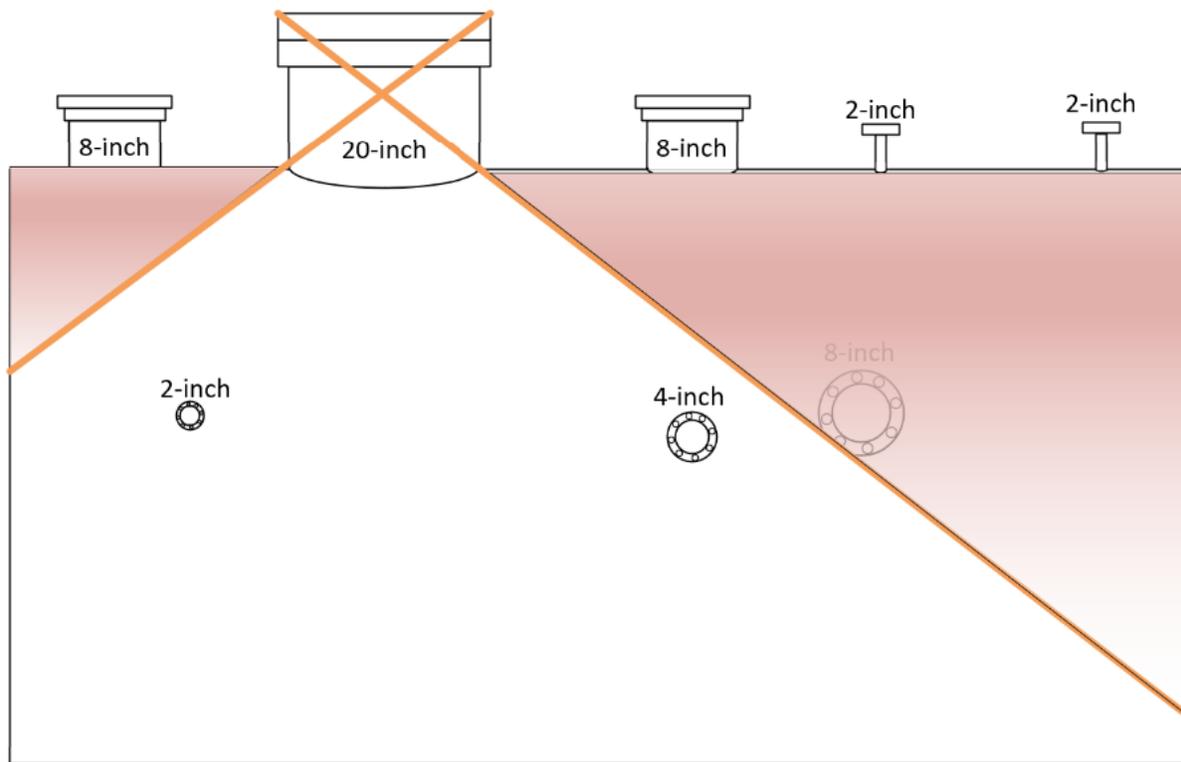
Figure 16 below shows the limitations of performing a last check visually from the largest manway of the reflux drum. As shown by the shaded areas of the reflux drum, the operator likely would not have been able to visually inspect a large portion of the vessel. The portable work lights used in the reflux drum were magnetic and could be attached to the side of the vessel. If the lights were turned off and stuck to the wall, it is unlikely that a visual inspection from the manway would identify any lights left behind, no matter how thoroughly the operator looked through the manway. This is especially the case since Dow did not require the operator to use an inspection mirror or other inspection device.

Dow's vessel closure procedure did not provide adequate steps to ensure that tools, equipment, and debris were not left behind. As a result, there was no adequate process in place to prevent the work lights from remaining behind in the reflux drum.

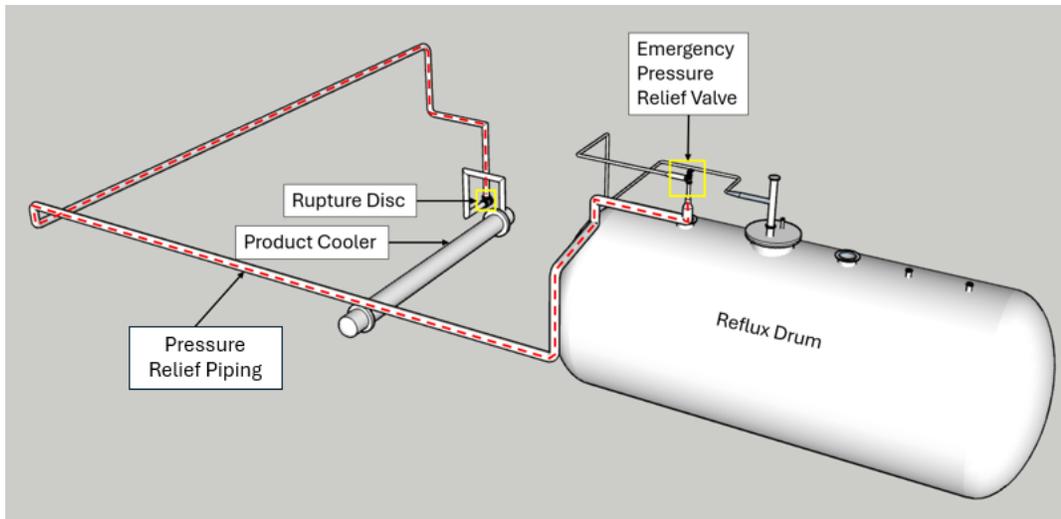
At Dow’s LAO Plaquemine facility, nitrogen is generally used as the inerting gas to prevent the ignition or decomposition of ethylene oxide. The Glycol II unit at the facility has a nitrogen system used for purging, inerting, and pressure control utilizing nitrogen supplied to the site by an industrial gas supplier. At the facility, nitrogen is one of the primary safeguards to ensure any large vessel with large quantities of ethylene oxide that contained a vapor phase, such as in the final product storage drums, would not react or combust in the vapor space. The reflux drum vapor space is kept inerted through a nitrogen “blanket” which is controlled by a control system and pressure is maintained by continually pumping nitrogen into the reflux drum from a plant nitrogen header through the discharge of the product cooler PRV. Leading up to the incident, no nitrogen was continually supplied to the piping between the rupture disc and the product cooler PRV (shown in **Figure 17** as the piping with the dotted red line), however. Instead, nitrogen would be manually charged into this piping segment whenever the pressure relief piping was opened for maintenance or inspection, and no procedure required regular charging of nitrogen.

Figure 17. Pressure relief piping between the product cooler and the reflux drum. The dotted red line shows the portion of the pressure relief piping that was not kept inerted when the incident occurred (Credit: CSB)

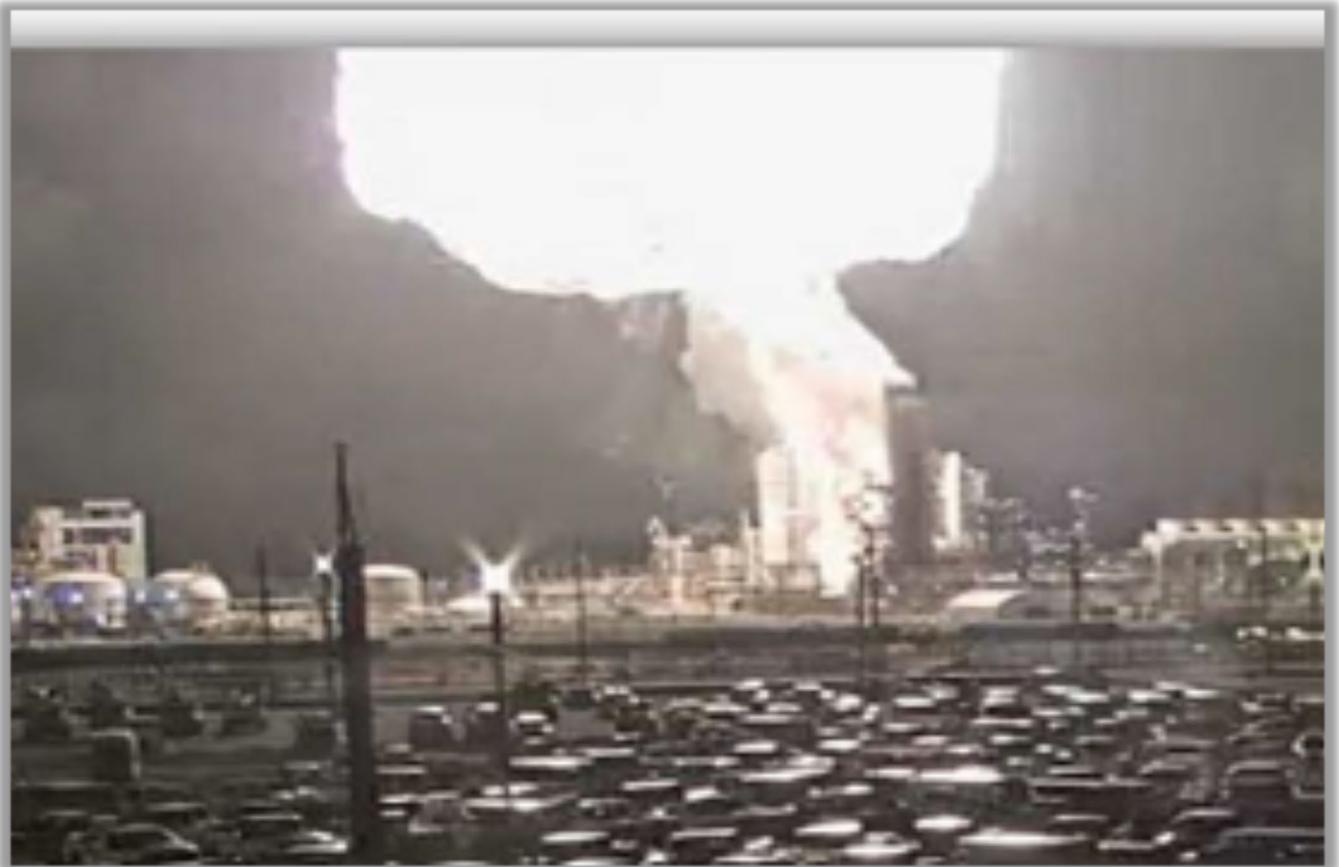
After the ethylene oxide ignited within the pressure relief piping, the flame front built pressure as it propagated toward the PRV and the reflux drum. When this flame front reached the reflux drum, it heated and ignited the large quantity of ethylene oxide present in the drum, which decomposed and significantly increased the severity of the incident when the reflux drum exploded (**Figure 20**). This was possible because the pressure relief piping from the product cooler vented to the reflux drum.

Figure 20. Explosion when the reflux drum catastrophically failed (Source: Dow)
