### August 2018

On April 26, 2018, an explosion (Figure 1) and subsequent fire (Figure 2) occurred at the Superior Refinery Company LLC refinery in Superior, Wisconsin (“Husky Superior Refinery”).<sup>1</sup> The incident occurred in the refinery’s Fluid Catalytic Cracking Unit (FCCU). In preparation for the shutdown, the refinery brought in hundreds of contractors and increased operations staffing. The contractors were performing many tasks such as electrical work, preparing for chemical cleaning, building scaffolding, and welding. As a result of the explosion, thirty-six people sought medical attention, including eleven refinery and contract workers who suffered OSHA recordable injuries. In addition, a large portion of Superior,<sup>2</sup> Wisconsin was evacuated.

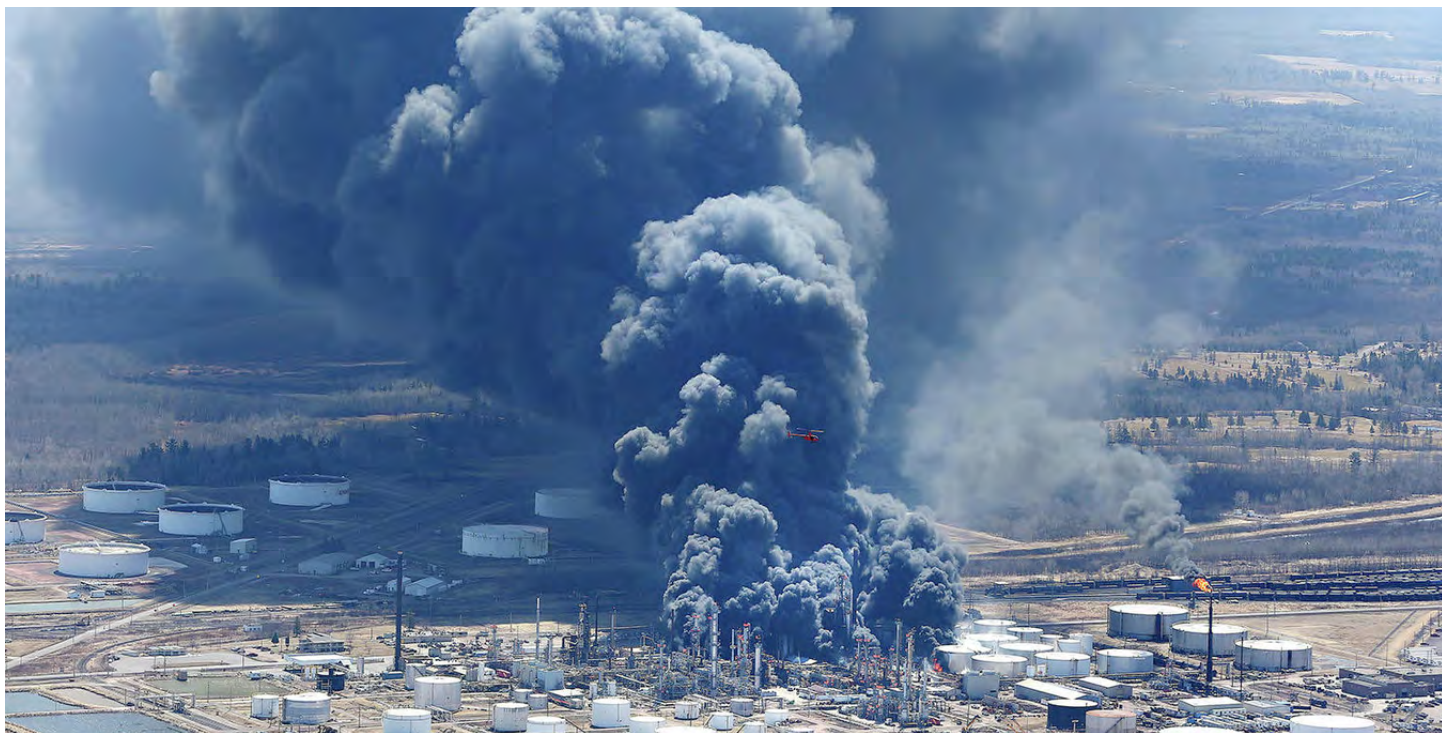
**Figure 2.** Smoke from the Fire at the Husky Superior Refinery. Credit: WDIO ABC News.

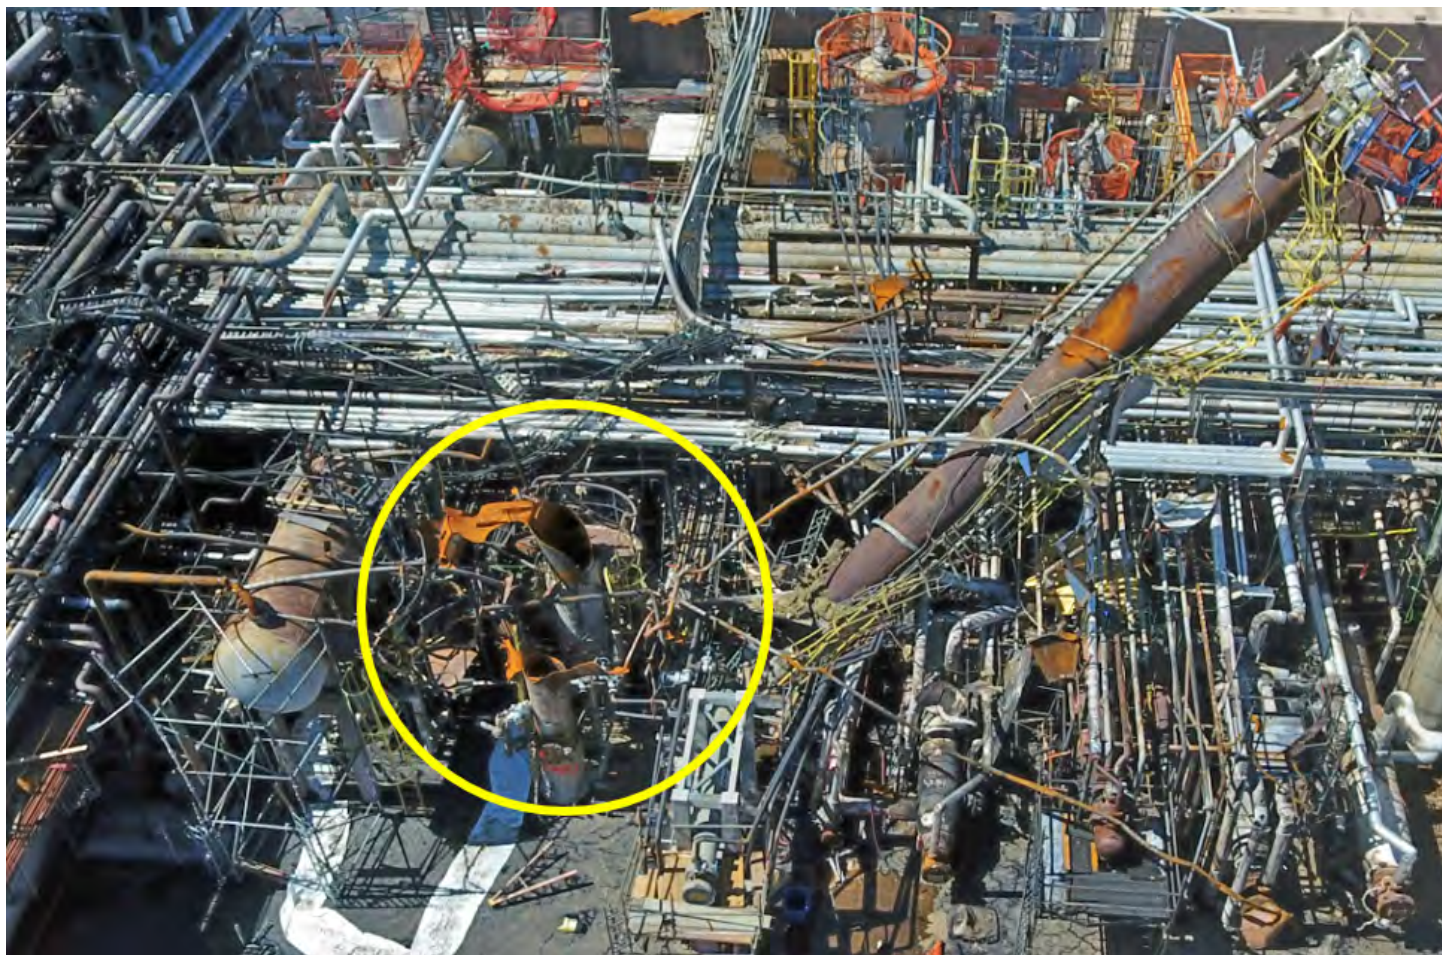
**Figure 3.** Two of the Vessels Destroyed in the Explosion at the Husky Superior Refinery (yellow circle). The photo shows that only the bottom portion of the two process vessels remained after the explosion. The remaining portions of the vessels were blown into surrounding units of the refinery. Credit: Husky Superior Refinery.

it will ignite spontaneously when exposed to air.” The Husky Superior Refinery planned to treat its FCCU equipment susceptible to containing iron sulfide with a chemical to mitigate iron sulfide deposits after shutting down the unit. Because these procedures had not been implemented at the time of the explosion, however, iron sulfide deposits were not yet treated and could provide a source of ignition if exposed to air.

Two FCCU vessels,<sup>6</sup> the primary absorber<sup>7</sup> and sponge absorber<sup>8</sup>

7 The dimensions of the primary absorber were 36 inches (internal diameter) by 69.5 feet tall. The vessel had a maximum allowable working pressure of 250 pounds per square inch at 150 °F. The primary absorber was constructed in 1961 using SA-212-B steel and the vessel was not stress relieved.

8 The dimensions of the sponge absorber were 30 inches (internal diameter) by 48 feet tall. The vessel had a maximum allowable working pressure of 250 pounds per square inch at 150 °F. The sponge absorber was constructed in 1961 using SA-201-A steel and the vessel was not stress relieved.

(Figure 3), were destroyed in the explosion. The primary and sponge absorbers serve to recover heavy hydrocarbons<sup>9</sup> from a gas stream by mixing the gas stream with a liquid stream that absorbs the heavy hydrocarbons.
