## Investigation Update

June 2024

This document provides an update on the CSB investigation of the July 14, 2023 incident at Plaquemine, Louisiana.

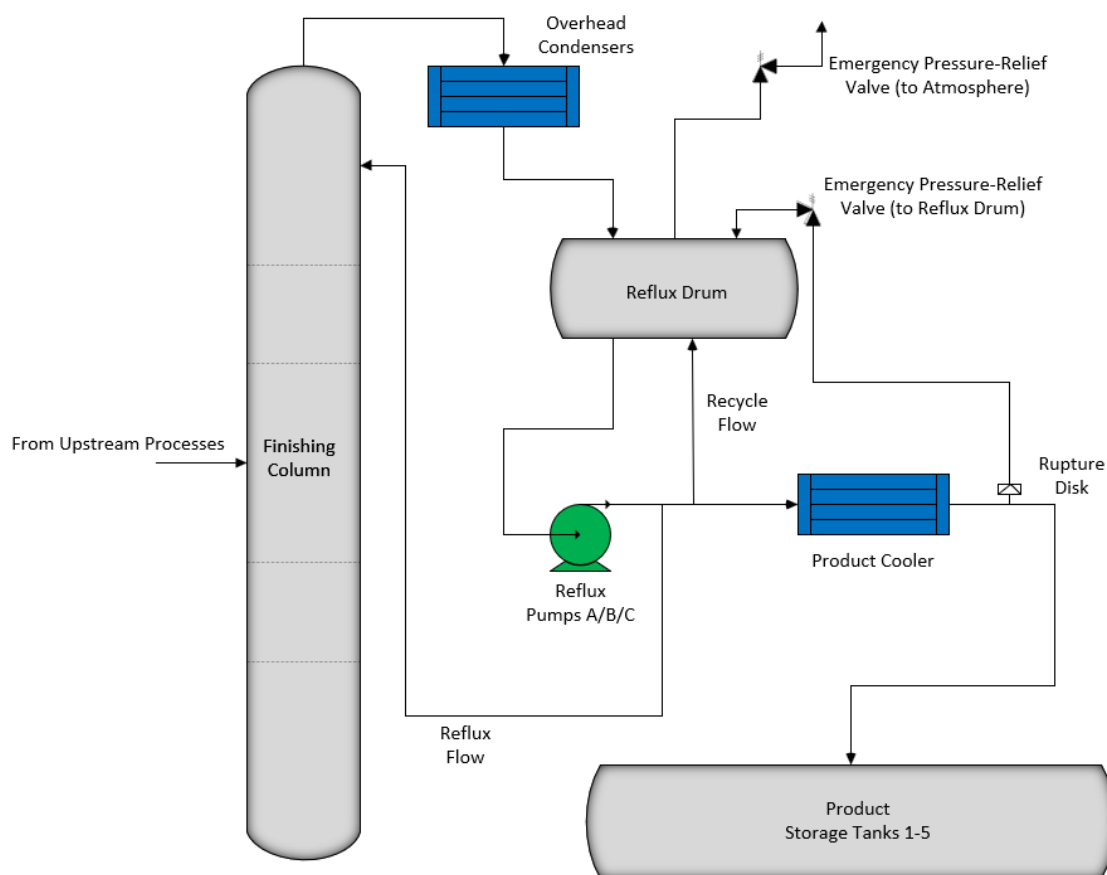
- In the EtO finishing operations section of the Glycol II plant, purified EtO flows from the top of a distillation tower, is condensed, and then sent to a reflux drum. The EtO in the reflux drum flows to multiple locations through its reflux pumps.<sup>a</sup> The EtO can be pumped back to the distillation column to be used as reflux, recycled back to the reflux drum, or sent to storage tanks as a final product. EtO flow to the storage tanks also includes pumping the EtO through a heat exchanger, called the product cooler. **Figure 1** provides a simplified graphical depiction of portions of the EtO finishing operations process related to this incident.

**Figure 1.** Simplified process flow diagram of the EtO Finishing Process. (Credit: CSB)

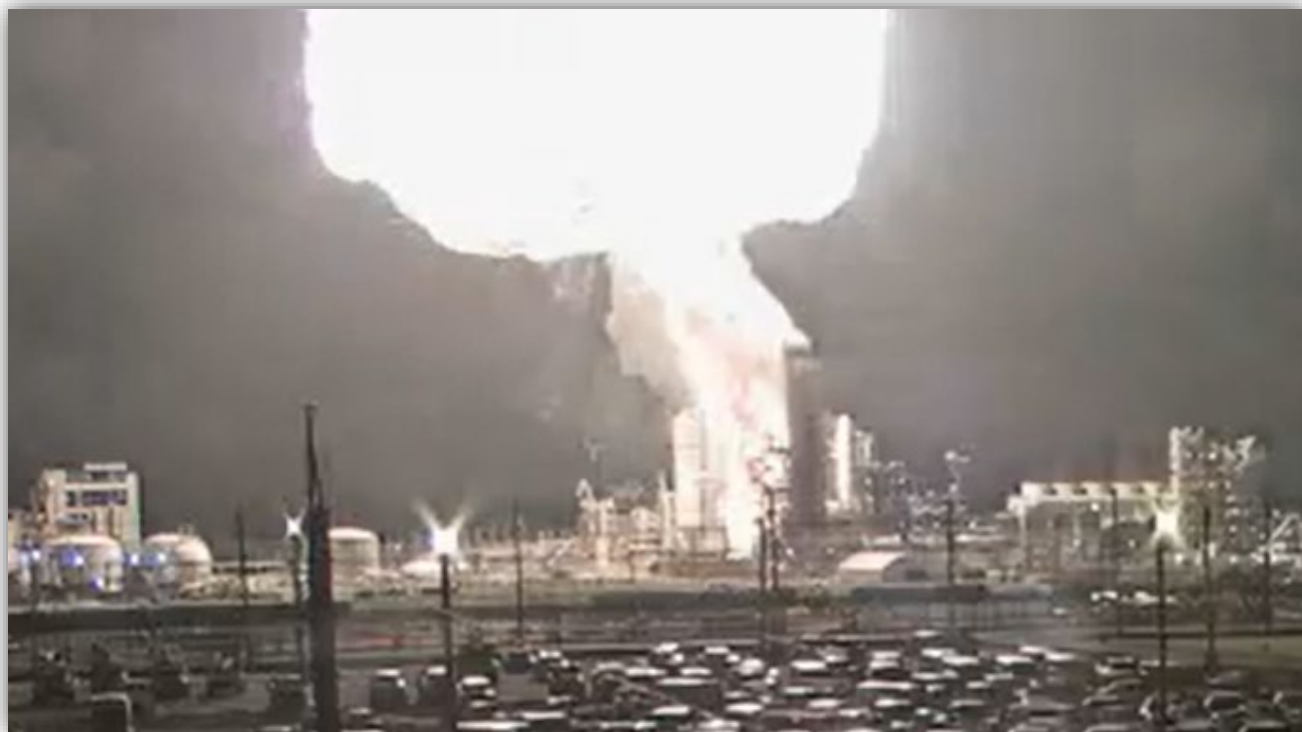
- At approximately 9:15 p.m., an explosion occurred in the vicinity of the reflux drum. Two Dow operators were working nearby, observed the explosion, and then quickly returned to the control room.

- Following the initial explosion, a fire developed near the reflux drum. Shortly after the initial explosion, the reflux drum, which was approximately half-full of liquid EtO, exploded. At the time of the incident, the reflux drum was equipped with an emergency pressure-relief valve, but the valve was unable to prevent the reflux drum from exploding.

**Figure 2.** Surveillance footage of the explosion at approximately 9:15 p.m. (Credit: Dow)
