Furnace Tube Rupture and Fire at Marathon Martinez Renewables Facility

Martinez, California | Incident Date: November 19, 2023 | No. 2024-01-I-CA

Investigation Update

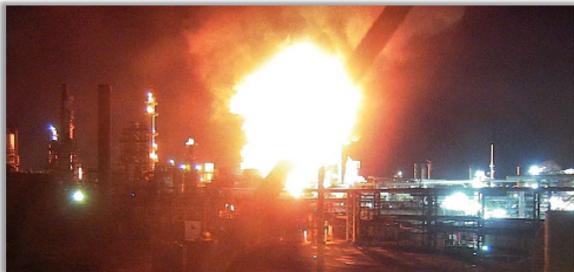
On November 19, 2023, at approximately 12:21 a.m., a metal tube ruptured within a reactor charge furnace during a unit startup at the Martinez Renewables facility in Martinez, California. The ruptured tube released renewable diesel and hydrogen, resulting in a fire that seriously injured one Marathon employee (Figure 1). This document provides an update on the ongoing CSB investigation of this incident.

Figure 1. Surveillance footage of furnace fire. (Credit: Marathon)

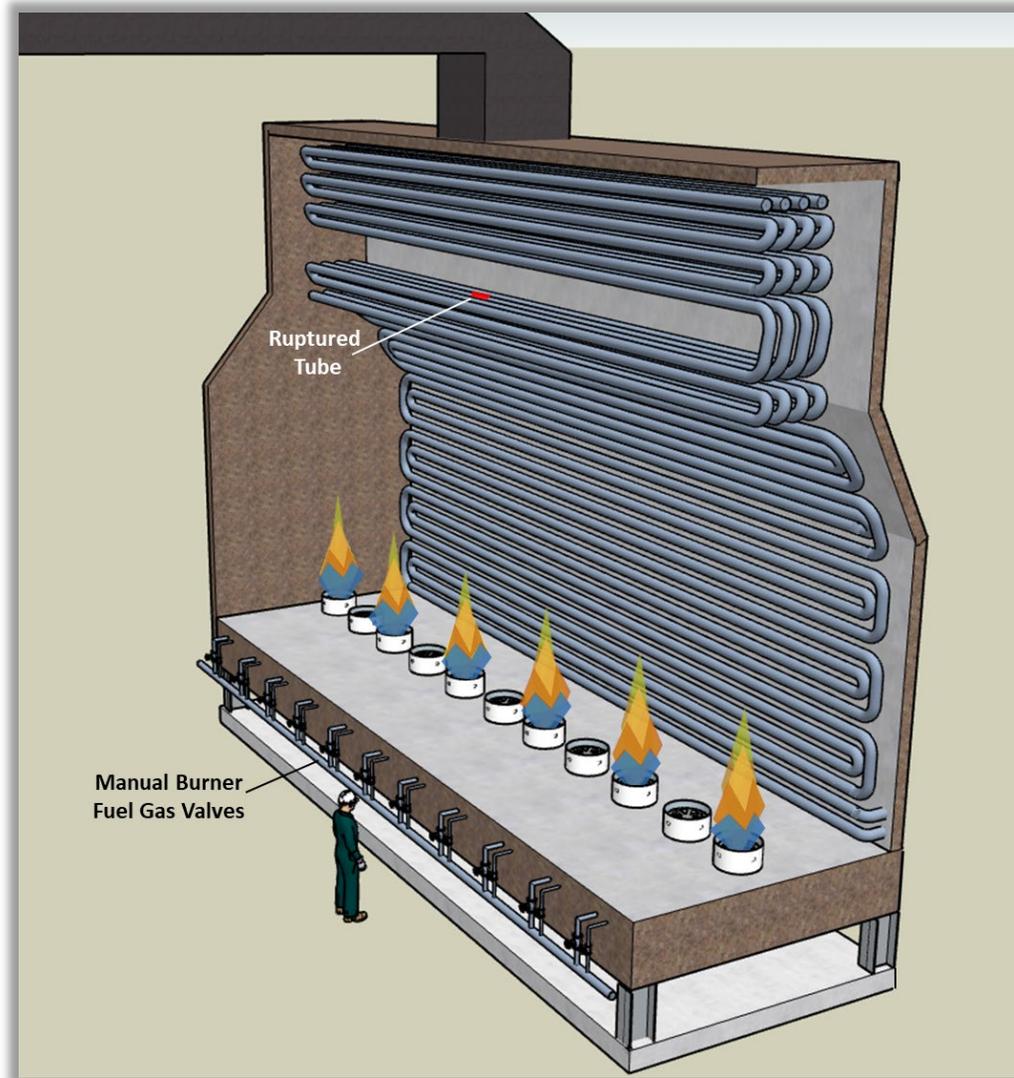
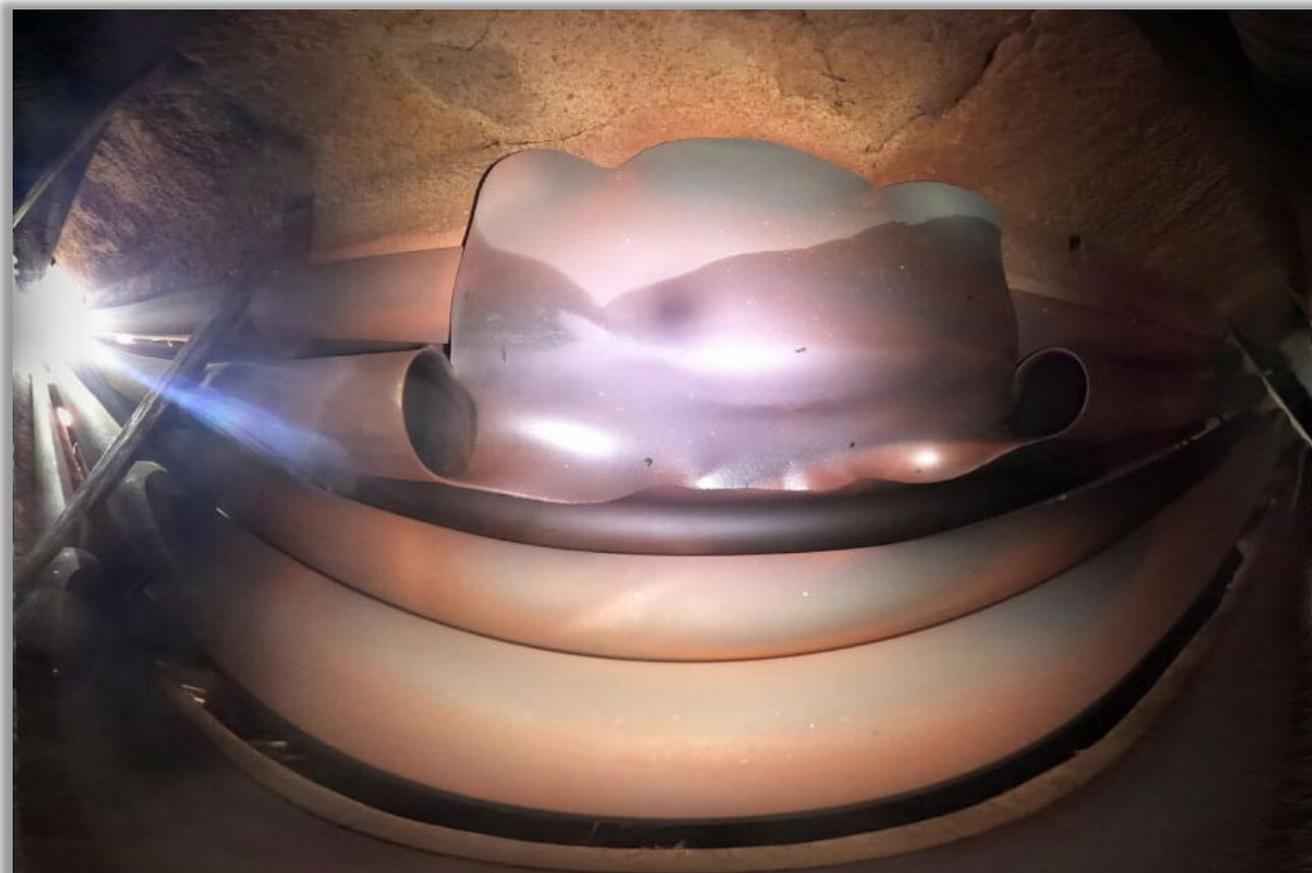
Furnace Tube Rupture

- November 19, 2023, 12:21 a.m.
- Furnace tube ruptured and fire erupted during a unit's initial startup
- Operator standing next to furnace seriously injured
- Renewables facility recently converted from petroleum refinery

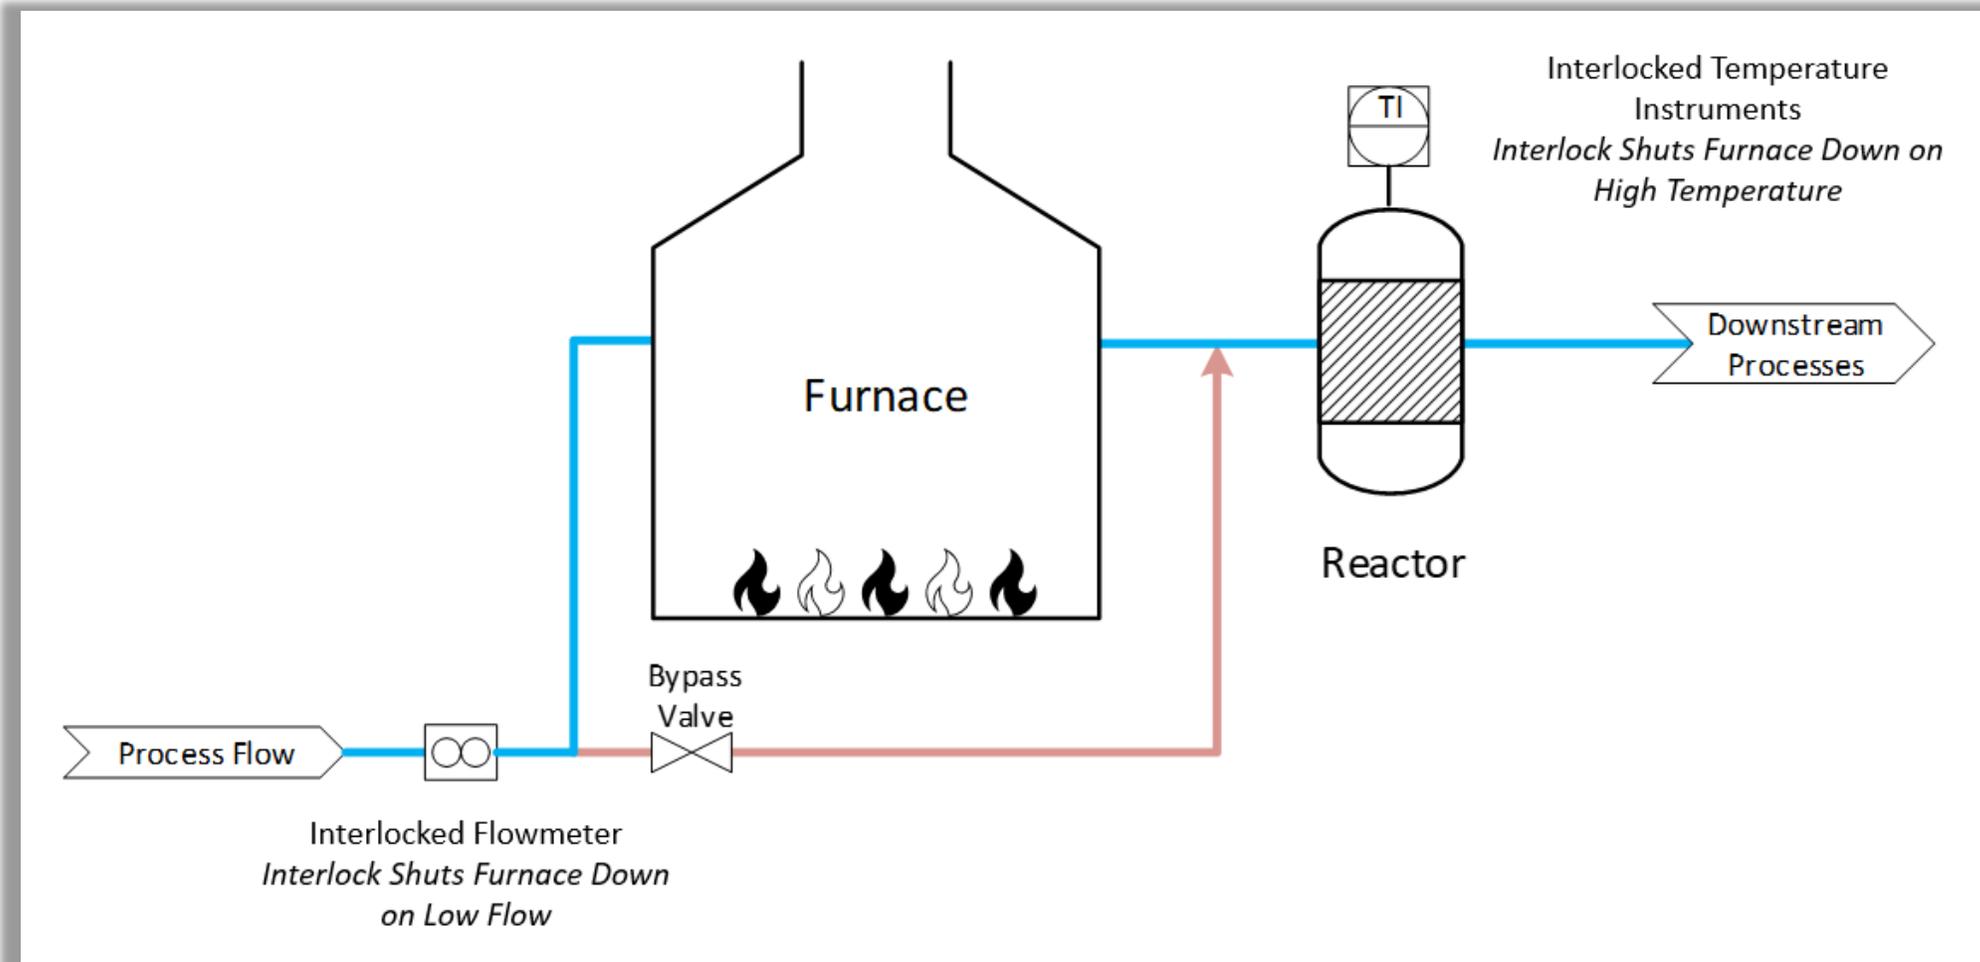
Simplified Process Overview

Post-incident, a normally closed manual bypass valve was found open, creating a potential flow path around the furnace.
