Report No. 5005.0005

**EXAMINATION OF A 0.75-INCH DIAMETER STAINLESS STEEL TUBE
COMPRESSION JOINT INVOLVED IN THE TESORO MARTINEZ ACID SPILL
THAT BURNED TWO WORKERS ON FEBRUARY 12, 2014**

Report To: U. S. Chemical Safety Board
Attn: Mark Wingard
P.O. Box 25465
Lakewood, CO 80205

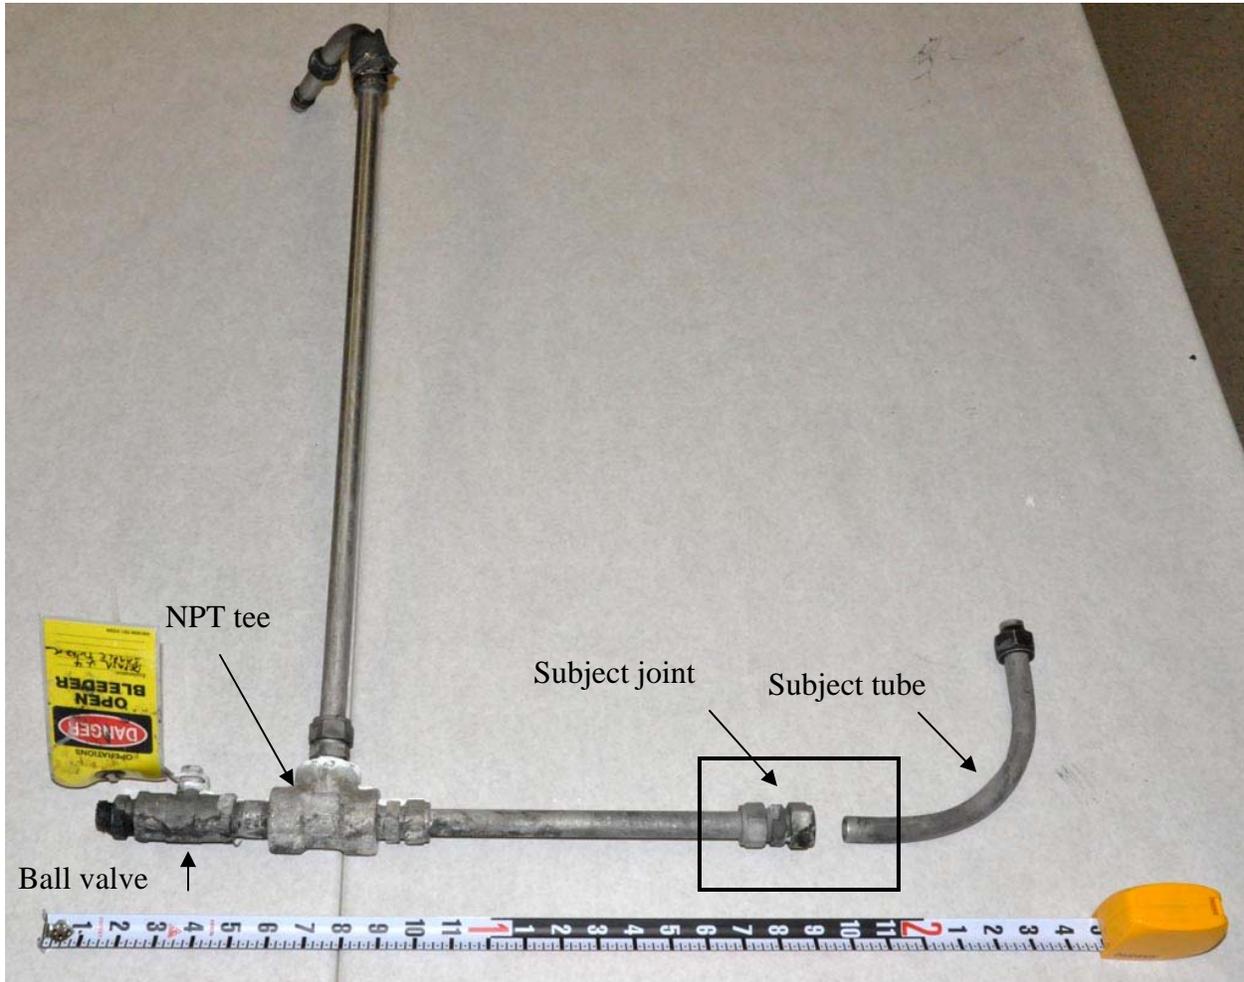
The subject is shown as-received in Figure 1 and Figure 2. The assembly consisted of several sections of 0.75-inch diameter tube joined by compression fittings, an NPT tee with NPT to compression fittings, and a ball valve joined to one side of the tee. White colored friable deposits were present on the subject, with the greatest accumulation on the tee. It was reported that the spill occurred at the compression union indicated by the boxed area in Figure 1, referred to in this report as the subject joint, and all of the following descriptions and observations relate

Figure 1 Tubing sub-assembly in the as-received condition. The boxed area indicates the subject joint.

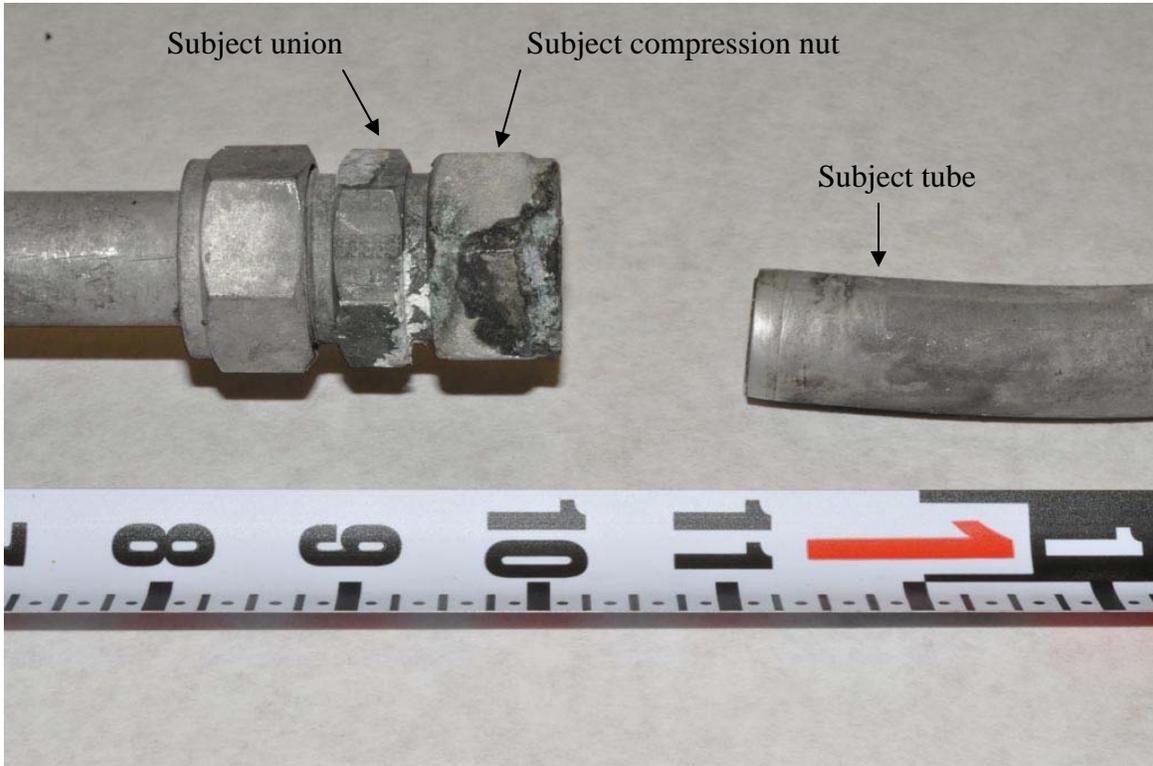
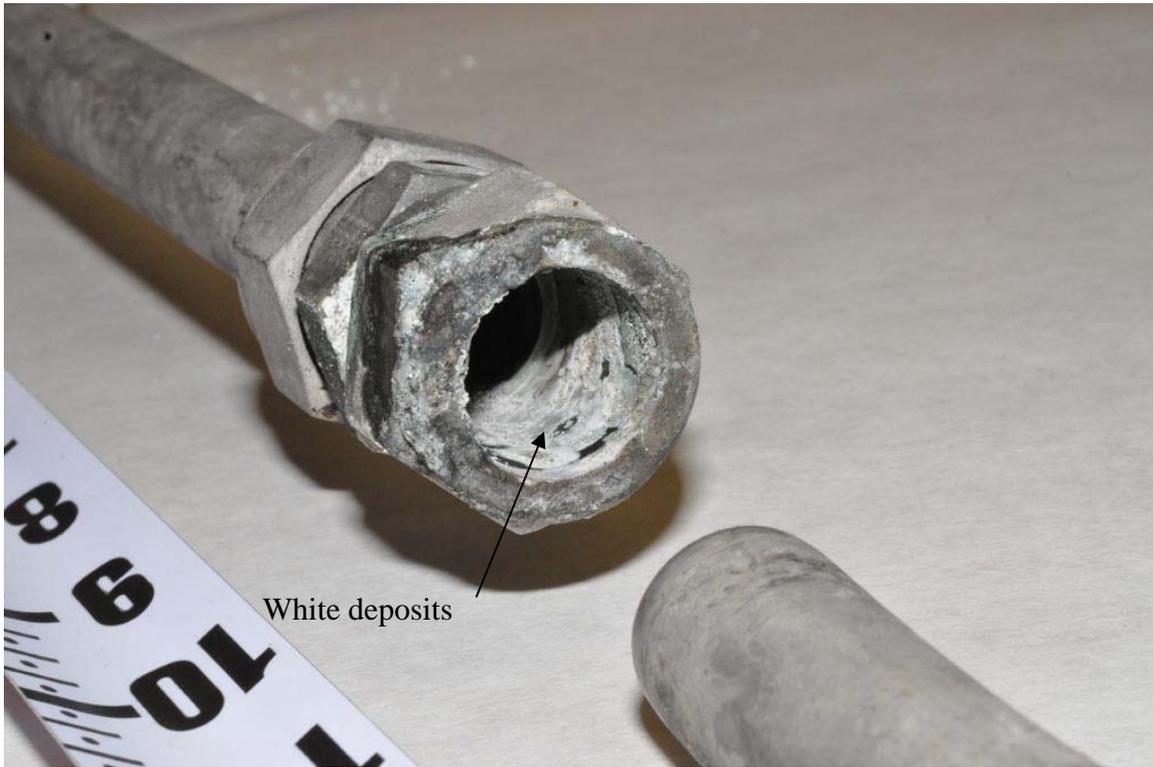
to the subject joint. Photographs of the subject joint in the as-received condition are shown in Figure 2. The end of the subject tube that had been connected by the union was relatively free of white deposits, and there was no evidence of fracture on the tube end, or parts of the subject tube remaining in the union. Consequently, the subject tube had pulled out of the union.

Figure 2 Two views of the subject joint in the as-received condition.

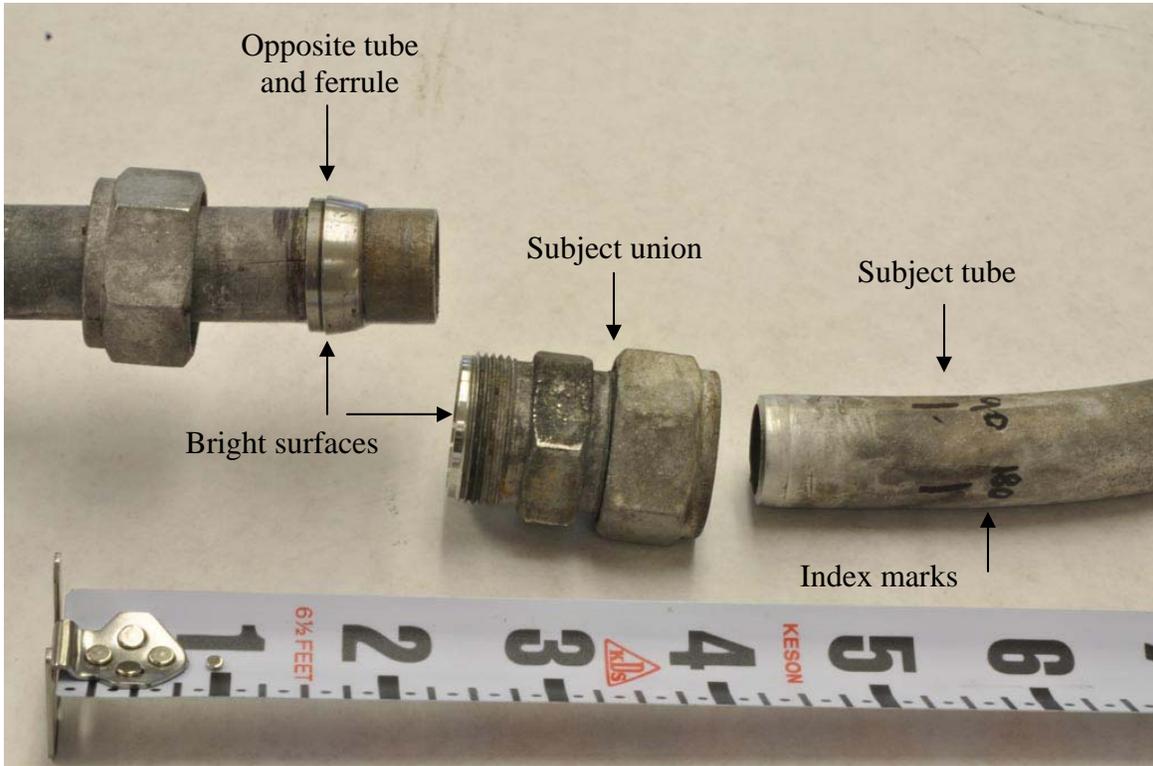
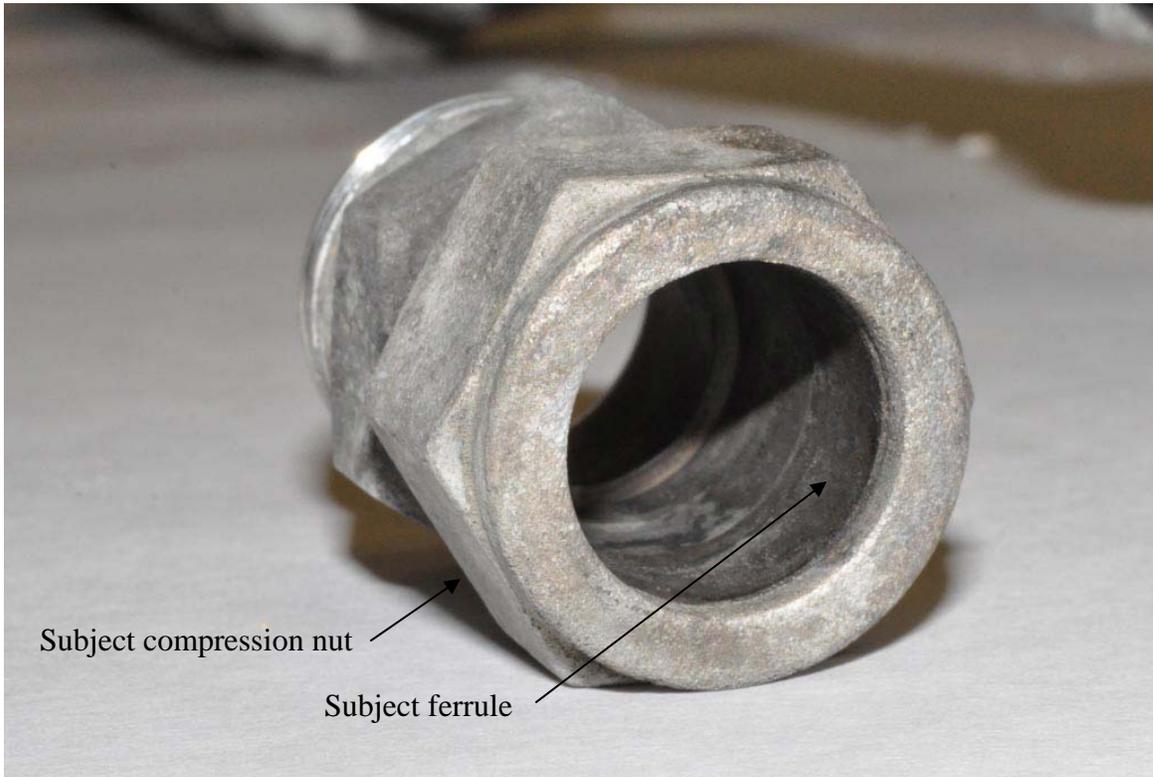
Wrenches were used to disconnect the subject union from the remainder of the assembly opposite the subject tube, and the compression nut was found to be tight. Surfaces of the opposite union and ferrule were bright, as shown in Figure 3a, consistent with a good connection. The union was rinsed in tap water, which readily removed the white deposits. As shown in Figure 3b, a ferrule was present in the union on the subject side. The subject compression nut was disconnected from the union, and the subject ferrule was found to have the correct orientation with respect to the union. A narrow band of bright metal on the outside surface of the ferrule and a similar band on the inside surface of the union, shown in Figure 4 and Figure 5a, indicated that there had been contact between the two sealing surfaces. No evidence of cracks or mechanical damage of the union, ferrule, or compression nut was detected.

Figure 3 Subject union with opposite compression nut and ferrule disconnected. Photographs taken after rinsing in tap water.

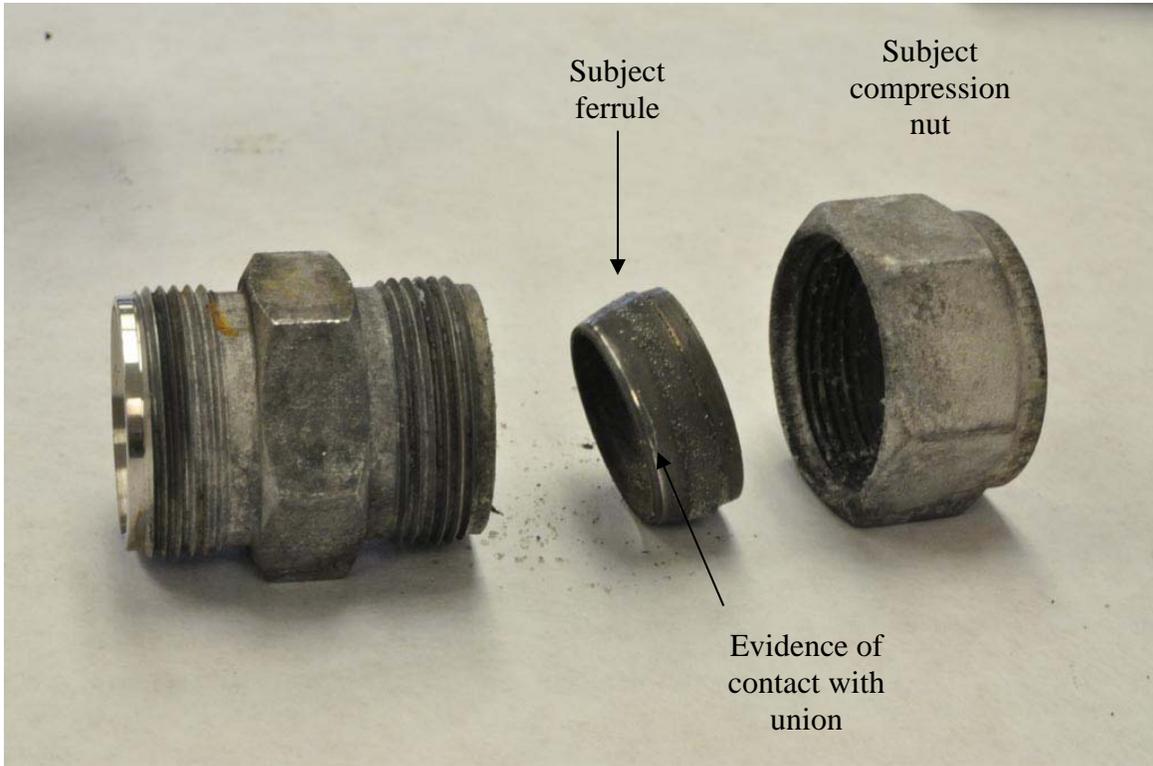
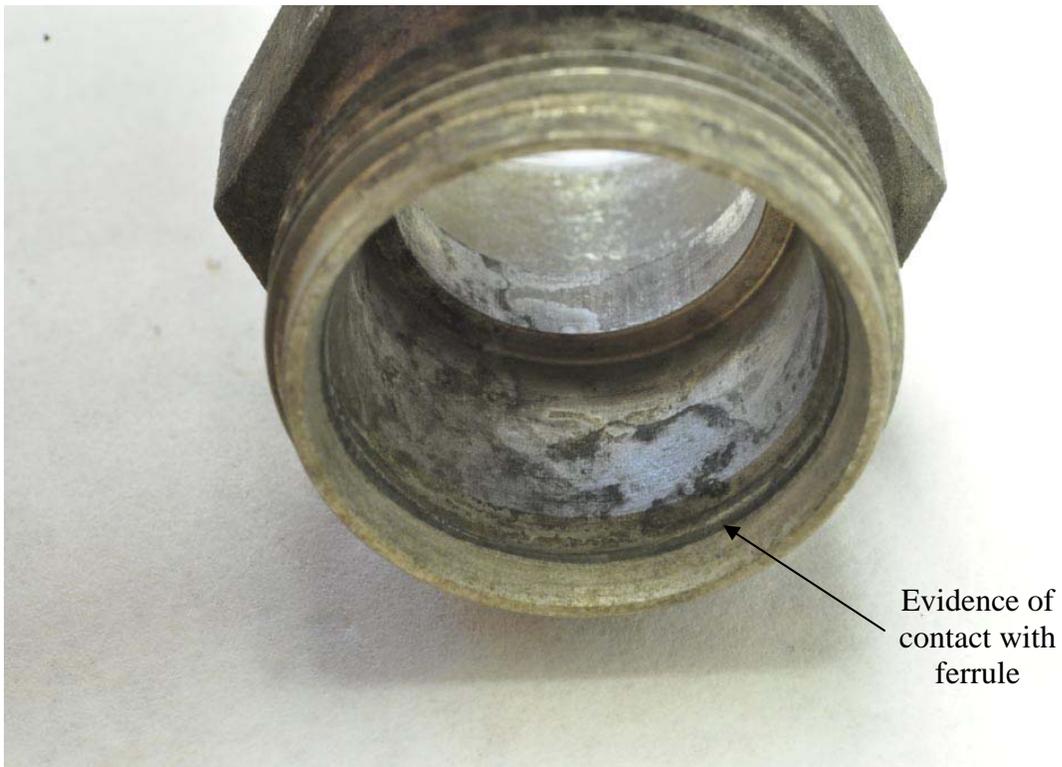
(b) Inside surface of union, subject joint side

Figure 4 Subject union, ferrule, and compression nut after disassembly.

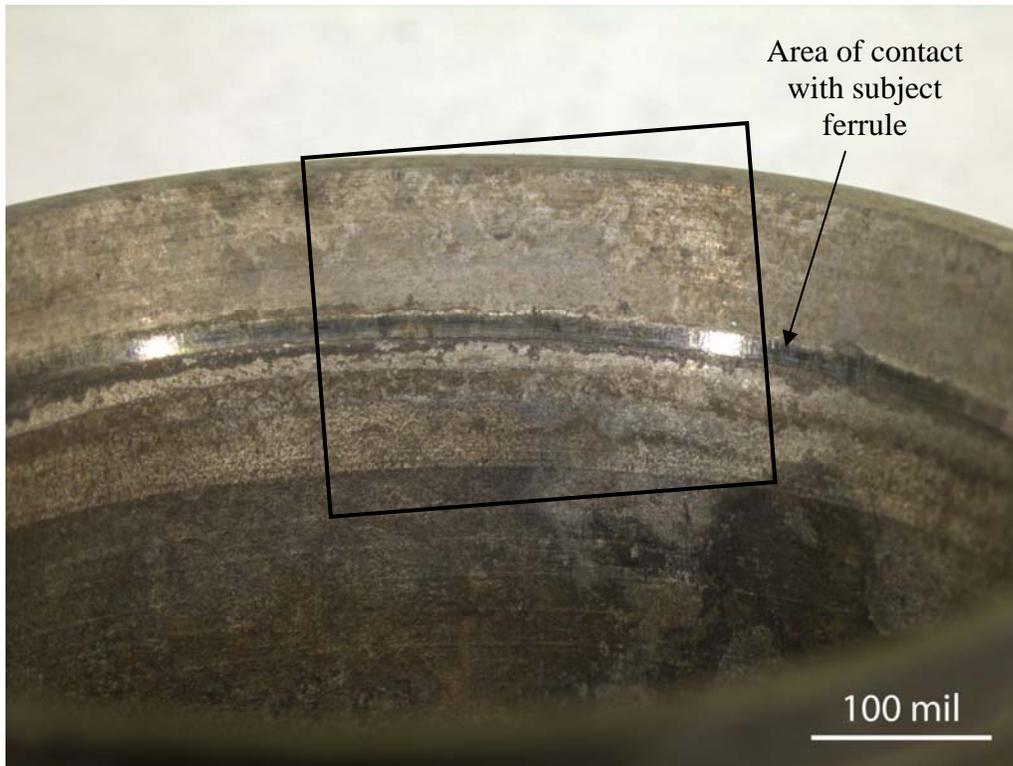
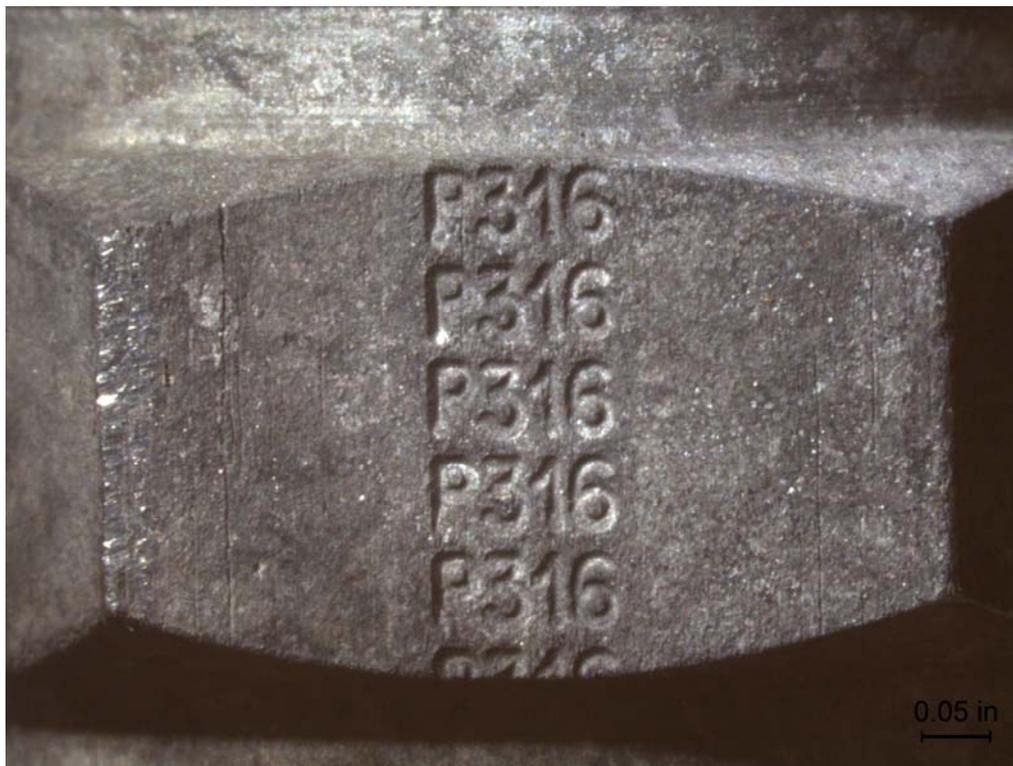
Small areas on the subject tube, ferrule, union, and compression nut were ground flat with 400-grit silicon carbide paper and analyzed by semi-quantitative EDS. The results, listed in Table 2, were consistent with Type 316 stainless steel. As shown in Figure 5b and Figure 6a, the union and ferrule were stamped P316, a common designation for Type 316 stainless steel.

(b) Stamped wrench flat

Figure 5 Macrographs of the subject union. The orientation shown in (a) is rotated 180 degrees from the orientation shown in Figure 4b.

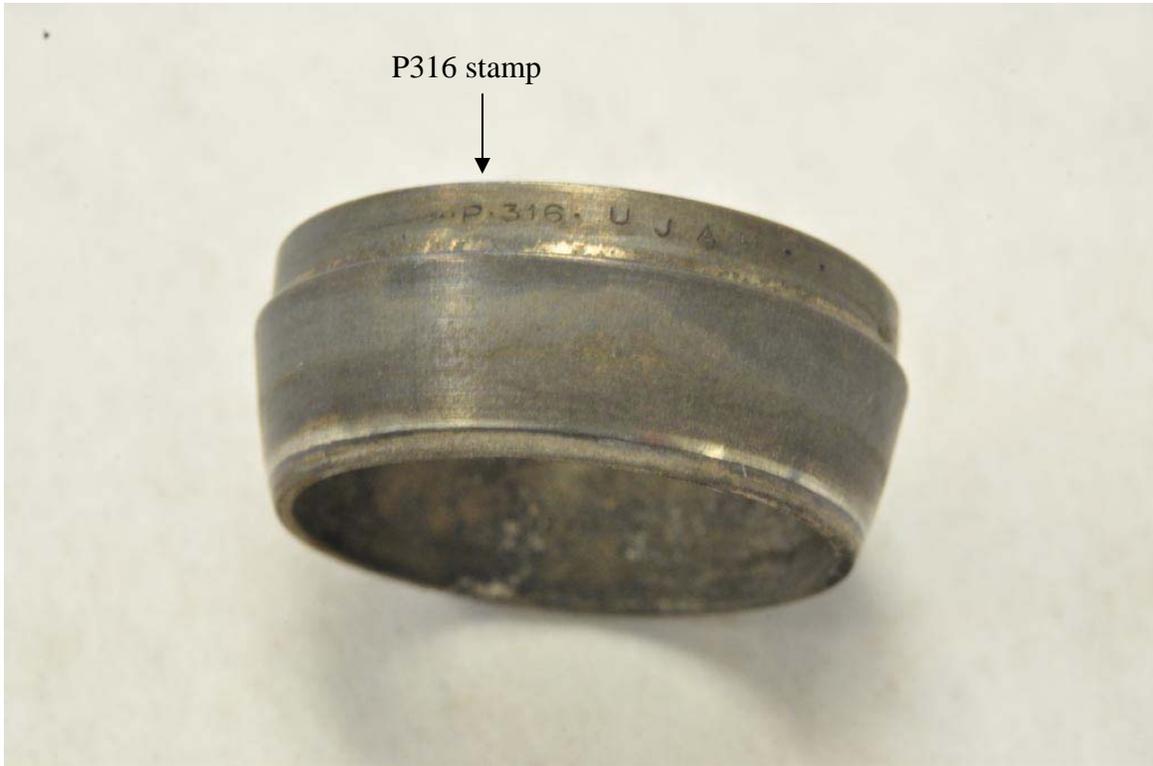
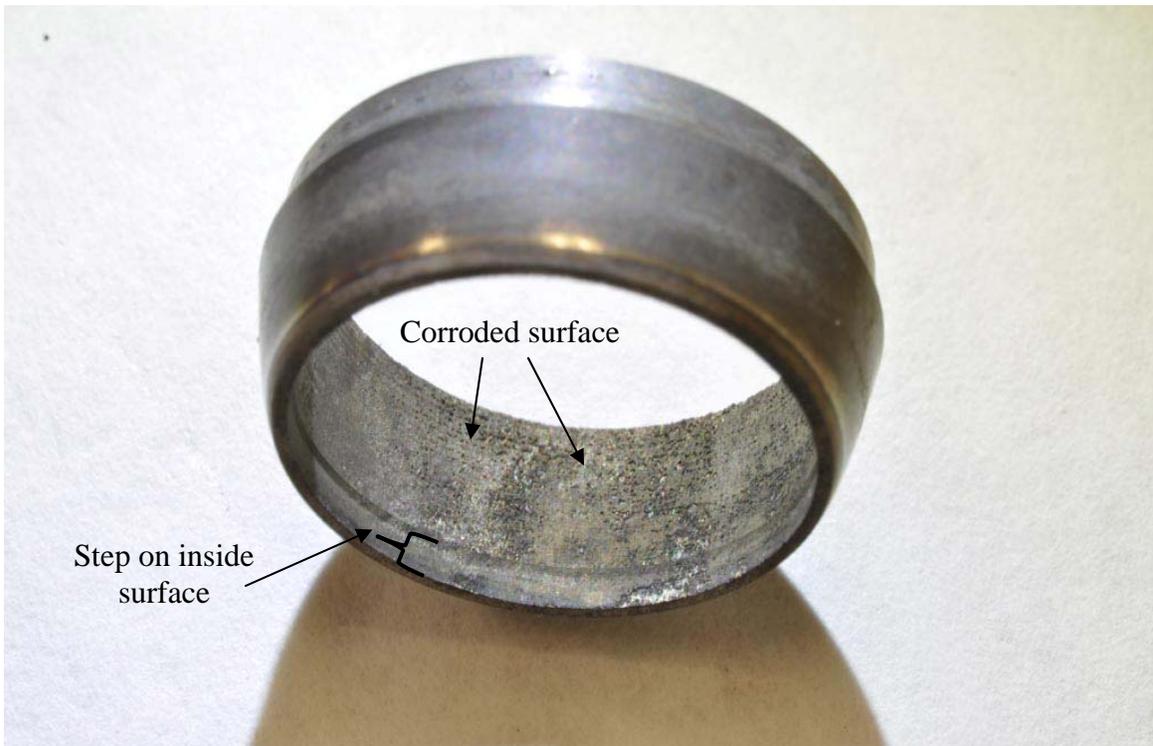
The subject ferrule is shown in Figure 6. The outside surface was covered with a smooth, greenish colored oxide layer, except for the bright area of contact noted previously. A step in the inside diameter of the ferrule was noted. Corrosion was evident on the inside surface of the ferrule, as shown in Figure 7.

Figure 6 Subject ferrule.

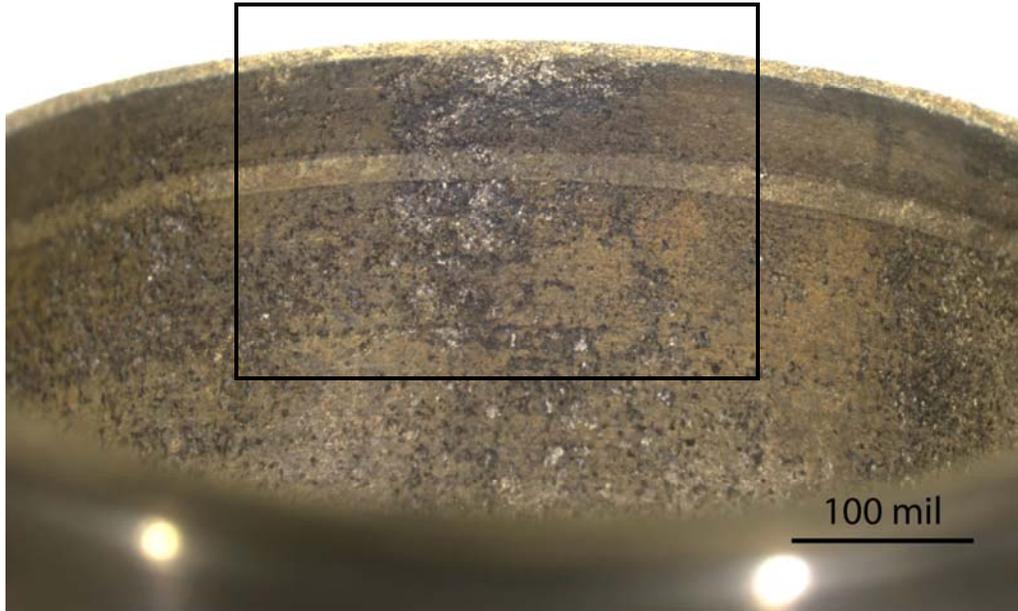
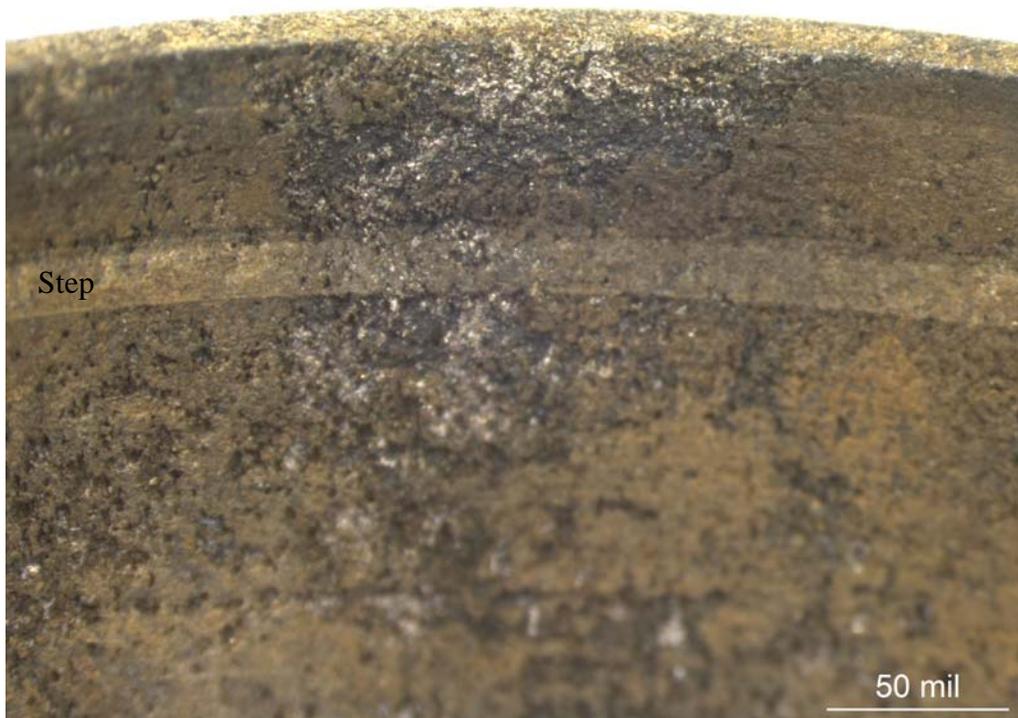
Figure 7 Macrograph and SEM micrographs of the subject ferrule inside surface. Note the step which slightly increases the inside diameter at the end of the ferrule.

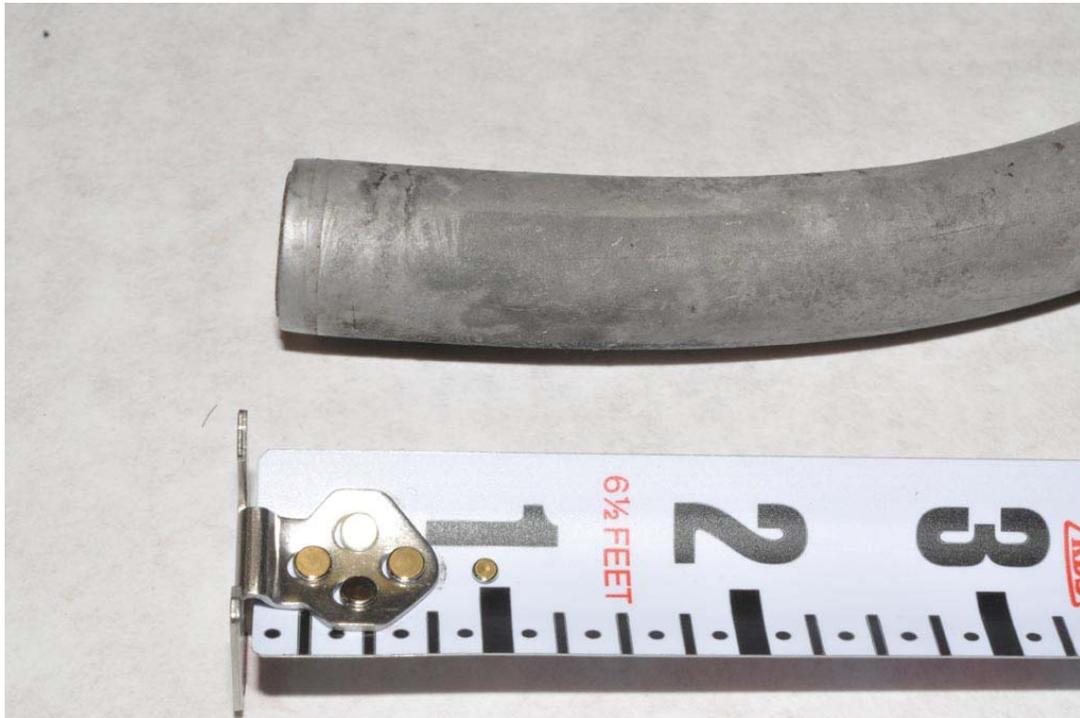
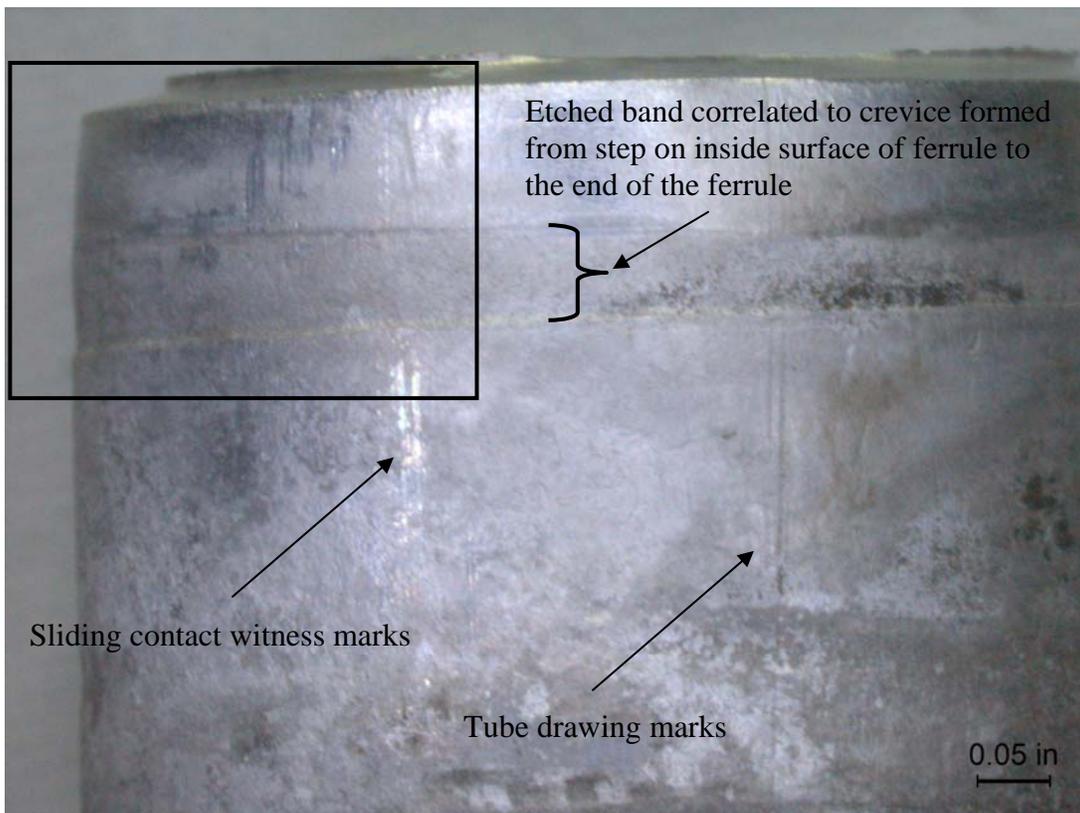
The end of the subject tube that had been inserted into the joint is shown in Figure 8. The end had geometry consistent with that formed by rotary tube cutters. In general, the outside surface of the tube had matte texture. Isolated, fine, longitudinal witness marks indicated axial sliding contact with the outside surface of the tube, consistent with pull out from the union. A circumferential band of etched metal, noted in Figure 8b, correlated to the step on the inside surface of the ferrule. The step likely formed a crevice and associated accelerated corrosion of the tube outside surface.

Figure 8 Subject tube end.

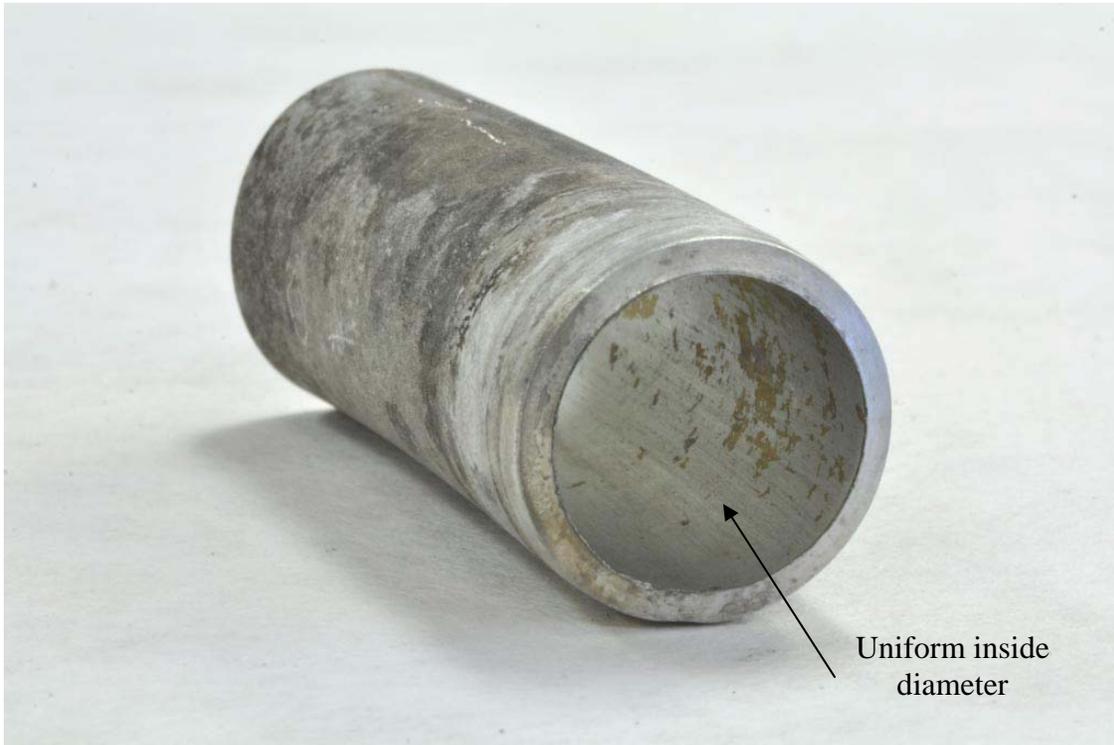
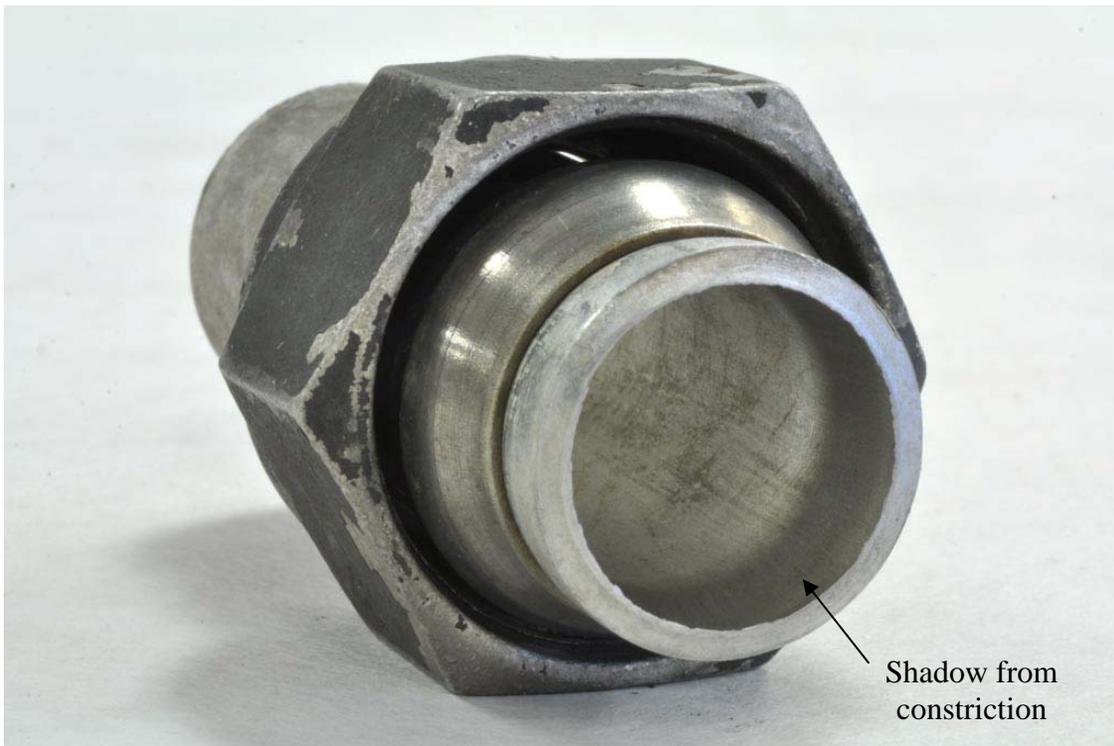
The subject tube was sectioned to remove the subject end and the opposite end. The inside diameter of the subject end was uniform from the cut face past the location of the compression nut. In contrast, the inside diameter of the opposite end was constricted in the vicinity of the ferrule, as shown in Figure 9. An exemplar tube assembly had been submitted for comparison to the subject. The inside diameter of the exemplar tube ends were constricted like the opposite end of the subject tube, as shown in Figure 10 and Figure 11. Inside diameters of the subject end, opposite end and exemplar tubes were measured using a snap gage and micrometer. The results are listed in Table 1. Lack of inside diameter constriction of the subject end indicated that the ferrule had not been completely crimped onto the tube.

The physical condition of the subject tube end indicates that the tube pulled out of the compression joint. Corrosion between the subject tube and the ferrule indicated a lack of physical seal, and absence of tube inside diameter constriction indicated insufficient clamping force between the tube and the ferrule. Evidence of contact between the subject ferrule and the mating surface of the union suggests that enough clamping force to prevent leakage and immediate failure of the joint may have existed when the assembly was placed in service. However, insufficient clamping force was generated to crimp the ferrule onto the tube and produce a constriction of the tube inside diameter. A poor seal between the subject ferrule and tube allowed corrosion between the ferrule and tubing surfaces within the subject joint.

Figure 9 Photographs of the subject tube ends. No constriction of the failed end of the subject tube (a) was visible, but constriction of the opposite end of the failed tube (b) was visible.

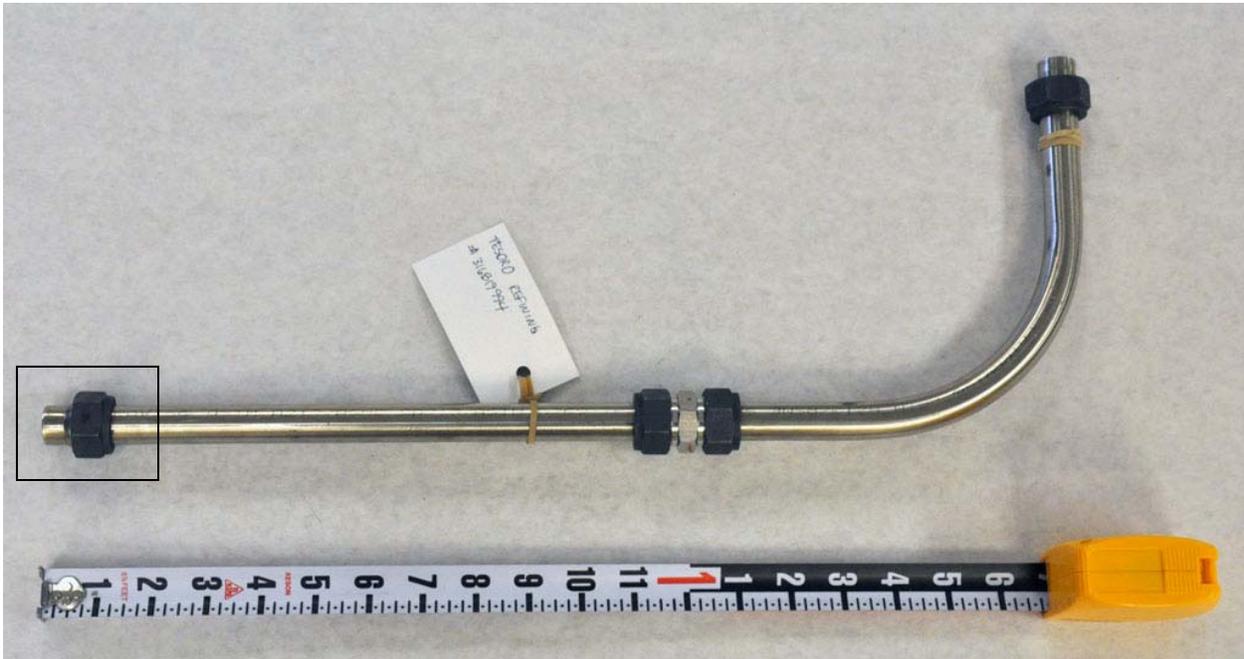
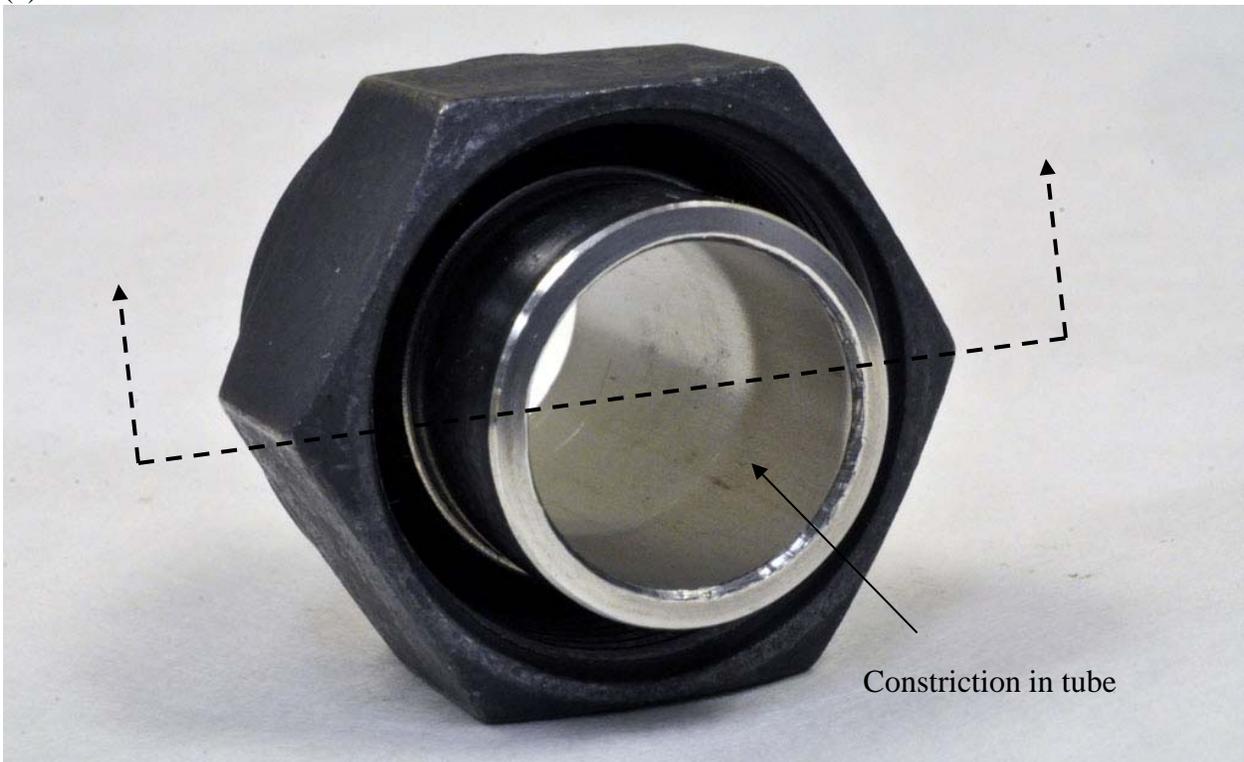
Figure 10 Photographs of the exemplar assembly. The dashed lines in (b) indicate an axial section prepared to show the tube constriction caused by clamping force between the nut and the ferrule.

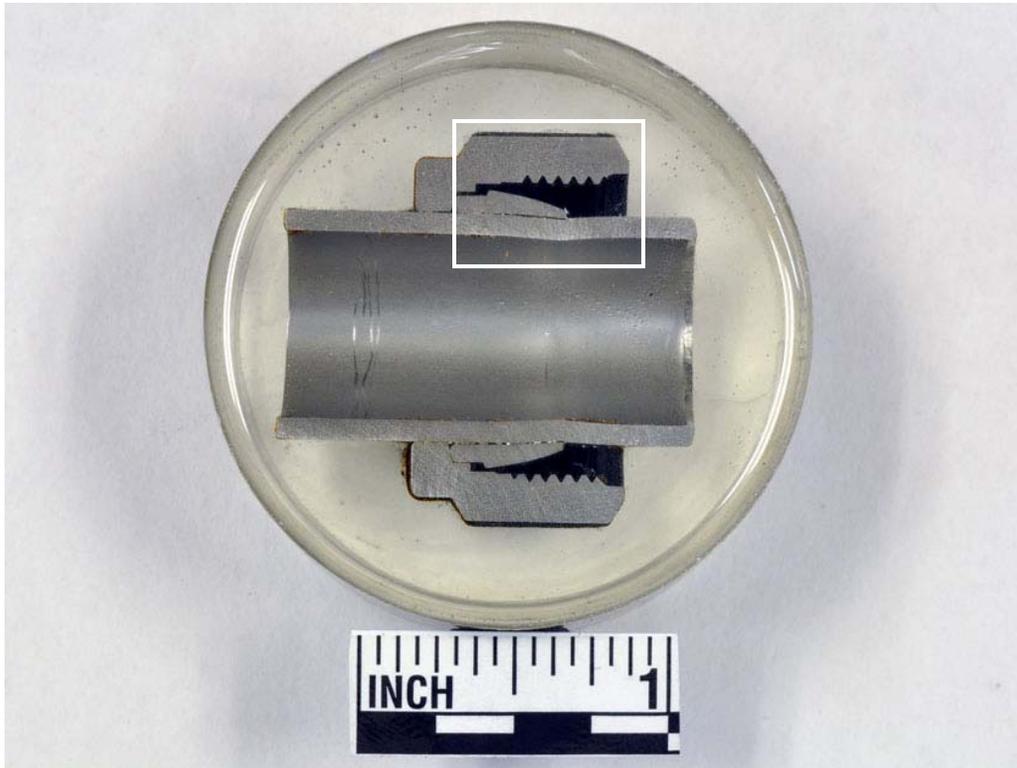
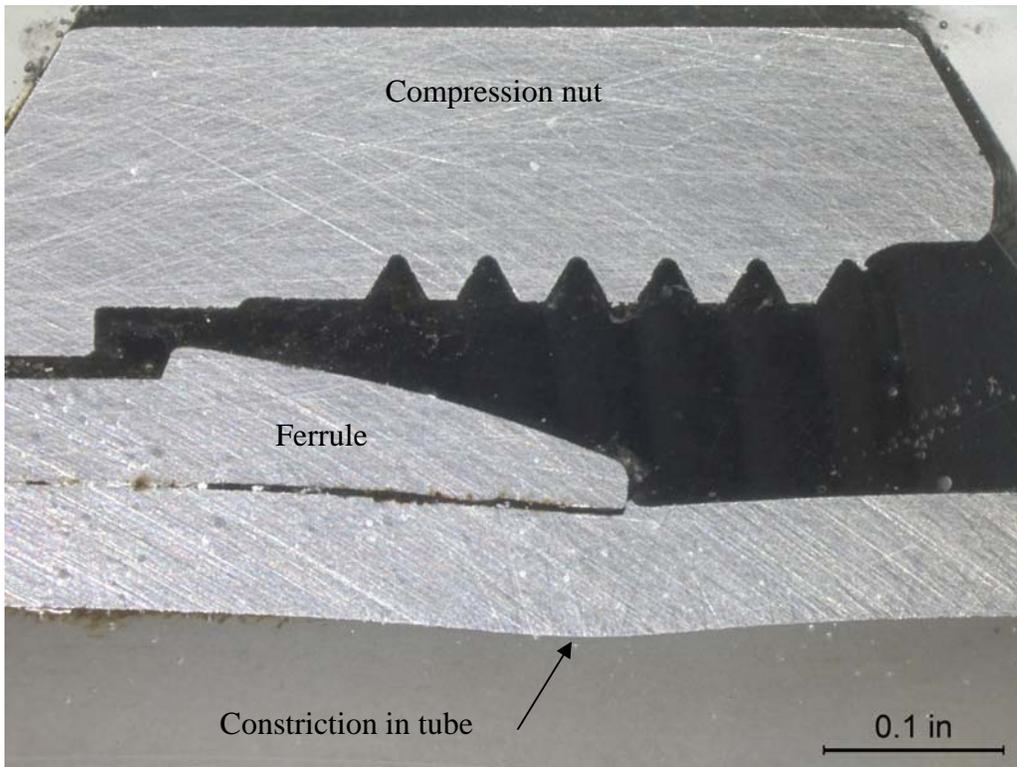
Figure 11 Axial section of the exemplar tube end shown Figure 10.

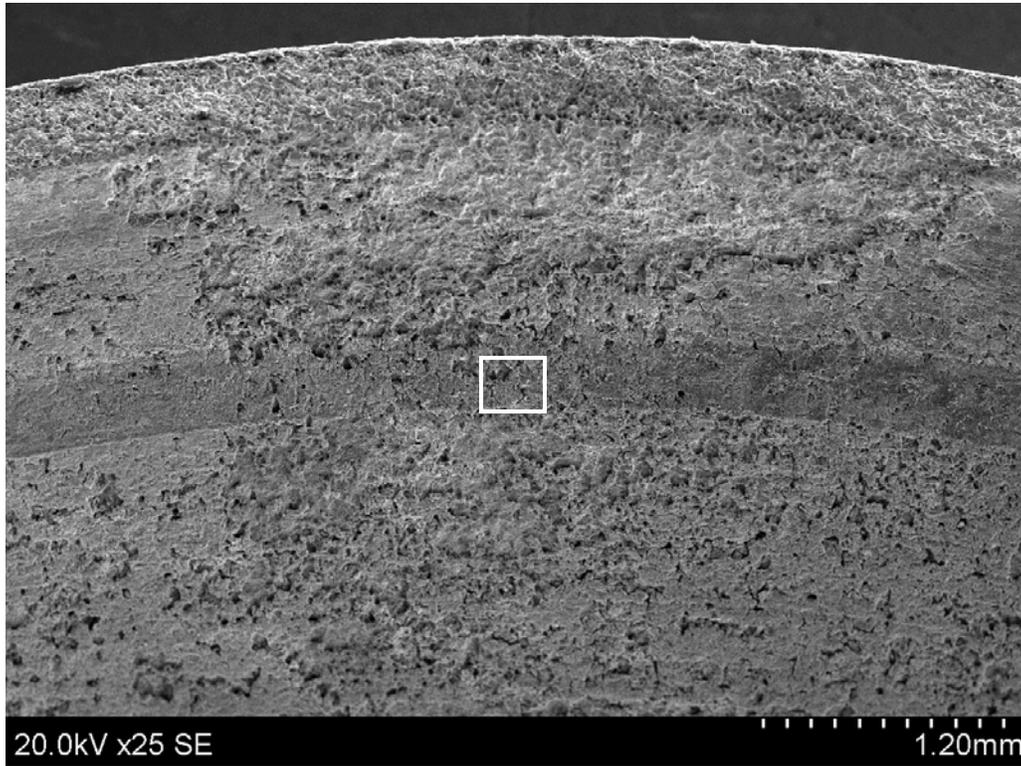
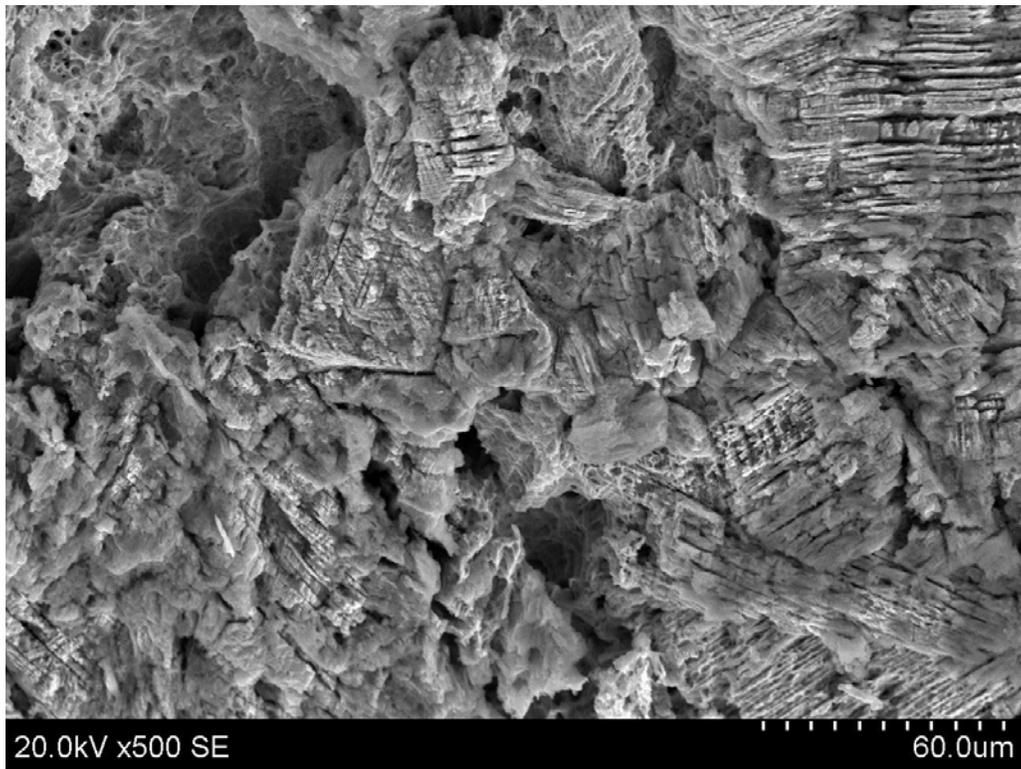
Representative SEM micrographs are shown in Figure 12 through Figure 16. The surface morphologies confirmed corrosion was active between the ferrule and the tube, consistent with insufficient mechanical seal. As shown in Figure 13, fine axial witness marks were caused by axial sliding contact. Likewise, the morphology shown in Figure 16 confirmed contact between the inside surface of the union and the outside surface of the ferrule.

Figure 12 SEM micrographs of the inside surface of the subject ferrule.

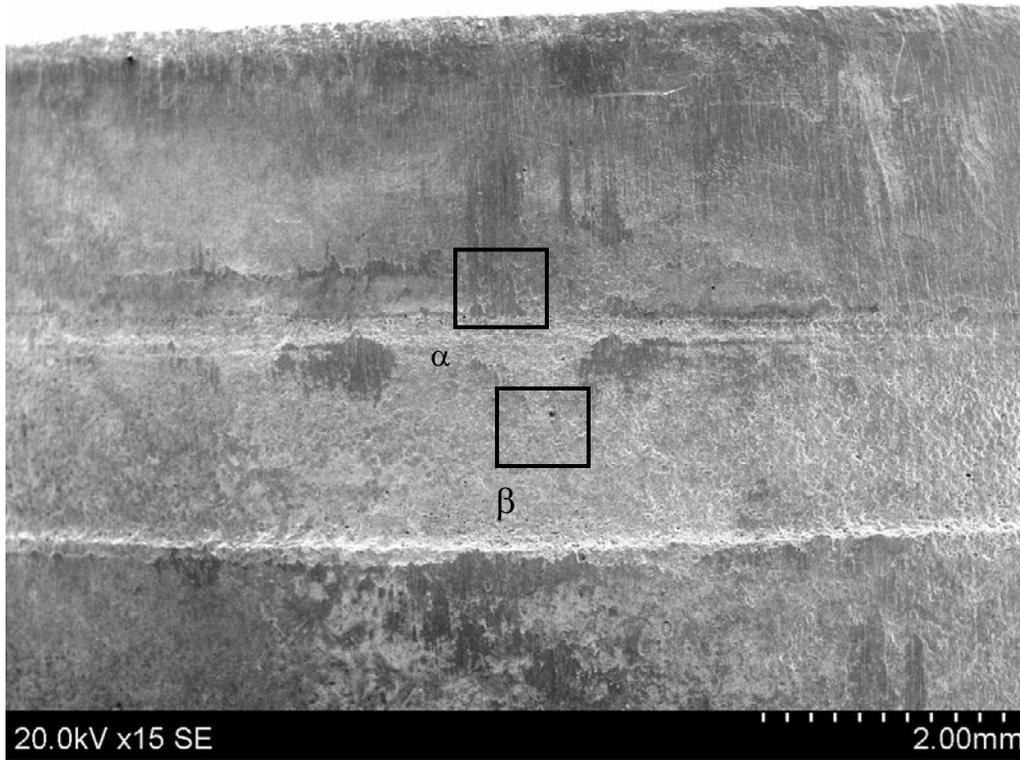
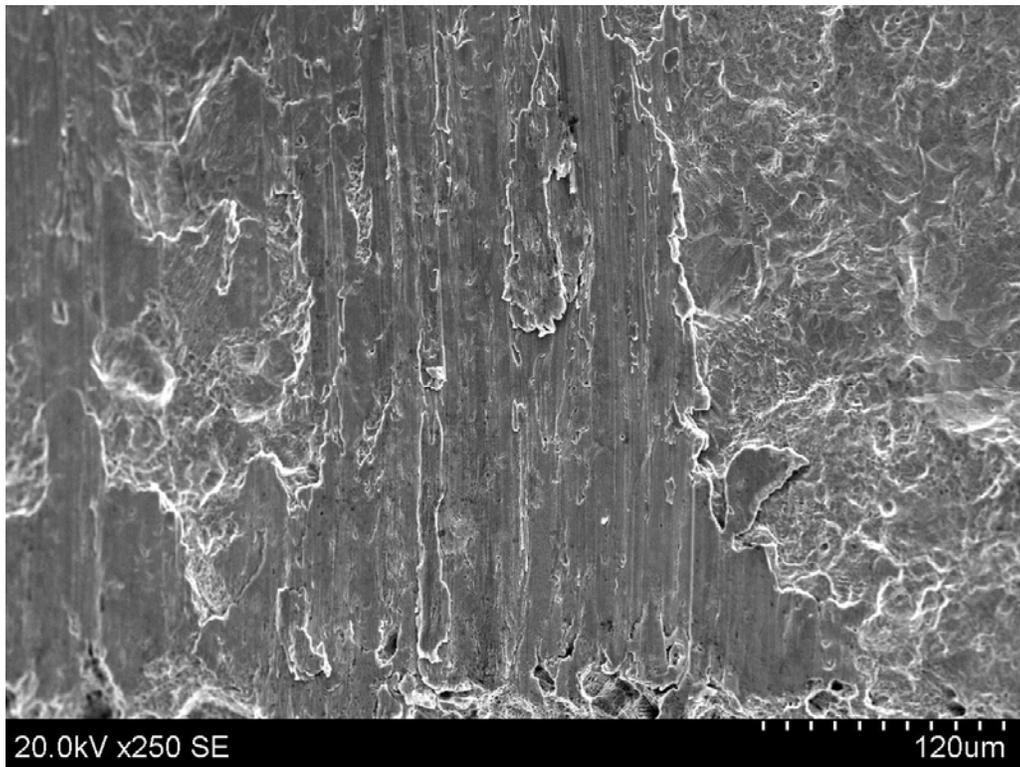
Figure 13 SEM micrographs of the subject tube end outside surface. Sliding contact deformation was likely caused when the joint separated during the incident.
