Report No. 5005.0005

**EXAMINATION OF A 0.75-INCH DIAMETER STAINLESS STEEL TUBE
COMPRESSION JOINT INVOLVED IN THE TESORO MARTINEZ ACID SPILL
THAT BURNED TWO WORKERS ON FEBRUARY 12, 2014**

Report To: U. S. Chemical Safety Board
Attn: Mark Wingard
P.O. Box 25465
Lakewood, CO 80205

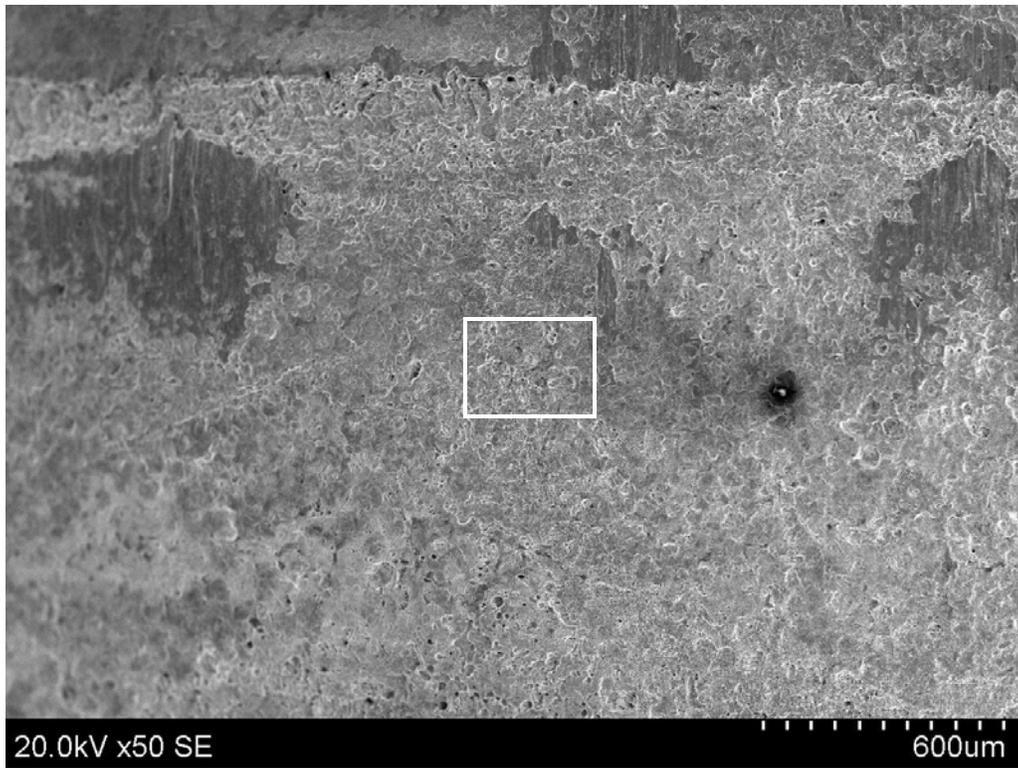
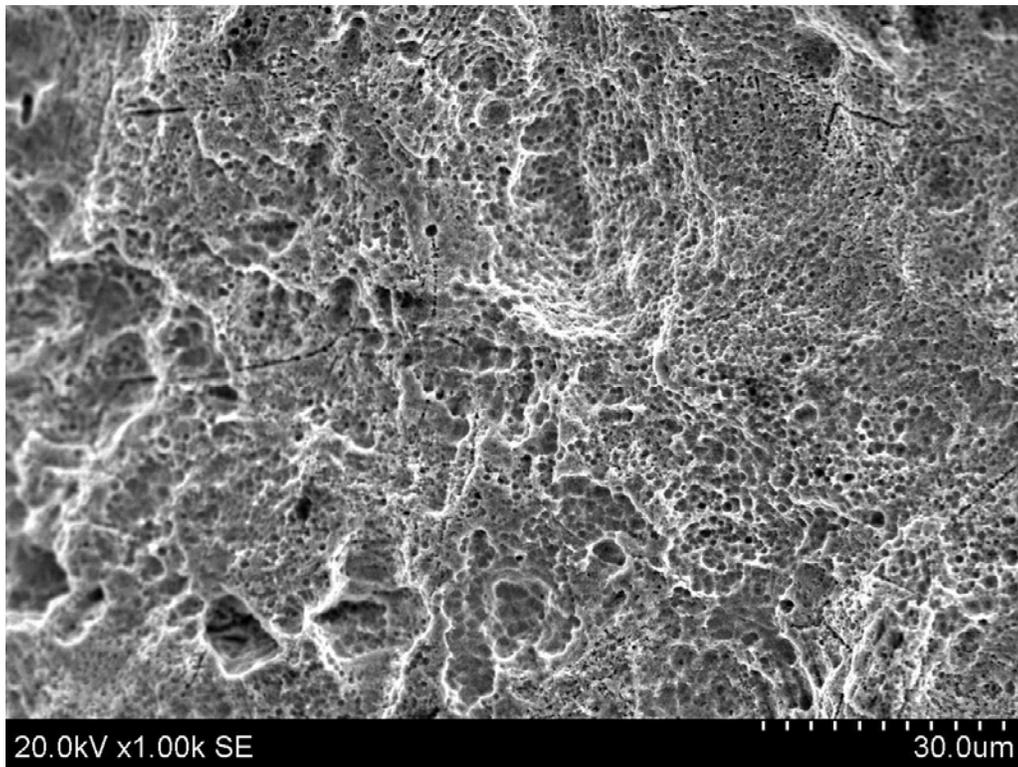
Figure 14 SEM micrographs of the subject tube end outside surface.

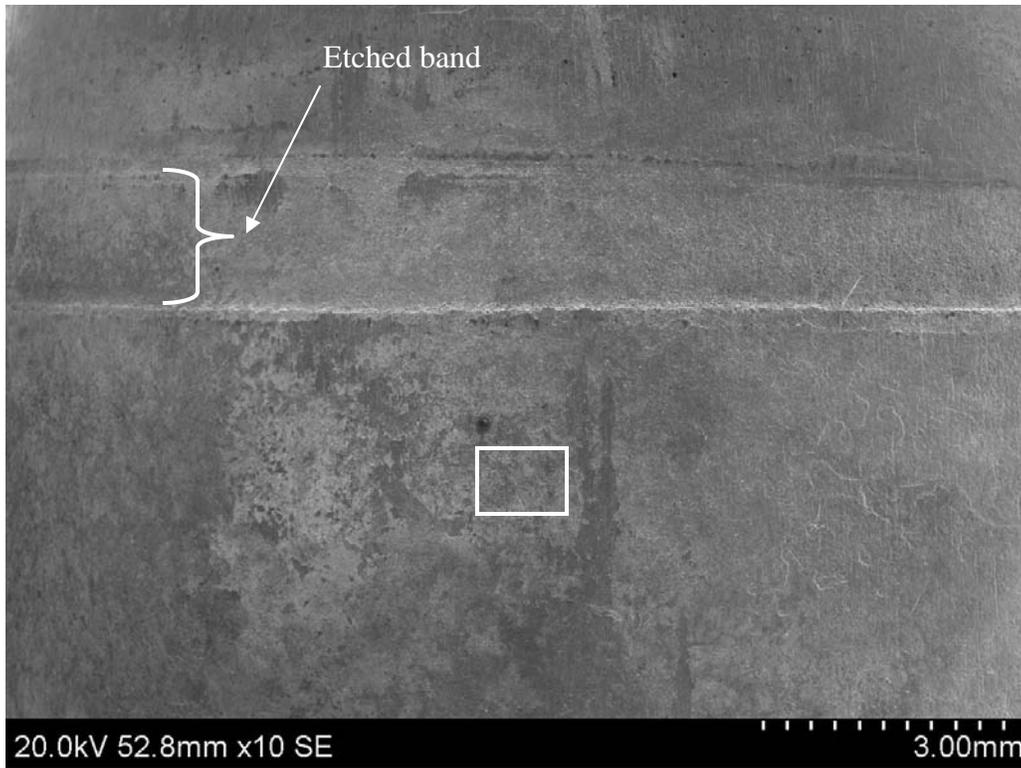
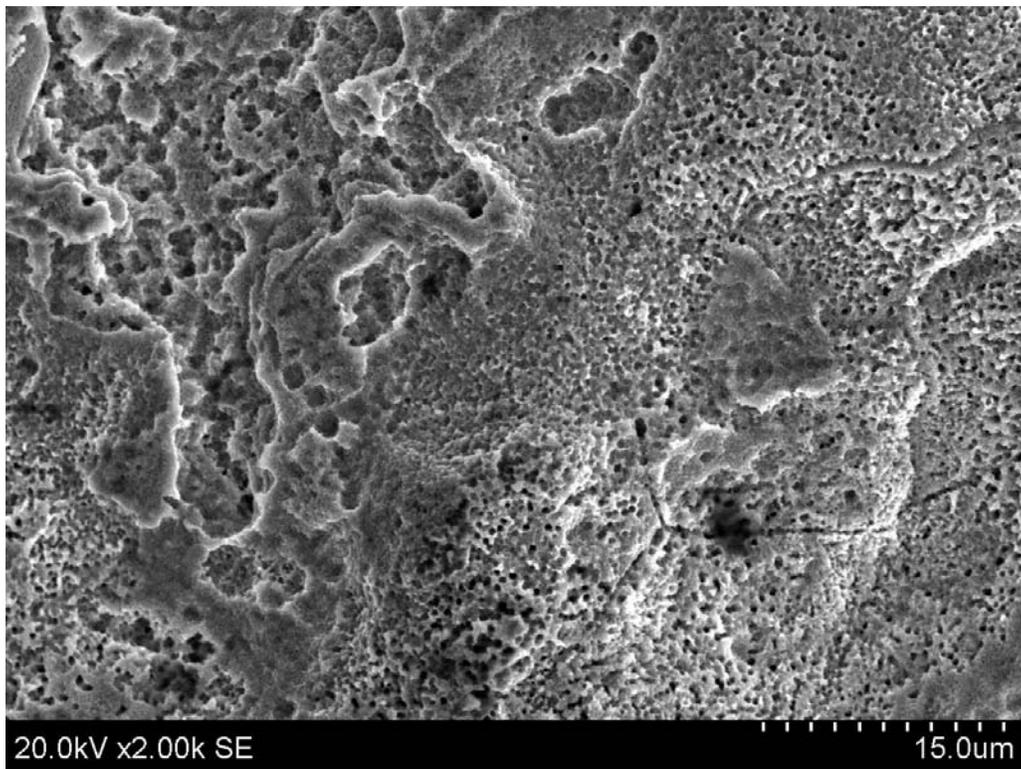
Figure 15 SEM micrographs of the subject tube outside surface at the etched band.

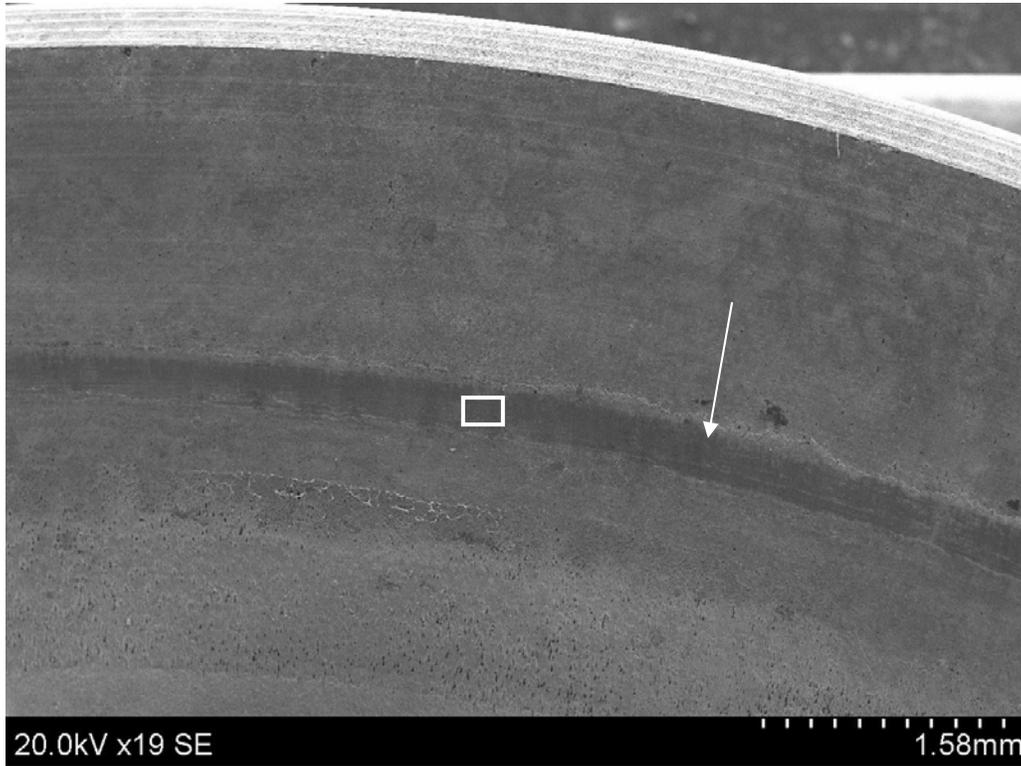
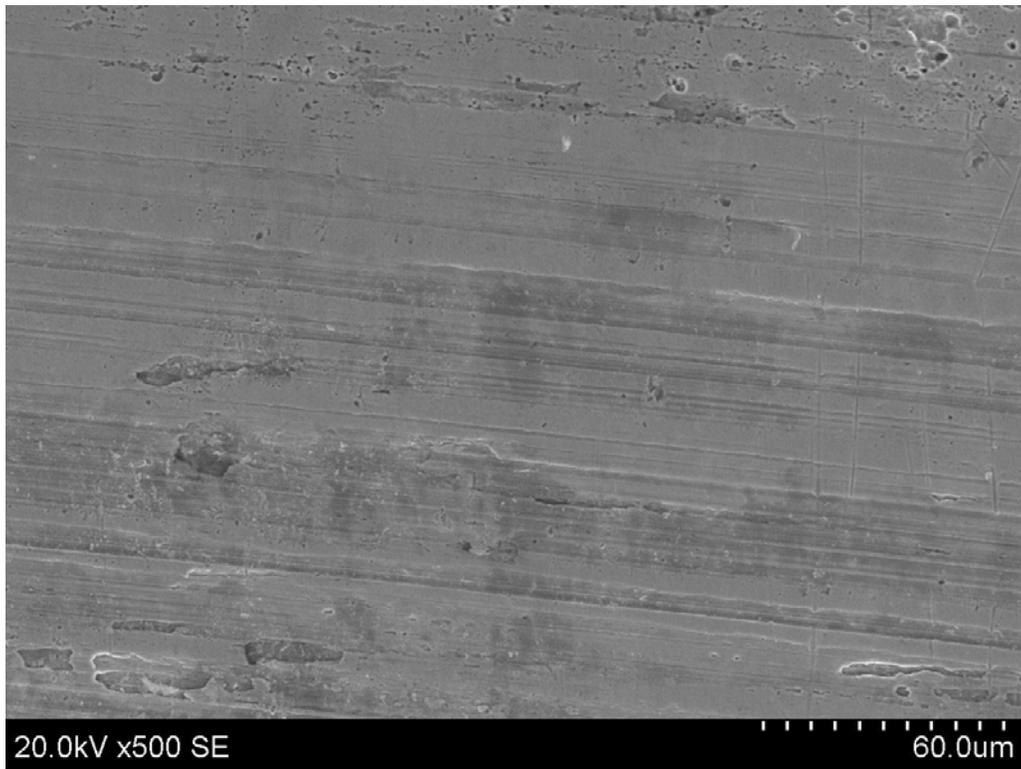
Representative SEM micrographs are shown in Figure 12 through Figure 16. The surface morphologies confirmed corrosion was active between the ferrule and the tube, consistent with insufficient mechanical seal. As shown in Figure 13, fine axial witness marks were caused by axial sliding contact. Likewise, the morphology shown in Figure 16 confirmed contact between the inside surface of the union and the outside surface of the ferrule.

Figure 16 SEM micrographs of the inside surface of the subject union from the boxed area in Figure 5a.
