U.S. CHEMICAL SAFETY AND HAZARD INVESTIGATION BOARD

INVESTIGATION REPORT

Pesticide Chemical Runaway Reaction Pressure Vessel Explosion

Report No. 2008-08-I-WV
January 2011

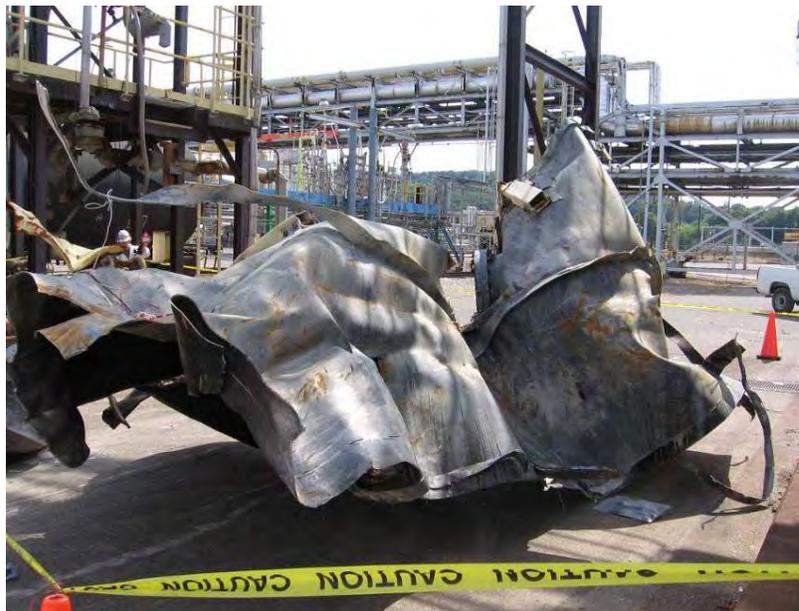
Figure 13. Residue treater shell and top head recovered from inside the Methomyl-Larvin unit

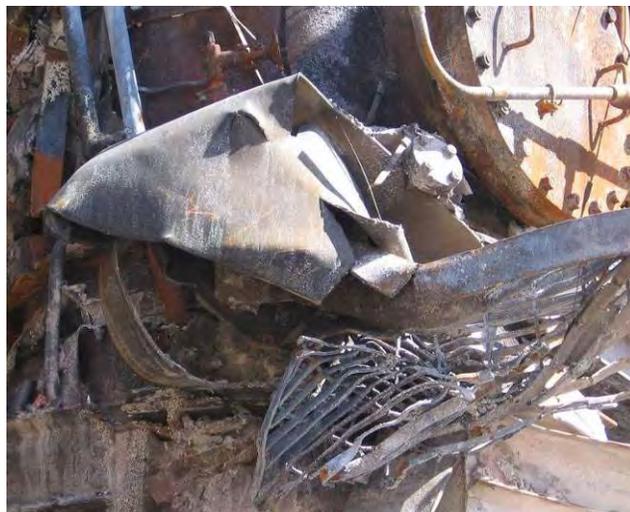
Figure C-4. Residue treater shell fragment lodged in catwalk of adjacent distillation column
