# Chemical Safety and Hazard Investigation Board

Subject: Notation Item 896

3. CSB staff have prepared the attached proposed case study, including proposed recommendations, based upon their investigation of the three iron dust flash fires and hydrogen explosion that occurred between January 31, 2011, and May 27, 2011, at the Hoeganaes Corporation metal powder facility in Gallatin, Tennessee.

## 3.0 THE INCIDENTS

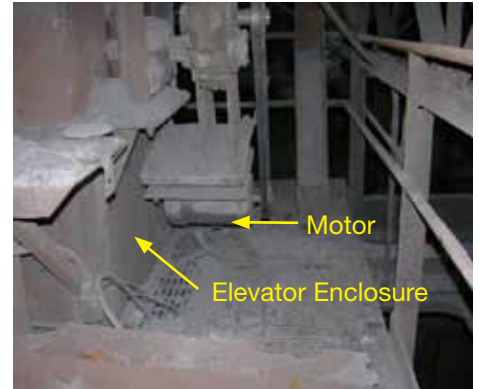
**FIGURE 4 (RIGHT)**

Scene of January 31, 2011, incident area.

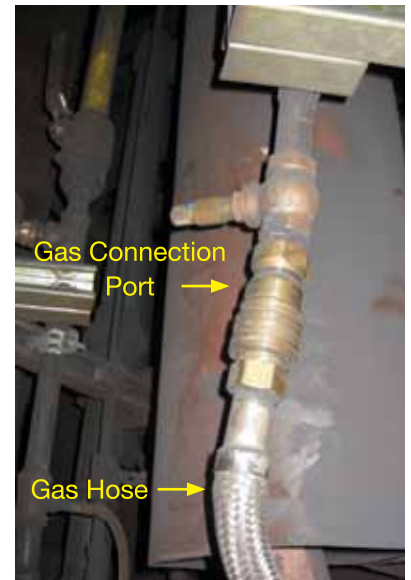
**FIGURE 7 (RIGHT)**

The gas line connection involved in March 29, 2011, incident.

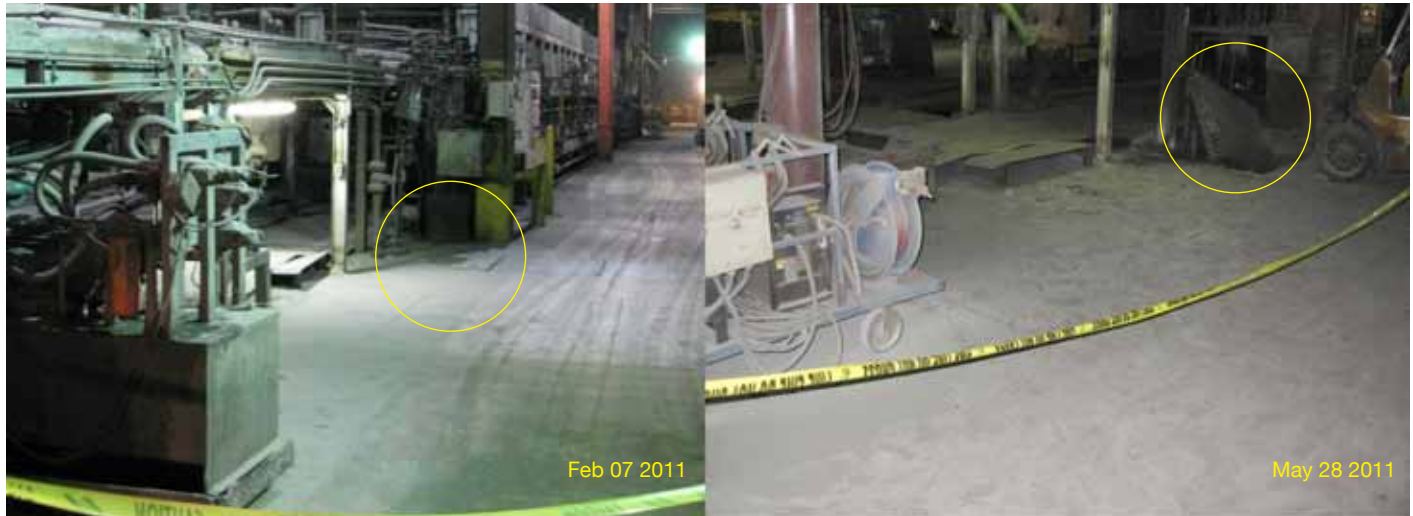
**FIGURE 9 (TOP)**

Scene of the May 27 incident before (left, taken during the CSB's January 31 incident investigation) and after (right). Note visible accumulations of iron powder on surfaces. Circled areas show trench cover location.

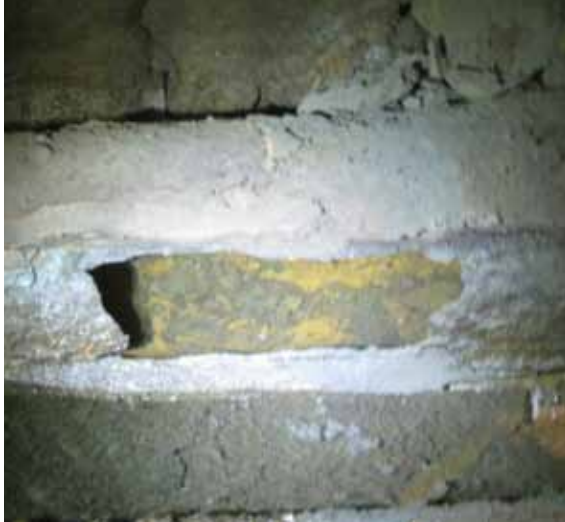
**FIGURE 11 (TOP LEFT)**

Interviews with eyewitnesses indicate that just as the first trench cover was wrenched from its position by the forklift, friction created sparks, followed by a powerful explosion. Several days after the explosion, CSB investigators observed a large hole (approximately 3 x 7 inches) in a corroded section of piping that carried hydrogen and ran through the trench (Figure 11).

Hole in 4-inch piping after the May 27, 2011, incident.

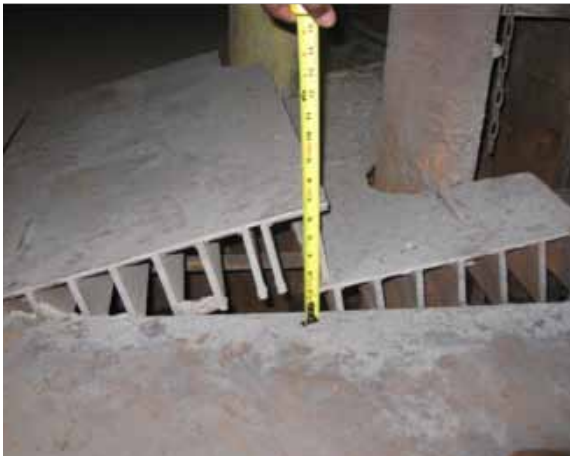
**FIGURE 13 (BOTTOM)**

Upward disturbance of trench covers caused by the hydrogen explosion in the May 27, 2011, incident.

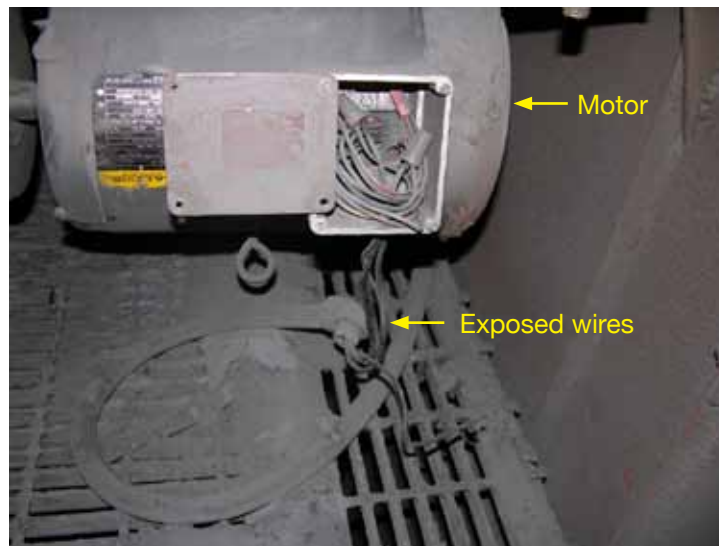
FIGURE 15

Exposed electrical wiring on elevator motor near January 2011 incident site (motor panel cover was rotated post incident by fire department).

The testing contracted by Hoeganaes in 2010 determined that the minimum ignition energy for representative iron dust samples was greater than 500 mJ, and that a continuous arc would ignite the samples. One witness at ground level reported hearing an “electric sound” at the time of the incident. The motor operating bucket elevator #12 was a likely source of ignition since it had exposed wiring, was not properly grounded, and was within a few feet of the dust cloud source. The wiring was exposed because the electrical conduit supplying power to this motor was not securely connected to the motor’s junction box.

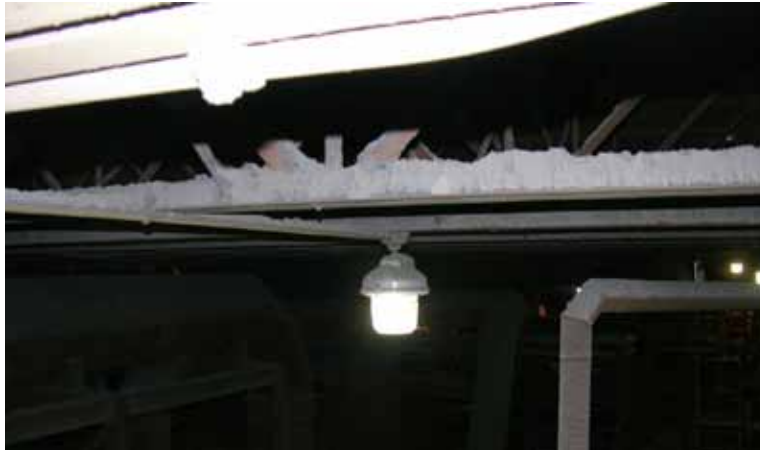
**FIGURE 16**

Mounds of iron dust along elevated surfaces at the Gallatin plant, February 3, 2011.

The Building Construction section of the code states, “Avoid beams, ledges or other places where dust may settle, particularly overhead.” The Gallatin facility, built in the 1980s, was not designed to avoid significant overhead accumulations of dust. The code calls for designing and maintaining dust-tight equipment to avoid leaks and, where this is not possible, to enforce good housekeeping procedures.

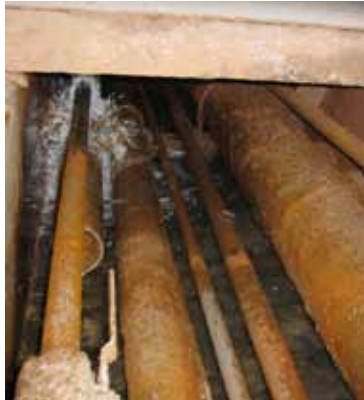
**FIGURE 17**

Water flow (upper left of photo) and externally corroded pipes in the trench involved in the May 27, 2011, incident.

According to ASME B31.3, design concerns about ambient conditions around process pipes focus on environments and changes that can create physical stresses in the piping. Section 10.5.3 of NFPA 55 requires annual maintenance including inspection for physical damage and leak tightness. CGA G-5.4 similarly requires regular inspection for physical damage and leak tightness. However, Hoeganaes did not regularly inspect the pipes in the trench. The design and maintenance of this trench, should have addressed the issue of slow corrosion over time caused by the hot water runoff and solids accumulation.

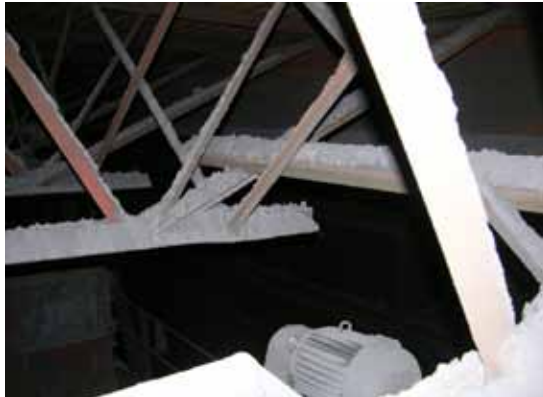
**FIGURE 18 (LEFT)**

Observations by CSB investigators at the Gallatin facility shortly after the first incident indicated that combustible dust was leaking from equipment and that housekeeping was ineffective (see Figures 16, 18, 19, 20 and 21). Combustible iron dust coated almost every

Iron dust on rafters,  
February 3, 2011.

surface up to 4 inches deep and was visible in the air. Mitigation of the combustible dust hazard by Hoeganaes was limited to a less-than-adequate vacuuming service, sparsely enclosed conveyance equipment, and an inadequate baghouse filtration system.

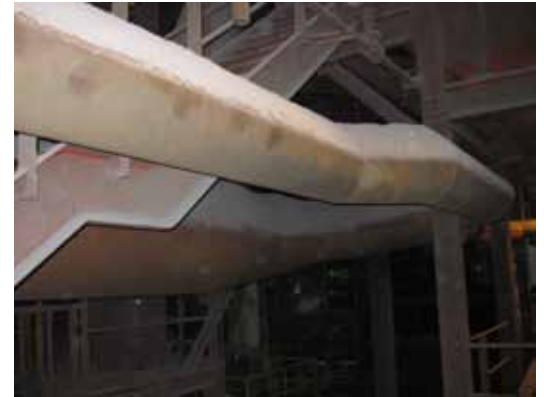
**FIGURE 19 (RIGHT)**

Iron dust on overhead  
surfaces, February 3, 2011.

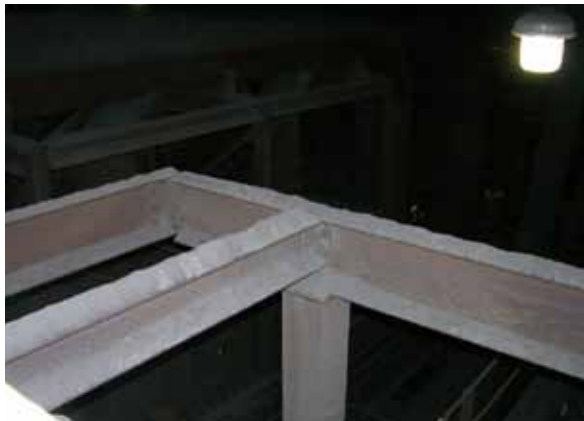
**FIGURE 20**

Iron dust on structural  
supports, February 3, 2011.

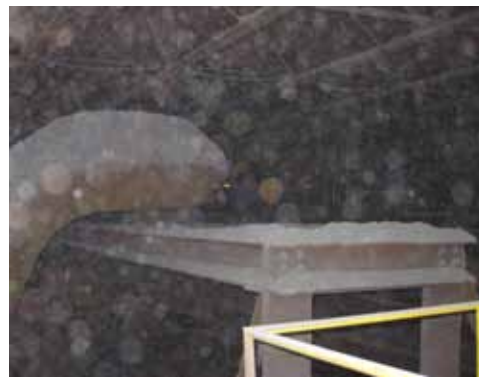
**FIGURE 21**

Photo of equipment obscured by airborne dust, taken by CSB investigators, February 7, 2011.
