# INVESTIGATION REPORT

## REFINERY FIRE INCIDENT

### TOSCO AVON REFINERY

REPORT No. 99-014-I-CA  
ISSUE DATE: MARCH 2001

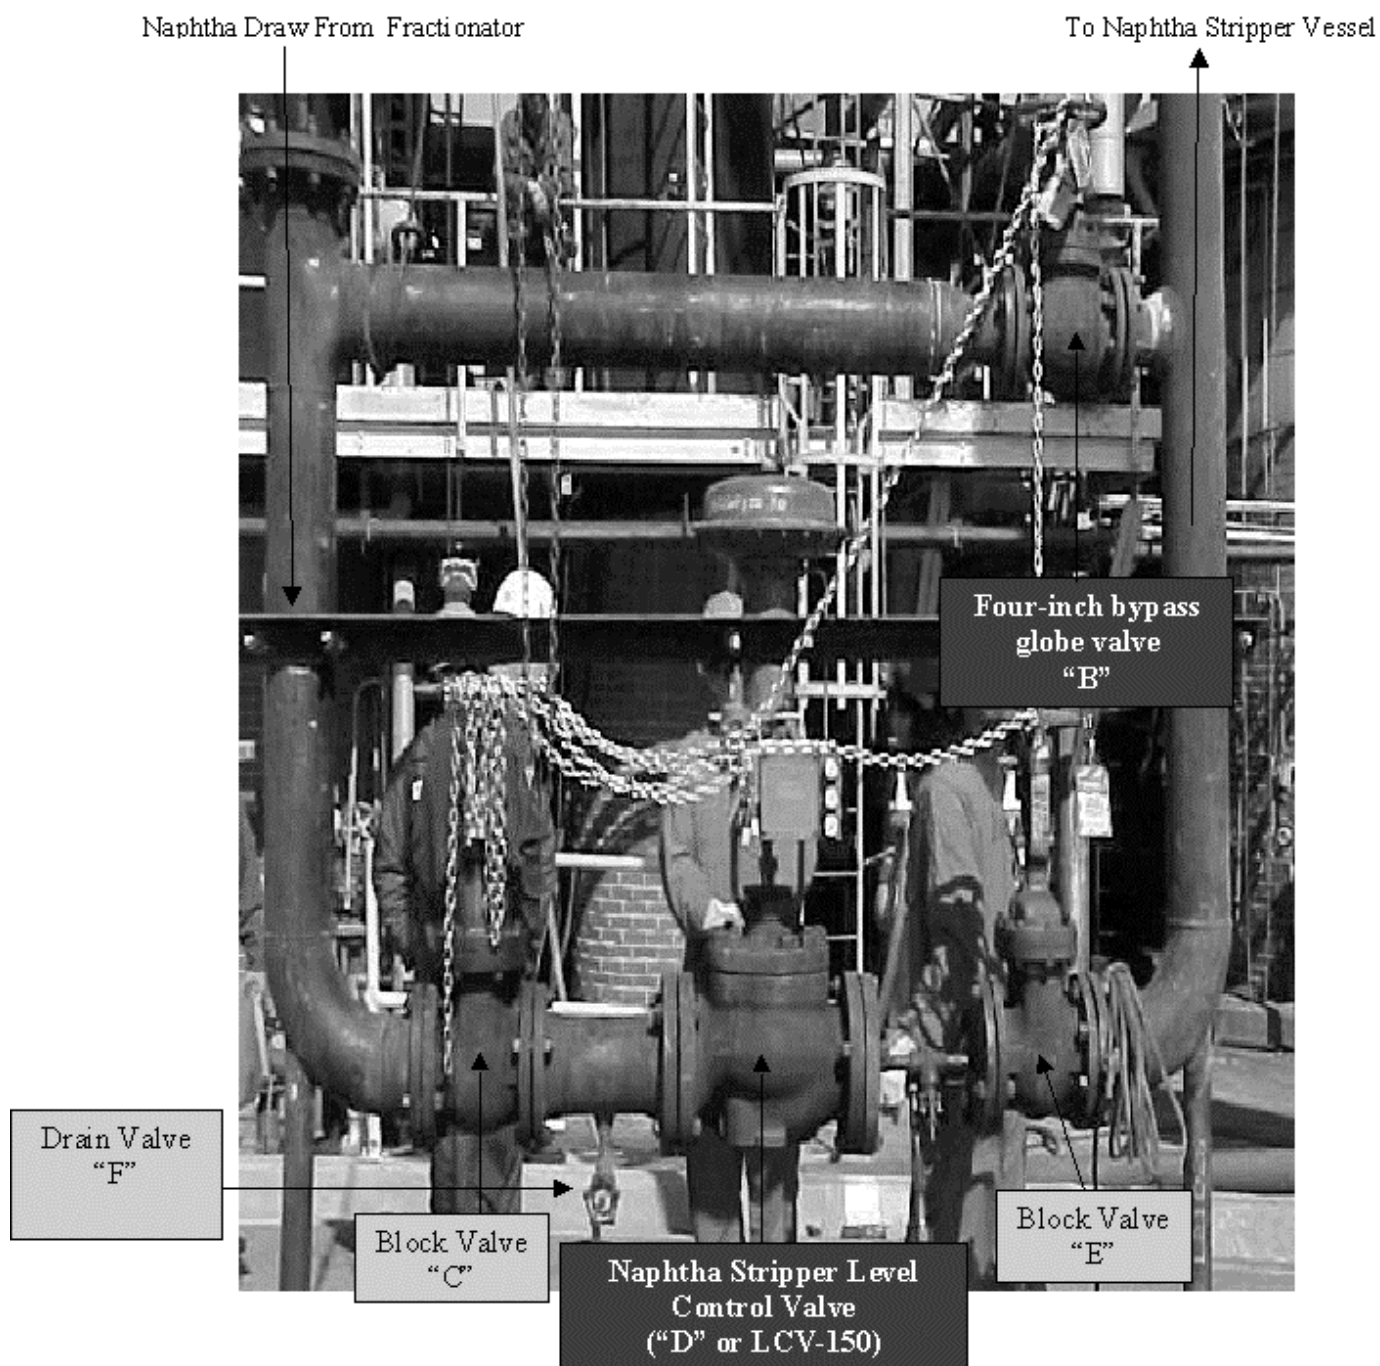
Figure 1. Naphtha stripper level control valve manifold removed to ground level.  
The valve at the top right of manifold is the 4-inch bypass valve.

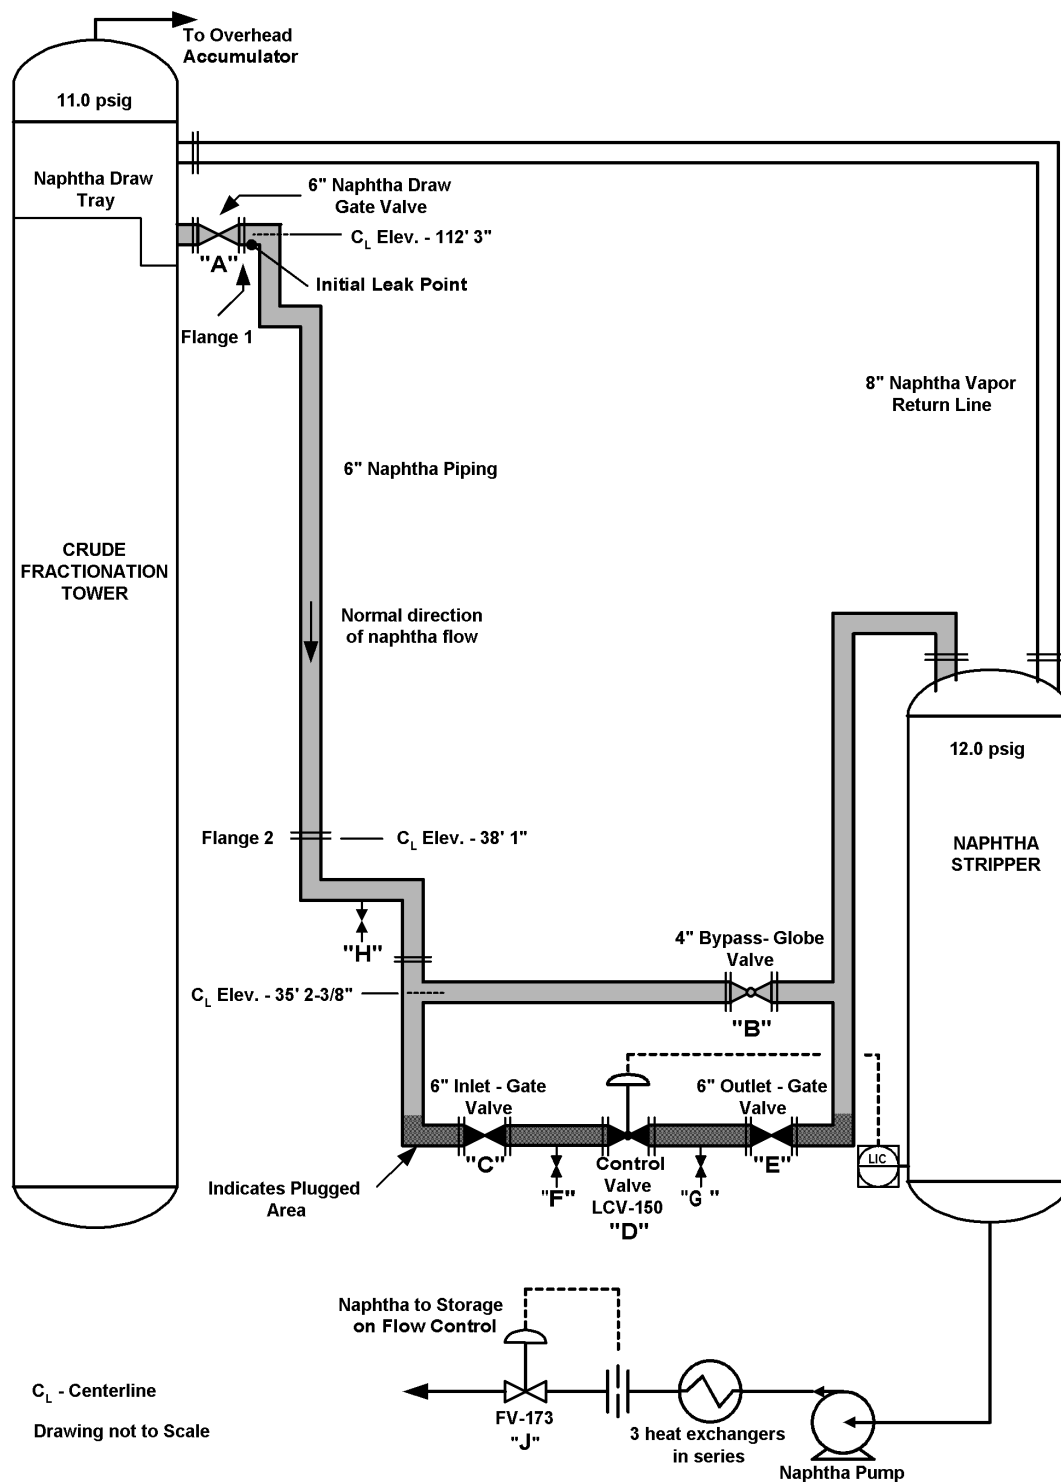
Figure 2. Fractionator and naphtha draw, simplified diagram at time of initial leak.

Once the insulation was stripped from the piping, the leak was determined to have originated from a 0.16-inch-long pinhole perforation on the inner radius of an elbow directly downstream of the block valve off the fractionator (valve A), at an elevation of 112 feet. Further inspection using ultrasound and X-ray techniques revealed that much of the piping was severely corroded and thin. Technical staff recommended that the entire line be replaced from valve A to the naphtha stripper.

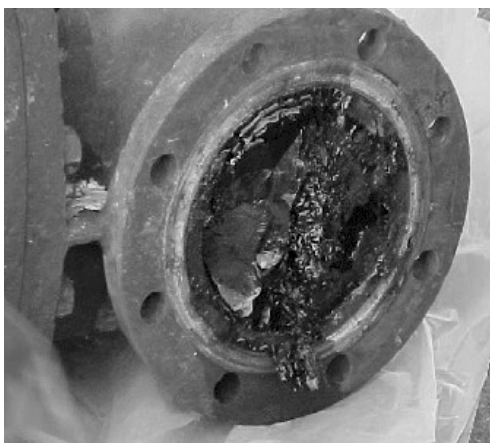
On February 18, pipefitters again attempted to clear the drain lines (valves F and G) at the naphtha stripper level control valve by using a reaming device. However, the device broke due to the hardness of the material in the line.

Figure 3. Closeup of material blockage of block valve (C), upstream of LCV-150.

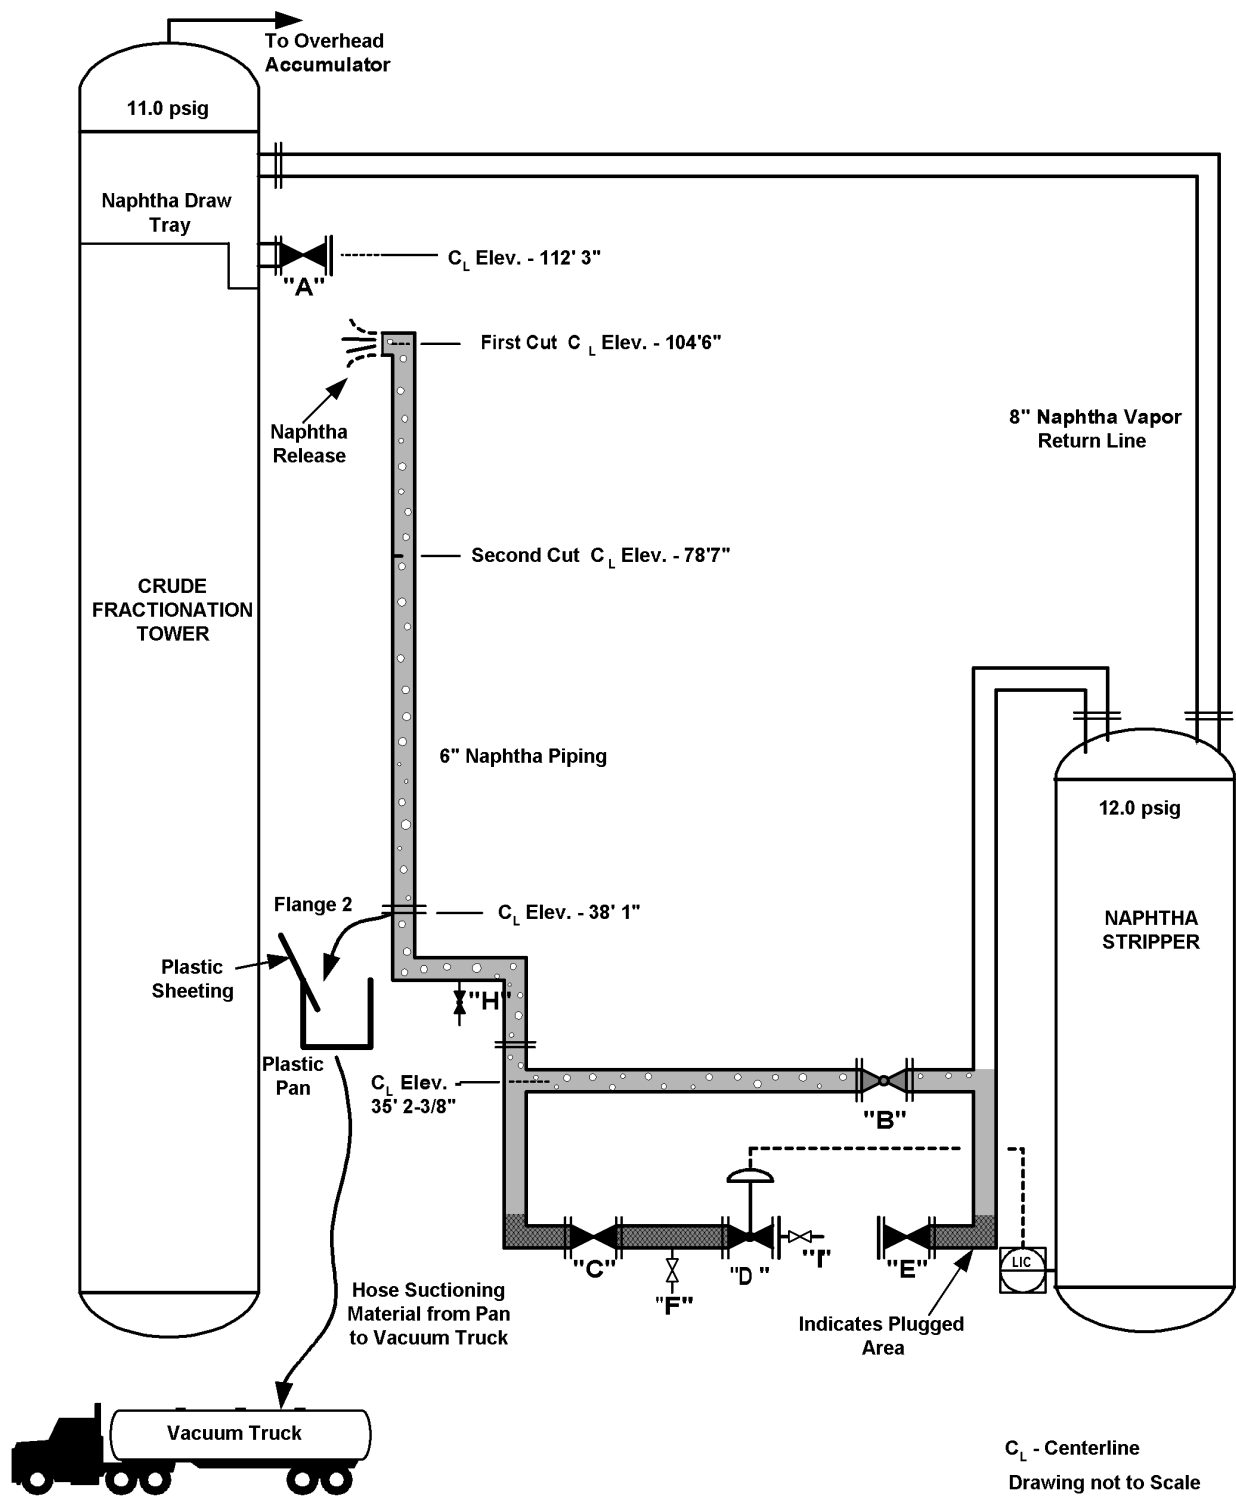
Figure 4. Fractionator and naphtha draw, simplified diagram, draining at lower flange at time of release.

The maintenance supervisor decided to again attempt to drain the line by opening flange 2, located upstream of the naphtha stripper level control valve (valve D) and within 3 feet of the fractionator (Figure 4). Workers loosened the bolts on flange 2, which allowed liquid to flow. Plastic sheeting was hung to deflect the draining liquid away from the hot fractionator and into an open plastic pan, from which it was suctioned to the vacuum truck.

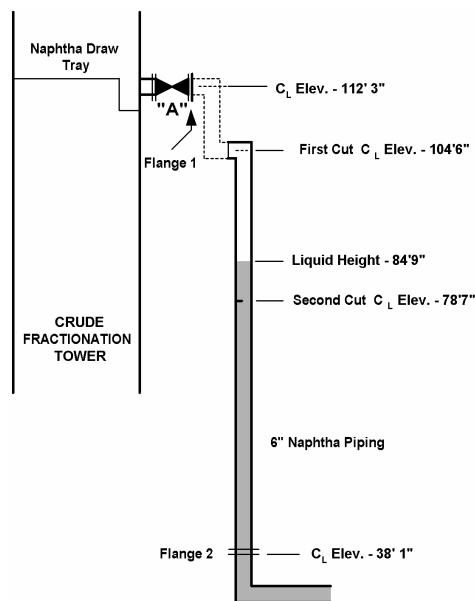
Figure 6. Fractionator and naphtha draw, simplified diagram, first cut and second cut.

For the second cut, the maintenance supervisor directed workers to start 26 feet below the location of the first cut (Figure 6). When the saw pierced the inside diameter of the pipe wall, a small amount of liquid began to leak from the line. The worker operating the saw ceased cutting and was sent to obtain a pipe clamp to seal the leak.

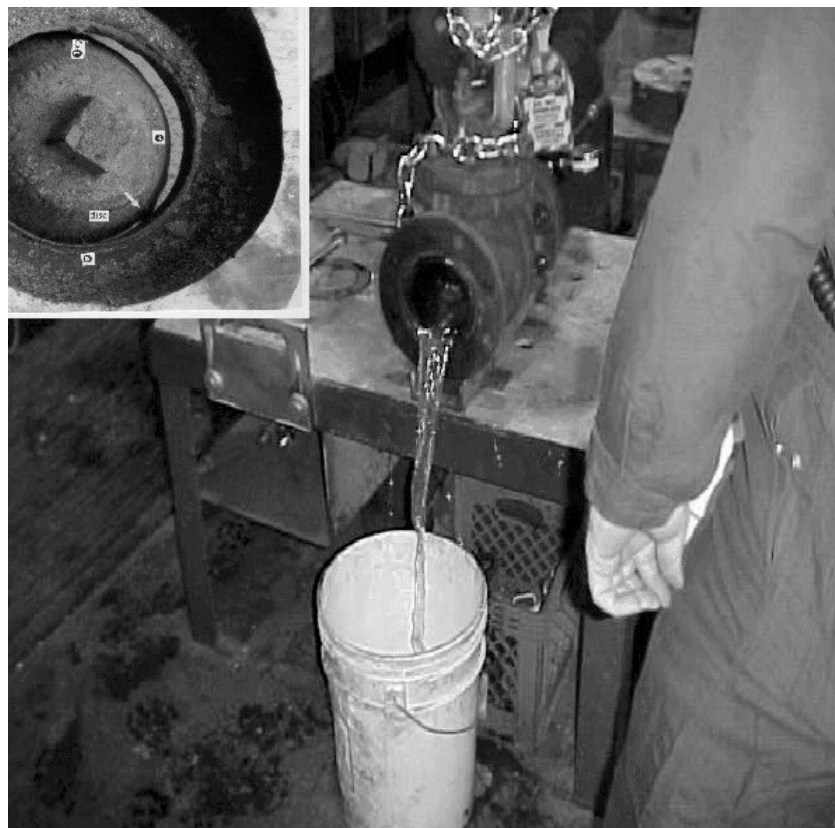
Following the incident, Cal/OSHA commissioned a metallurgical analysis of the failed piping and components. It was determined that the bypass valve was eroded to such an extent that—when closed—it leaked (Figure 7) at a rate equivalent to a 1.5-inch-diameter hole (FTI Anamet, 1999; p. i).

*It was determined that the bypass valve was eroded to such an extent that—when closed—it leaked at a rate equivalent to a 1.5-inch-diameter hole.*
