# INVESTIGATION REPORT

## ALLIED TERMINALS, INC.– CATASTROPHIC TANK COLLAPSE

CHESAPEAKE, VIRGINIA

REPORT NO. 2009-03-I-VA

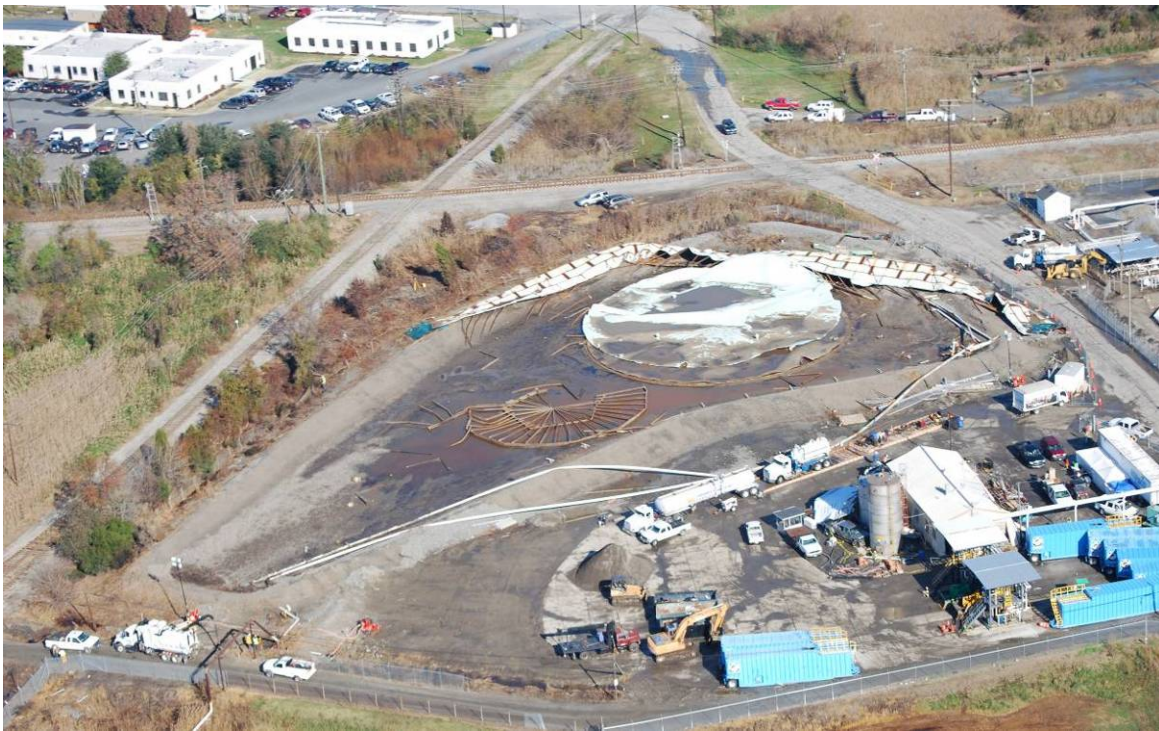
Figure 1. Allied collapsed tank and neighboring business.

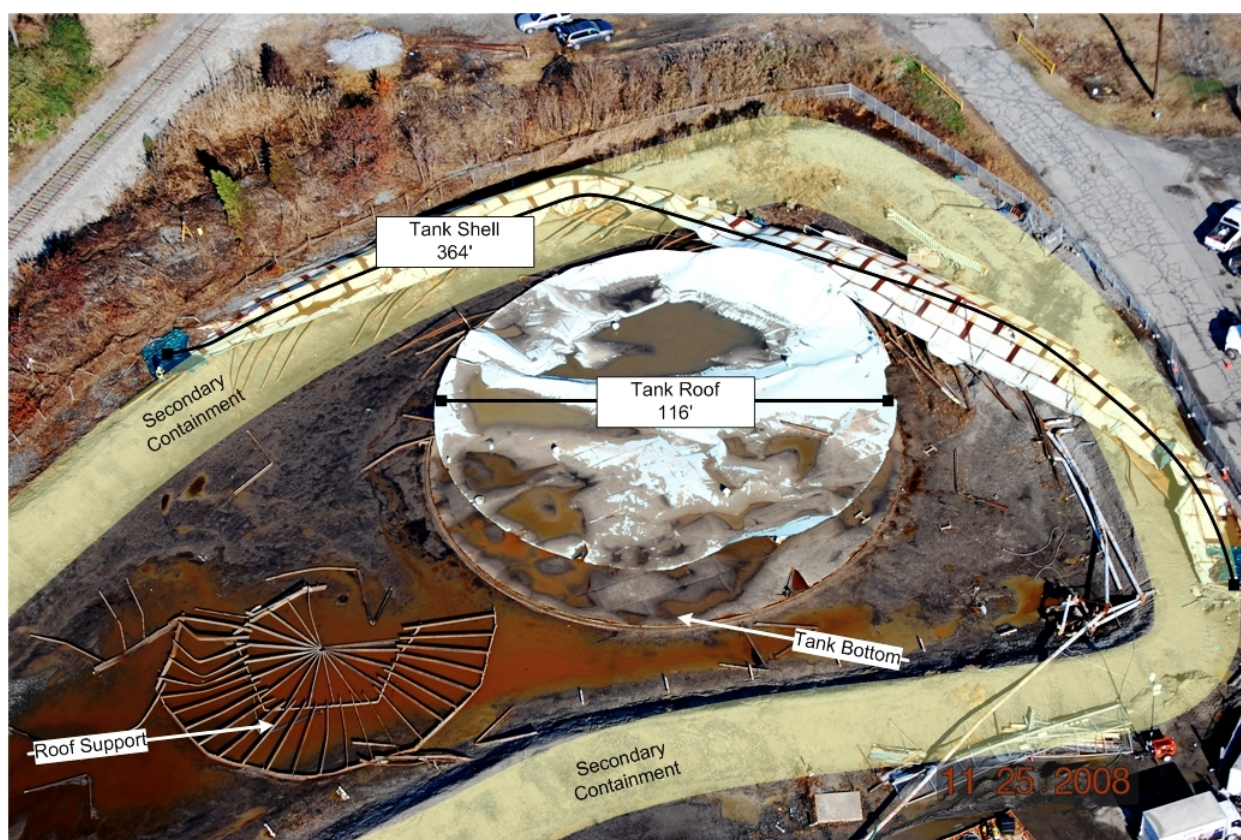
At about 2:20 pm, as the tank reached a level of 26.72 feet, a vertical split started midway up the shell and rapidly extended to the floor and roof of the tank on the side opposite the workers. As the pressure of the liquid fertilizer inside the tank opened the split, the tank shell separated from the bottom and roof (Figure 4), rapidly releasing the tank's contents.

Figure 4. Tank 201.
