U.S. CHEMICAL SAFETY AND HAZARD INVESTIGATION BOARD

INVESTIGATION REPORT

HONEYWELL INTERNATIONAL, INC.

REPORT NO. 2003-13-I-LA

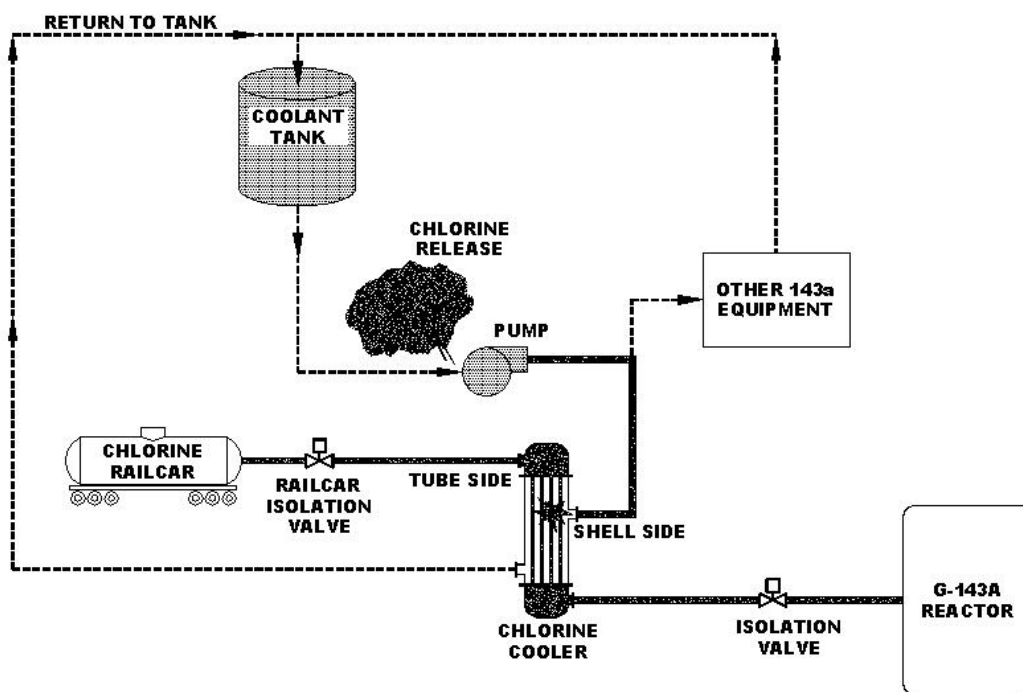
Figure 6. Failure of chlorine cooler, causing release at coolant pumps.

As depicted in Figure 6, the immediate cause of the July 20 release was a failure in the chlorine cooler, which allowed chlorine to enter the coolant system. Because Honeywell did not anticipate the coolant pumps coming into contact with chlorine, their materials of construction were not compatible with it. The pumps failed, releasing chlorine to the atmosphere.

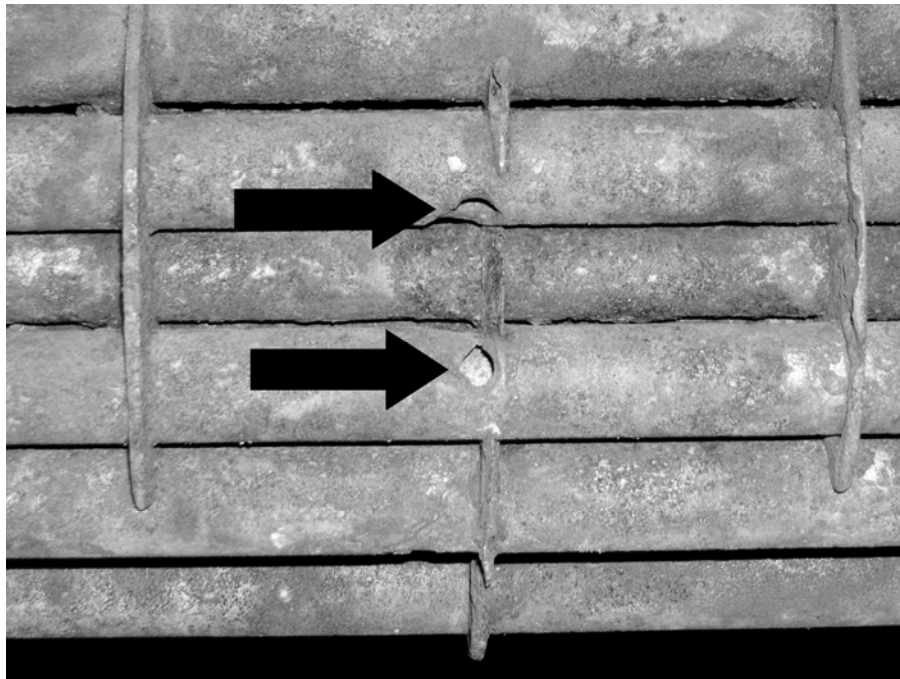
Figure 8. Chlorine cooler tube bundle showing two holes.

Following the July 20 incident, the chlorine cooler was cut open and inspected. Visual inspection revealed three holes in the tubes and a buildup of corrosion products at the bottom (two holes are shown in Figure 8). All corrosion products and the holes were found in the lower section of the cooler; the holes originated on the outside surface of the tubes (refer to Figure 2). One hole was crescent shaped and about 0.5 inch long, while the two other holes were about 0.25 inch in diameter and approximately 5 inches higher on adjacent tubes. After the visual inspection, two holes were confirmed by magnetic flux testing performed by a Honeywell contractor; however, the third hole's test results showed only significant wall thinning.

A magnetic flux leakage inspection in October 2003 followed the July 20, 2003 incident. Two of the three holes were identified by that inspection, but the third showed only as wall thinning. This finding suggests that either the methodology or the testing apparatus is less than adequate to positively detect thinning and failure of the 0.109-inch tube walls.

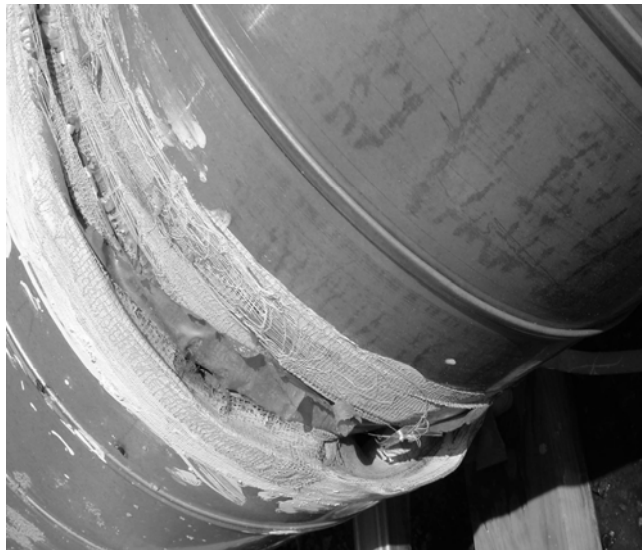
Figure 9. Condition of duct tape used to seal gaps.

During the July 20 release, chlorine entered the control room. CSB investigators found that it was drawn into the building through holes and gaps in the HVAC intake ducts located on the roof. Some holes appeared to have been drilled in the duct and not plugged, while others resulted from gaps in joints. Duct tape was used to seal some gaps, but the tape became dry and brittle over time. Figures 9 and 10 show this deterioration. Figure 11 shows the proximity of the coolant system chlorine leak in relation to the HVAC system.

- There was no maintenance program for the control room, including HVAC ductwork.²³
- Duct tape used to seal some joints in HVAC ductwork eventually became brittle and exposed gaps in the joints.
- There were numerous entrances and exits from the control room—none of which had a double door air lock system.
- There were no toxic gas alarms on the HVAC intake system. Alarms could have warned operators to use the escape respirators and exit the control room.
- Although the positive pressure control room system was listed as a safeguard in a hazard analysis, it was not designated as critical equipment or maintained as such.²⁴

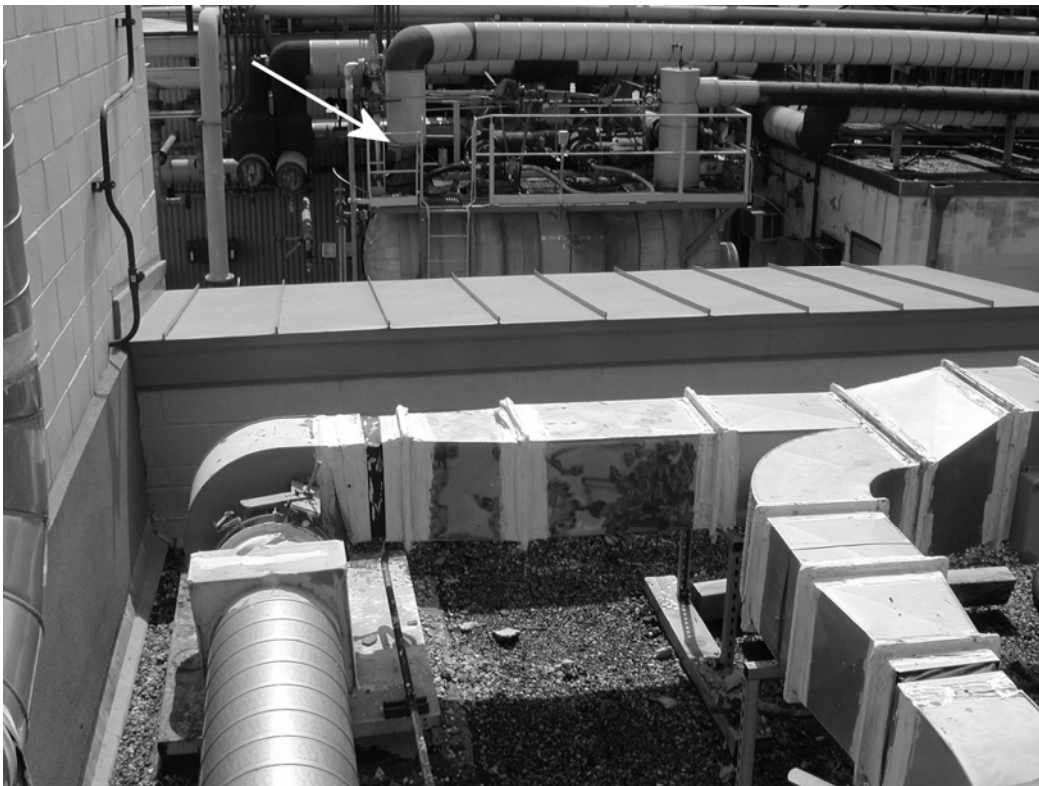
Figure 11. HVAC intake system on control roof (foreground).

Arrow points to location of coolant system chlorine leak.

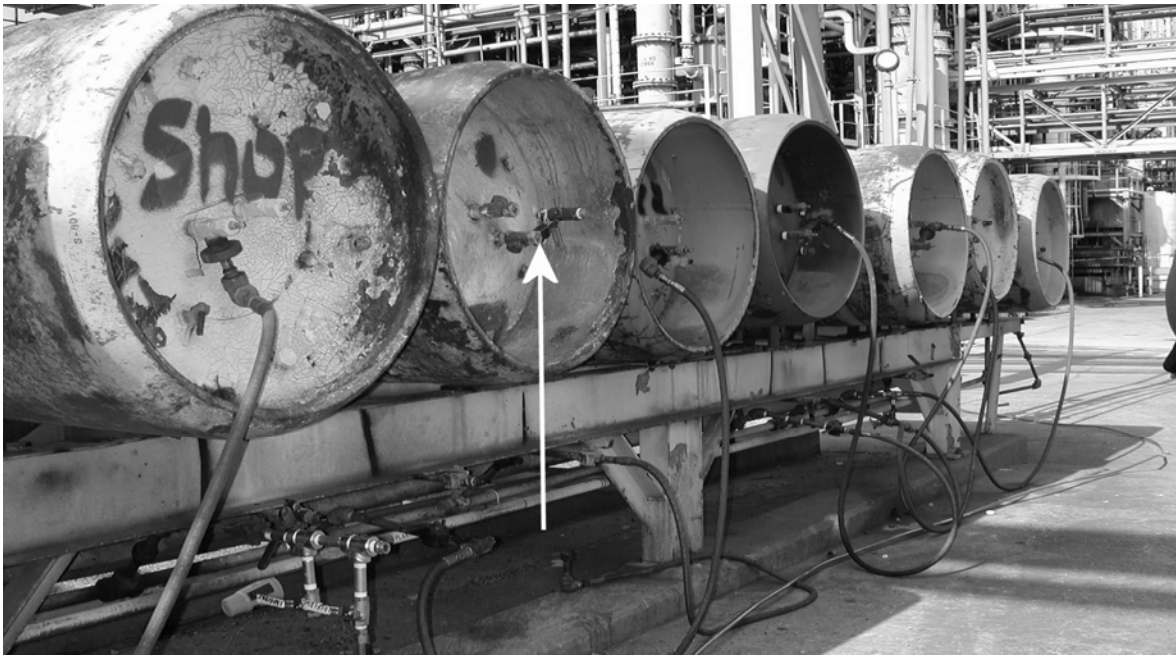
Figure 13. Incident cylinder (83-3410), which is not connected to vent system.

Ten 1-ton cylinders labeled “refrigerant gas” were found on the ton-cylinder rack. Nine of the 10 cylinders were connected to the vent system and properly drained/cleared of residual refrigerant. The 10th cylinder—which had serial number 83-3410 (and was painted white and green as opposed to the standard gray for antimony pentachloride)—was not hooked up to the vent system (Figure 13); and a plug at the five o’clock position had been removed from the end of the cylinder.

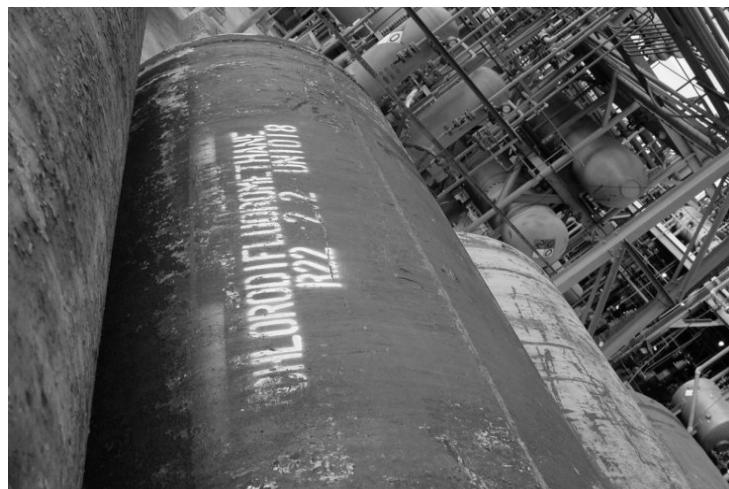
Figure 14. Stencil on cylinder 83-3410.

This cylinder was identified by a “Chlorodifluoromethane R-22” stencil (Figure 14). Further examination of cylinder 83-3410 revealed that the valves would not open due to buildup of corrosion products.

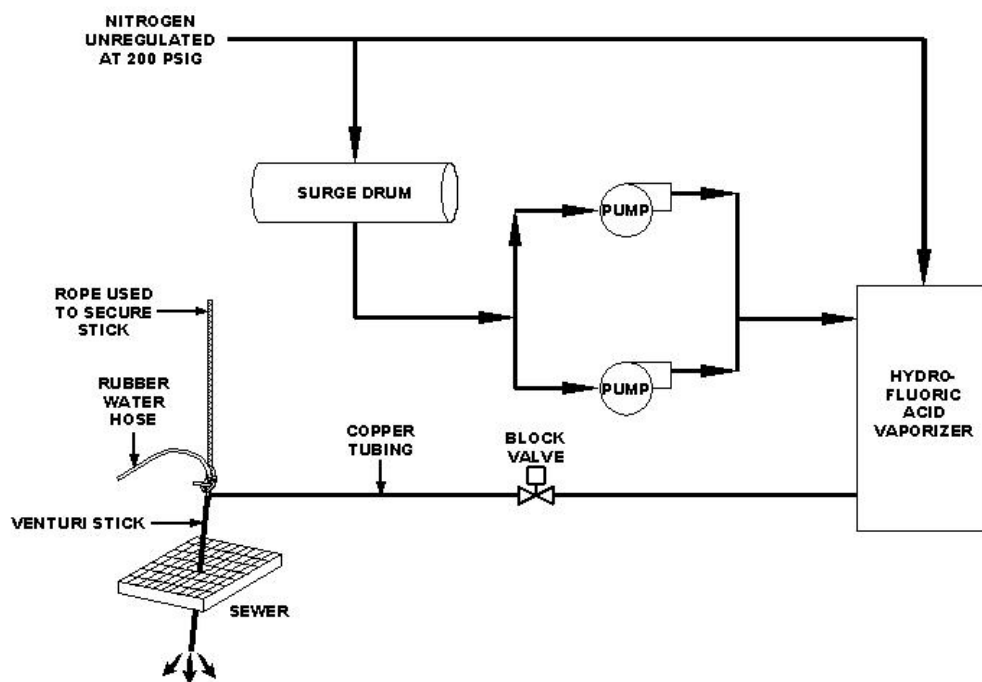
Figure 17. Simplified diagram of the setup to remove liquid hydrogen fluoride utilizing a venturi stick.

On August 12, the operations department set up a venturi stick to empty the G-22 HF vaporizer. Personnel fed plant nitrogen—with a 200-pound-per-square-inch gage (psig) supply pressure—to the equipment upstream of the vaporizer. They attached a venturi stick with copper tubing to the vaporizer, inserted it into the plant sewer, and attached a water hose to the end of the stick to draw the liquid hydrogen fluoride to the sewer (Figure 17). The venturi stick was tied off with a rope.

Once the system was in place, operations personnel began to empty the liquid hydrogen fluoride from the vaporizer. This draining operation continued into the next day, August 13. At approximately 9 am on that day, an operator monitoring the venturi process checked on its progress. The operator suspected a problem with nitrogen flow to the vaporizer, and opened and closed some valves to create a surge in the system and clear any blockage. Flow to the sewer rapidly increased, causing the venturi stick to lift out of the sewer—which created a cloud that likely contained hydrogen fluoride.
