U. S. CHEMICAL SAFETY AND HAZARD INVESTIGATION BOARD

INVESTIGATION REPORT

STEEL MANUFACTURING INCIDENT

**BETHLEHEM STEEL
CORPORATION**
BURNS HARBOR DIVISION
CHESTERTON, INDIANA
FEBRUARY 2, 2001

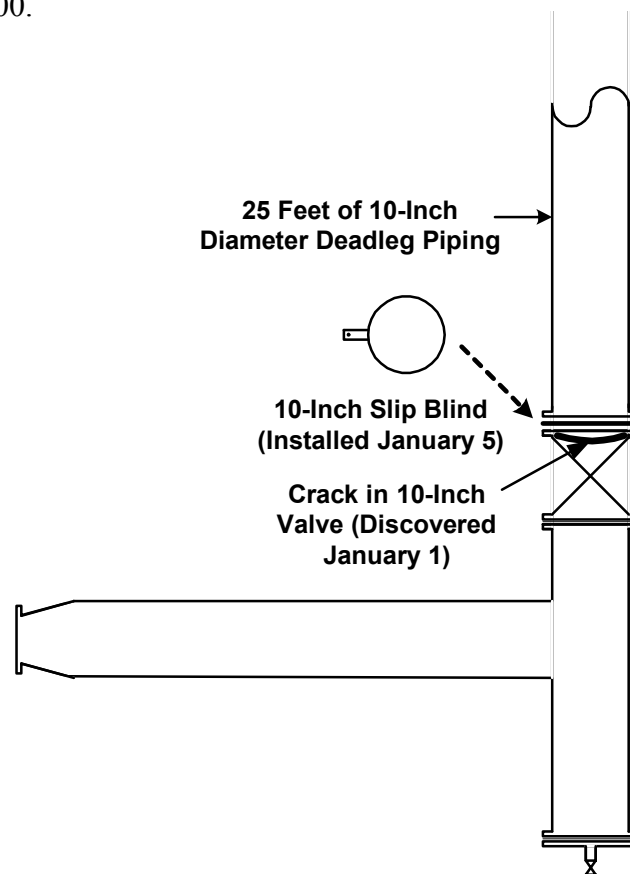
Figure 5. #4 Batch furnace COG piping.

The #4 batch furnace in the 160-inch plate mill was shut down in 1992, at which time a 10-inch isolation gate valve was closed to prevent the flow of coke oven gas to the furnace. This created a 25-foot vertical deadleg⁸ of 10-inch-diameter piping above the valve, which was open to the COG distribution piping (Figure 5). Furnace demolition began in summer 2000.

CSB determined that the 10-inch valve likely cracked when water trapped in the deadleg above the valve froze and expanded. The leak became apparent as the ice thawed. Although outdoor temperatures remained below freezing for most of December, a significant warmup in the month allowed for thawing inside the furnace area. It is

probable that any liquid in the deadleg drained through the crack before the gas was detected. As shown in Figure 5, the crack was located at the upper flange of the valve, above the gate that blocked flow.

The leaking valve problem was the subject of a meeting of supervisors from the plate mill and the utility departments between January 2 and 5. The managers decided to install a slip blind in the flange above the leaking valve (Figure 5) instead of the preferred blind flange and drain valve assembly. It would have taken additional time to fabricate the blind flange and drain valve, and the plant wanted to switch more quickly from natural gas to the less expensive coke oven gas.

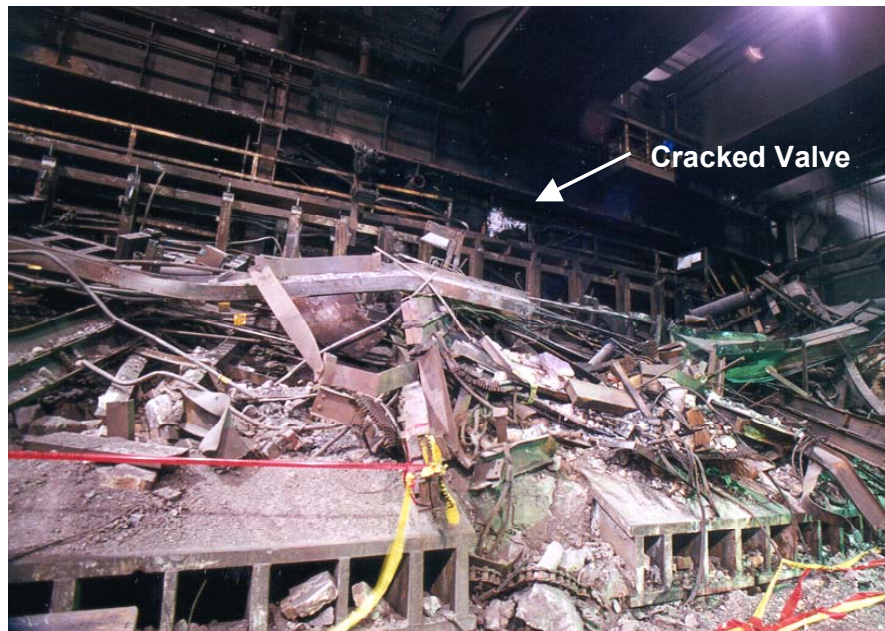
Figure 6. #4 Batch furnace debris pile present before incident.

Over the Thanksgiving 2000 weekend, the furnace structure was knocked down. Figure 6 shows the resulting rubble pile.

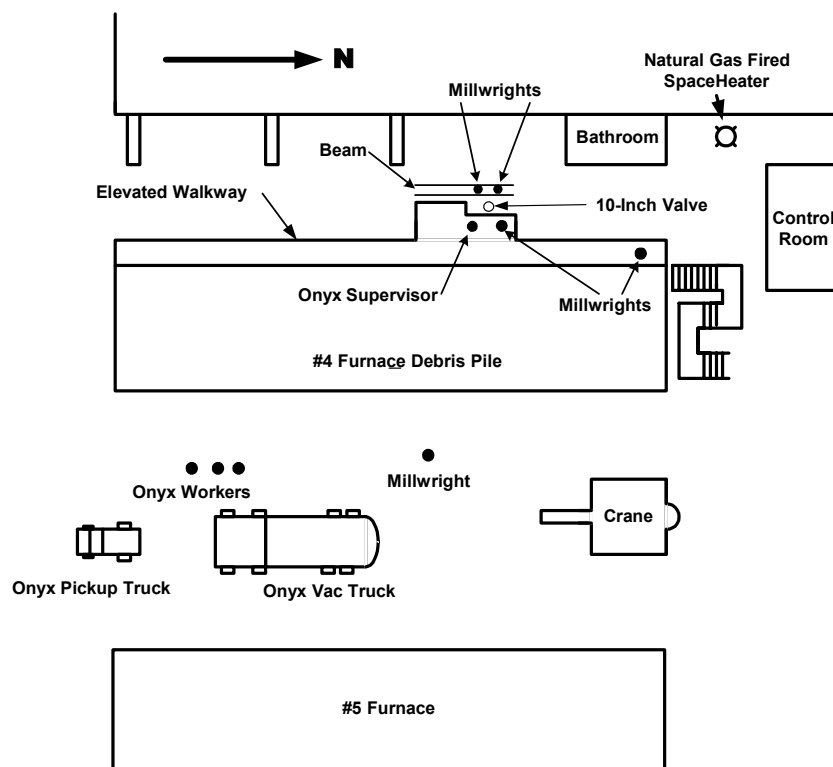
Figure 7. Location of personnel at time of release, February 2, 2001.

At this time, the workers were located as shown in Figure 7. Two millwrights were balanced on the piping behind the valve, off the walkway. Another millwright was standing on the walkway. The Onyx supervisor was standing to the side of the valve. The fourth millwright was working near the end of the walkway, and the fifth millwright and three of the Onyx personnel were located on the ground.

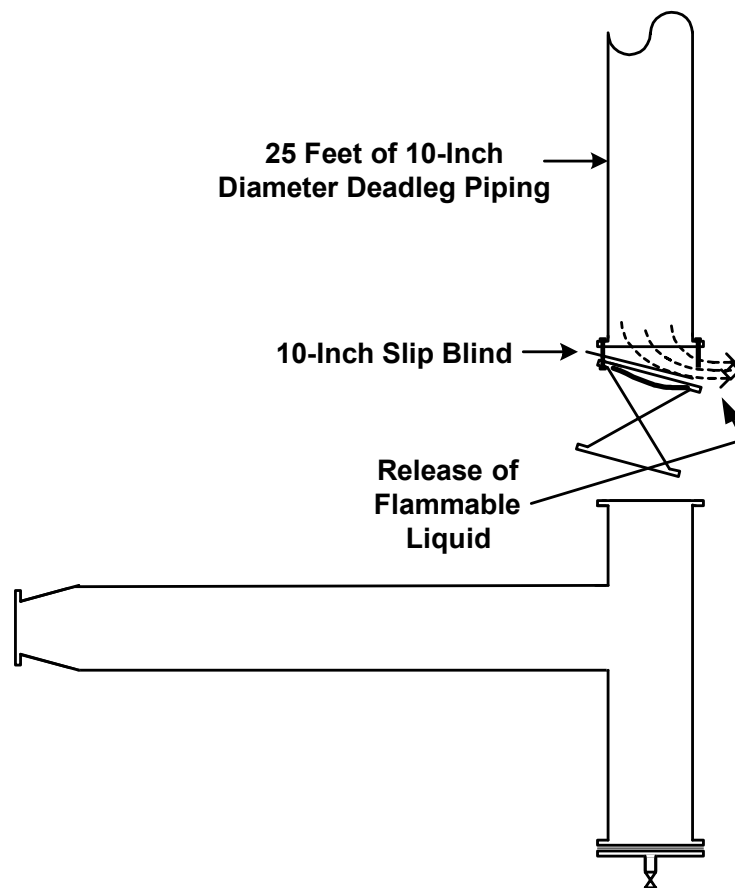
Figure 8. #4 Batch furnace COG piping, release of flammable liquid, February 2, 2001.

on the top flange of the valve, around the slip blind. A small stream of liquid began to seep from the flange, in addition to black tar-like material; and the valve suddenly dropped down several inches against the loosened bolts (Figure 8). Flammable condensate sprayed out and soaked the two millwrights positioned on the piping and the Onyx supervisor. The condensate ignited. Another millwright observed the flame move from the north and below him along the wall to the south, toward the valve. As the flame reached the valve and the now open pipe, there was a blast and flammable liquid sprayed in all directions.

The two millwrights on the piping were engulfed in the flames and fell behind the furnace structure. One of these millwrights died; the other was injured, with burns and

contusions. The Onyx supervisor fell off of the east side of the walkway onto the furnace debris pile and suffered fatal burns. (There was no railing on the east side of the walkway due to the demolition activities.). The third millwright ran down through the flames across the debris pile and was seriously burned. The fourth millwright suffered smoke inhalation as he ran down the stairs through the flames.

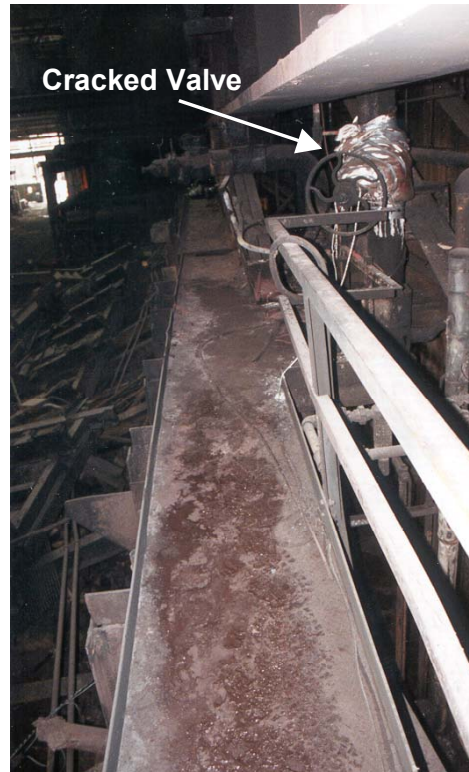
Figure 9. Elevated walkway looking south (note absence of handrail on left side).

These obstructions and lack of handrails made it difficult for workers to escape the area when the leak and fire started. It is probable that the loss of life and injuries would have

been lessened if an easier means of exit was available. The job planning process should have addressed exit routes.

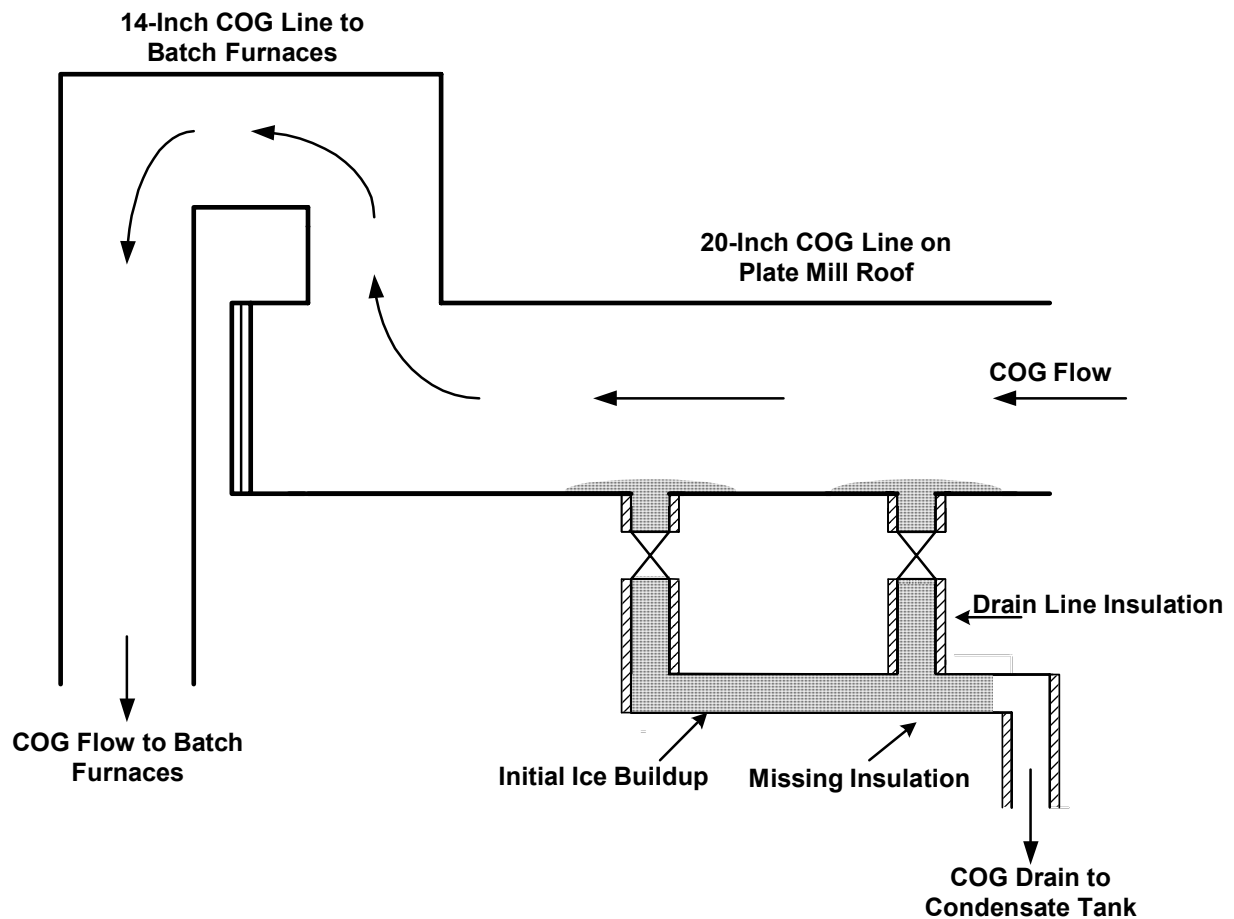
Figure 10. Probable flammable liquid buildup scenario-ice formation.

In August 1999, millwrights removed insulation from the COG condensate drain lines, located on the roof of the plate mill, to perform maintenance. The insulation was not replaced. The winterization program for the plate mill consisted of a checklist of preventive measures for locations known to be susceptible to freezing, but it did not call for a survey or inspection to identify other areas that might require or might have lost freeze protection.

The ambient temperature at the Burns Harbor mill between mid-December and mid-January was generally below freezing. Around the middle of December 2000, the COG condensate stopped draining to the tank at the plate mill. Without pipeline insulation, the water in the condensate probably froze, plugging the drain lines. It is likely that water then began to build up and freeze in the COG distribution piping. As the water froze, flammable material remained in the liquid state and floated on top of the water and ice (Figure 10).

6. Establish procedures to ensure that insulation is replaced when removed for maintenance.

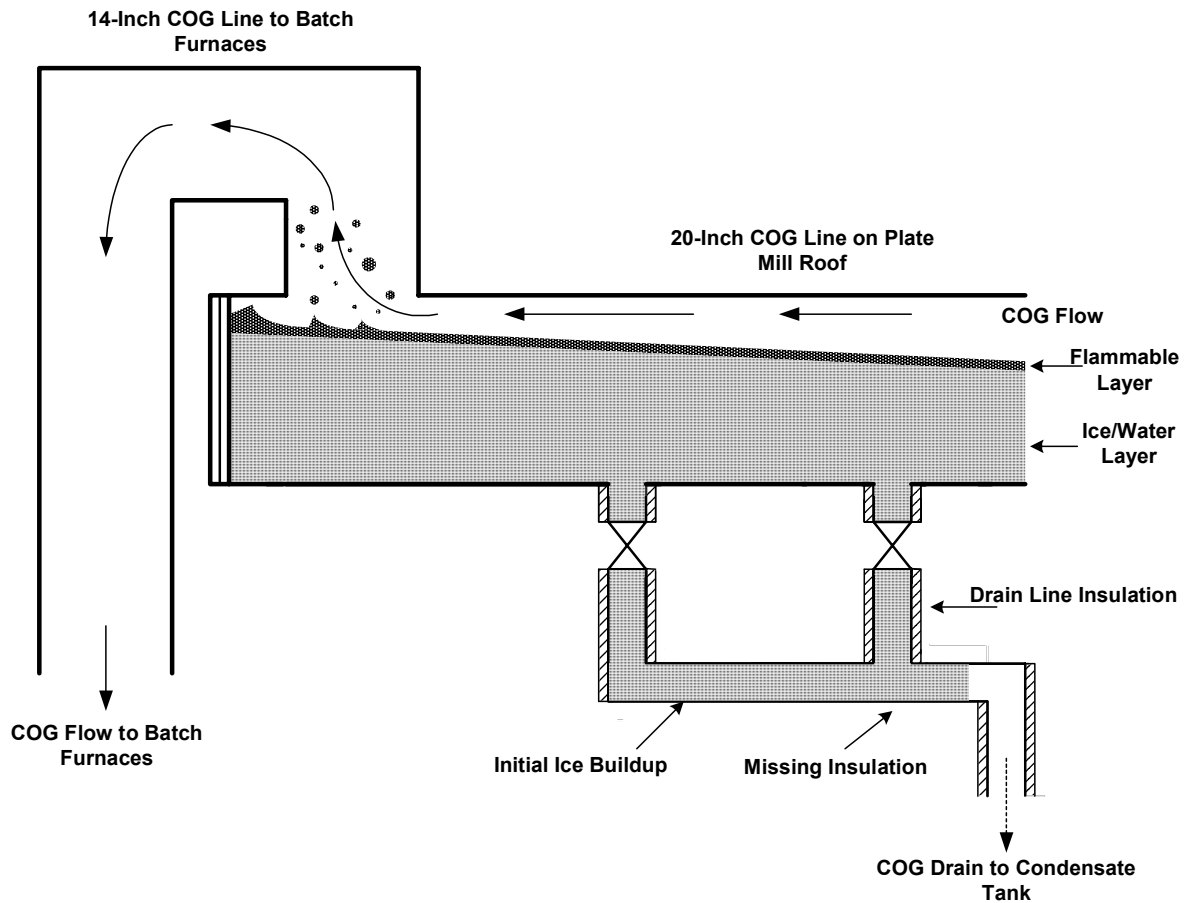
Figure 11. Probable flammable liquid carryover scenario.

As the liquid/ice level in the COG piping increased, it is likely that the flammable liquid phase either flowed over the top of it or was entrained with the coke oven gas into the furnace lines (Figure 11). This flammable liquid carryover probably settled in the lowest points of the piping, such as the deadleg at the #4 furnace—from which it was subsequently released and ignited.
