U. S. CHEMICAL SAFETY AND HAZARD INVESTIGATION BOARD

# INVESTIGATION REPORT

## PROPANE TANK EXPLOSION (2 DEATHS, 7 INJURIES)

Herrig Brothers Feather Creek Farm  
Albert City, Iowa  
APRIL 9, 1998

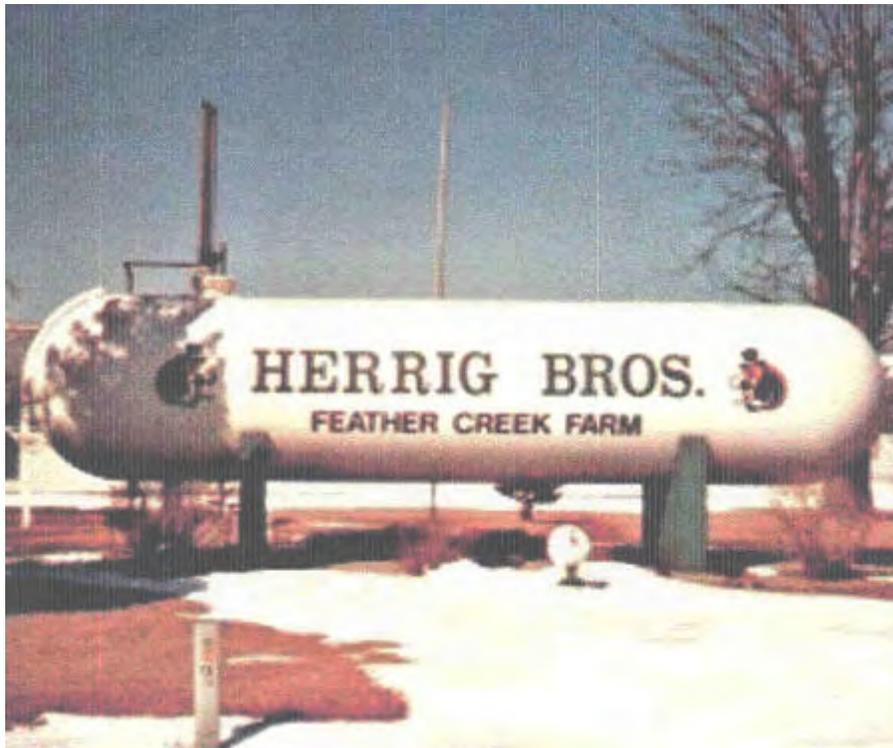
**Figure 3. The 18,000-gallon Propane Tank That Exploded**

Neither the tank nor the aboveground piping was protected by a fence or any other barrier designed to prevent damage from vehicles. According to one of the co-owners of the farm, the closest that vehicles came to the tank was when propane supply trucks parked at the fueling truck point-of-transfer to the west of the tank. There were no posted warnings for vehicles to stay out of the area immediately adjacent to the tank.

1. Install protection (i.e., fencing or barricades) to protect aboveground propane pipes from possible damage from vehicles.

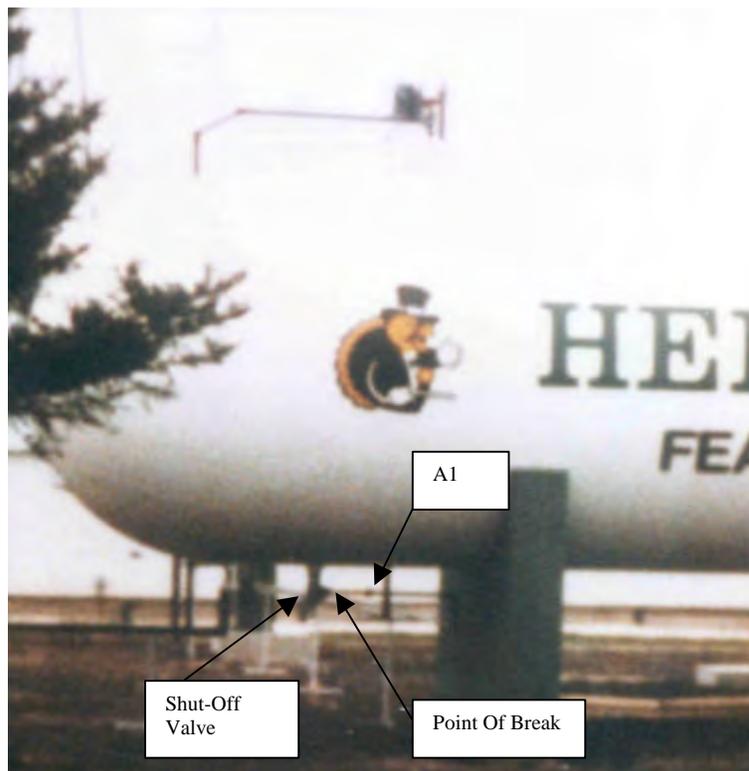
**Figure 4. Liquid Line Shut-Off Valve and Point of Break**

The first component in the liquid line leading to the vaporizer was a 3-inch excess flow valve. This metal valve was threaded into a 3-inch pipe coupling that was welded to the bottom shell of the tank. This excess flow valve was connected to a manual shut-off valve by a 2-inch diameter pipe (nipple) that was 2 inches in length. This metal 90°-angle valve changed the orientation of the liquid line from a downward direction to a horizontal and eastward direction. Two bushings (adapters designed to permit the joining of pipes with different diameters) connected the shut-off valve to a ¾-inch schedule 80 carbon steel pipe (outlet pipe). This outlet pipe ran to the east for approximately 30 inches toward the concrete saddle supporting the tank, and then turned downward for approximately 7 inches. This segment of pipe was subsequently labeled “A1” for evidentiary purposes (See Figure 4 below and Figure 29 in Appendix B). The outlet pipe then turned again to the north and ran to the vaporizers on a series of steel supports spaced at regular intervals. These supports placed the outlet pipe approximately 3 feet above the ground for its entire 37-foot course from the tank to the vaporizers. The arrows in Figure 4 point to liquid line components and to the approximate location of the break that occurred under the tank.

The liquid line (which measured approximately  $\frac{3}{4}$ -inch inside diameter) was completely severed from the tank at the location where it was connected to a manual shut-off valve directly beneath the tank (see Figure 6, item A20). An excess flow valve protecting the liquid line (see Figure 6, item FV3) failed to function, and propane leaked out of the tank at the point of the break. As the liquid propane sprayed out of the tank, it rapidly changed to vapor. Propane vapor may have also leaked from the damaged vapor line.<sup>8</sup> Propane from the damaged pipes formed a cloud, and within a few minutes this propane vapor ignited. Although the source of ignition was not conclusively established, the likely source was the direct-fired vaporizers.<sup>9</sup> A fire, fed by the broken liquid line, began burning vigorously under the tank.

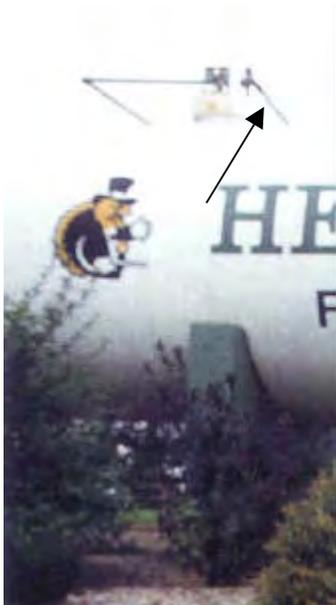
**Figure 5a. Southern Exposure**

The vapor line involved in this incident exited the tank vertically from a 2-inch excess flow valve screwed into the manway<sup>7</sup> on top of the tank. A small segment of pipe connected this excess flow valve to a shut-off valve. This 90°-angle valve changed the course of the vapor line to a horizontal direction. The vapor line then ran northward until it extended beyond the side of the tank and then ran downward to the same elevation as the liquid line. From this point, the vapor line ran parallel to the liquid line on the same series of steel supports until both lines reached the vaporizers. Figures 5a and 5b are photographs of the west end of the tank that illustrate the vapor lines exiting the manway. The arrows point to the vapor line that ran to the vaporizers.

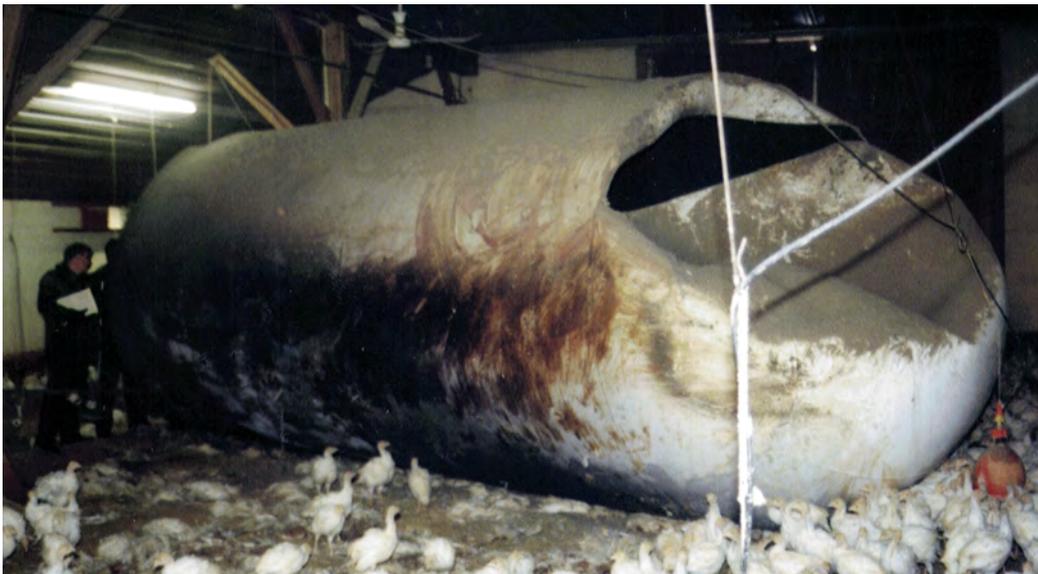
**Figure 10. Piece of 18,000-gallon Tank Inside Turkey Barn (1f)**

diameter) was propelled to the east, through the end of a turkey barn wall (see Figure 2, item 1f) and came to rest inside the barn (see Figure 10). This piece, which represented about one-half of the tank, caused the damage to the west end of turkey barn 1f, shown in Figure 11. A second large fragment traveled north, causing the damage to another turkey barn shown in Figure 12. (See also Figure 2, item 1g for location of the barn). Two other large pieces traveled in a northwesterly direction and landed between a workshop and a feed storage bin. One of these pieces likely caused the damage to the two-story workshop shown in Figure 13. Smaller tank pieces traveled in various directions. Some of these pieces were discovered in the grain fields that surround the property. A map that depicts the location of tank debris following the explosion is provided in Appendix C.

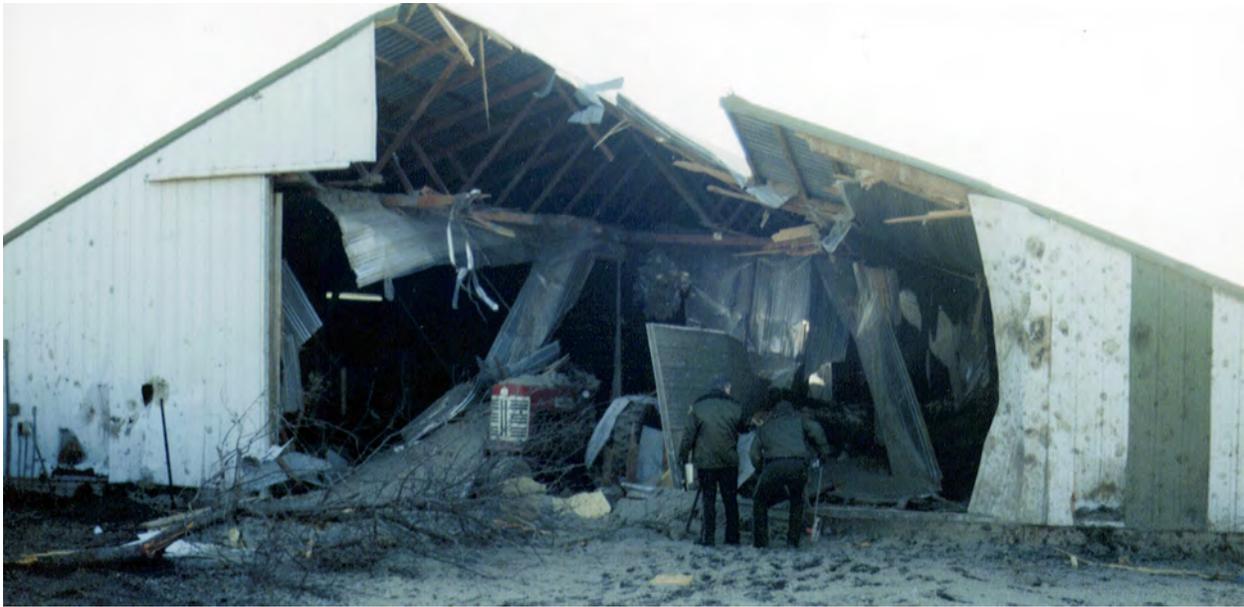
**Figure 11. Damage to West End of Turkey Barn (1f)**

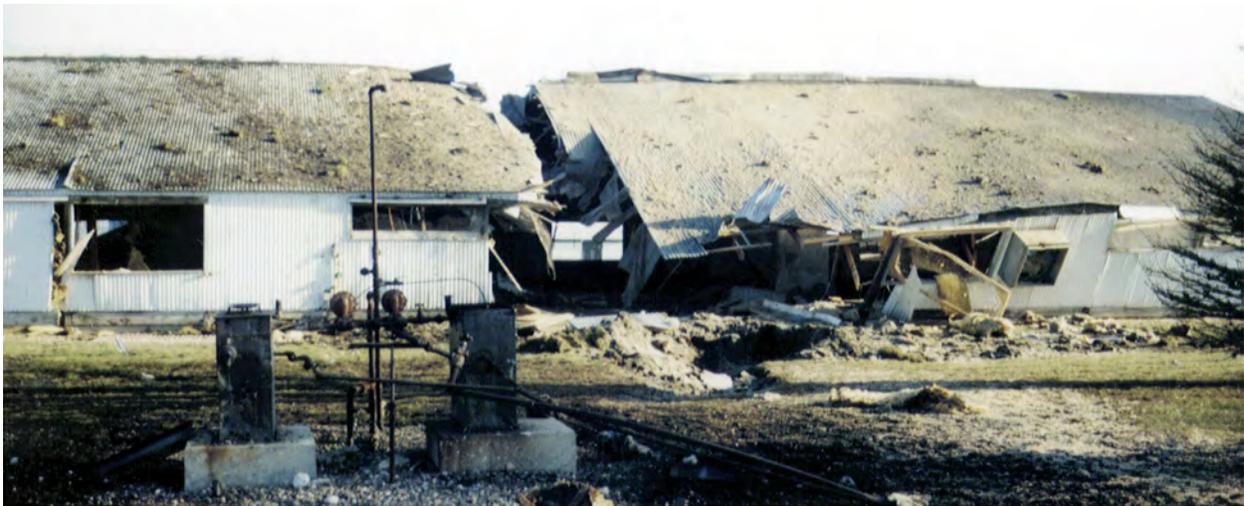
**Figure 12. Damage to Turkey Barn (1g) Caused by Impact of Large Tank Fragment**

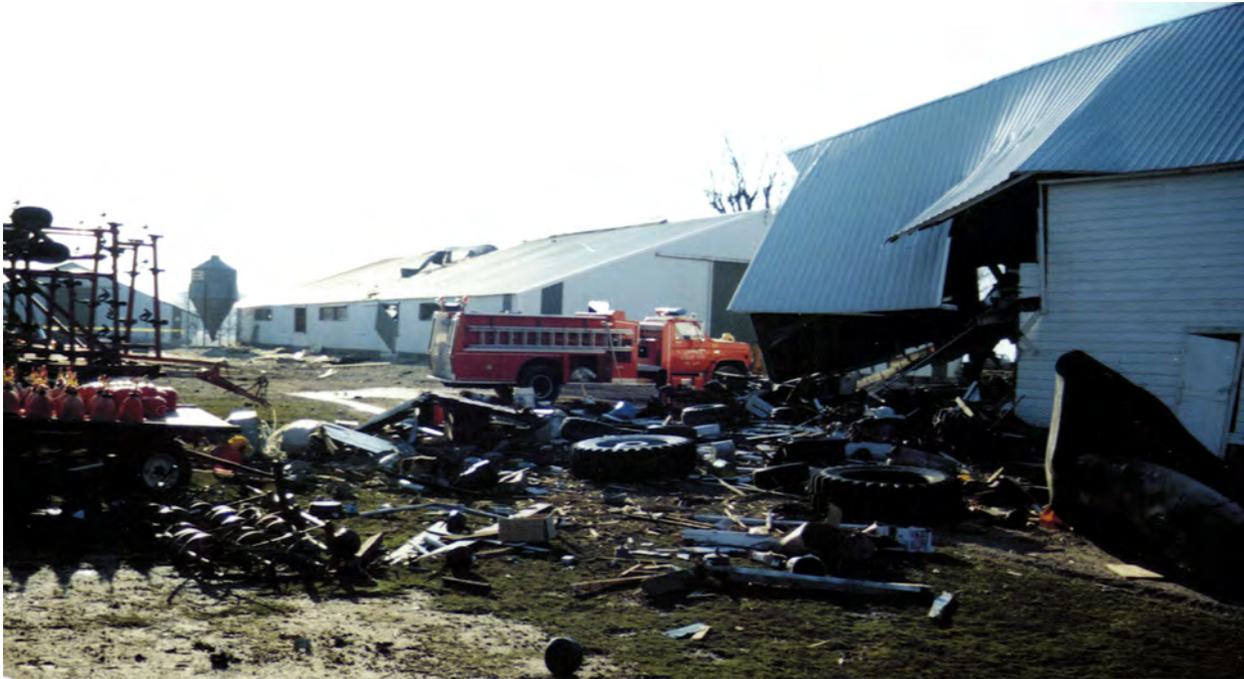
**Figure 13. Southeastern View of Damage to Workshop Caused by Impact of Large Tank Fragment**

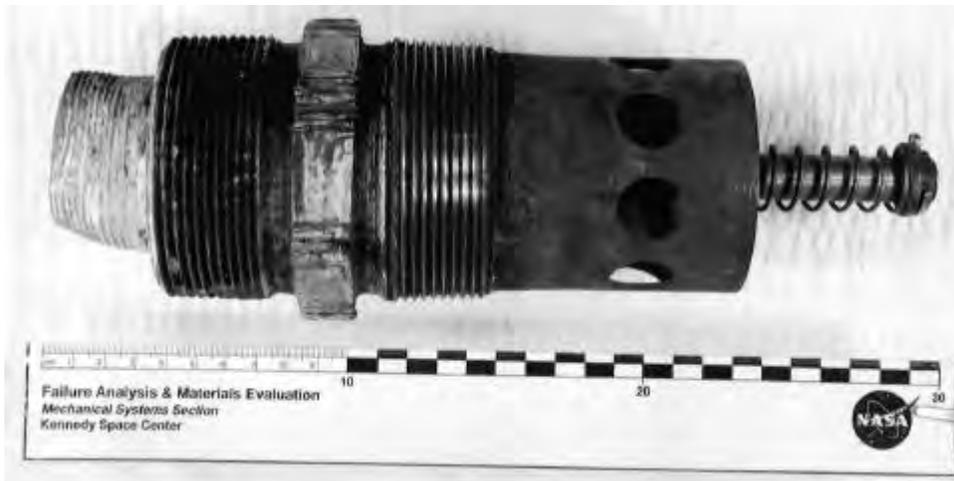
FIGURE 5

The liquid line that ran from the tank to the vaporizers was equipped with an excess flow valve, which was designed to automatically close when the flow through the valve exceeded a predetermined rate -- the closing rating. This particular valve had a closing rating of approximately 200 gallons per minute. In the event of a complete break in the outlet pipe downstream from the excess flow valve, the valve should have closed and greatly reduced<sup>24</sup> the flow of propane from the broken pipe. When the ATV severed the liquid line, however, the excess flow valve failed to close because the flow capacity of the outlet piping system was less than the closing rating of the excess flow valve.

Liquid flow control valve FV3 as-received in the laboratory.

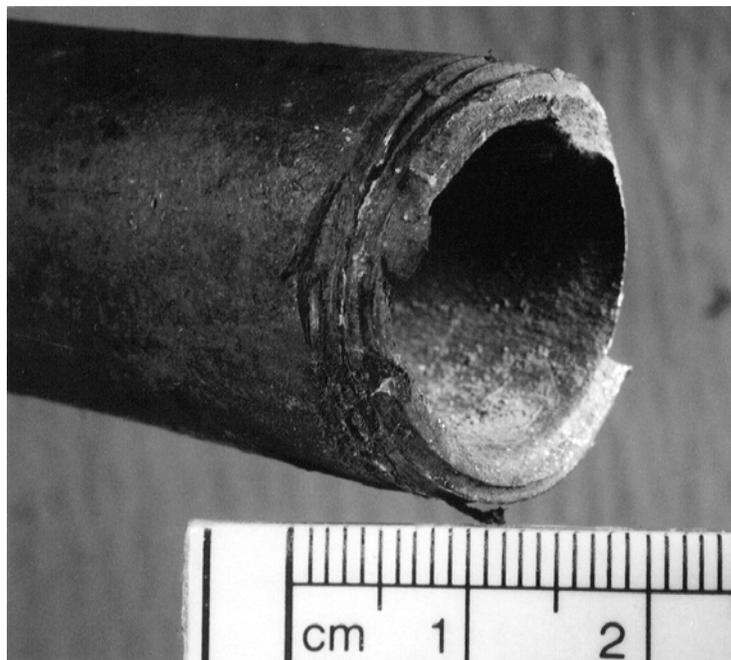
FIGURE 11

Fracture surface of the one inch pipe that previously connected to hand valve A20.

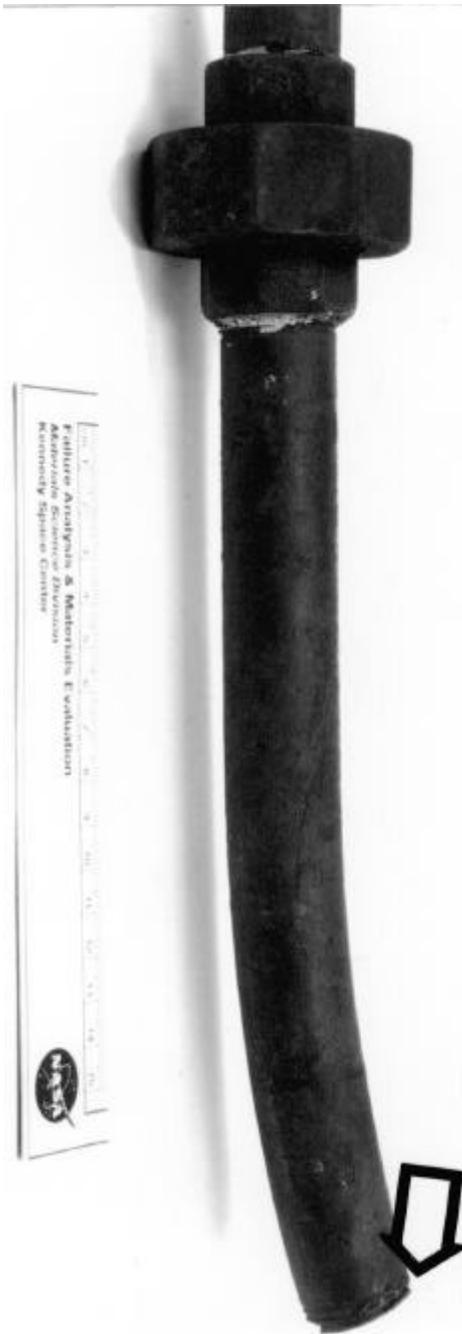
FIGURE 36

View of the end of the liquid propane pipe which fed the vaporizer and mated with the outlet of the hand valve. Note the tube bend and deformation of the threads (arrow).

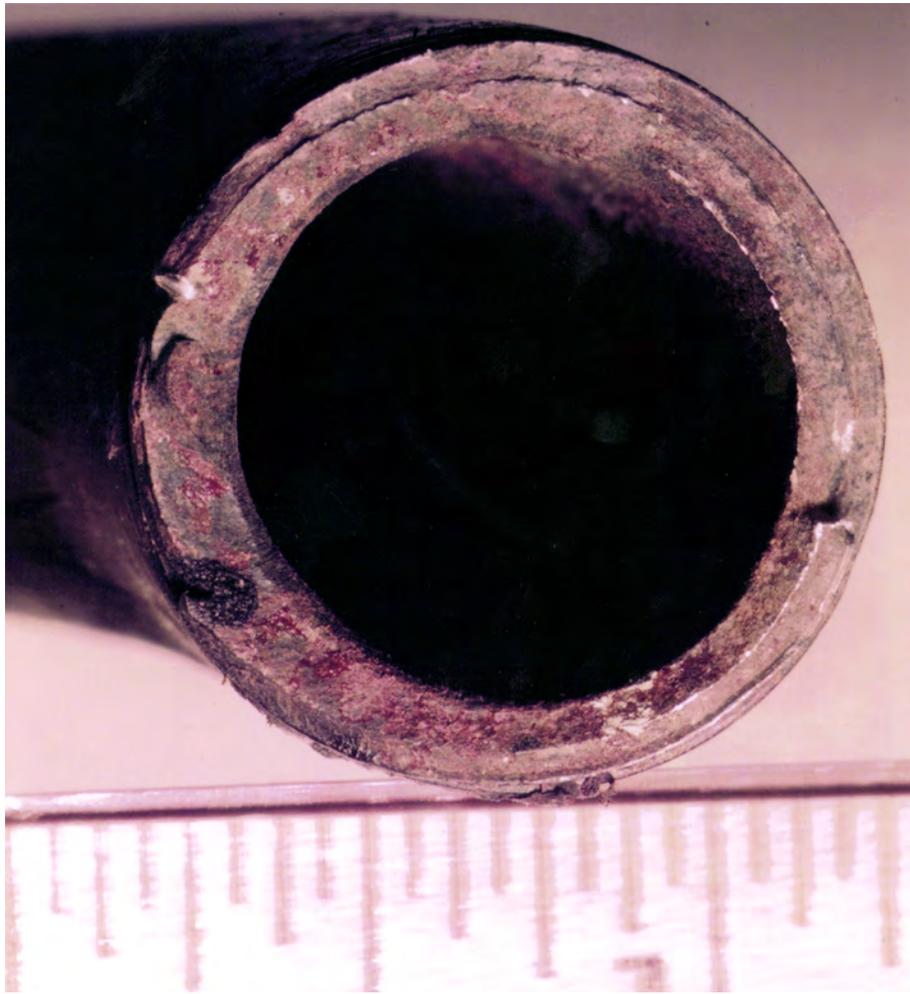
Horizontal stress patterns identified on the edge of the A1 pipe segment that connected to the A20 valve also revealed that the pipe failed in a horizontal plane (see Figure 37, Appendix B). Had the A1 piece been completely connected to the A20 valve at the time of the explosion, these stress patterns would almost certainly have been twisted with a vertical orientation, not a horizontal one. Thus, the force required to produce these stress patterns most likely occurred when the ATV hit the liquid line. The direction of thread deformation on the A1 edge (Appendix B, Figures 36-39) also indicates that the pipe was subjected to a horizontally applied load such as that likely caused by the impact of the ATV.

Figure 37  
View of the fracture surface of the one inch pipe (A1) which carried liquid propane to the vaporizer unit

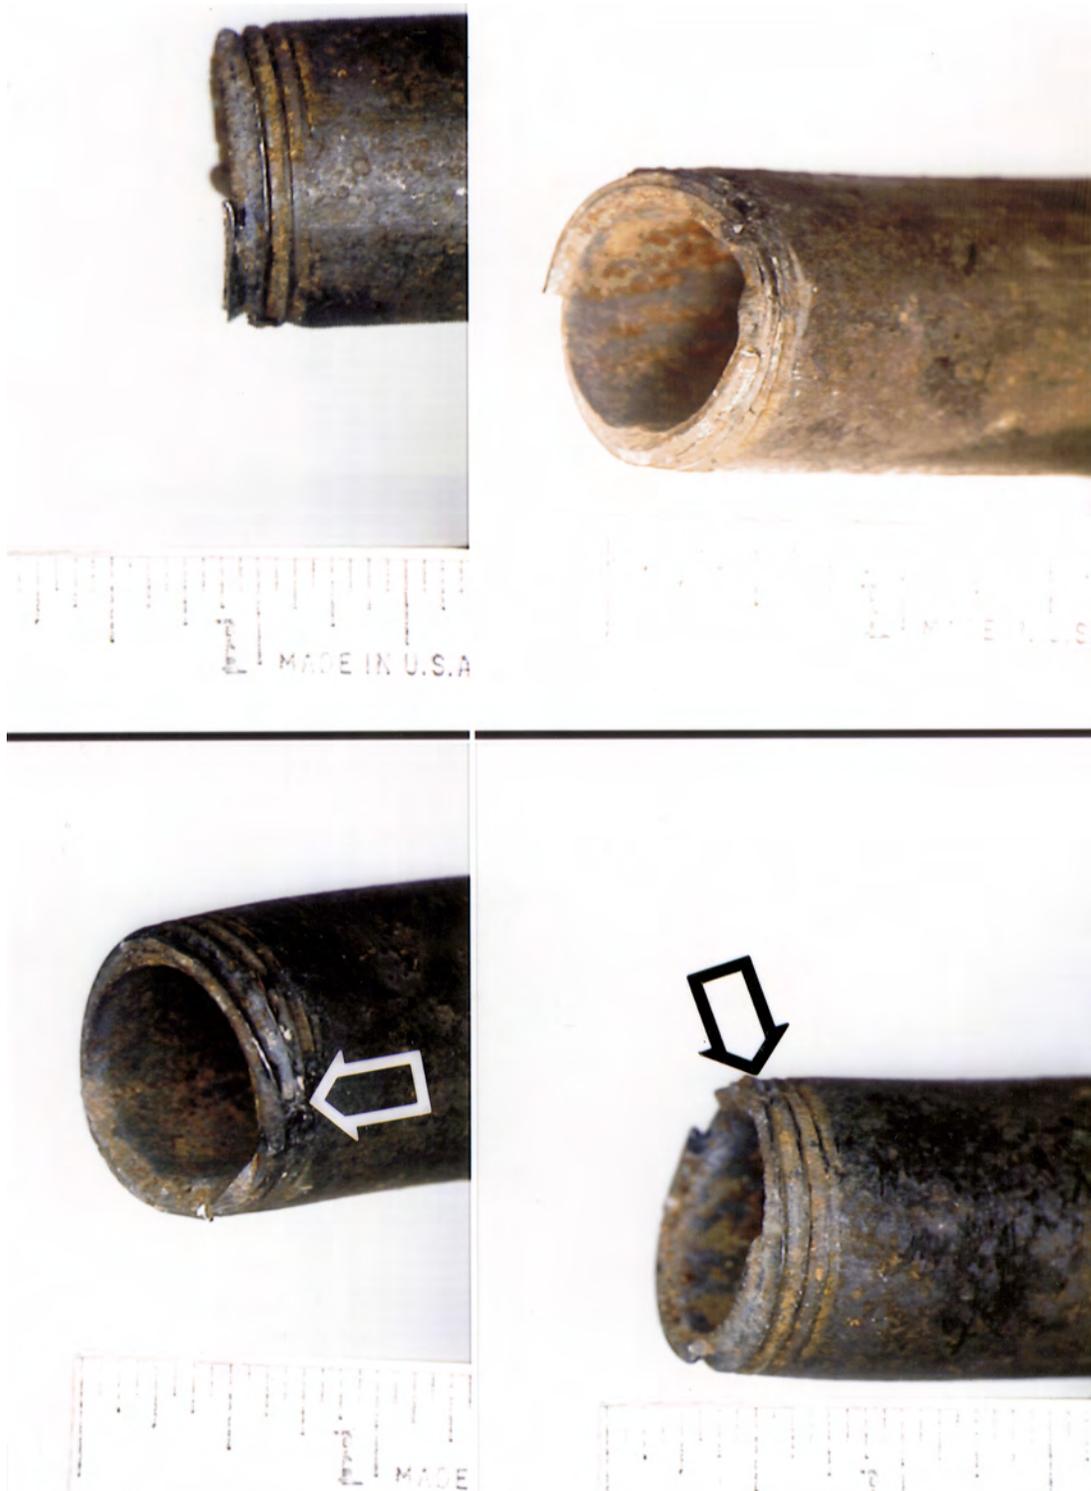
Figure 38

90° rotational view of the threaded end of the one inch pipe (A1). Arrow indicate deformed threads.

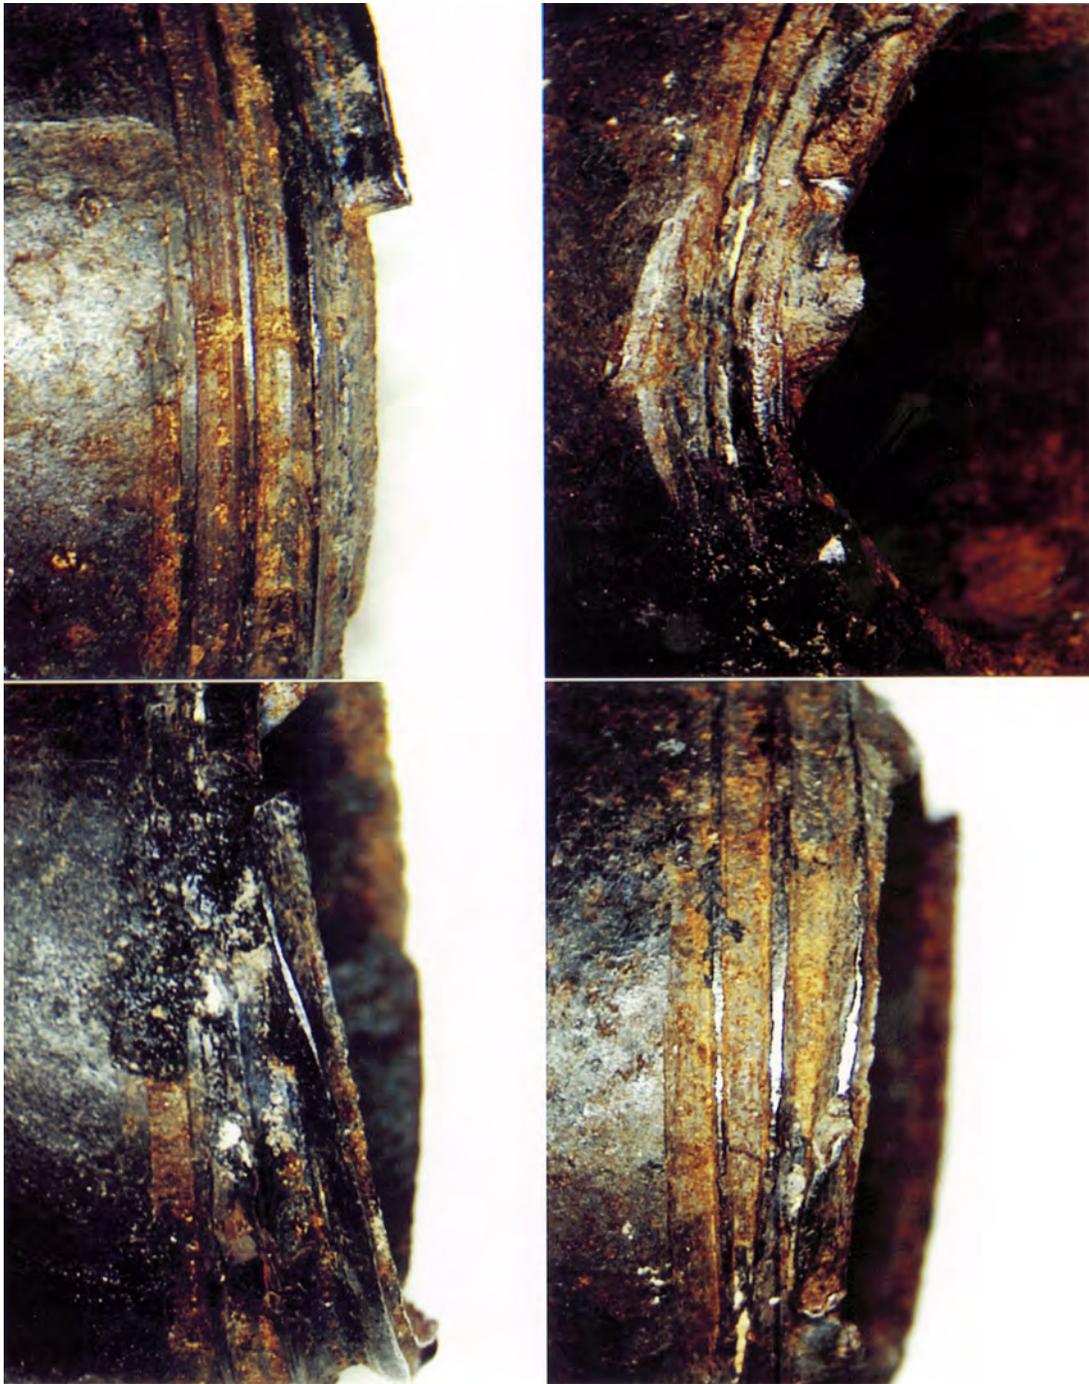
Figure 39  
90° rotational view of the condition of the pipe threads on the one inch pipe (A1).  
MAGNIFICATION: 5X
