U.S. CHEMICAL SAFETY AND HAZARD INVESTIGATION BOARD

# INVESTIGATION REPORT

## PETROLEUM PRODUCTS FACILITY INCIDENT

**THIRD COAST INDUSTRIES**

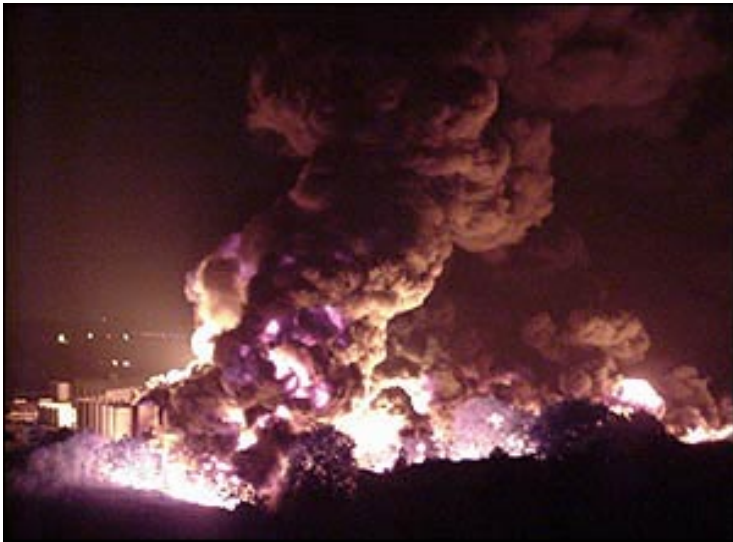
As the fire spread into the storage tank area, the liquid pool fire was also observed to be moving from the warehouse 1 area toward the front of the facility. This caused the fire to spread to a loaded box trailer and warehouse 2, and also across the southern property line into a neighbor's garage and machine shop. Over the course of the next several hours, the fire engulfed the entire tank farm and spread through warehouses 2, 3, and 4 (Figures 4 and 5)

**Figure 4. Peak hours of fire, early morning, May 1, 2002.**

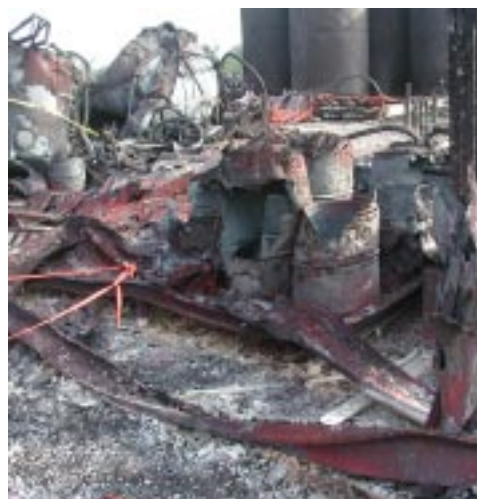
Approximately 10 drums of combustible liquid were located on and around packaging line 4, just outside warehouse 1 (Figure 6). The drums would have loosely surrounded the worktable, where the security guard observed the initial fire. Evidence indicates that these drums ruptured due to internal pressure and released their contents, which subsequently ignited. The sounds heard by the Pearland Fire Chief upon his arrival on scene were most likely caused by the drums rupturing.

The drums at packaging line 4 were of standard metal construction without drum relief devices. This device is a plastic closure that melts during fire exposure and remains open, allowing pressure to vent. It is an option for flammable and combustible liquid containers. The drum relief device protects the container from failure, which would release the entire contents, and also helps prevent the risk of drums rocketing into the air and causing damage when they fall. Empty drums were found on property surrounding the Third Coast site.

Figure 6. Drums located at packaging line 4.

*Evidence indicates that these drums ruptured due to internal pressure and released their contents, which subsequently ignited.*

The Pearland Fire Chief's initial observation of a pool fire surrounding the box vans and the tank wagon indicates that the drummed material near packaging line 4 was likely the first large quantity of liquid involved in the fire. Steel drums exposed to a pool fire will typically rupture within 5 to 15 minutes due to the buildup of internal pressure. "The end result of a sealed drum exposed to fire is the violent failure of the container" (FM, 2000b). When the drums ruptured, their contents added more fuel to the growing fire and spread it faster.

Although drum relief devices do not prevent ultimate failure and release of liquid contents when exposed to a long-duration fire, they do allow for longer retention of liquid. If the Third Coast drums had been equipped with relief devices, it is likely that they would have largely vented pressure rather than rupturing.

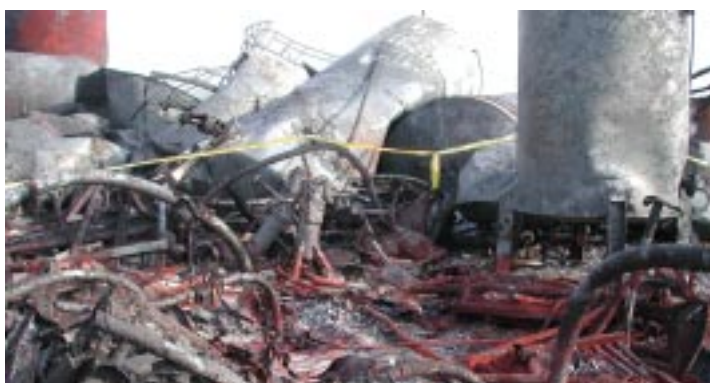
Several 2,000-gallon blend tanks were located to the northeast of warehouse 1. The tanks were supported about 3 feet above ground by steel legs with no external fireproofing. As the pool fire surrounded this area, the legs buckled, and the tanks toppled and contributed their contents to the fire (Figure 7).

Figure 7. Collapsed blend tanks located near warehouse 1.

The blend tanks were located directly adjacent to the storage tank farm, separated by a low dike wall. In addition, numerous steel pipes from the storage tanks traversed the dike walls. Although valves were closed at the end of each pipe, the lines were typically not isolated with closed valves at the storage tanks. As the pipelines failed due to fire exposure, they released materials from the storage tanks that also contributed to the pool fire.

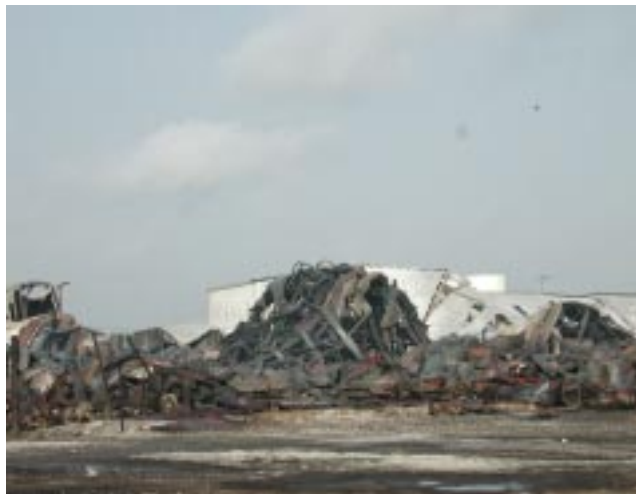
The Third Coast facility lacked adequate drainage or containment to prevent liquids released from the drums, blend tanks, and tank wagon from flowing toward the rest of the facility or offsite. The dike wall on the south side of the tank farm, closest to the fire origin, was composed of two courses of hollow cinderblock. The cinderblock was broken in places and mortared joints were cracked, which allowed the burning liquid to enter the tank farm and begin pooling around the storage tanks. The intense heat from the fire caused the bulk storage tanks to fail, either by overpressure or collapse; the containerized combustible liquids stored inside burned and destroyed the warehouse buildings (Figures 9 and 10).

Figure 10. Remains of warehouse.

The warehouse walls at Third Coast were constructed of corrugated metal. It is likely that they would have lasted only 15 to 30 minutes before failing. As a result, the fire quickly breached the warehouse walls and moved through the facility.

*The warehouse walls at Third Coast were constructed of corrugated metal. It is likely that they would have lasted only 15 to 30 minutes before failing.*

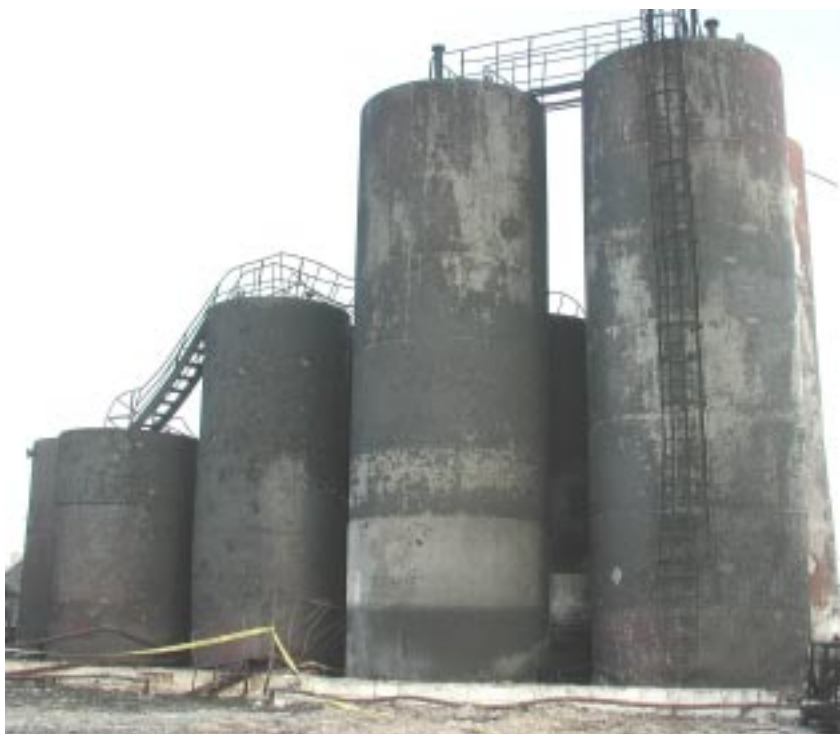
*The cinderblock [wall] was broken in places and mortared joints were cracked, which allowed the burning liquid to enter the tank farm and begin pooling around the storage tanks.*

The storage tanks were located within 1 foot of the dike wall; in the vicinity of the initial fire, the wall was composed of two courses of hollow masonry cinderblock. The wall was in poor condition and cracked in some spots (Figure 11), which facilitated spread of the pool fire. Because of the proximity of the tanks to the wall and processing areas, radiant heat from the pool fire would have heated the contents of the closest tanks.

Figure 11. Section of south dike wall, storage tank farm.
