# Safety Bulletin

U.S. Chemical Safety and Hazard Investigation Board

## MANAGEMENT OF CHANGE

No. 2001-04-SB | August 2001

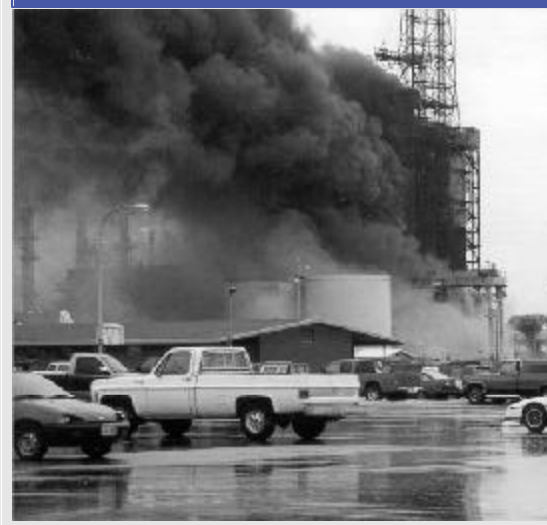
On November 25, 1998, a fire at the Equilon Enterprises oil refinery delayed coking unit in Anacortes, Washington, caused six fatalities (Figure 1). A loss of electric power and steam supply approximately 37 hours prior to the fire had resulted in abnormal process conditions.

● Figure 1. Equilon Enterprises oil refinery fire.

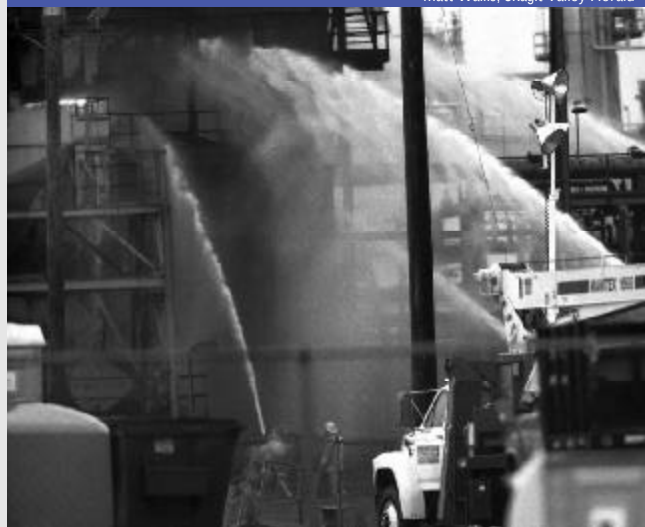
The top head was unbolted and lifted from the drum. The bottom head was also unbolted and held in place by a hydraulic dolly. The operator then activated a release mechanism to lower the dolly. Witnesses reported hearing a whooshing sound and seeing a white cloud of vapor emanate from the bottom of the drum. The hot petroleum vapor burst into flames. The process supervisor, an operator, and the four contract personnel assisting were caught in the fire and did not survive (Figure 2).

● Figure 2. Fire control efforts at Equilon refinery.

After the incident, Equilon relocated the controls for the hydraulic dolly to allow workers to position themselves farther from a drum when opening it.

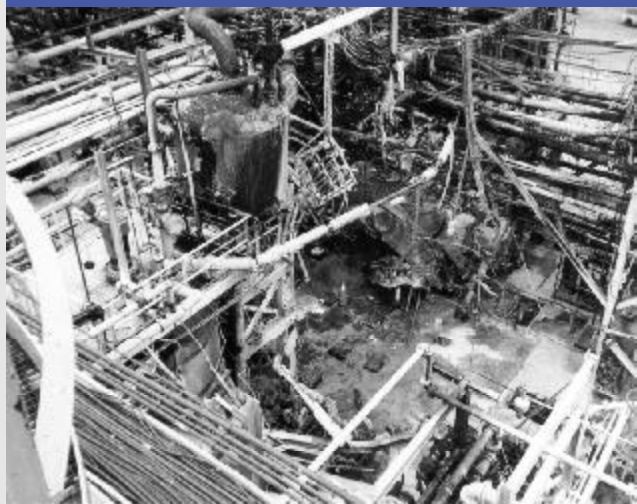
On October 13, 1998, a reaction vessel explosion and fire at the CONDEA Vista Company detergent alkylate plant in Baltimore, Maryland, injured four people (Figure 3).

● Figure 3. Site of ruptured reactor, CONDEA Vista Company detergent alkylate plant.

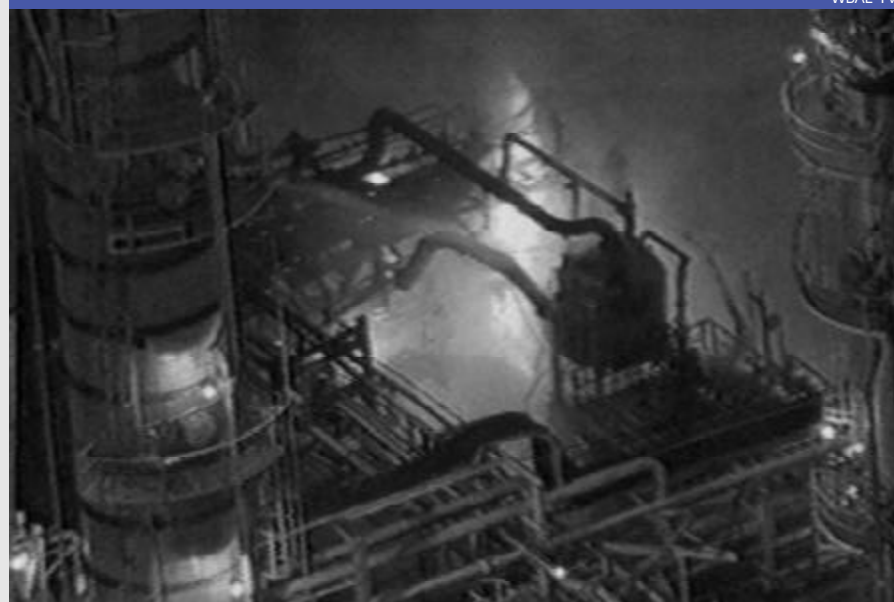
The night shift supervisor instructed an operator to add steam to the reactor. Minutes after the operator started to continuously inject the steam, it reacted with the metallic aluminum and the aluminum chloride residue in the sludge. The reactor vessel exploded (Figure 4).

From both a project and an operational standpoint, the incident at CONDEA Vista emphasizes the importance of systematically managing changes. Post-incident investigations noted that the density of the new catalyst (powdered aluminum) was higher than that of aluminum chloride. The higher density material—combined with problems related to initial overfeeding of the aluminum—overtaxed the mixing capability of the agitator and allowed aluminum to settle in the bottom of the reactor, where it plugged the lower nozzle and accumulated as sludge.

● Figure 4. CONDEA Vista plant fire.
