Safety Bulletin

No. 2005-04-B | October 12, 2006

BP TEXAS CITY, TX REFINERY FIRE

POSITIVE MATERIAL VERIFICATION: PREVENT ERRORS DURING ALLOY STEEL SYSTEMS MAINTENANCE

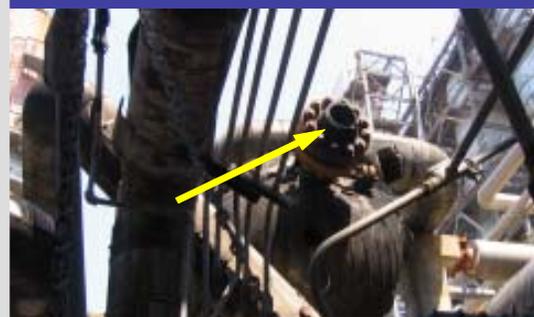
The RHU incident investigation determined that an 8-inch diameter carbon steel elbow inadvertently installed in a high-pressure, high-temperature hydrogen line ruptured after operating for only 3 months. The escaping hydrogen gas from the ruptured elbow quickly ignited.

Figure 1. Carbon steel RHU heat exchanger outlet pipe (arrow) ruptured after operating only 3 months in high-temperature hydrogen service.

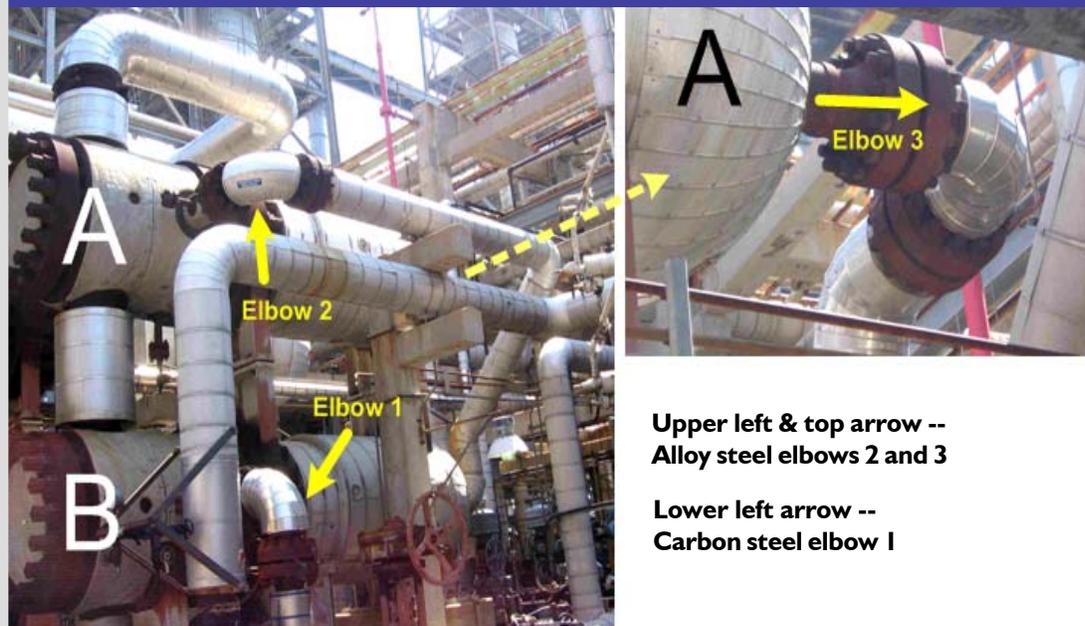
Figure 2. Dimensionally identical piping elbows on RHU heat exchangers A and B.

Construction costs may have been saved by making elbows 1, 2, and 3 on each heat exchanger assembly dimensionally identical, as doing so requires fewer pipe assembly fabrication drawings and weld joints in each assembly. Because the elbows are dimensionally identical, the piping contractor had to ensure that the low alloy steel elbows 2 and 3 were installed in the correct locations when the RHU was built. Had the elbow 1 design

dimensions been different, elbow 1 would not have been interchangeable with elbow 2 or 3 (see Figure 2).

Designers should consider the entire process system life cycle, including planned maintenance, to avoid piping configurations that allow critical alloy piping components to be interchanged with non-compatible piping components.

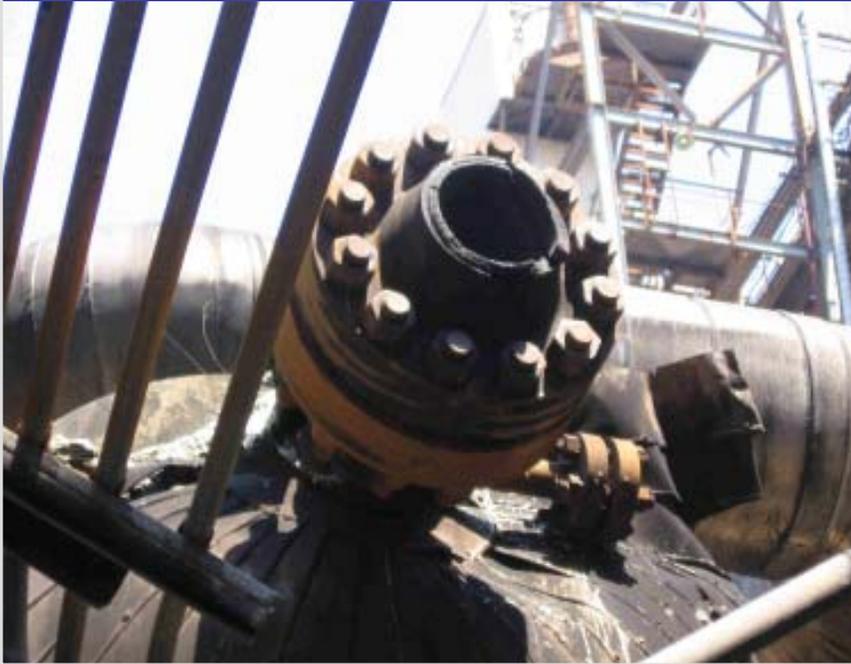
BP personnel examined the extensively damaged unit and determined that an 8-inch diameter pipe elbow on an RHU heat exchanger hydrogen gas outlet pipe ruptured (Figure 3). The BP investigation team recovered the elbow segments that remained attached to the pipe and three pieces found in the debris (Figure 4).

Figure 3. Ruptured 8-inch pipe elbow on heat exchanger A outlet.

The elbow segments recovered from the damaged unit were examined to identify the steel and the failure mechanism. Chemical analysis and microscopic examination determined that the elbow was made from carbon steel. Microscopic examination also revealed that the segments were severely decarburized and had deep fissures on the inside surface (see Figure 4). The decarburized steel and severe fissuring confirmed that HTHA caused the catastrophic elbow failure.

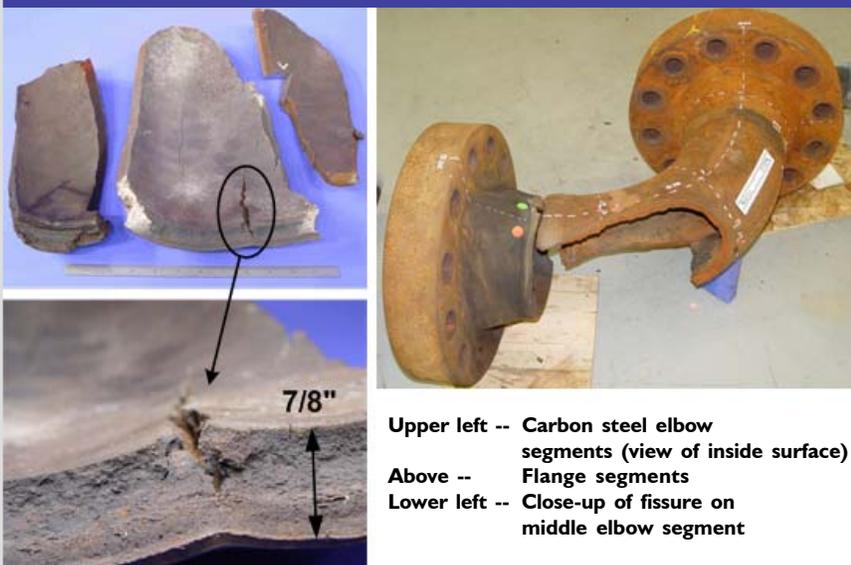
Figure 4. Ruptured 8-inch carbon steel pipe elbow pieces recovered after the fire

Detailed metallurgical examinations and micro-hardness testing quantified the extent of hydrogen damage to estimate the total time the elbow could have been in the high-temperature, high-pressure hydrogen service before it failed. The results, compared to existing experimental data and empirical service life predictions, concluded that the elbow failed after being in service for fewer than 3000 hours.⁴

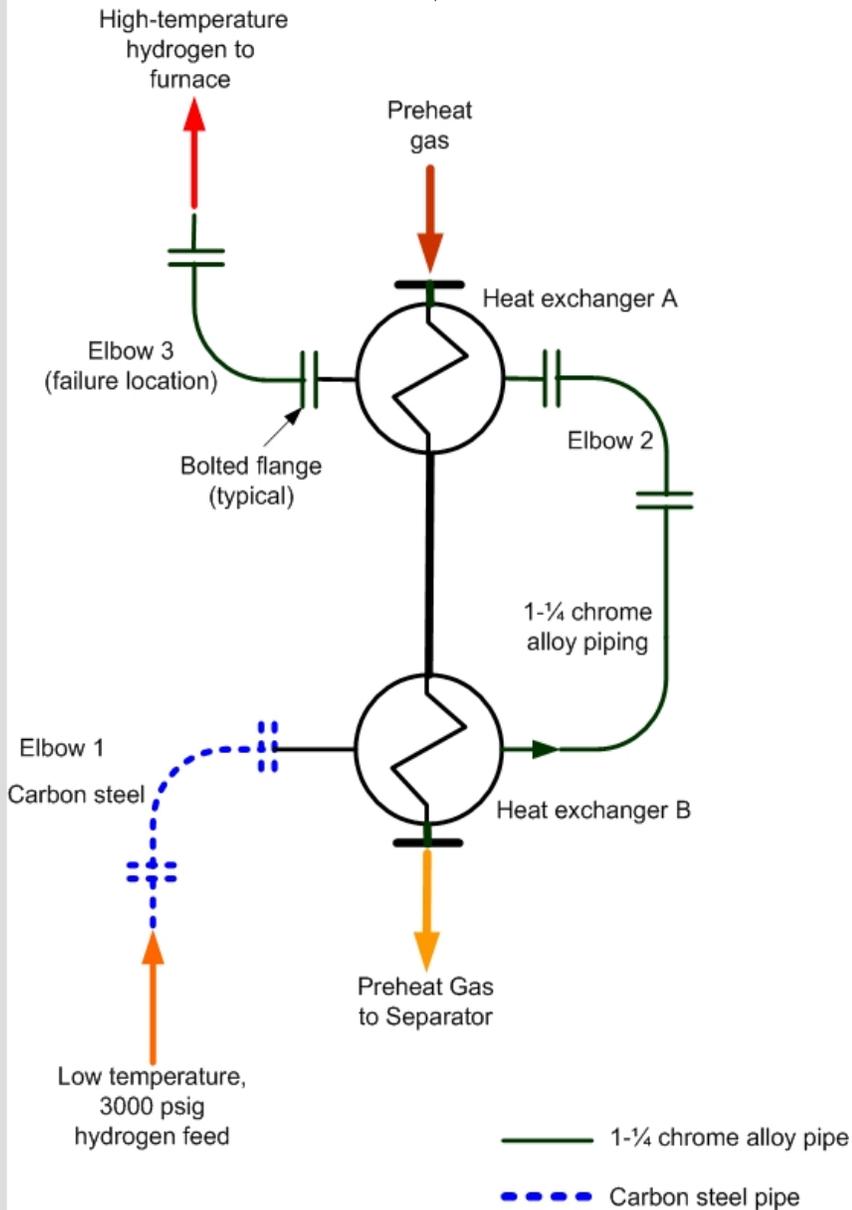
Designed in the early 1980s, the RHU has three parallel operating systems. Each system contains a heat exchanger assembly that consists of two series-connected heat exchangers to preheat the hydrogen. For high-temperature hydrogen gas service piping to resist HTHA, the piping design specification requires 1.25% chrome “low alloy” steel, but for piping in hydrogen service at low temperatures, or those below 450°F, non-HTHA resistant carbon steel is specified, as using this material minimizes material cost.⁵ Because heat exchanger B inlet piping and components operate at temperatures below 450°F, they are carbon steel; heat exchanger B outlet and all downstream piping and components (Figure 5) are required to be low alloy steel because they operate at temperatures above 500°F.

Figure 5. RHU hydrogen heat exchanger piping material requirements.

Metallurgical analyses after the incident concluded that the carbon steel elbow could withstand the high-temperature, high-pressure service for only a few thousand hours. X-ray fluorescence testing confirmed that an alloy steel elbow was installed in the carbon steel elbow position on the heat exchanger B inlet. Therefore, the CSB concluded that carbon steel elbow

1 was inadvertently switched with alloy steel elbow 3 when the maintenance contractor reassembled the piping during the winter 2005 heat exchanger overhaul.

In-situ alloy steel material verification using x-ray fluorescence, or other non-destructive material testing, is an accurate, inexpensive, and fast PMI test method. Facility owners, operators, and maintenance contractors should ensure that the verification program requires PMI testing, such as specified in API Recommended Practice 578, or other suitable verification process, for all critical service alloy steel piping components that are removed and reinstalled during maintenance.

At a minimum, piping components and their respective locations should be tagged or marked before removal, and the correct installed location is verified after reinstallation.
