# Safety Bulletin

U.S. Chemical Safety and Hazard Investigation Board

No. 2005-04-B | October 12, 2006

*BP TEXAS CITY, TX REFINERY FIRE*

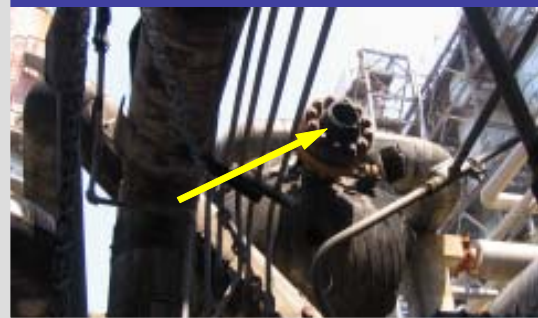
The RHU incident investigation determined that an 8-inch diameter carbon steel elbow inadvertently installed in a high-pressure, high-temperature hydrogen line ruptured after operating for only 3 months. The escaping hydrogen gas from the ruptured elbow quickly ignited.

This incident occurred after a maintenance contractor accidentally switched a carbon steel elbow with an alloy steel elbow during a scheduled heat exchanger overhaul in February 2005. The alloy steel elbow was resistant to high temperature hydrogen attack (HTHA) but the carbon steel elbow was not. Metallurgical analyses of the failed elbow concluded that HTHA severely weakened the carbon steel elbow.

Figure 1. Carbon steel RHU heat exchanger outlet pipe (arrow) ruptured after operating only 3 months in high-temperature hydrogen service.

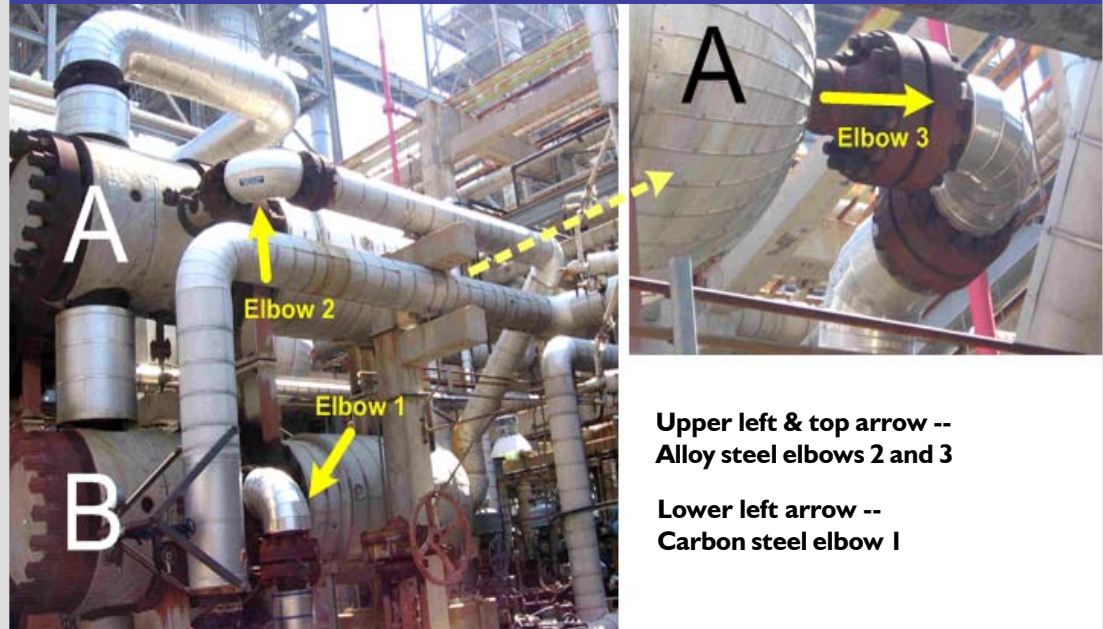
Figure 2. Dimensionally identical piping elbows on RHU heat exchangers A and B.

Construction costs may have been saved by making elbows 1, 2, and 3 on each heat exchanger assembly dimensionally identical, as doing so requires fewer pipe assembly fabrication drawings and weld joints in each assembly. Because the elbows are dimensionally identical, the piping contractor had to ensure that the low alloy steel elbows 2 and 3 were installed in the correct locations when the RHU was built. Had the elbow 1 design

dimensions been different, elbow 1 would not have been interchangeable with elbow 2 or 3 (see Figure 2).

Because of this component interchangeability, any heat exchanger piping disassembly/reassembly for maintenance or repair requires the maintenance crew to be careful to install each elbow in the correct location. Because carbon steel and low alloy steel are visually indistinguishable, special test equipment<sup>6</sup> is needed to distinguish the two low alloy steel elbows from the carbon steel elbow. Otherwise, to prevent switching elbow 2 or 3 with incompatible carbon steel elbow 1, the crew must clearly label or mark each elbow before removing them, then confirm that each has been reinstalled in the correct location.

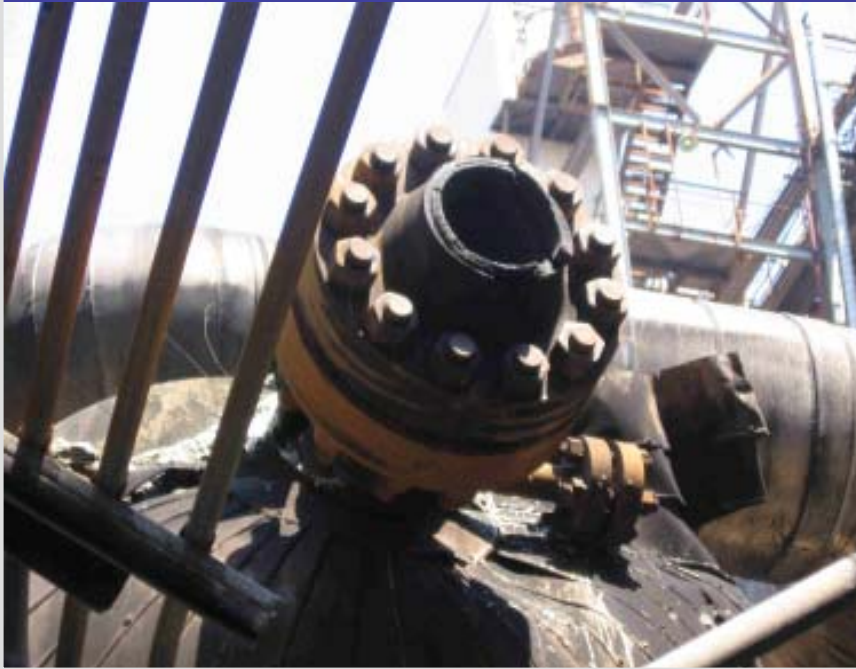
BP personnel examined the extensively damaged unit and determined that an 8-inch diameter pipe elbow on an RHU heat exchanger hydrogen gas outlet pipe ruptured (Figure 3). The BP investigation team recovered the elbow segments that remained attached to the pipe and three pieces found in the debris (Figure 4).

Figure 3. Ruptured 8-inch pipe elbow on heat exchanger A outlet.

Incidents involving HTHA date back to the 1940s. Carbon steel in hydrogen service at temperatures above about 450°F and pressures above 100 psia is susceptible to HTHA. At these operating conditions, atomic and molecular hydrogen permeates the steel and reacts with dissolved carbons or carbides<sup>1</sup> to form methane gas. The loss of carbon in the steel, or “decarburization,” significantly degrades the steel’s mechanical properties, including tensile strength and ductility.<sup>2</sup> The methane gas creates high localized stresses, which combine with the normal piping system stresses to create voids and fissures in the steel, which ultimately causes the pipe to rupture (API, 2004).

The elbow segments recovered from the damaged unit were examined to identify the steel and the failure mechanism. Chemical analysis and microscopic examination determined that the elbow was made from carbon steel. Microscopic examination also revealed that the segments were severely decarburized and had deep fissures on the inside surface (see Figure 4). The decarburized steel and severe fissuring confirmed that HTHA caused the catastrophic elbow failure.

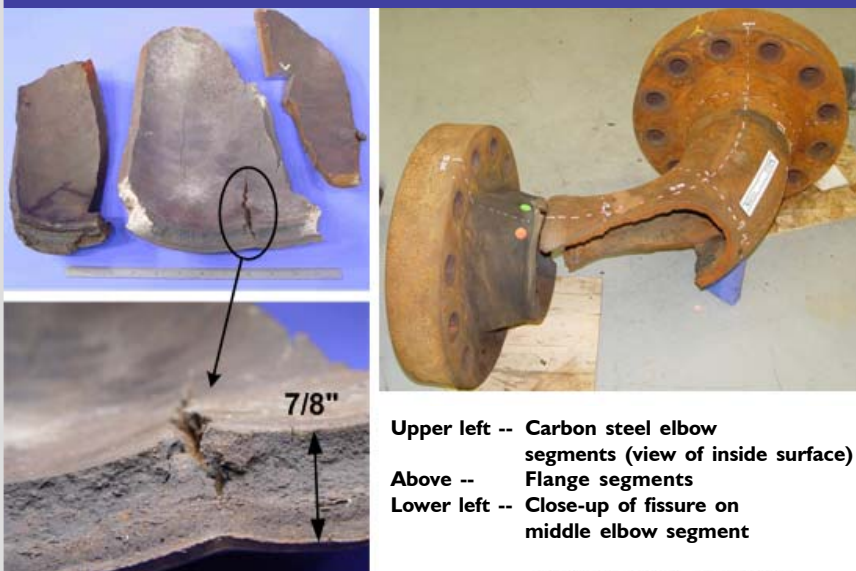
Figure 4. Ruptured 8-inch carbon steel pipe elbow pieces recovered after the fire

Detailed metallurgical examinations and micro-hardness testing quantified the extent of hydrogen damage to estimate the total time the elbow could have been in the high-temperature, high-pressure hydrogen service before it failed. The results, compared to existing experimental data and empirical service life predictions, concluded that the elbow failed after being in service for fewer than 3000 hours.<sup>4</sup>

Metallurgical analyses after the incident concluded that the carbon steel elbow could withstand the high-temperature, high-pressure service for only a few thousand hours. X-ray fluorescence testing confirmed that an alloy steel elbow was installed in the carbon steel elbow position on the heat exchanger B inlet. Therefore, the CSB concluded that carbon steel elbow

1 was inadvertently switched with alloy steel elbow 3 when the maintenance contractor reassembled the piping during the winter 2005 heat exchanger overhaul.

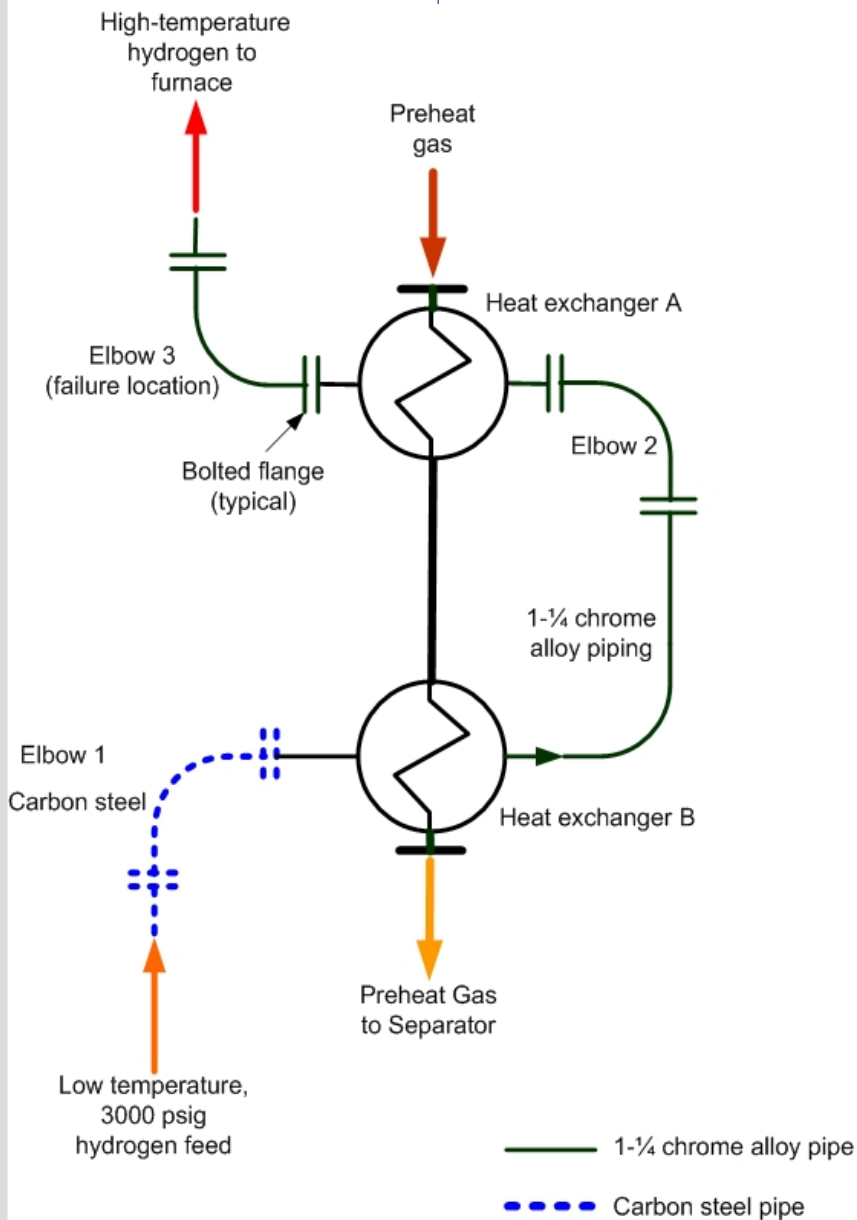
Designed in the early 1980s, the RHU has three parallel operating systems. Each system contains a heat exchanger assembly that consists of two series-connected heat exchangers to preheat the hydrogen. For high-temperature hydrogen gas service piping to resist HTHA, the piping design specification requires 1.25% chrome “low alloy” steel, but for piping in hydrogen service at low temperatures, or those below 450°F, non-HTHA resistant carbon steel is specified, as using this material minimizes material cost.<sup>5</sup> Because heat exchanger B inlet piping and components operate at temperatures below 450°F, they are carbon steel; heat exchanger B outlet and all downstream piping and components (Figure 5) are required to be low alloy steel because they operate at temperatures above 500°F.

Figure 5. RHU hydrogen heat exchanger piping material requirements.

- BP did not alert the maintenance contractor that two of the three elbows were alloy steel piping components and must not be interchanged with the carbon steel elbow.
- The maintenance contractor, JV Industrial Companies, did not adequately control the disassembly, storage, and reassembly of the piping components to ensure that all the piping components were returned to their original installed locations.
- The maintenance contractor inadvertently switched carbon steel elbow 1 (Figures 2 and 5) with the alloy steel elbow 3 during the January 2005 RHU heat exchanger overhaul.

- Piping systems can be designed such that incompatible components cannot be interchanged. All three elbows could have been made from the same low alloy steel material, even though this would have meant additional material expense. Alternatively, elbow 1 could have been dimensionally different from elbow 2 and 3, although this would have meant additional construction costs.

Designers should consider the entire process system life cycle, including planned maintenance, to avoid piping configurations that allow critical alloy piping components to be interchanged with non-compatible piping components.
