U.S. CHEMICAL SAFETY AND HAZARD INVESTIGATION BOARD

HYDROGEN SULFIDE EXPOSURE

No. 2003-02-C-OH
September 2003

ENVIRONMENTAL ENTERPRISES, INC.

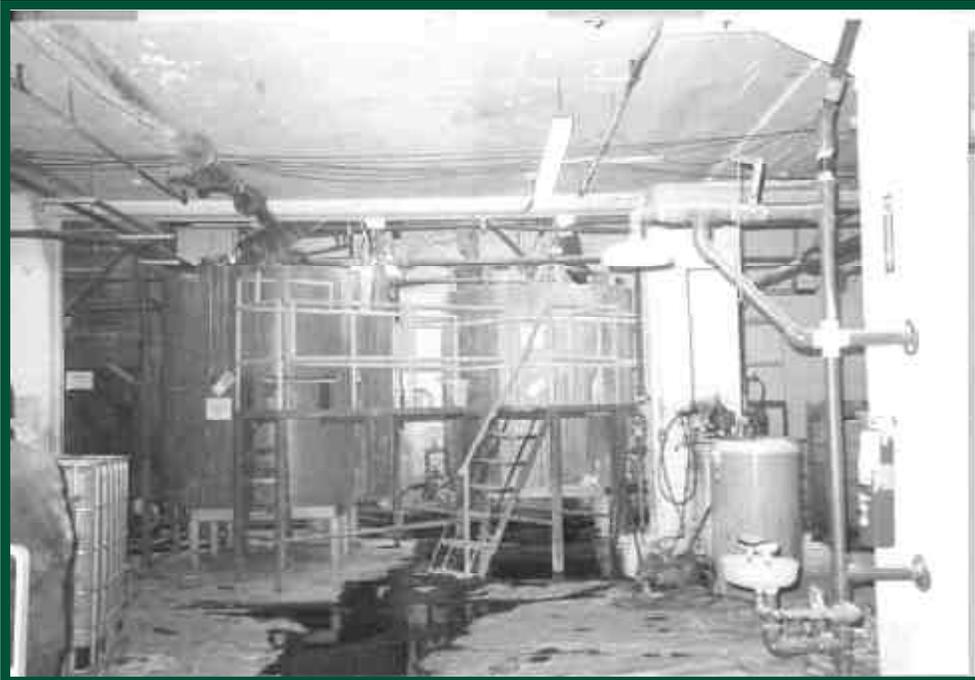
Cover photo:

EEI wastewater treatment vessels. The clarifier is in the back far left; the treatment tank is in the center.

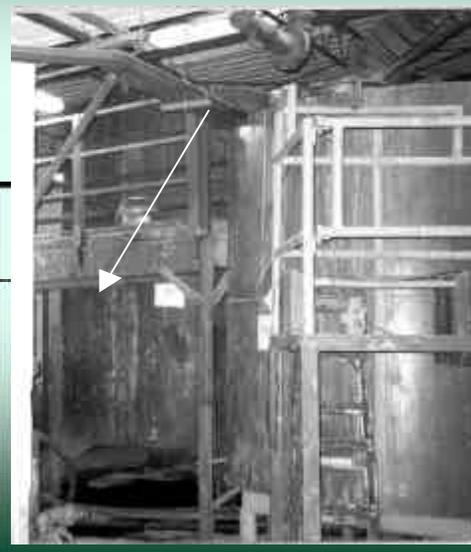
Figure 1
Open-top WWT clarifier

At approximately 2:00 pm on December 11, 2002, a maintenance employee entered the wastewater treatment (WWT) room at Environmental Enterprises, Inc. (EEI), in Cincinnati, Ohio, to retrieve a tool. His path brought him directly alongside the WWT clarifier, an open-top tank with a conical bottom for settling solids (Figure 1).

In this case, the operator used air to mix the contents of the clarifier—a vessel designed to settle its contents. He should have transferred the batch back to the treatment tank, which is equipped with both adequate mixing and ventilation.

The air used in the clarifier did not provide sufficient mixing to completely dissolve the Na₂S flake and distribute the strongly acidic PAC. This produced a localized condition under which the two chemicals combined to form H₂S, which was released from the top of the open vessel.

The waste was chemically treated in the clarifier, a vessel not designed or intended for such use.

Management oversight includes approving facility operating procedures and providing for proper technical consultation whenever employees need to deviate from procedures. If such oversight had been in effect at EEI, it could have ensured that the proper treatment methods were used, including returning all failed wastes from the clarifier to the treatment tank for chemical addition.

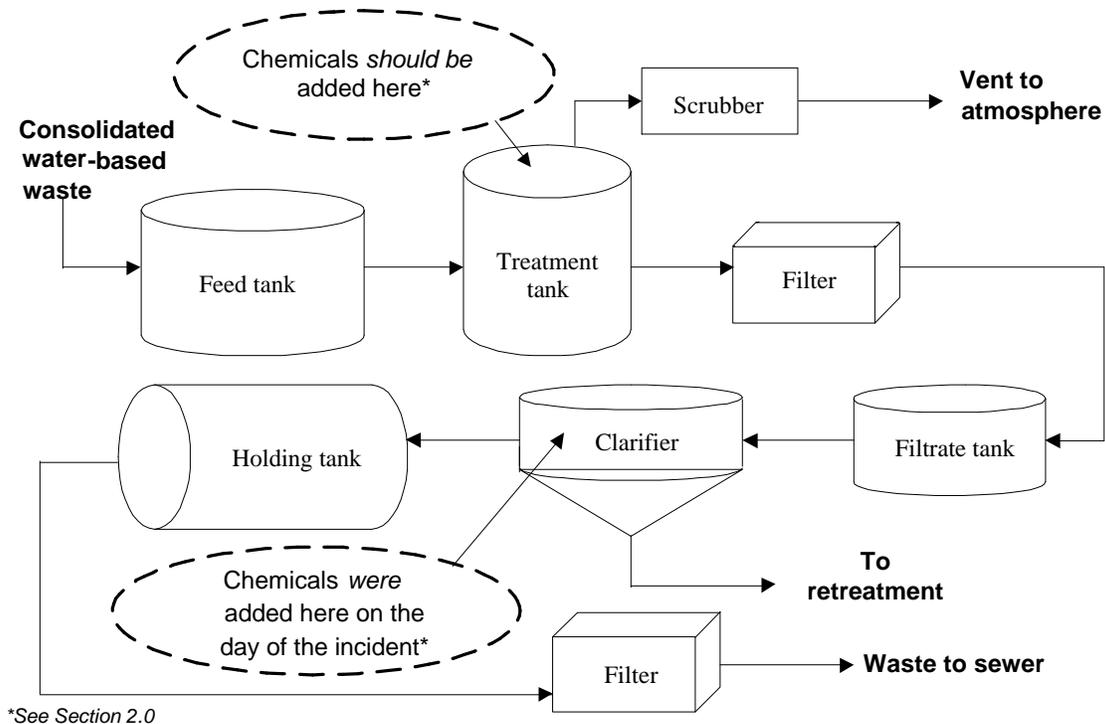
Figure 2

Simplified process flow diagram for WWT operation at EEI

⁴The treatment tank—not the clarifier—is the proper location for this type of chemical treatment (Figure 2) because it is enclosed, vented to a scrubber, and equipped with a mixer.

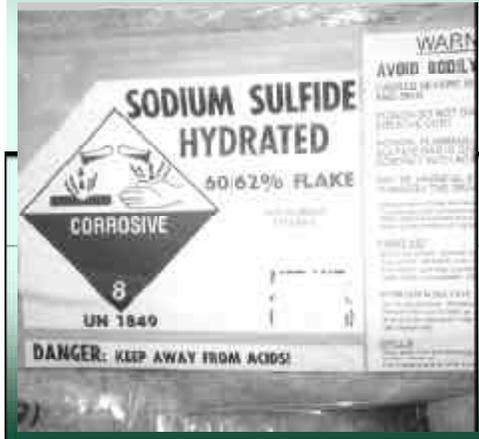
Figure 3
Sodium sulfide flake

On December 11, the waste treatment operator added 50 pounds of sodium sulfide (Na_2S)³ flake to the water-based waste in the clarifier to precipitate mercury

³The pH of Na_2S is 13.5 in a 10 percent solution. The material safety data sheet (MSDS) states that Na_2S is incompatible with strong acids and decomposes to release H_2S .

To reduce the potential for H₂S evolution, the order specified that Na₂S flake must be dissolved before being added to the waste. The order required EEI to install an H₂S detector in the WWT area.

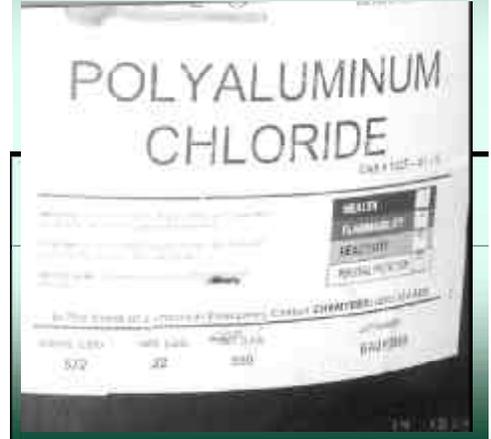
Figure 4
Polyaluminum chloride

The operator then added an acidic chemical—polyaluminum chloride⁶ (PAC)—to the clarifier (Figure 4). This was intended to bring the mercury salts together into larger, heavier clusters (i.e., to flocculate) and to adjust the pH toward neutral (the permitted range is 6 to 10).⁷ Three 55-gallon drums of PAC were added over a few hours.

⁶Aluminum hydroxychloride: $\text{Al}_2(\text{OH})_x\text{Cl}_{(6-x)}$. The MSDS indicates that the PAC solution used at EEI has a pH of 2 to 3 and is incompatible with alkalis (i.e., basic materials, or those with high pH).

The air hose draped into the clarifier (a vessel *designed to settle its contents*) did not provide sufficient mixing to completely dissolve the Na₂S flake, which combined with PAC to form H₂S. Fortunately, the duration of the release was limited by the amount of Na₂S available to react with the strong acid as it entered the clarifier.

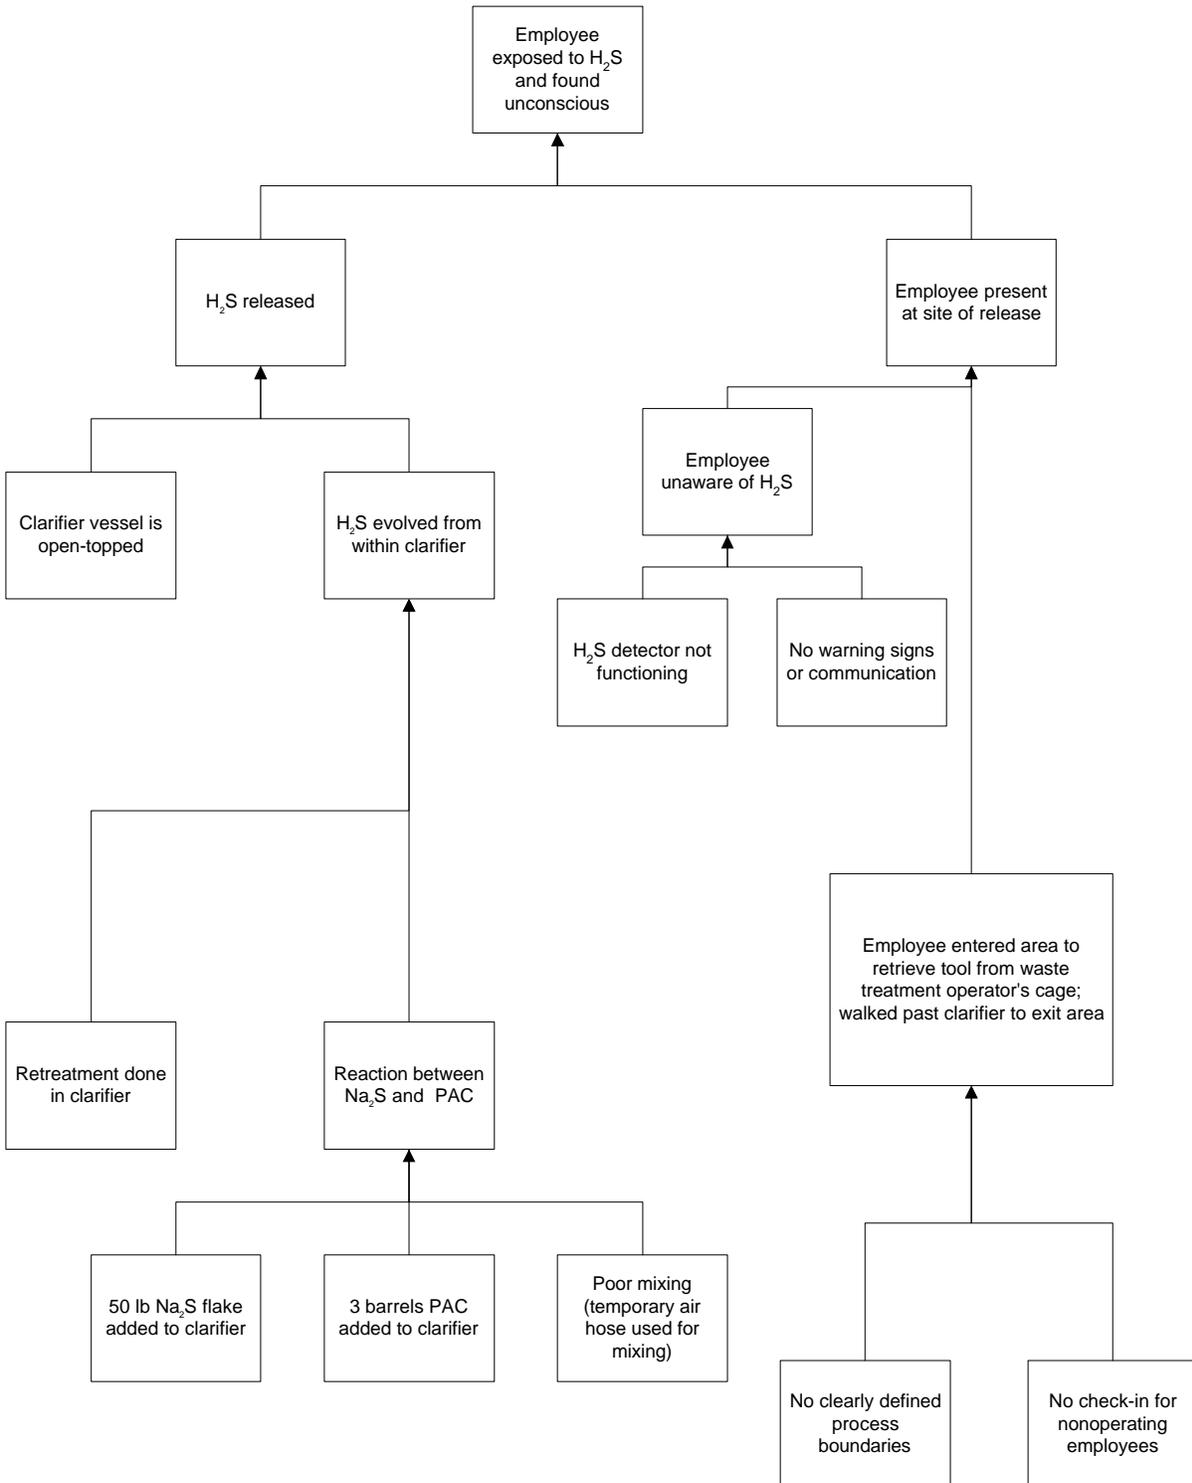
Figure 5 shows the sequence of events leading up to the incident.

Event tree, hydrogen sulfide release
