# CASE STUDY

## Mixing and Heating a Flammable Liquid in an Open Top Tank

**Universal Form Clamp, Inc.**  
Bellwood, Illinois  
June 14, 2006

Investigation No. 2006-08-I-IL  
April 2007

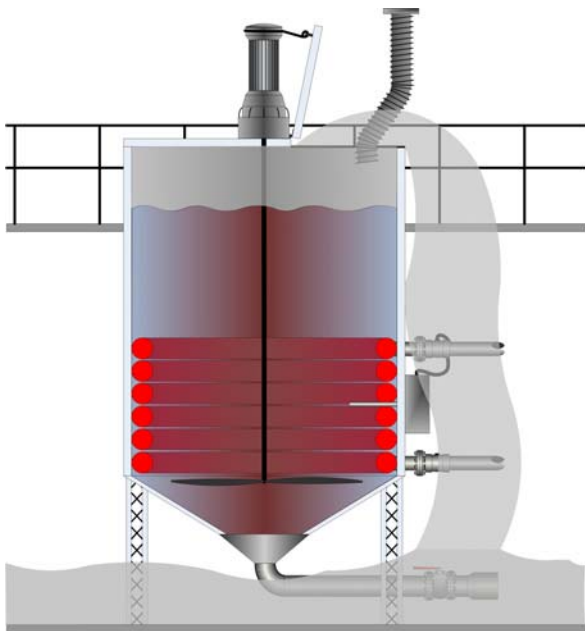
As the operator was adding an ingredient to the batch, he observed a “dense fog” accumulating on the floor below the tank (Figure 1).

Figure 1. Vapor spilling from top of mixing tank

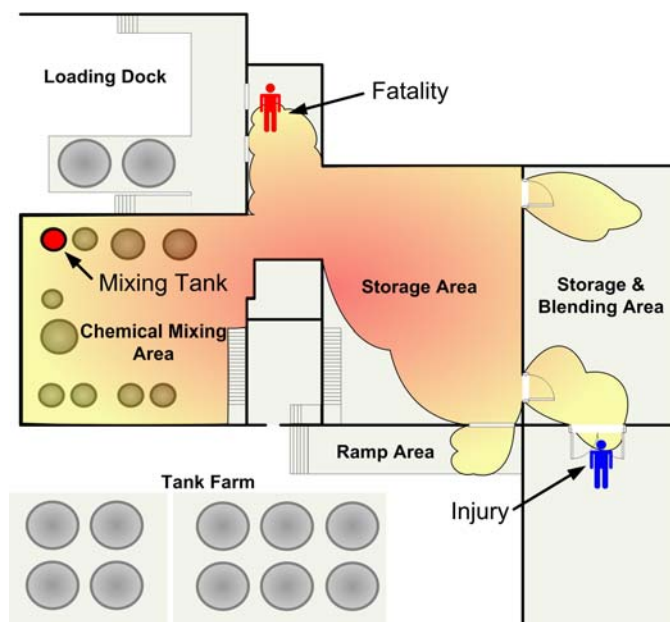
As the vapor cloud spread throughout the mixing area and surrounding workspaces, other employees exited the building (Figure 2).

Figure 2. Vapor cloud propagation

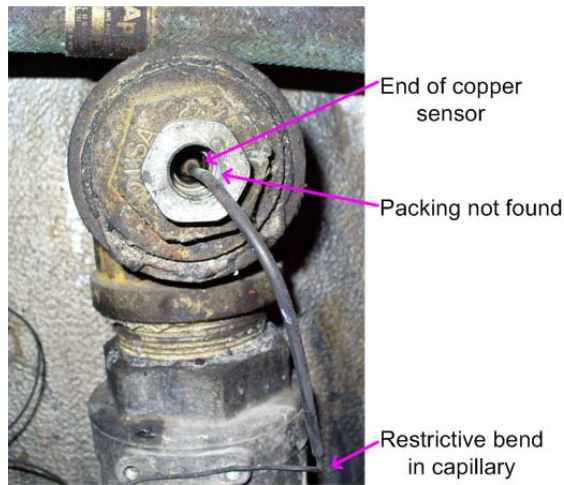
- The temperature-sensing bulb and thermometer well housing (thermowell) did not conform to the manufacturer's specifications.
  - The thermowell, designed to be filled with thermal conductive fluid, was dry, and parts designed to hold the bulb in place were missing (Figure 3).
  - The bulb was not fully inserted into the well (Figure 4).

Both of these conditions may have contributed to inaccurate temperature sensing or a delayed response, and may have caused the steam valves to remain open long enough to boil the mixture.

Figure 3. Temperature sensor well

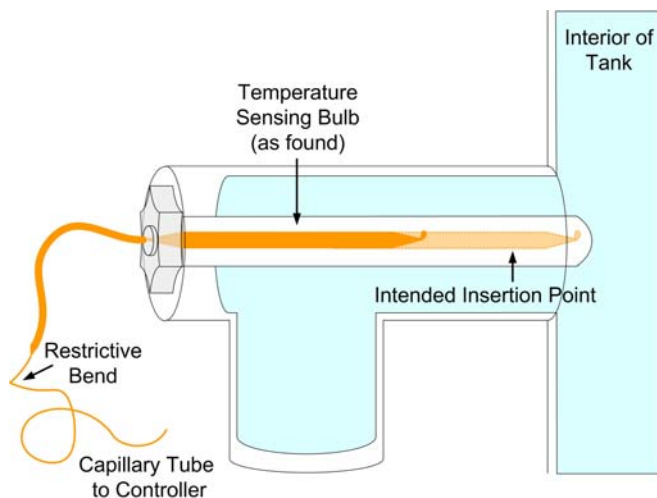
- There was a restrictive bend in the liquid-filled capillary tube connecting the sensing bulb to the temperature controller (Figure 4). Fluid inside the bulb must be able to expand and move freely through the capillary tube for the controller to operate properly. This bend may have caused the controller to perform sluggishly or to malfunction.

Figure 4. Intended sensor location

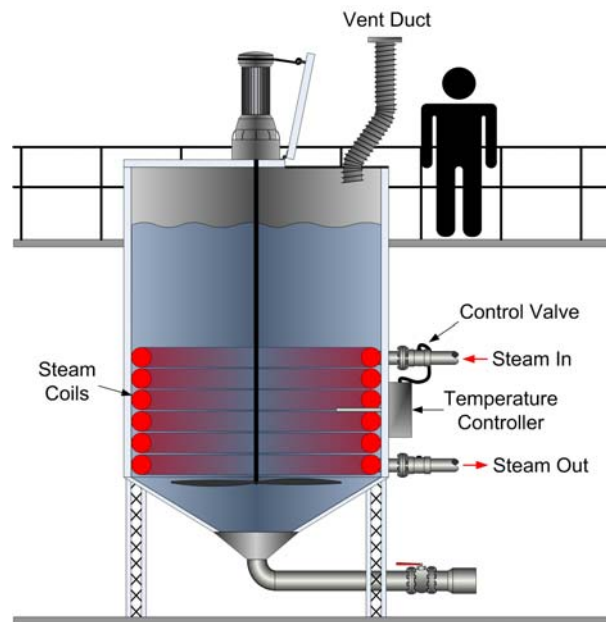
Figure 5. Mixing tank mechanical systems

The local exhaust system included two exhaust fans connected to a main duct with flexible ducts extending into the tops of the mixing tanks (Figure 5). This system was incapable of controlling vapors released from the tank because

- both exhaust fan drive belts were broken before the incident, and
- it was not designed to capture and remove a high volume of vapors from an open top tank.
