U.S. CHEMICAL SAFETY AND HAZARD INVESTIGATION BOARD

INVESTIGATION REPORT

T2 LABORATORIES, INC.

RUNAWAY REACTION

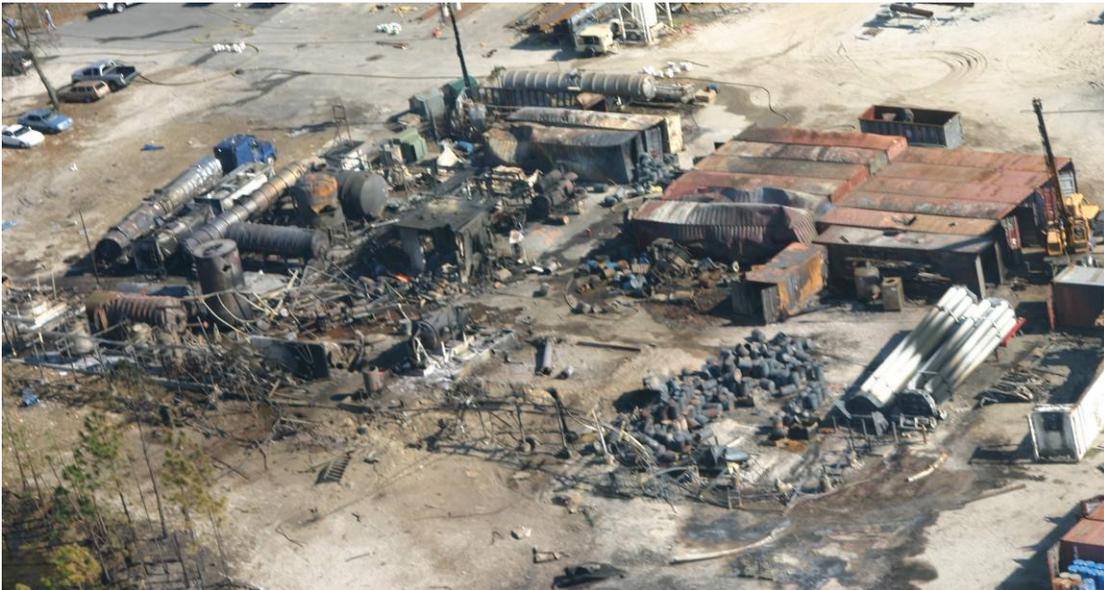
Figure 1. Aerial photograph of T2 taken December 20, 2007.

Debris from the explosion was found up to one mile away, and the blast damaged buildings within one quarter mile of the facility. The City of Jacksonville subsequently condemned buildings used by four of the businesses surrounding T2. Three of these businesses relocated operations while their buildings were repaired; the remaining business, a trucking company adjacent to T2, permanently closed due to lost business.

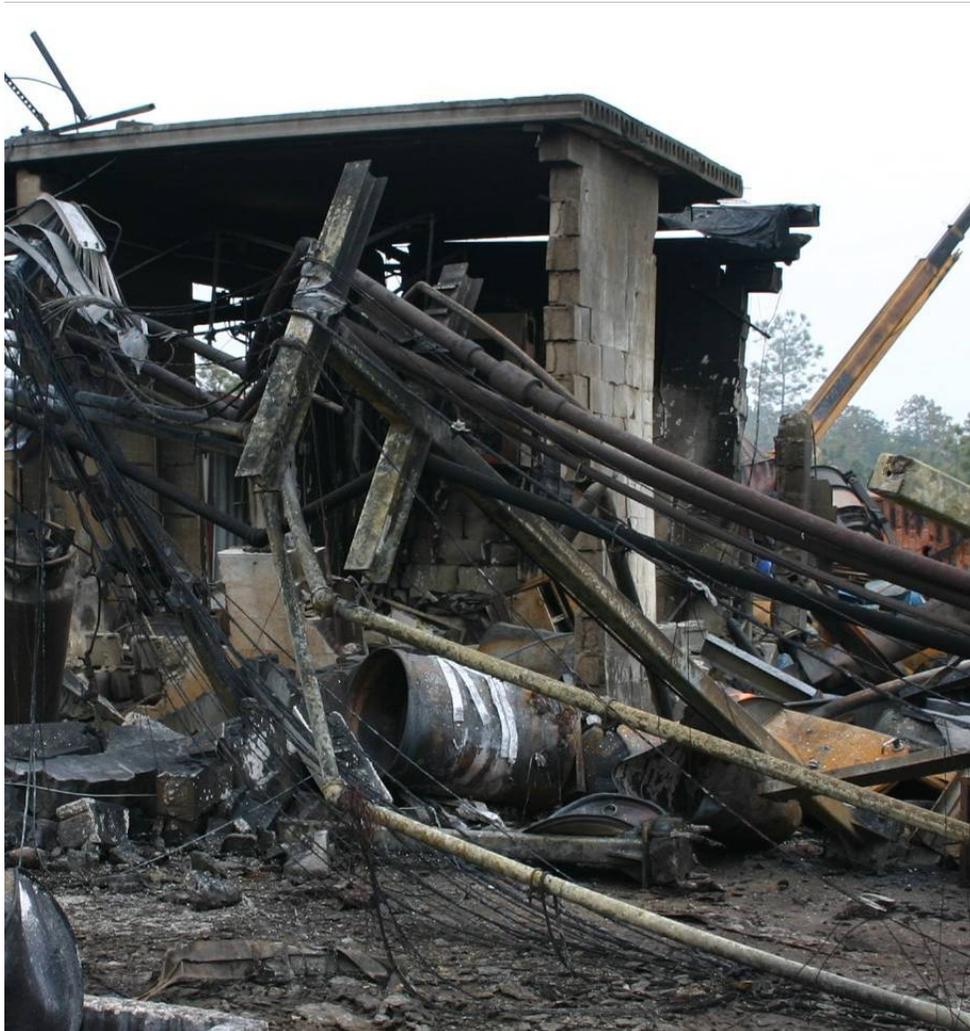
Figure 2. Control room.

⁸ Survivors' accounts indicate that the process operator (deceased) reported a cooling system problem.

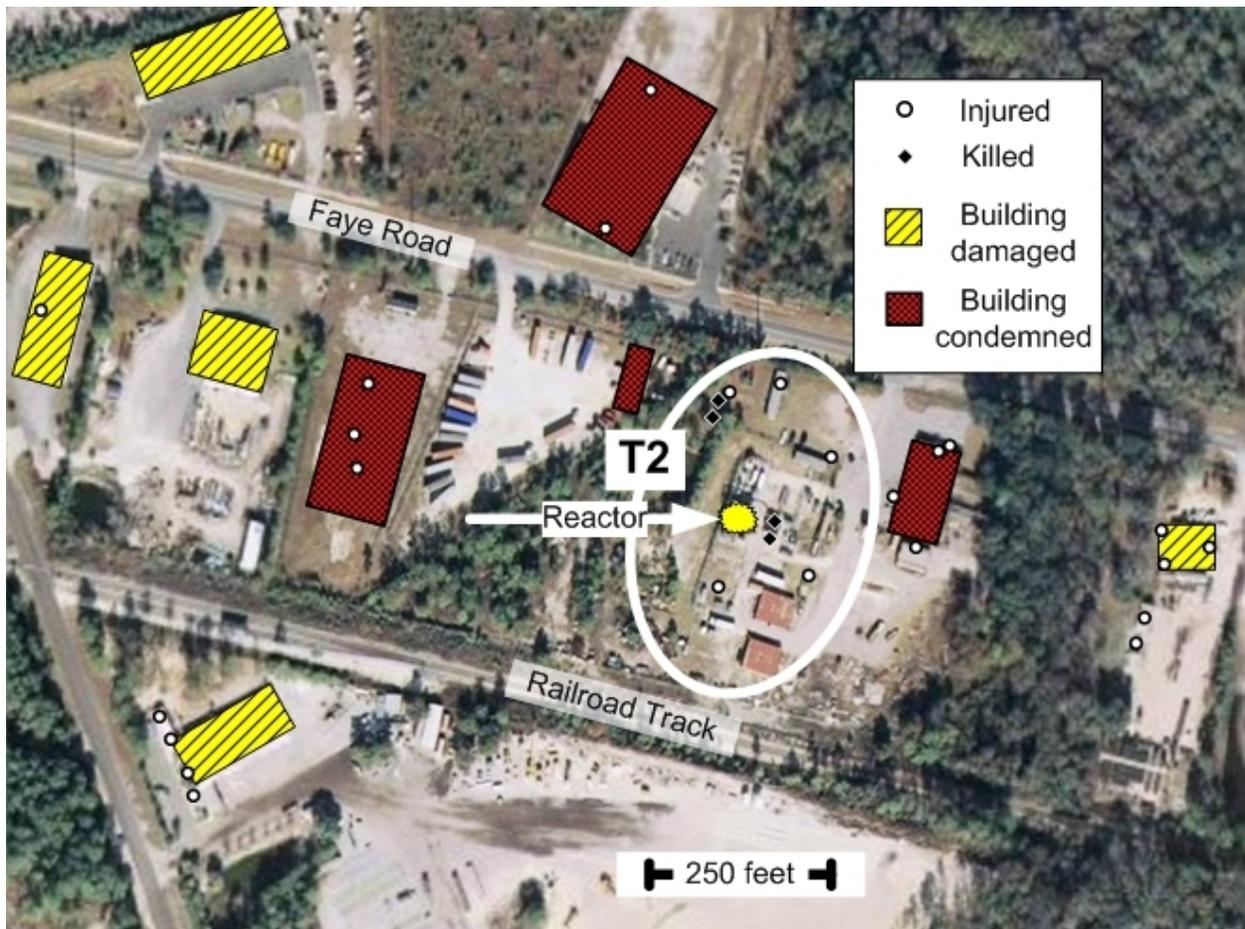
Figure 4. Injury and business locations.

The CSB conducted a community survey of the surrounding businesses to characterize injuries and structure damage (Figure 4). At the nine businesses within 1,900 feet of the reactor, the explosion injured 27 workers. Of those, 11 suffered lacerations and contusions, seven reported hearing loss, and five fell or were thrown by the force of the blast. The CSB survey team photographed and catalogued 32 damaged structures, some as far as 1,700 feet from T2.

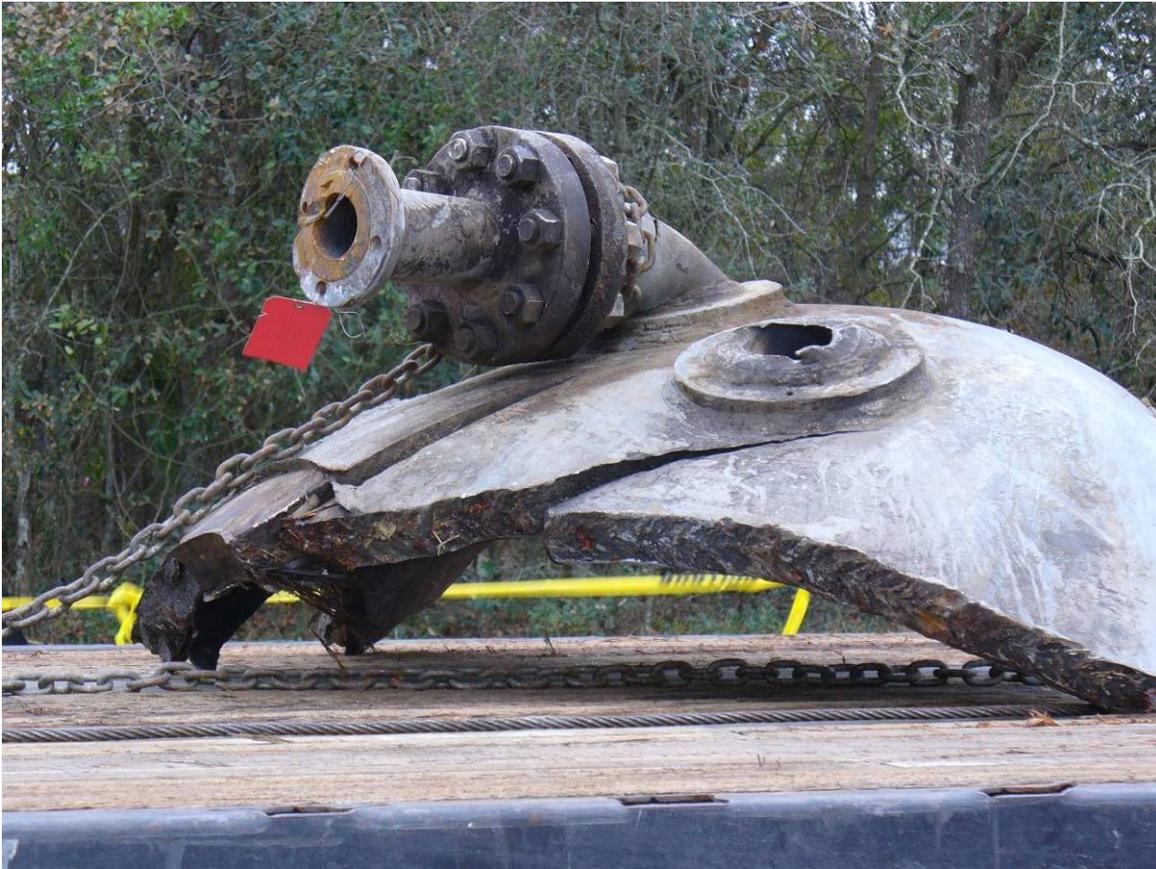
Figure 5. Portion of the 3-inch-thick reactor.

The explosion leveled the plant, propelling debris in all directions. Two large steel support columns from the reactor structure traveled about 1,000 feet along Faye Road in both directions. A 2,000-pound section of the 3-inch-thick reactor head (Figure 5) impacted railroad tracks adjacent to T2, pushing a rail out of place, before impacting and damaging a building about 400 feet from the reactor. The explosion threw piping from inside the reactor hundreds of feet onto the other businesses and wooded areas surrounding T2. The 4-inch diameter agitator shaft from the reactor was thrown about 350 feet across Faye Road in two large pieces that imbedded in a sidewalk and the ground (Figure 6).

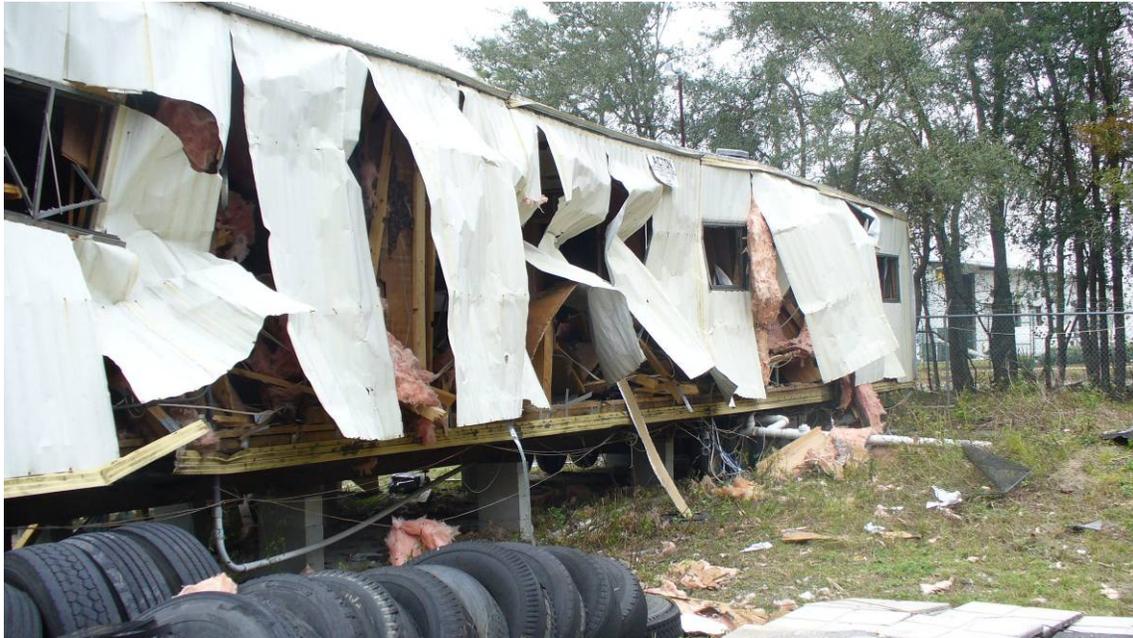
Figure 7. Trucking company trailer adjacent to T2.

Businesses near T2 sustained heavy damage. Structures sustained window damage from the overpressure up to 1,700 feet away from T2. The explosion destroyed a trucking company office trailer located 250 feet from the reactor (Figure 7). If trucking company employees had been in the trailer at the time of the incident, it is likely that they would have been seriously injured or killed.¹¹ Two warehouses located about 400 to 500 feet from the reactor both sustained heavy damage; nine of the 25 employees at these two businesses were injured.

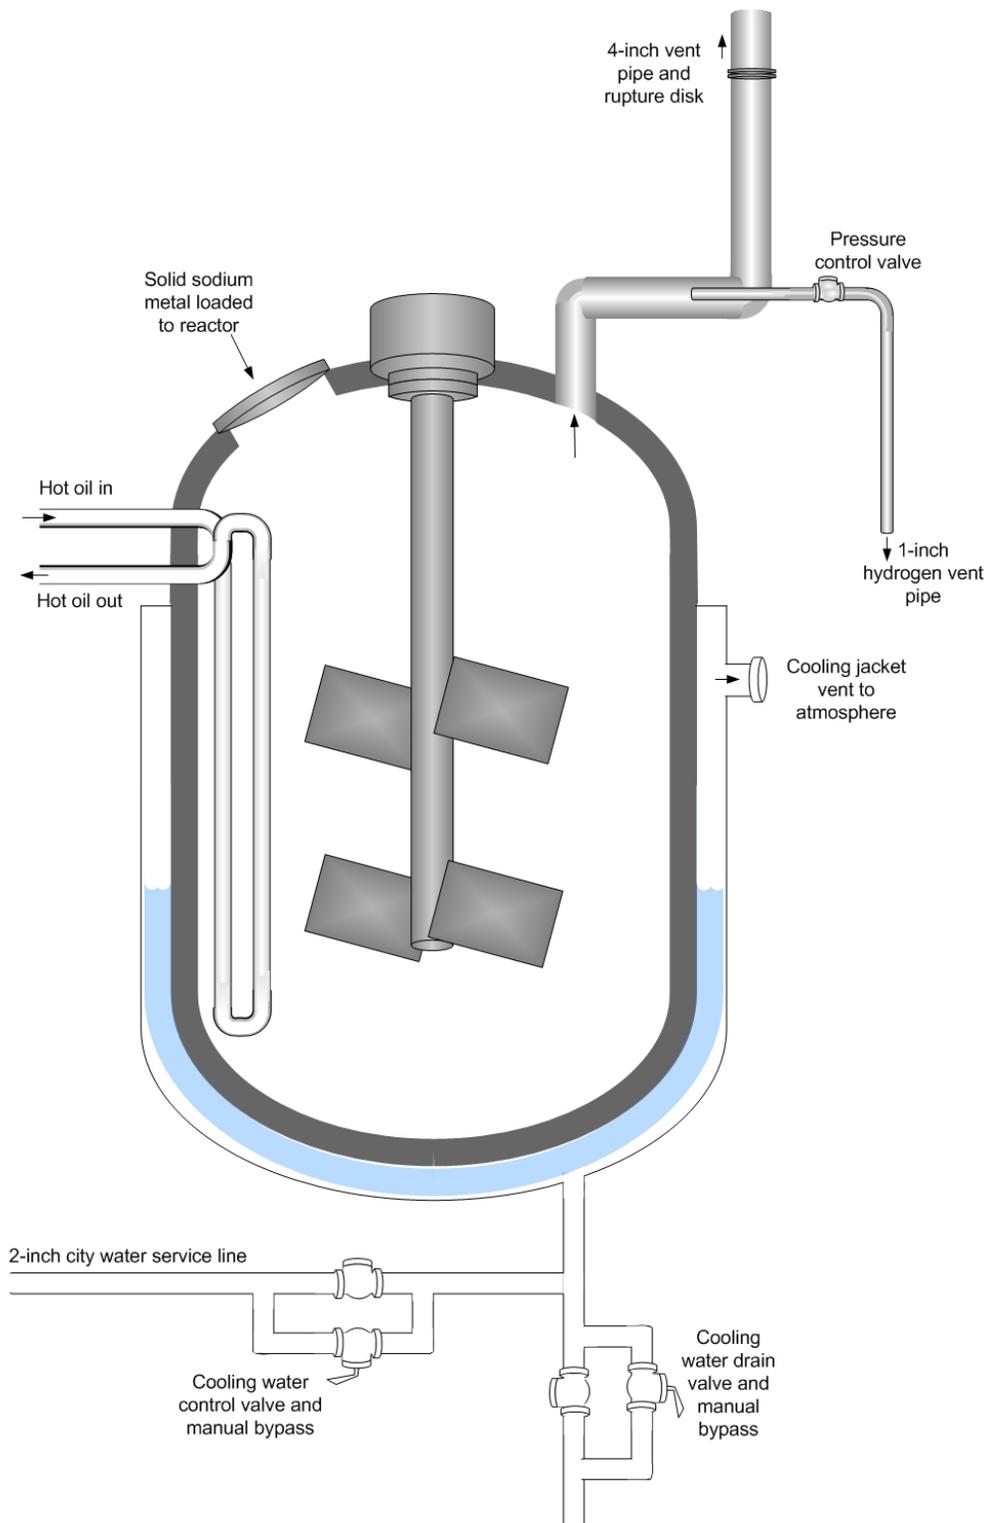
Figure 8. Reactor cross-section.

A 4-inch¹⁹ vent pipe that made two 90-degree pipe bends before connecting to a 4-inch rupture disk provided overpressure protection for the reactor. Employees stated that the rupture disk was set at 400 psig. A pressure control valve installed in a 1-inch vent pipe, which branched off of the 4-inch vent pipe below the rupture disk, controlled reactor pressure.

Similarly, T2 sized the reactor relief devices based on anticipated normal operations, without considering potential emergency conditions. T2 employees stated that the owner/chemical engineer sized the rupture disk based on the maximum expected hydrogen gas generation during normal operation. T2 could not provide any documents related to the sizing and set point of the rupture disk. However, there was no evidence that T2 evaluated a runaway reaction as a possible overpressure source.

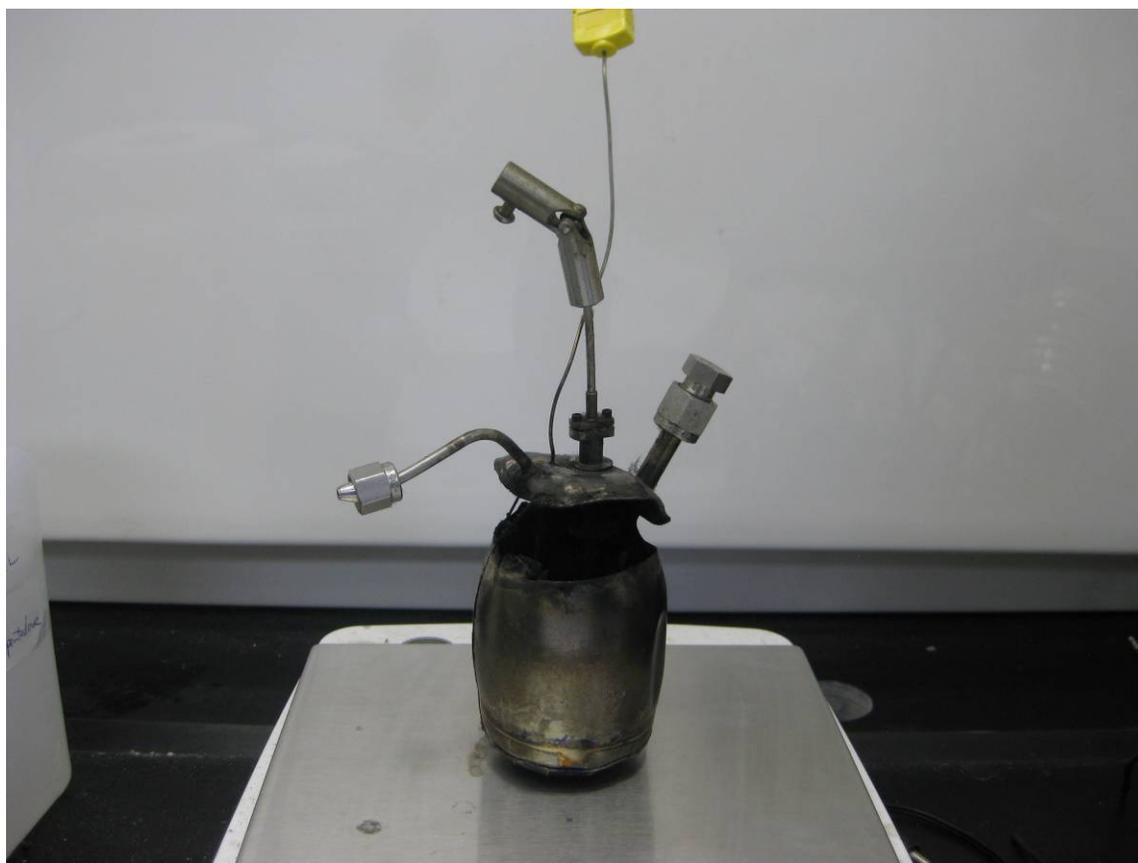
Figure 16. Burst VSP2 Test Cell.

For the first two VSP2 tests, the test cell was open to the containment vessel and results similar to the ARRST tests were obtained. The CSB conducted the remaining four VSP2 tests in a closed (sealed) test cell. A second and more energetic exothermic reaction was observed when the temperature exceeded 390°F (198.9°C) in two test that used the T2 recipe. The pressure and temperature rise during the second exothermic reaction was about 32,000 psig per minute (2,206 bar per minute) and 2340°F per minute (1300°C per minute) respectively and burst the test cells (Figure 16). The other two tests performed using only sodium and diglyme solvent, suggest that this second more energetic exothermic reaction is a reaction between the sodium and diglyme solvent.

The results of this testing show that the standard T2 chemical recipe is capable of producing the reactor failure observed on December 19, 2007. Using the data obtain from these tests, the CSB determined by calculation failure of the reactor from this second exothermic reaction could not have been prevented by an overpressure relief device. Failure could only be prevented by relieving pressure before the second exothermic reaction and allowing the MCPD and Diglyme solvent to boil and vent. Allowing the MCPD and diglyme to boil and vent removes heat from the mixture and reactants from the reactor. For T2 this would have required a rupture disk set at 75 psig in lieu of the 400 psig disk that was used.

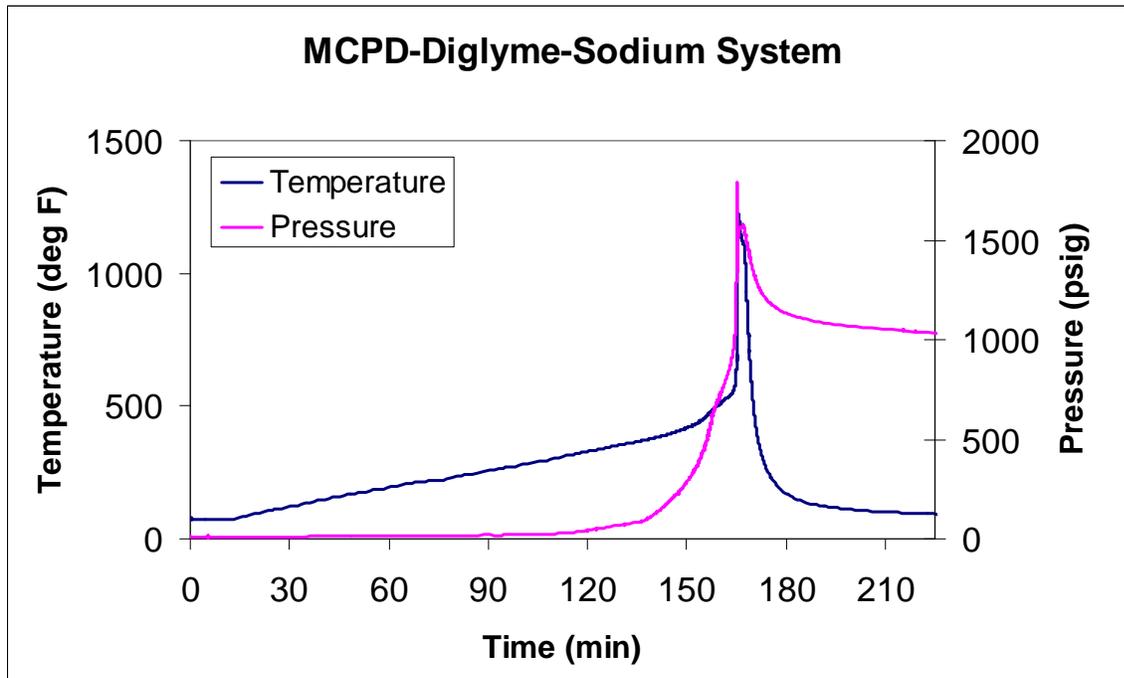
Figure 18. MCPD Diglyme Sodium Test Results.

The peak rate of temperature rise for the final test is 2340°F/minute (1300°C/minute) and the peak rate of pressure rise is 32,000 psi/minute (2206 bar/minute). In the closed system, a strong exothermic reaction occurs using the normal T2 chemical recipe.
