# CASE STUDY

## Explosion and Fire in West Carrollton, Ohio

2009-10-I-OH  
JULY 21, 2010

**Veolia Technical Solutions, LLC**  
West Carrollton, Ohio  
May 4, 2009

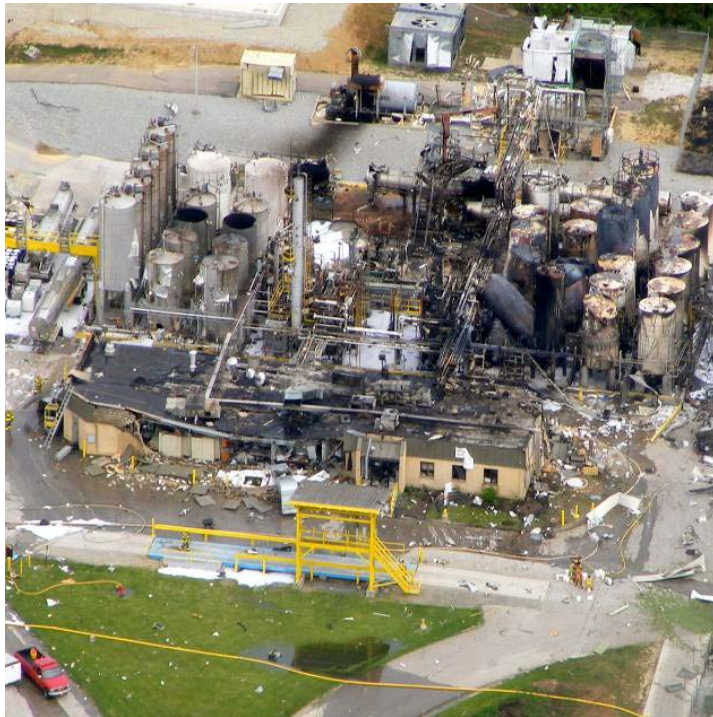
Photo Courtesy of Ohio State Fire Marshal

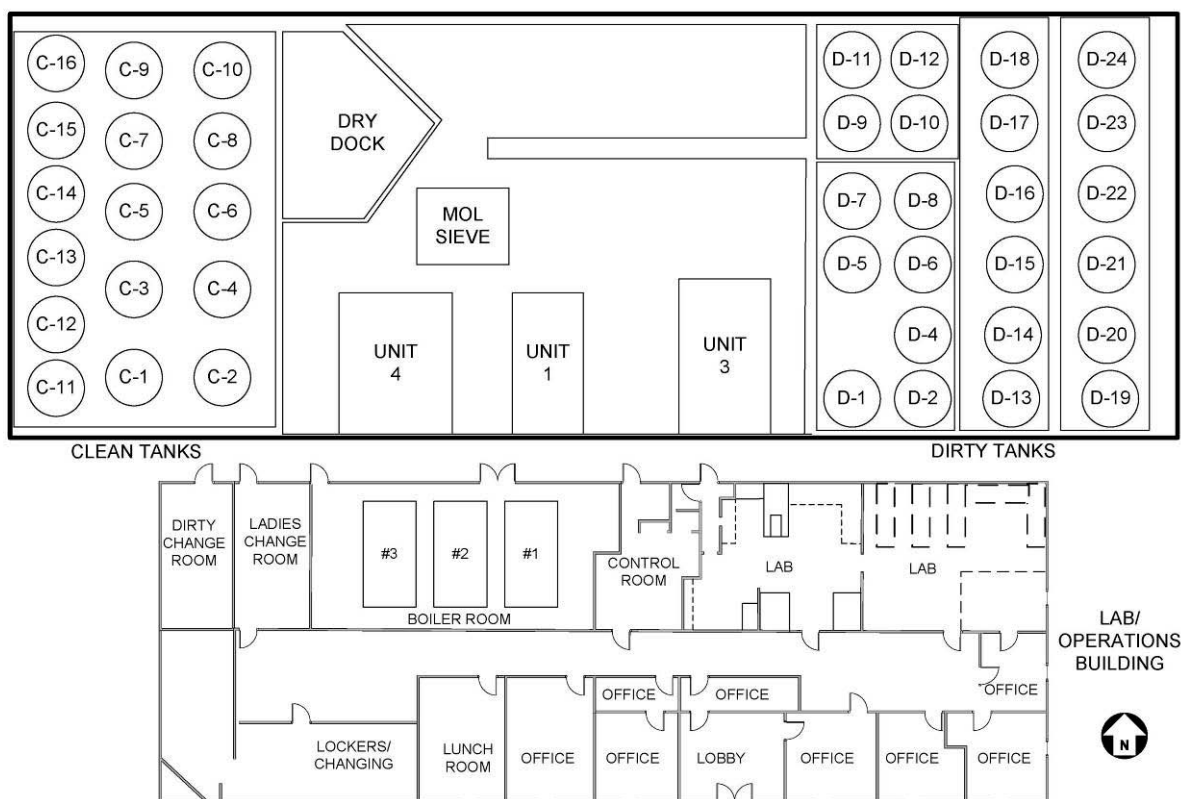
**Figure 2. Plot plan of Units 1, 3, and 4; clean and dirty tanks; and the lab/operations building (not to scale)**

The lab/operations building, which is likely the point of origin for the initial ignition of flammable vapor, was also severely damaged. The interior of the structure displayed minimal fire damage based on post-incident inspection; however, the masonry block, drywall, and doors in the boiler room deflected in an outward direction from the center of the room (Figure 4). Walls throughout the structure were similarly oriented outward, including most of the exterior south wall of the lab/operations building. Roof panels above the boiler area blew upward. The north side of the building, directly facing the operating plant, remained intact with the exception of the northeast corner, which was due

south of the suspected source of the release (Figure 2).

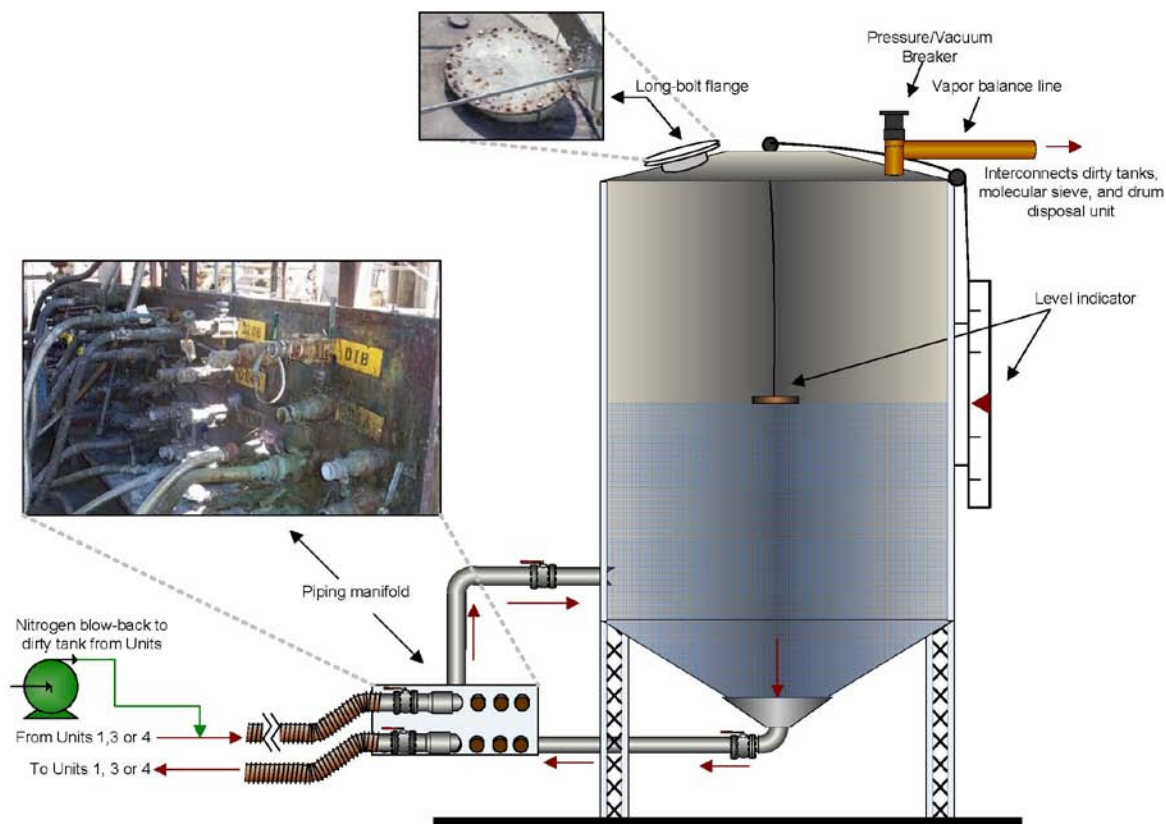
Figure 3. Dirty tank, manifold, and relief systems

The U.S. Chemical Safety Board (CSB) concluded that uncontrolled venting allowed vapors to accumulate to explosive concentrations outside process equipment. Relief valves and rupture disks protected equipment in Units 1, 3, and 4 and relieved to the atmosphere. A two-inch pressure/vacuum vent relief device provided protection for “normal breathing” when pressure exceeded 0.5 psig or vacuum exceeded 1.55 mmHg for each tank in the dirty and clean tank farms. This device relieved pressure whenever an unbalanced transfer occurred or brought in ambient air to avoid tank collapse under negative pressure. On the dirty

tanks, 18-inch “long-bolt” manways<sup>8</sup> provided emergency venting. The weight of the manway cover kept the opening sealed against the gasket. When pressure developed to lift the cover, the bolts allowed the cover to lift at least 1.5 inches. Both of these relief devices vented directly to the atmosphere.

All relief valves and rupture disks for pressure vessels relieved directly to the atmosphere. Units 3 and 4 rupture disks were oriented upward toward the north while the relief valves vented to the east or the north. Tanks and vessels that suffered the most severe damage were located near the D-14 tank that served as the source of feed to Unit 3. The unit operator blew nitrogen into this tank just prior to the release.

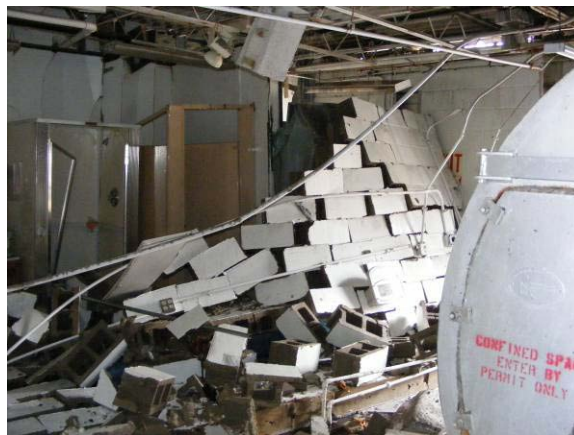
**Figure 4. Boiler and locker room damage**

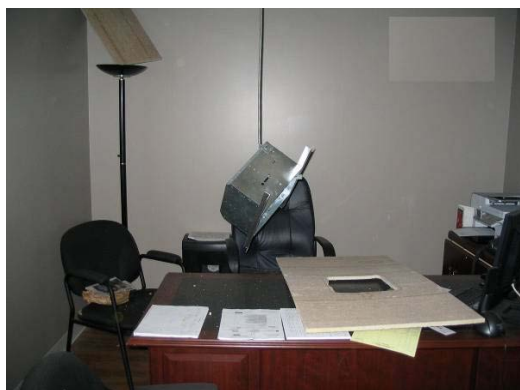
The West Carrollton Code Enforcement Officer and company records estimate that about 20 residences sustained damage from the explosion. Residents reported broken windows, bent garage doors, and chimney detachment. The Code Enforcement Officer condemned the garage of one residence. About five neighboring businesses also sustained damage. One local business less than a quarter-mile away suffered extensive damage, including cracked masonry block walls, broken windows, cracked walls, misaligned doors, broken ceiling light fixtures, foundation shift, bent steel framing, and fallen ductwork. Some offices displayed damage, suggesting workers may have been injured had they been present at the time of the explosion. Preliminary estimates, including lost production, property damage, and business disruption, place total costs at about \$27 million.

**Figure 6. Neighboring business office damage**

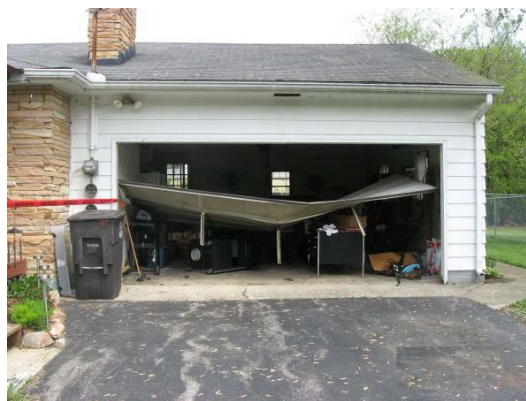
**Figure 5. Residential damage**

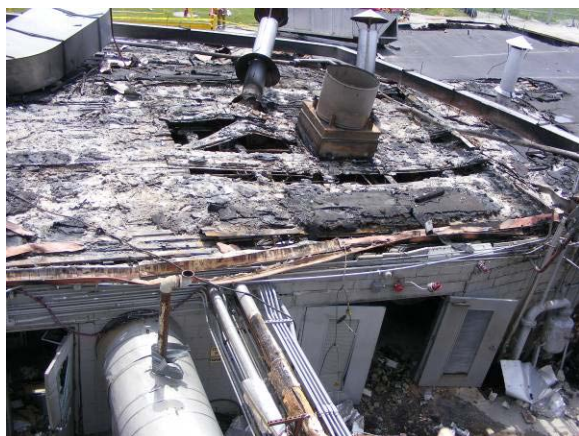
- The vent devices were not designed to contain or control hazardous and/or toxic vapor.
- Two natural gas-fired boilers were in service in the lab/operations building at the time of the incident and most likely provided the ignition source.

- The lab/operations building, which housed the source of the ignition, was located about 30 feet south of the operating plant and served as a mixed-use structure, which was occupied primarily by non-essential personnel throughout the day shift.

**Figure 7. Roof and north wall of lab/operations building and boiler room**

Conduct a process hazard analysis on all OSHA Process Safety Management covered processes to ensure all buildings and structures at the West Carrollton facility are located and designed in accordance with electrical classification and spacing as defined in NFPA 70.
