U.S. Chemical Safety and Hazard Investigation Board

## NDK Crystal, Inc., Belvidere, IL High-Pressure Vessel Rupture

December 7, 2009

No. 2010-04-I-IL

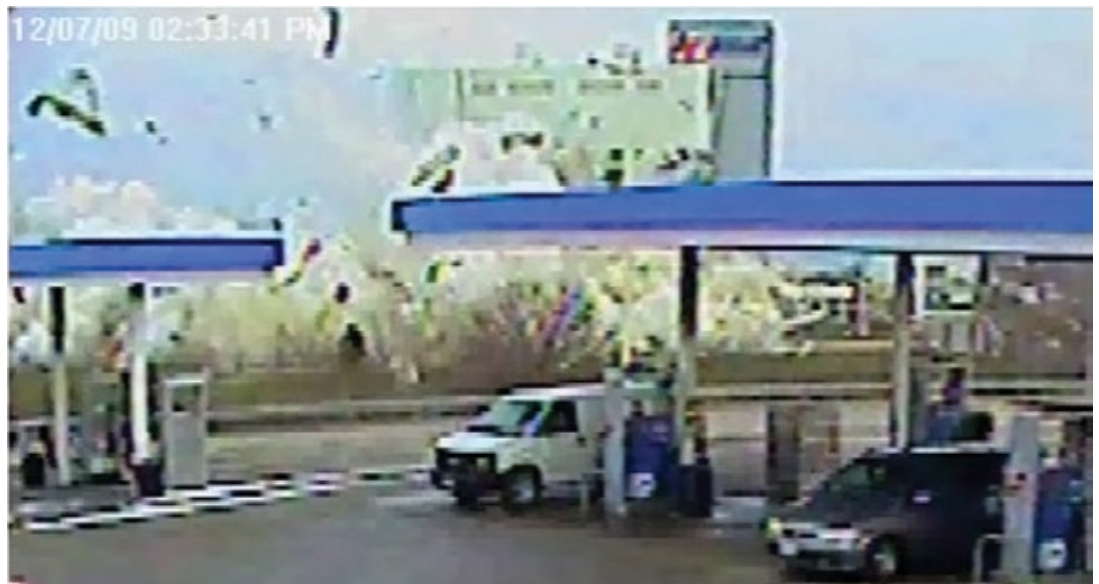
**FIGURE 5**

On December 7, 2009, at approximately 2:30 pm, State Special Vessel No. 2, under an operating pressure of 29,000 psig, suddenly and violently ruptured, 120 days into a 150-day operating cycle. A white cloud of steam and debris rapidly expanded outward from the facility, traveled onto the interstate, and dissipated within seconds (Figure 5).

Oasis security camera shows the expanding steam cloud and debris immediately after the vessel ruptured.

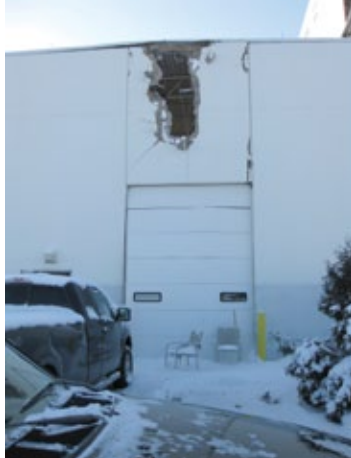
**FIGURE 6 (LEFT)**

The sudden release of superheated liquid caused an eight-foot tall by four-foot wide vessel fragment, weighing approximately 8,600 pounds, to travel through two concrete walls and finally land about 435 feet from the NDK building (Figure 6). The fragment skipped across a neighboring facility parking lot and slammed into the wall of an adjacent business office (Figure 7). The force of the impact pushed the wall inward causing furniture to shift and ceiling tiles to fall. One person working near the wall was injured.

The 8,600 pound vessel fragment exited the NDK production building through a reinforced concrete wall.

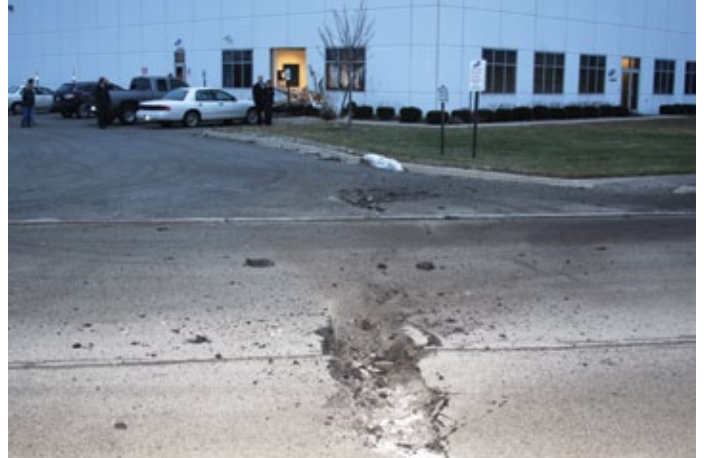
**FIGURE 7 (RIGHT)**

Damage from vessel fragment impact with roadway.

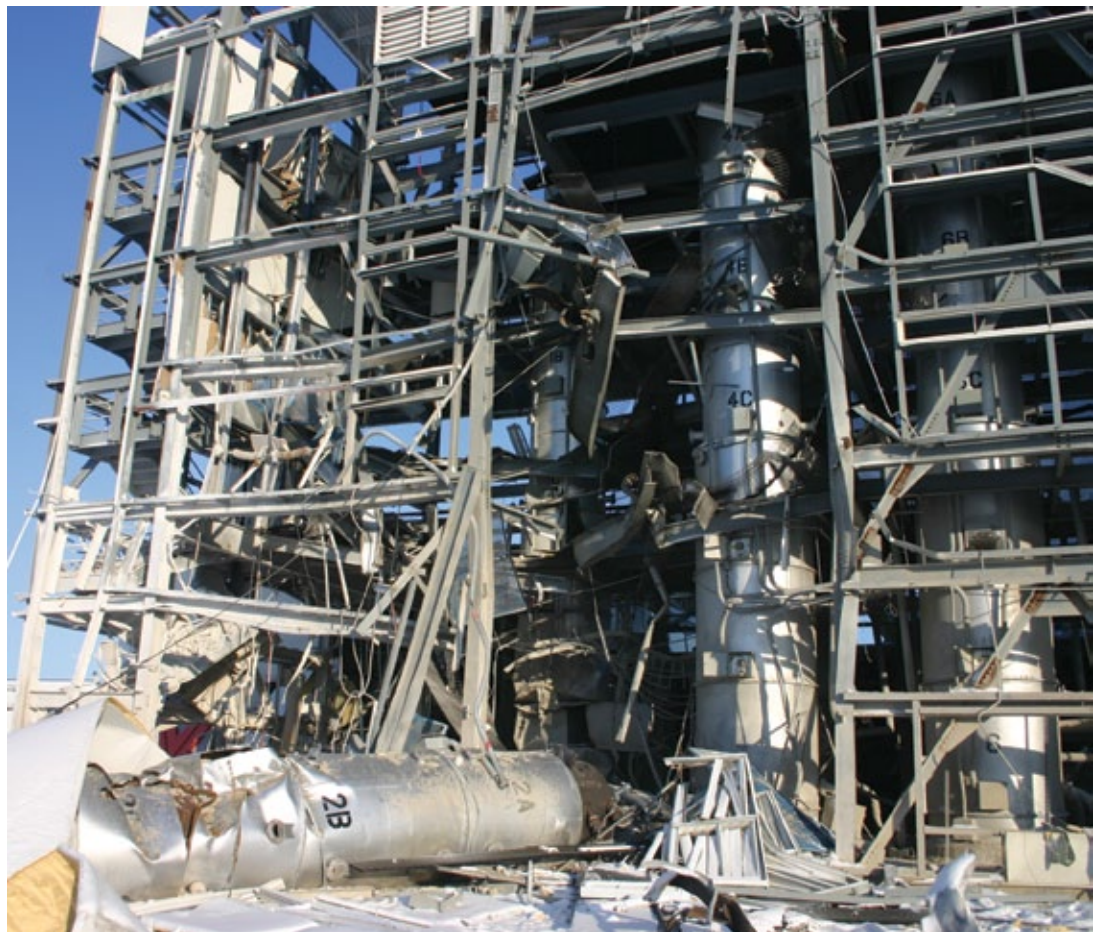
**FIGURE 8**

The thrust from the escaping liquid caused the base of the vessel to violently shear away from its foundation and blew pieces of structural steel out of the building into the parking lot of a nearby rest stop gas station, known as the Illinois Tollway (I-90) Oasis. One piece of structural steel struck and killed a truck driver at the rest stop. After shearing from its base and throwing shrapnel out of the facility, the vessel swung from the building and landed on the ground outside (Figure 8).

NDK Crystal damage after the incident; Vessel No. 2 rests on ground outside structure. The force of the explosion blew out most of the exterior wall panels.

The NDK production facility sustained major damage. Exterior insulating panels were completely blown off. The force of the explosion and the displaced vessel destroyed steel framing, stairwells and floor grating near Vessel No. 2. The office and lab areas showed varying degrees of damage and much of the final product was destroyed. The product storage area, laboratory, and production offices were heavily damaged. The NDK America facility attached to the NDK Crystals production facility also received major damage from the vessel rupture. NDK America employees relocated office activities for three months during repairs.

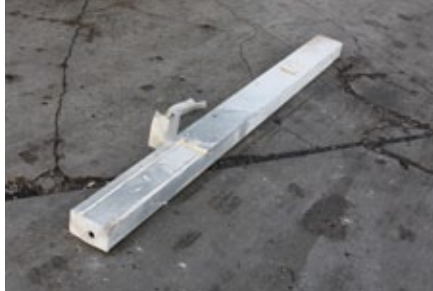
FIGURE 9

Structural steel fragment

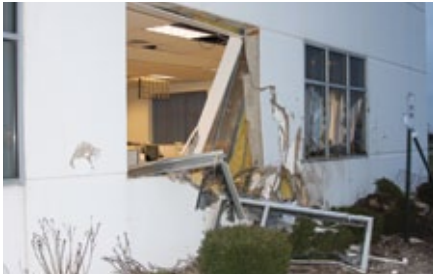
FIGURE 10

Grupo Antolin facility damage from vessel fragment.

The neighboring facility, Grupo Antolin, received damage to one wall, multiple ceiling tiles, and lights from the impact of the 8,600-pound projectile from the pressure vessel (Figure 10). Several automobiles in the parking lot sustained damage from the force of the explosion and flying debris. One piece of shrapnel, a 2-foot by 2-foot window, landed in the Oasis parking lot, 950 feet away (Figure 11).

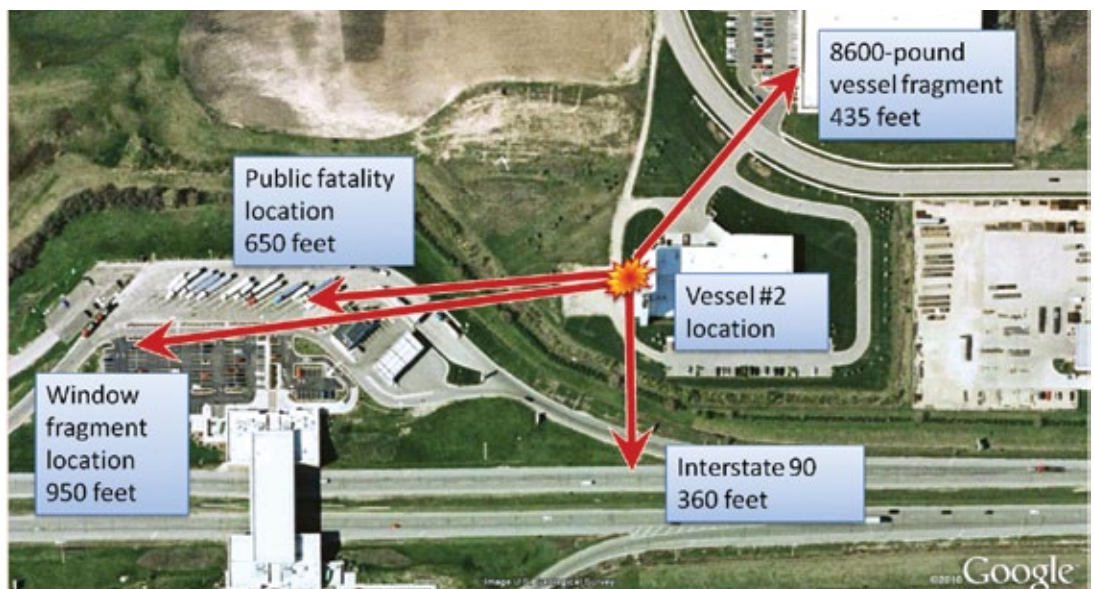
FIGURE 11

Overhead photo of explosion fragment locations and distance from the facility.

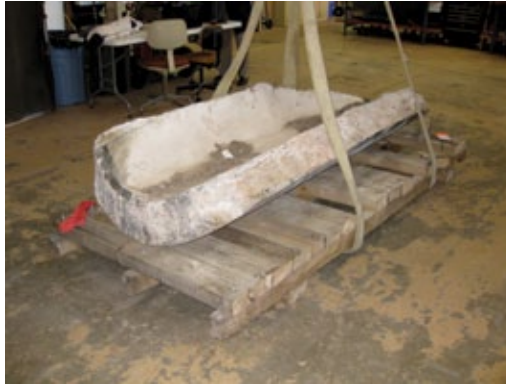
**FIGURE 12 (LEFT)**

CSB investigators observed non-destructive evaluations (NDEs)<sup>12</sup> and destructive testing performed on the 8,600-pound vessel fragment (Figures 12, 13). After consultation with engineers and metallurgists from the various agencies, the metallurgical lab cut several samples from the vessel fragment inner diameter, outer diameter, thickness, and fracture surfaces for microscopic examination and testing. The metallurgical labs involved in the vessel fragment examinations provided all participating agencies with test data and photographs collected during testing. The CSB commissioned an independent review of the data by expert metallurgists at the National Institute of Standards and Technology (NIST) Materials Reliability Division, to assist in identifying the failure mechanism.

8,600-pound vessel fragment subjected to metallurgical tests.

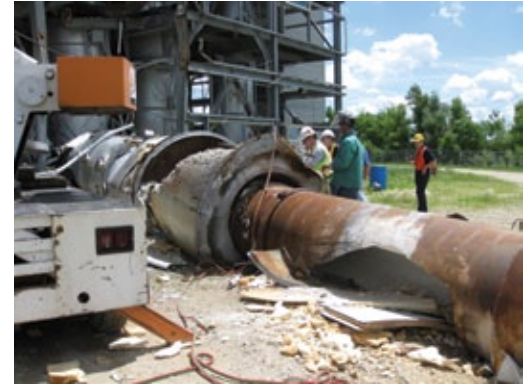
**FIGURE 13 (RIGHT)**

Photo of the ruptured Vessel No. 2 with insulation removed.

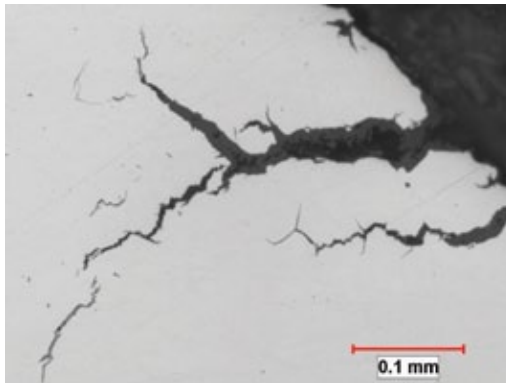
**FIGURE 14**

After a review of the metallurgical testing data, the CSB found strong evidence of cracking on and near the inner diameter of the vessel fragment. The cracks reduced the vessel material toughness,<sup>13</sup> which eventually led to large flaws resulting in the catastrophic failure. Stress corrosion cracking (SCC) was the likely failure mechanism that caused the cracks. SCC is the formation of cracks through the simultaneous action of applied stresses and a corrosive environment.<sup>14</sup> Microscopic examinations of the steel revealed strong evidence that SCC existed in many regions of the vessel fragment (Figure 14). The vessel at NDK contained an alkaline, or basic, sodium hydroxide and water solution generally known to damage some steels. The caustic liquid created a degrading environment inside the vessel, particularly in small surface scratches, and likely resulted in the development of SCC. The fracture initiated at an existing, surface-breaking crack in the inner diameter of the lower portion of the vessel near the base.

Micrograph of cracking found on the fracture surface about 0.75 inches from inner diameter surface of vessel fragment. According to NIST, the branching of the crack is a telltale sign of SCC.<sup>15</sup>

EPSI designed the vessels using the material NDK selected under the implied assumption that the acmite layer formation would prevent SCC in the vessel wall. The evidence of SCC in the fragment suggests that the acmite did not adequately protect the vessel, or that it was removed from this region of the vessel through some type of mechanical process, such as scratching or abrasion, during product removal or vessel cleaning between runs.

During the fragment testing, metallurgists performed energy dispersive spectroscopy<sup>16</sup> (EDS) to characterize the coating on the vessel inner surface. Test results reported the presence of silicon, titanium, and aluminum in significant quantities, and sulfur and chloride in smaller quantities. These are known impurities for the lasca used as a feedstock for crystal growth. This evidence suggests that the process fluid was able to penetrate the surface cracks in the vessel, indicating the acmite coating was not adequate.

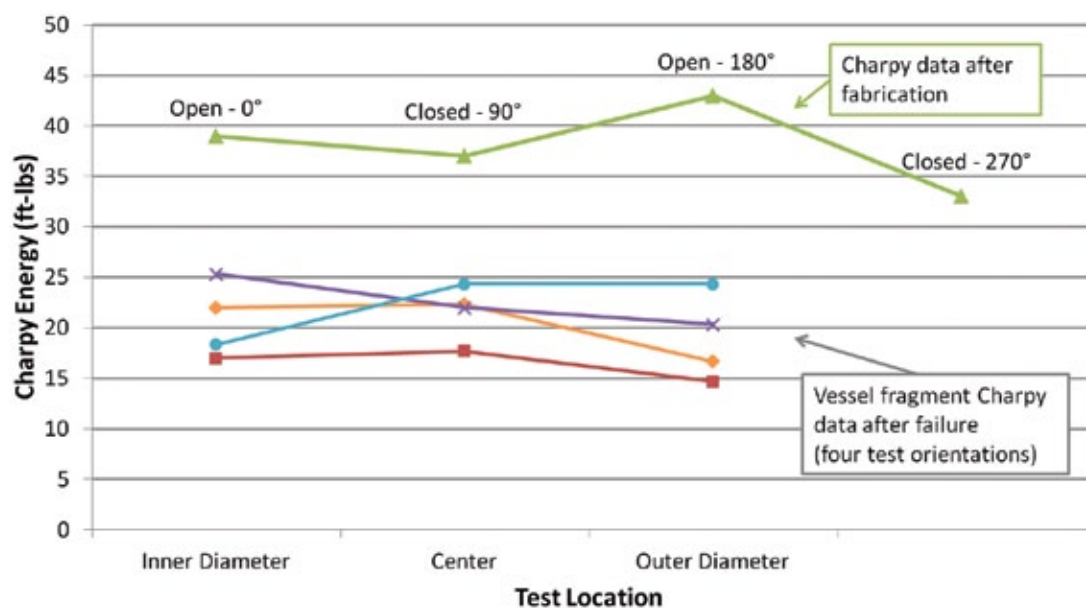
**VESSEL NO. 2 CHARPY ENERGY DECREASE POST FAILURE**

Metallurgists found possible evidence of temper embrittlement in the vessel sample from a review of Charpy impact test data. The Charpy impact test, also known as the Charpy V-notch test, is a standardized test, which determines the amount of energy absorbed by a material during fracture. A hammer on a pendulum arm strikes the sample specimen opposite the pre-machined notch. The energy absorbed by the specimen is determined by measuring the decrease in motion of the pendulum arm. This absorbed energy is a measure of a given material's notch toughness and along with the appearance of the fracture surface can determine the minimum service temperature of a material.

The CSB made comparisons between the manufacturing certification and post-failure testing, and found there were considerable variations in toughness in different regions of the vessel. This general loss of toughness was identified in all orientations (not just circumferential), which, according to NIST, suggests a general damage mechanism, such as temper embrittlement was acting in addition to the SCC (Figure 14). The reduction in Charpy energy shows that the vessel's ability to absorb energy before failure diminished over time, possibly caused by the SCC.

Comparison of Charpy impact test results after manufacture and post failure. Manufacturer's Charpy data were taken from a different orientation. Post failure data points are the average of three tests in four orientations. All tests measured at 212°F.
