Key Lessons for Preventing Hydraulic Shock in Industrial Refrigeration Systems

Anhydrous Ammonia Release at Millard Refrigerated Services, Inc.

January 2015

No. 2010-13-A-AL

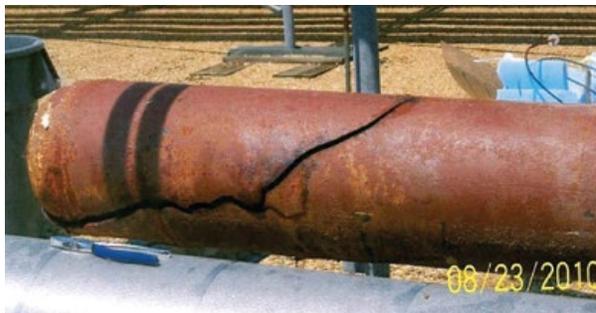
FIGURE 1

On August 23, 2010, at the Millard Refrigerated Services facility in Theodore, Alabama, hydraulic shock caused a roof-mounted 12-inch suction pipe to catastrophically fail leading to the release of more than 32,000 pounds of anhydrous ammonia. The hydraulic shock was enabled during the restart of the plant's ammonia refrigeration system following a 7-hour power outage. In addition to the catastrophic failure of roof-mounted piping, the pressure developed by the hydraulic shock event also caused an evaporator coil inside the facility to rupture.

Shortly before 9:00 am on the morning of August 23, 2010, Millard was in the process of loading two international ships with frozen poultry when the facility's refrigeration system experienced a hydraulic shock event that led to a catastrophic piping system failure and the release of 32,100 pounds of anhydrous ammonia. The majority of the ammonia released in this incident occurred through a compromised portion of the system's 12-inch suction pipe located on the roof (Figure 1). The resulting cloud of ammonia vapor traveled 0.25 miles to the south across the Theodore Industrial Canal, exposing a Millard employee and offsite contractors working outdoors.⁴ At approximately the same time, alarms sounded within the plant due to the detection of high concentrations of ammonia indoors by air-monitoring equipment in the freezers. The ammonia detected within the facility was the result of a second leak that developed because a portion of the system's blast freezer⁵ evaporator header ruptured (Figure 2).

Ruptured 12-inch diameter end cap of low-temperature suction line piping on the roof of Millard facility (OSHA).

1. For the design of ammonia refrigeration systems, avoid grouping multiple evaporators to a single set of control valves. This is especially important for large capacity evaporators in excess of 20 tons. Evaporators with hot gas defrost systems should be controlled by individual valve control groups dedicated to each evaporator coil.

2. Program or configure defrost control systems with interlocks to ensure the low-temperature liquid feed and hot gas remain isolated during the initiation and termination of the hot gas defrost cycle in the event of a power outage, cycle interruption, or other abnormal situation. Program the defrost control sequence to automatically depressurize or bleed the coils in defrost upon restart after an outage or interruption, prior to opening the suction stop valve to set the evaporator into cooling mode.

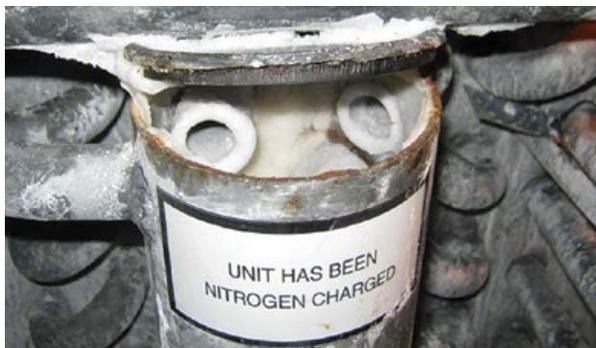
FIGURE 2

Freezer 5 evaporator coil weld failure after the incident (OSHA).

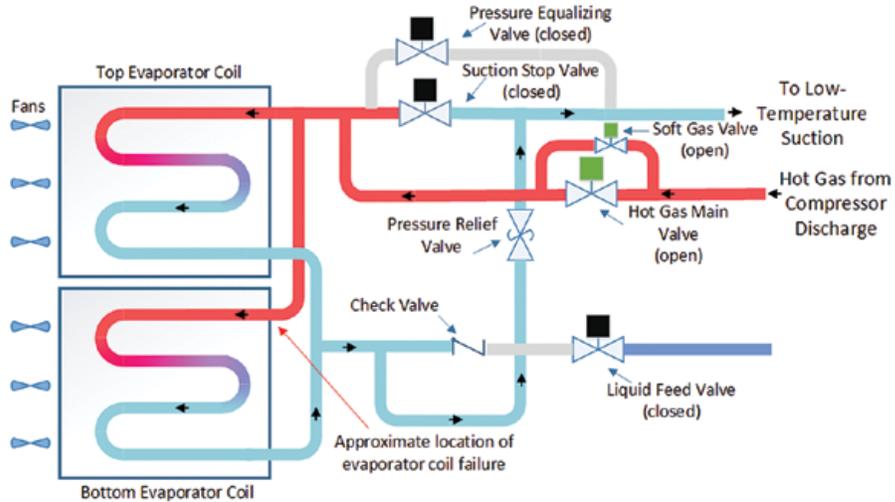
FIGURE 5

Another contributing factor in this incident was the design and configuration of the blast freezer evaporators at the Millard facility—specifically, connecting multiple evaporator units onto a single control valve group. This design approach allowed for an excessively large volume of high-pressure gas to be introduced to the suction line when the suction stop valve was prematurely opened. Millard and the designers of the refrigeration system designed the blast freezer evaporators at the Theodore facility with four evaporator coils grouped to one set of control valves. With this design, one set of valves controlled the liquid feed, hot gas, and suction for all four evaporator coils during cooling mode and the defrost cycle. The evaporator assembly at Millard consisted of a pair of evaporators with two coils each, stacked vertically. Liquid ammonia fed into the coils from the bottom of the coil and the hot gas fed the coils from the top (see Figure 5 for stacked evaporator configuration).

Designing the system with multiple evaporator coils controlled by a single valve arrangement reduced the overall number of valves that needed to be installed for each evaporator; therefore, reducing the initial system cost. Because of the poor controllability and the large internal coil volume, the practice of ganging multiple evaporators onto a single valve group should be avoided. The risk of hydraulic shock failure during hot gas defrost increases as coil volume increases and temperature decreases.²⁰ Accordingly, larger coils at lower temperatures have a higher risk of component failure, as exhibited at Millard. A large volume of hot gas will condense on a cold surface into a small volume of liquid.²¹ The greater the volume of hot gas, the larger the gas void created during the rapid condensation of vapor in the suction line, contributing to catastrophic failure.

Each evaporator coil at Millard had an aggregate capacity of 15 cubic feet of liquid ammonia or gas with a total of 60 cubic feet of ammonia for each blast freezer valve control bank. Because two evaporators (4 coils total) were assigned to the same set of control valves, when the suction valve suddenly opened, the total volume of each evaporator (totaling 60 cubic feet of hot gas at a pressure of 70 psig) was introduced into the low-temperature suction line. The large amount of energy stored in the four coils rapidly condensed to a liquid in the suction line, creating the condensation-induced shock that ruptured the evaporator piping manifold and rooftop piping. By grouping four large blast freezer evaporators together with one set of control valves, the opportunity for a large volume flow through the suction line enabled the catastrophic failure. The risk of such failure can be reduced by configuring each evaporator with its own individual set of control valves.

As the capacity of the evaporator coil increases, the hot gas defrost system requires a more detailed engineering analysis.²² Refrigeration system designers should avoid grouping multiple evaporators to one set of control valves. Had Millard assigned each evaporator to an individual set of control valves, only 15 cubic feet at 70 psig would have been released to the header when the control system reset signaled the suction stop valve to open. The lower volume of hot gas may have resulted in a minor shock event, such as an audible hammering or shaking, instead of a pipe rupture.
