# **FINAL INVESTIGATION REPORT**

## **CARIBBEAN PETROLEUM TANK TERMINAL EXPLOSION AND MULTIPLE TANK FIRES**

### **CARIBBEAN PETROLEUM CORPORATION (CAPECO)**

REPORT NO. 2010.02.I.PR

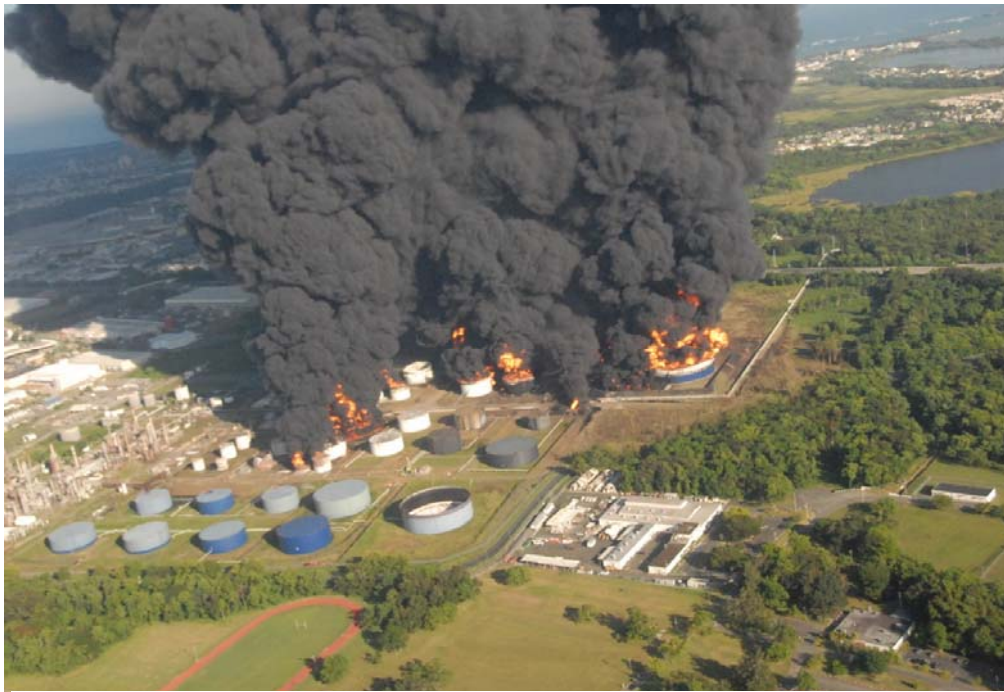
After the explosion, fuel in the damaged tanks burned for over two days while emergency responders fought to control the fire and prevent other tanks from igniting. The large fire demanded emergency personnel and resources from across the Commonwealth of Puerto Rico and the US mainland. Local fire departments with assistance from an industrial firefighting company took 66 hours to extinguish the fire after the explosion. As a result, 17 of the 48 tanks burned. (See Figures 5 and 6.)

Figure 5: CAPECO multiple tank farm fire, October 23, 2009.

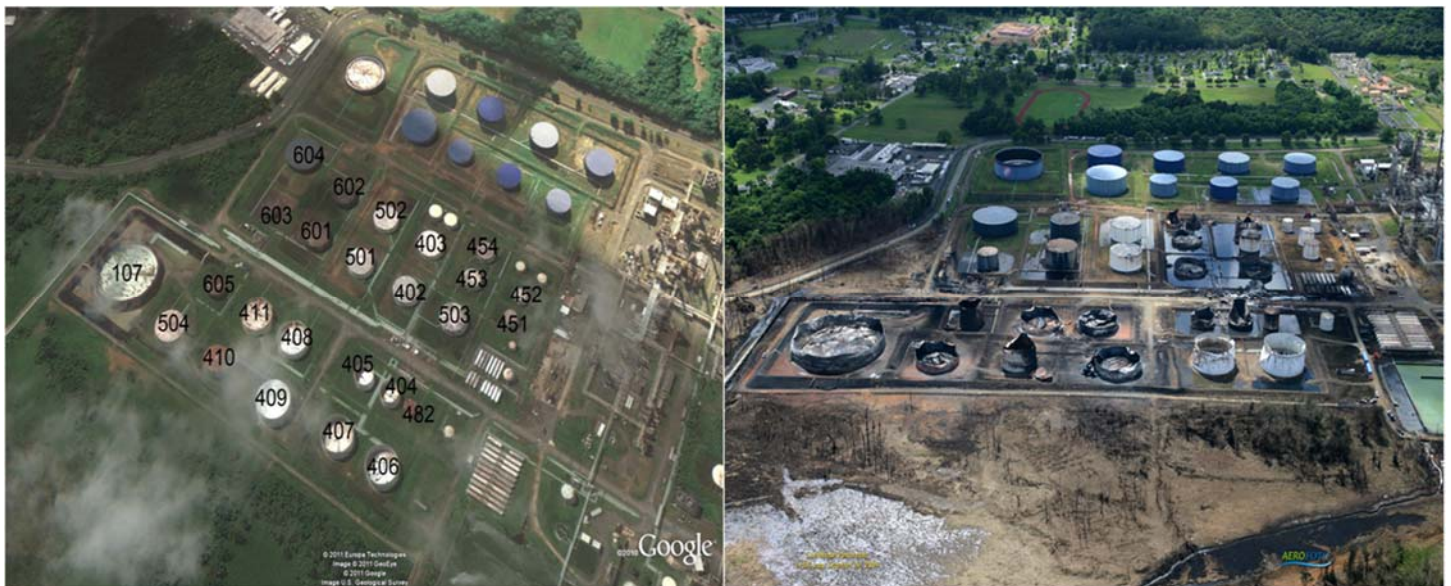
Figure 6: Impact of the explosion and multiple tank fires after the October 23, 2009 incident

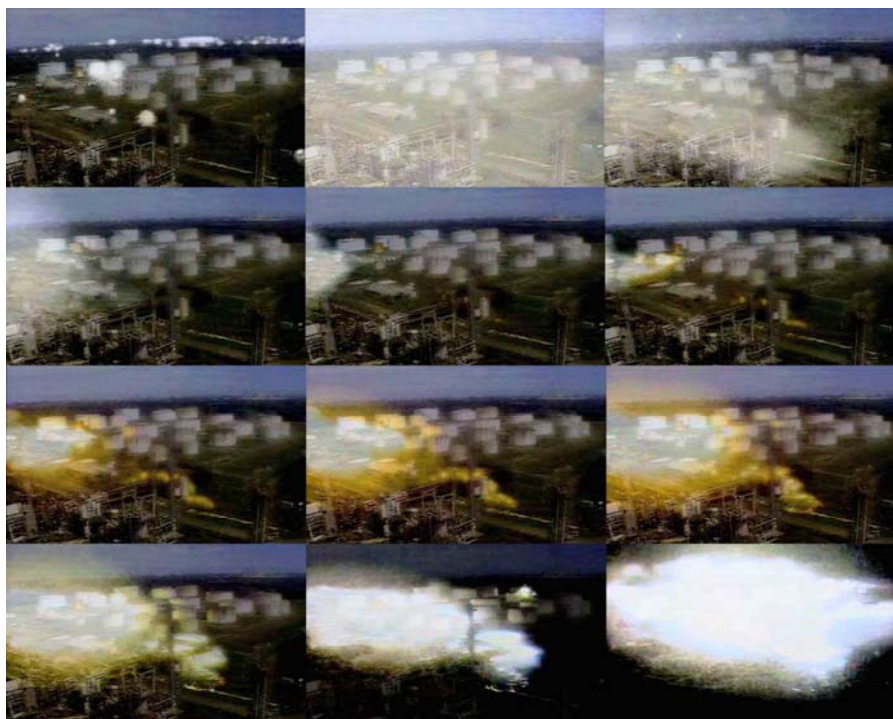
Figure 8: CAPECO surveillance footage of flame propagation during October 23, 2009 CAPECO explosion

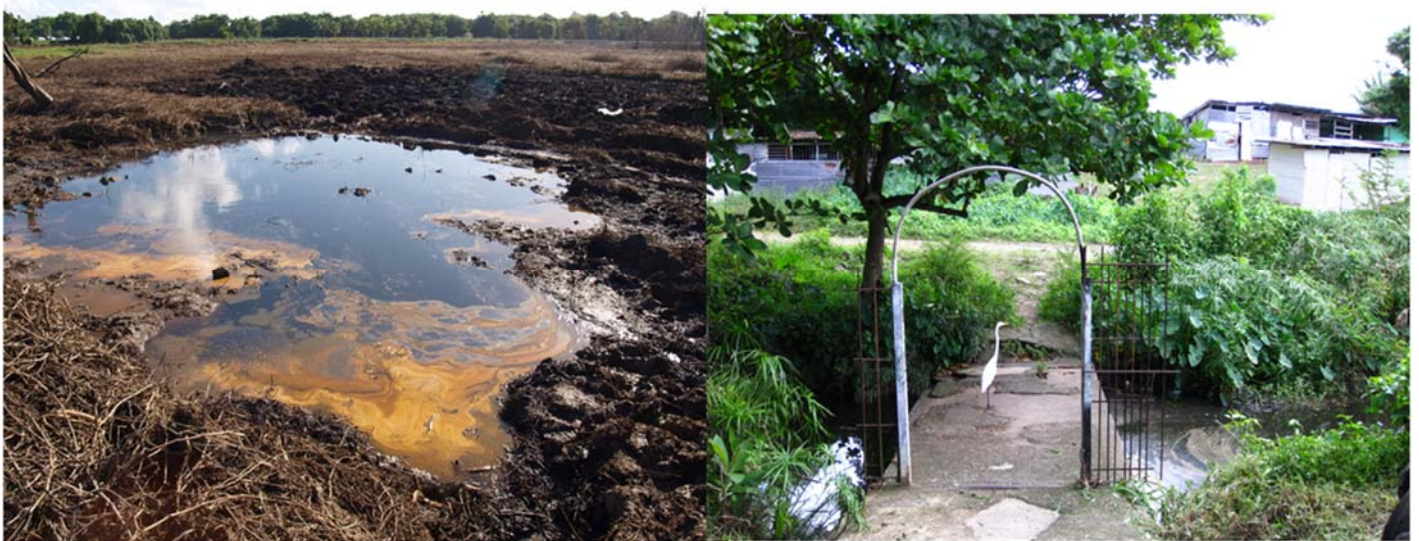
Figure 11: Oil Spill into nearby wetlands (photo from NOAA.gov) and in a local community drain after CAPECO explosion and tank fires

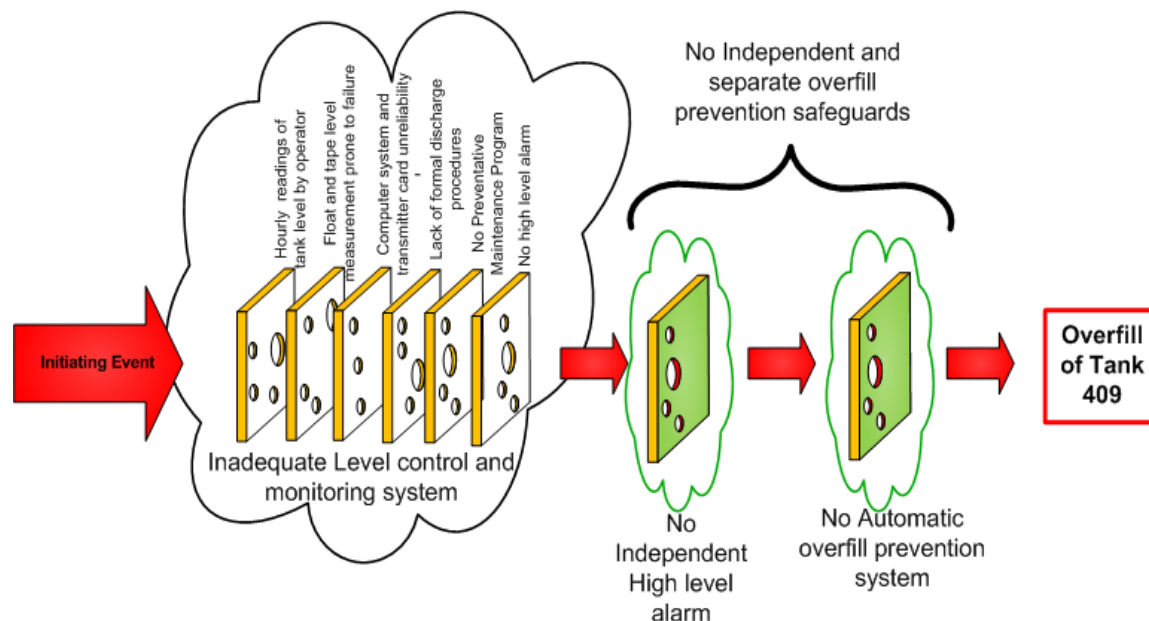
Figure 12: Contributing to the October 2009 overfill incident at CAPECO were multiple failures of the level control and monitoring system in addition to a lack of safeguards like a high level alarm, an independent level alarm and an automatic overfill prevention system that allows for automatic shutdown or diversion.

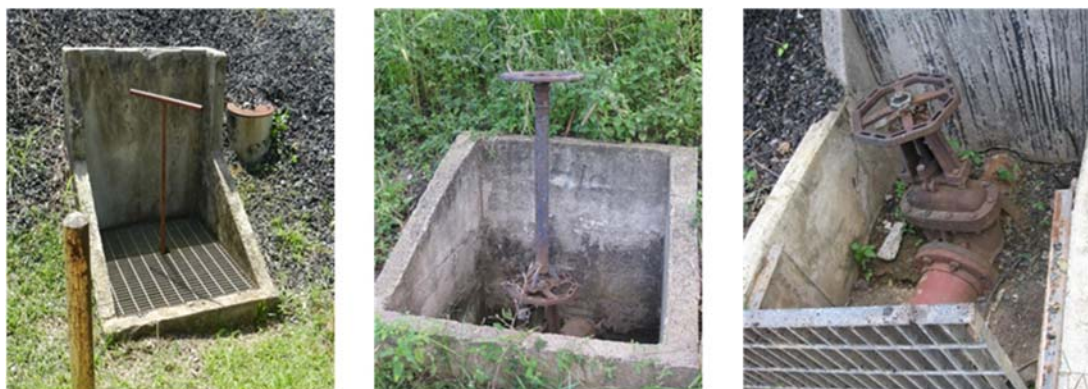
CAPECO's normal practices required operators to open and close valves during the day shifts. Operators customarily inspected whether the dike drain valves were open or closed from their vehicles as they drove by. The tank farm used both rising stem and fixed stem valves on the dike drains leading to the storm water retention pond in the WWT area. Rising stem valves allowed operators to easily observe the open or closed position while fixed stem valves do not provide a visual indication of the position. The fixed stem valve on the dike drain for Tank 409 made it difficult for tank farm operators to observe its position without physically turning it. (See Figure 15.) In some cases, the valve position could not be determined with a visual inspection because the rising stem valve position was hidden in the sump. (See Figure 15, center photo.) Furthermore, none of the dike valves shown in Figure 15 were consistent with RAGAGEP. Regulatory coverage under the EPA Risk Management Plan (RMP) or OSHA's Process Safety Management (PSM) Standard requires that CAPECO use the best available engineering practices to assess valve open/close status.

Figure 15: Various dike drain valves at CAPECO. Tank 409 fixed stem dike drain valve (left): position of the valve is undeterminable without physically turning the valve. Rising stem valves (center, right). In some cases, the valve position is hidden in the sump (center).
