### August 2018

**O**n April 26, 2018, an explosion (Figure 1) and subsequent fire (Figure 2) occurred at the Superior Refinery Company LLC refinery in Superior, Wisconsin (“Husky Superior Refinery”).<sup>1</sup> The incident occurred in the refinery’s Fluid Catalytic Cracking Unit (FCCU). In preparation for the shutdown, the refinery brought in hundreds of contractors and increased operations staffing. The contractors were performing many tasks such as electrical work, preparing for chemical cleaning, building scaffolding, and welding. As a result of the explosion, thirty-six people sought medical attention, including eleven refinery and contract workers who suffered OSHA recordable injuries. In addition, a large portion of Superior,<sup>2</sup> Wisconsin was evacuated.

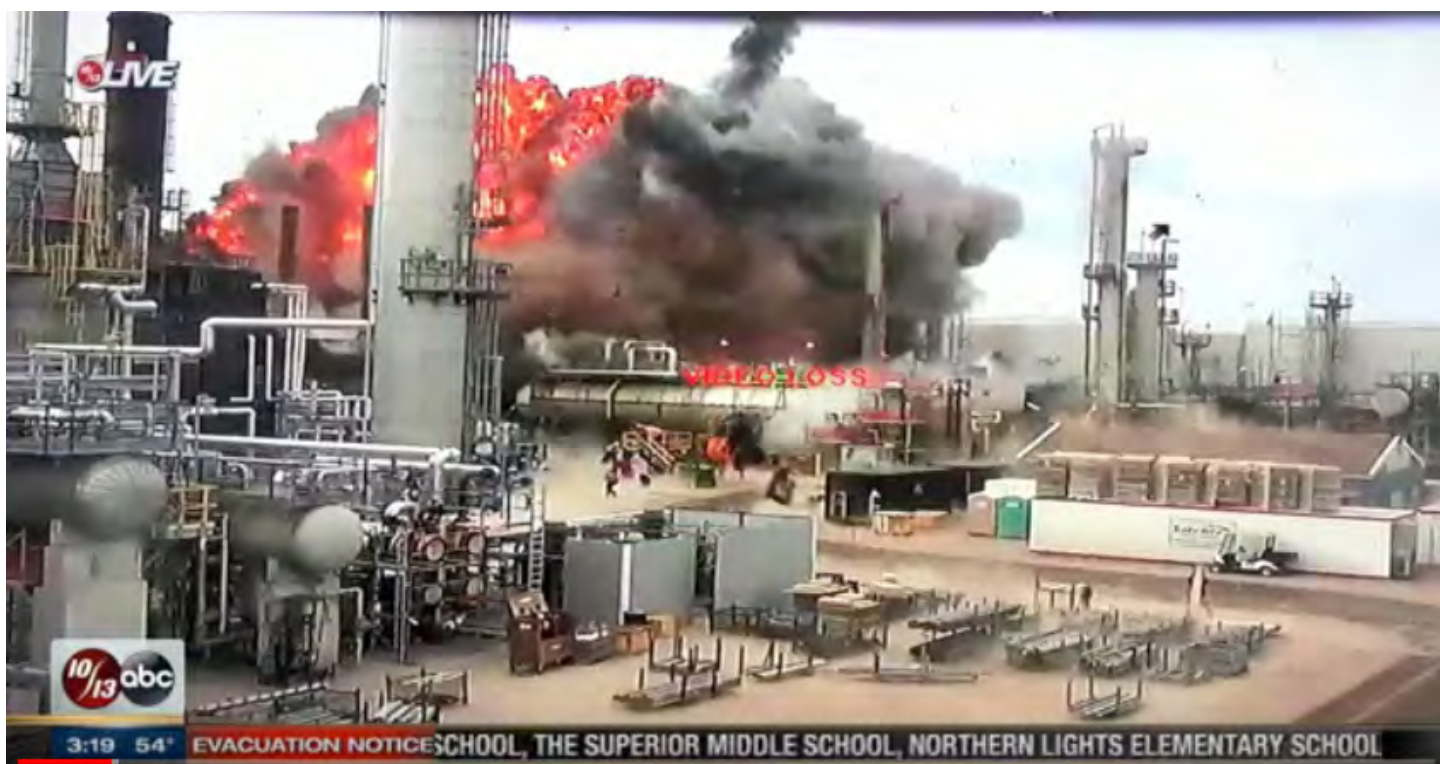
**Figure 1.** Surveillance Camera Image of the Husky Superior Refinery Explosion. Credit: WDIO ABC News.

The explosion occurred around 10:00 am on April 26, 2018, while the refinery was shutting down the FCCU for periodic maintenance and inspection. The explosion occurred during a scheduled break

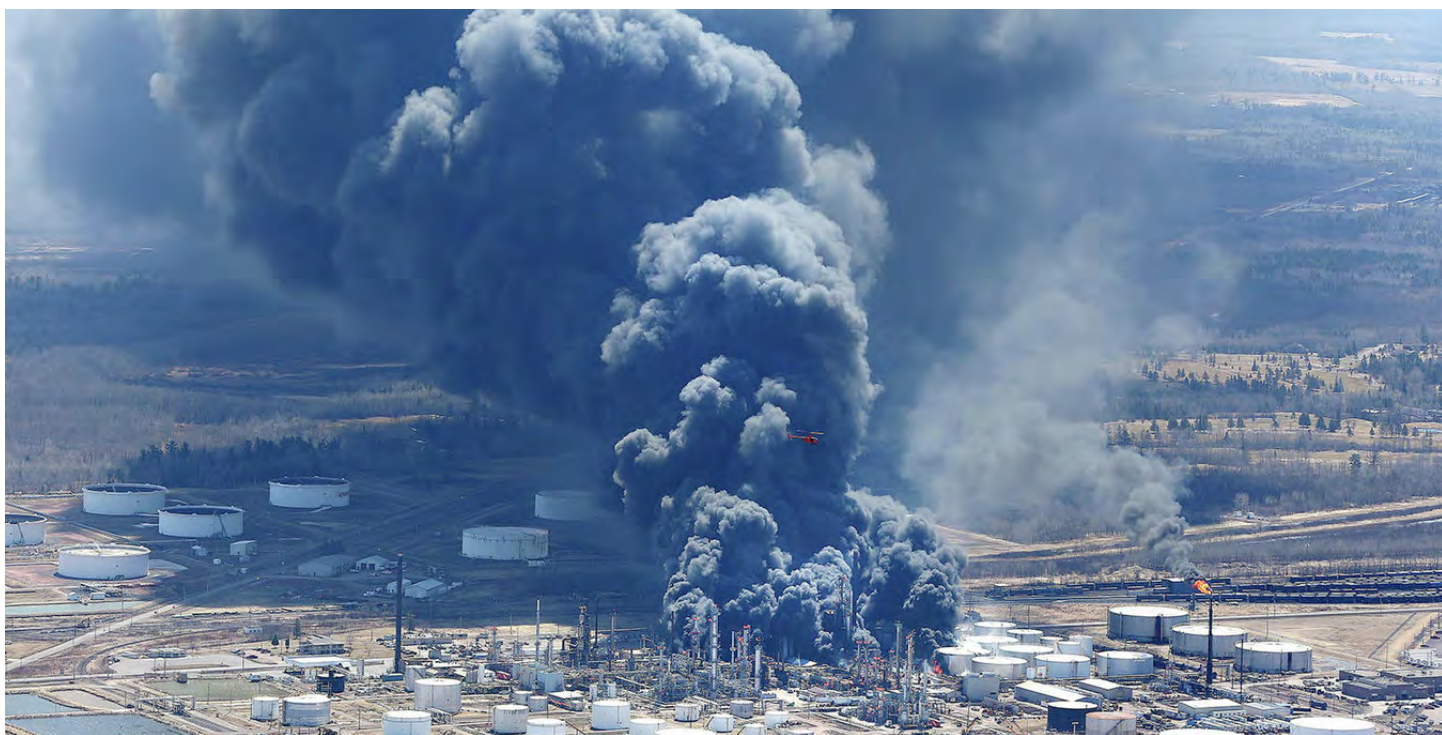
**Figure 2.** Smoke from the Fire at the Husky Superior Refinery. Credit: WDIO ABC News.

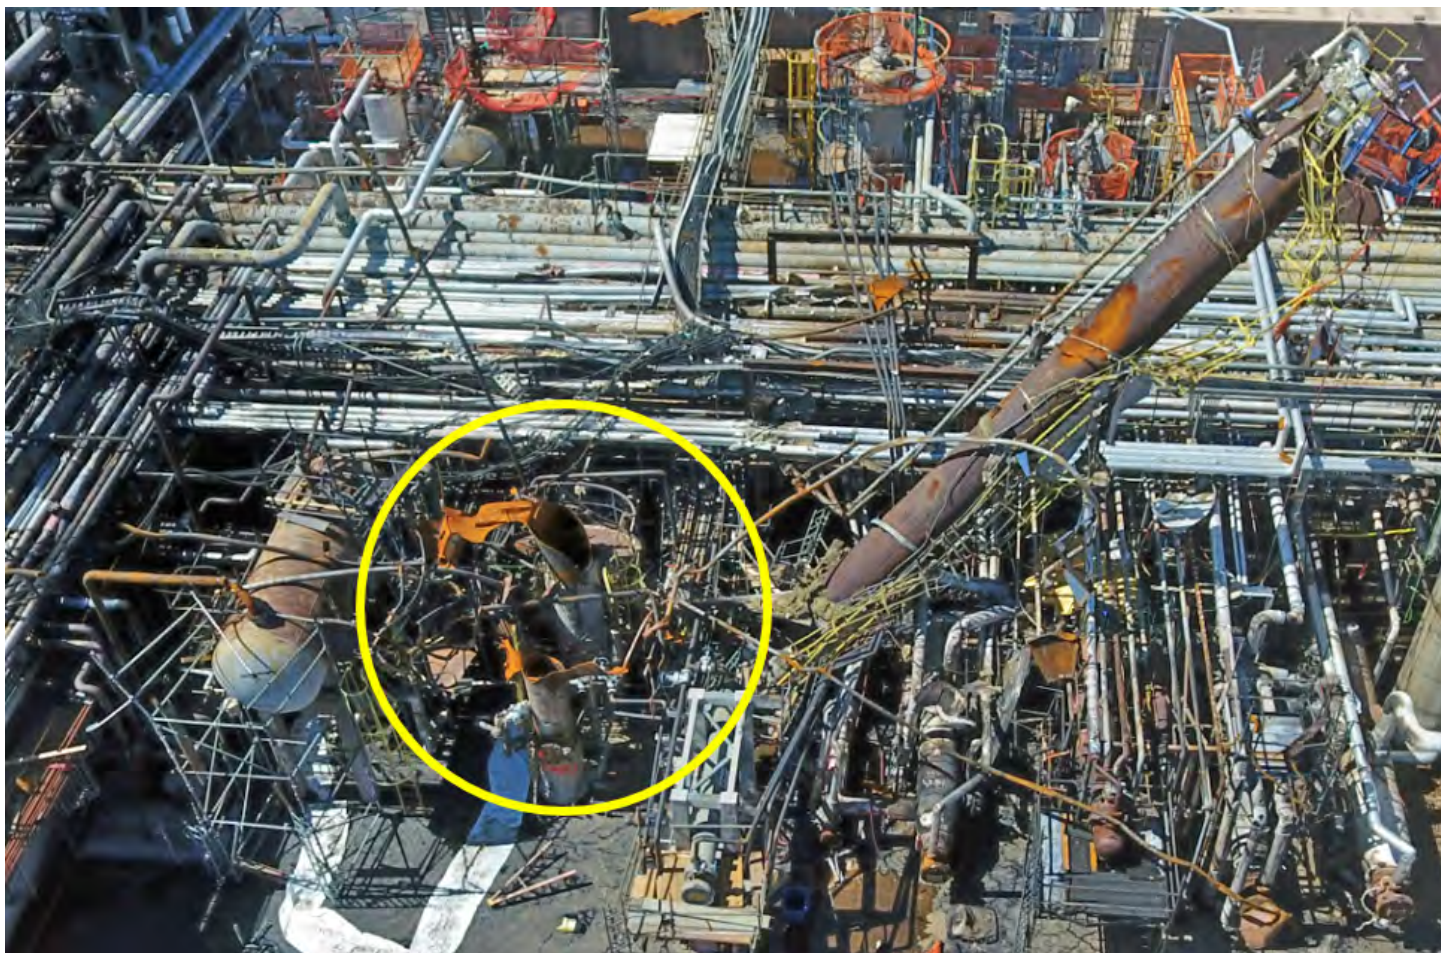
**Figure 3.** Two of the Vessels Destroyed in the Explosion at the Husky Superior Refinery (yellow circle). The photo shows that only the bottom portion of the two process vessels remained after the explosion. The remaining portions of the vessels were blown into surrounding units of the refinery. Credit: Husky Superior Refinery.

Two FCCU vessels,<sup>6</sup> the primary absorber<sup>7</sup> and sponge absorber<sup>8</sup>

(Figure 3), were destroyed in the explosion. The primary and sponge absorbers serve to recover heavy hydrocarbons<sup>9</sup> from a gas stream by mixing the gas stream with a liquid stream that absorbs the heavy hydrocarbons.

<sup>7</sup> The dimensions of the primary absorber were 36 inches (internal diameter) by 69.5 feet tall. The vessel had a maximum allowable working pressure of 250 pounds per square inch at 150 °F. The primary absorber was constructed in 1961 using SA-212-B steel and the vessel was not stress relieved.

<sup>8</sup> The dimensions of the sponge absorber were 30 inches (internal diameter) by 48 feet tall. The vessel had a maximum allowable working pressure of 250 pounds per square inch at 150 °F. The sponge absorber was constructed in 1961 using SA-201-A steel and the vessel was not stress relieved.

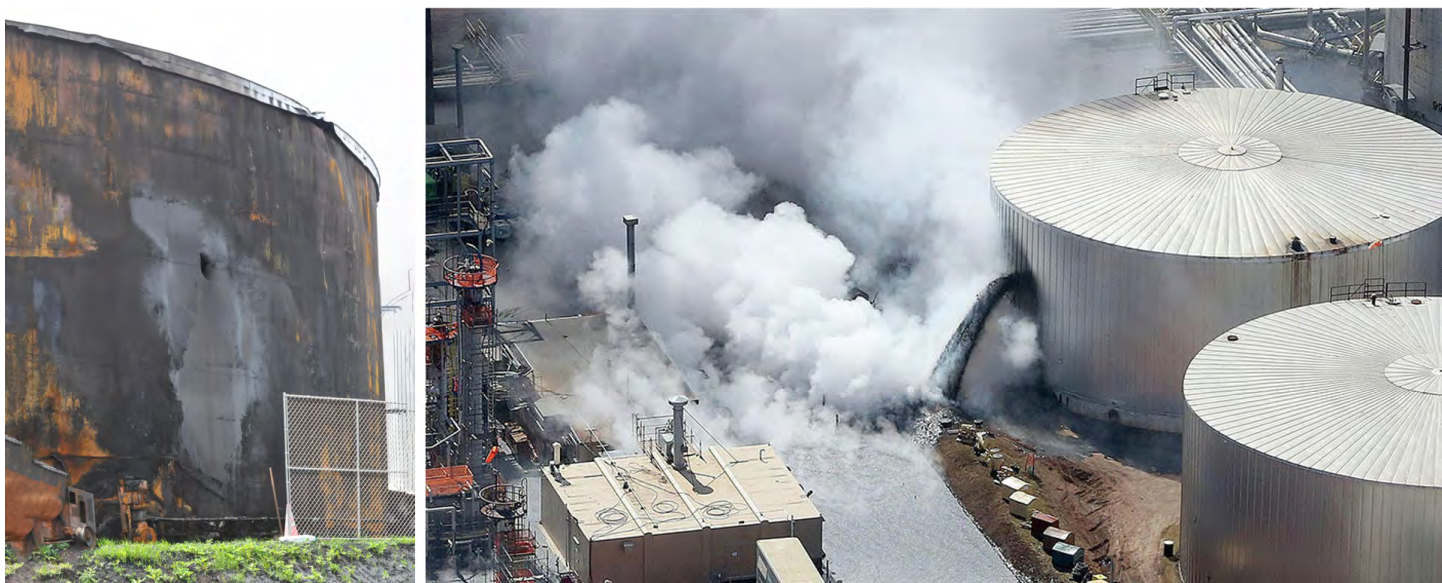
Debris from the explosion flew about 200 feet, and impacted a large, nearby, aboveground storage tank containing about 50,000 barrels of asphalt, puncturing the side of the steel tank and spilling over 15,000 barrels of hot asphalt into the refinery (Figure 4). This released asphalt ignited about two hours after the explosion, creating a large fire.

**Figure 4.** Post-incident photographs of the leaking Asphalt Storage Tank. Debris from the explosion punctured the side wall of the tank creating a large asphalt leak outside of the secondary containment area. Credit: CSB (left) Duluth News Tribune (right).

Around 12:15 pm the spilled asphalt ignited, creating a large fire spanning multiple units at the refinery. Because this fire risked compromising other process equipment containing hazardous chemicals, the Unified Command issued its first community evacuation notice at 1:00 pm. By 2:41 pm, the evacuation zone consisted of a 3-mile radius around the refinery, and a 10-mile rectangle extending south from the refinery (Figure 5). The evacuation zone size was established to protect the public from the smoke plume and as a precaution in case the refinery's highly toxic hydrofluoric acid equipment was compromised.<sup>10</sup>
