Investigation Report

Published: December 2019

KEY ISSUES:

On May 24, 2017, an explosion occurred at the Midland Resource Recovery (MRR) facility in Philippi, West Virginia, killing two workers^a and severely injuring another worker. The founder and president of MRR was one of the victims. The CSB initiated an investigation of the incident and deployed an investigative team on May 28, 2017. While the CSB was investigating this incident, the MRR facility experienced a second explosion, on June 20, 2017. This explosion fatally injured a contractor^b employed by Specialized Professional Services, Inc. (SPSI). MRR had hired SPSI to perform investigation and mitigation work at its Philippi facility following the May 24, 2017, explosion.

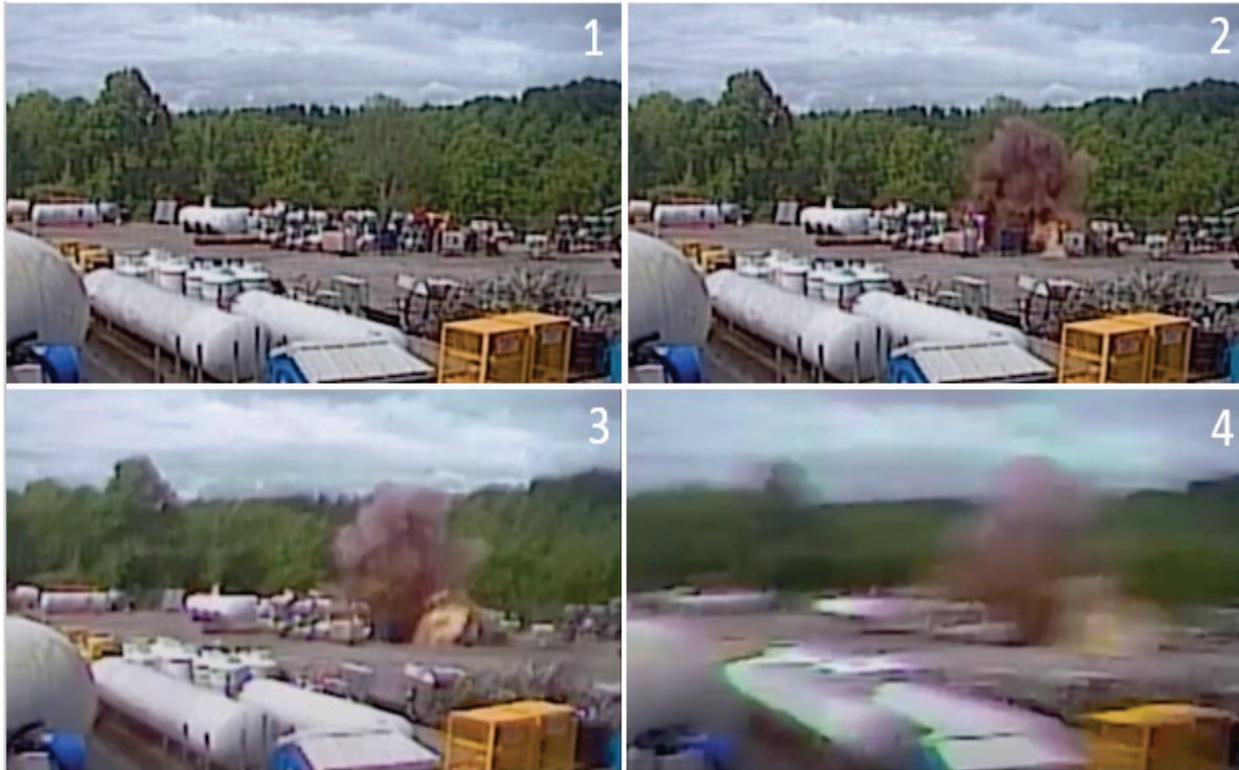
On May 24, 2017, two workers were assigned to drain some of the chemically treated MP odorizers. While working, they were accompanied by the company owner, who was at the Philippi site on a routine visit. The company owner developed MRR’s reactive chemical treatment process and at times, he trained MRR technicians and took part in chemical treatment operations. The MRR site manager told the CSB that during the late morning, the two workers and the company owner were preparing to drain one of the MP odorizers. MRR surveillance video shows that at 11:08 a.m., while the personnel were working on the odorizer, the top tank of the MP odorizer violently exploded, killing one worker and the company owner, and severely injuring the other worker.

Figure 9. Surveillance Video Capturing May 24, 2017, Explosion. These still frames from an MRR surveillance camera capture the May 24, 2017, explosion. (Credit: MRR).

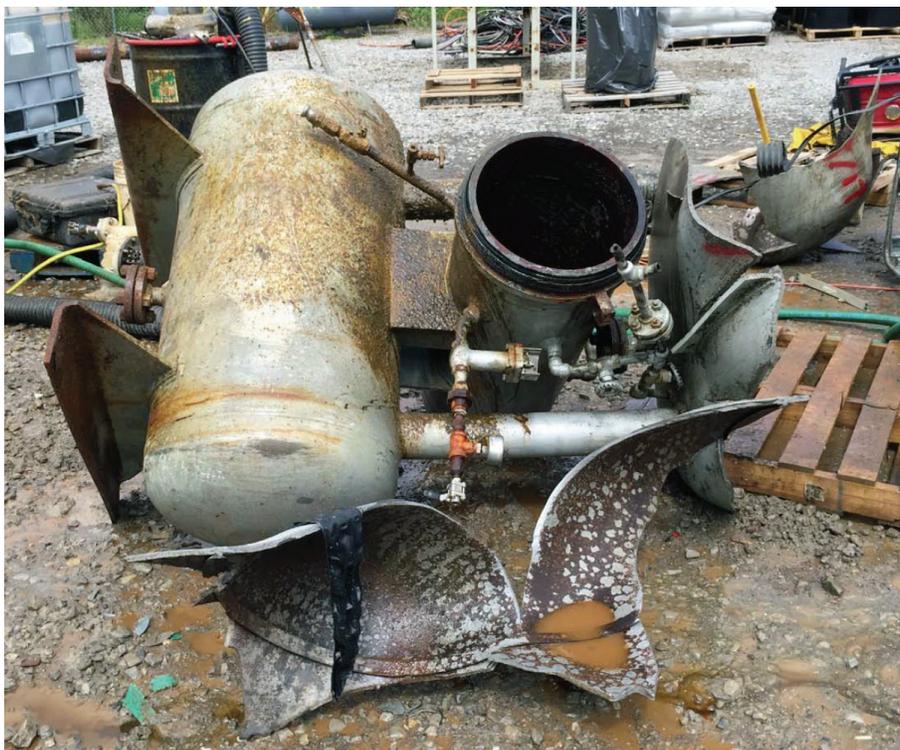
Figure 10. MP Odorizer That Exploded on May 24, 2017. This photo shows the failed MP odorizer from the May 24, 2017, explosion. (Credit: MRR).

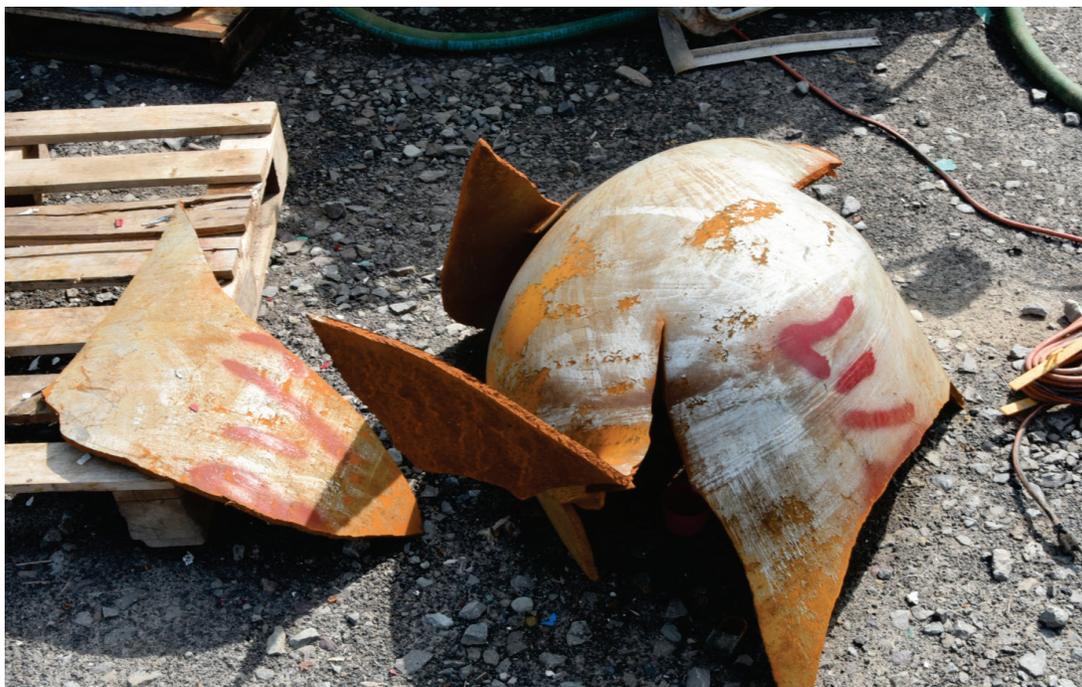
Figure 11. MP Odorizer Fragment from May 24, 2017, Explosion. This photo shows a portion of the top chamber of the MP odorizer after the May 24, 2017, explosion. (Credit: CSB).

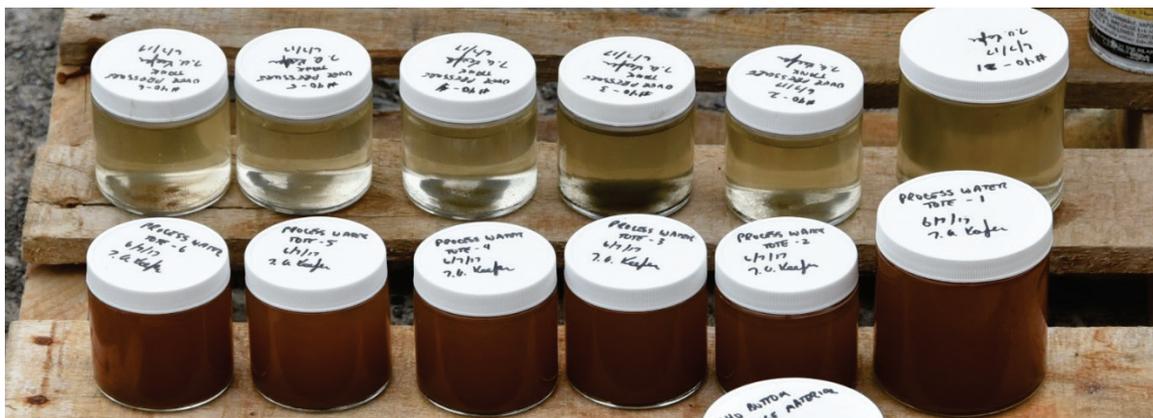
Figure 12. Process Water. The light-yellow samples (top row) were taken from the bottom chamber of the MP odorizer that exploded on May 24, 2017. The brown samples (bottom row) were taken from a “process water” tote not involved in the May 24, 2017, incident. Note the color differences showing the drastic color variation of the process water, indicating that different vessels likely had different types and quantities of materials in them before chemical treatment. (Credit: CSB).

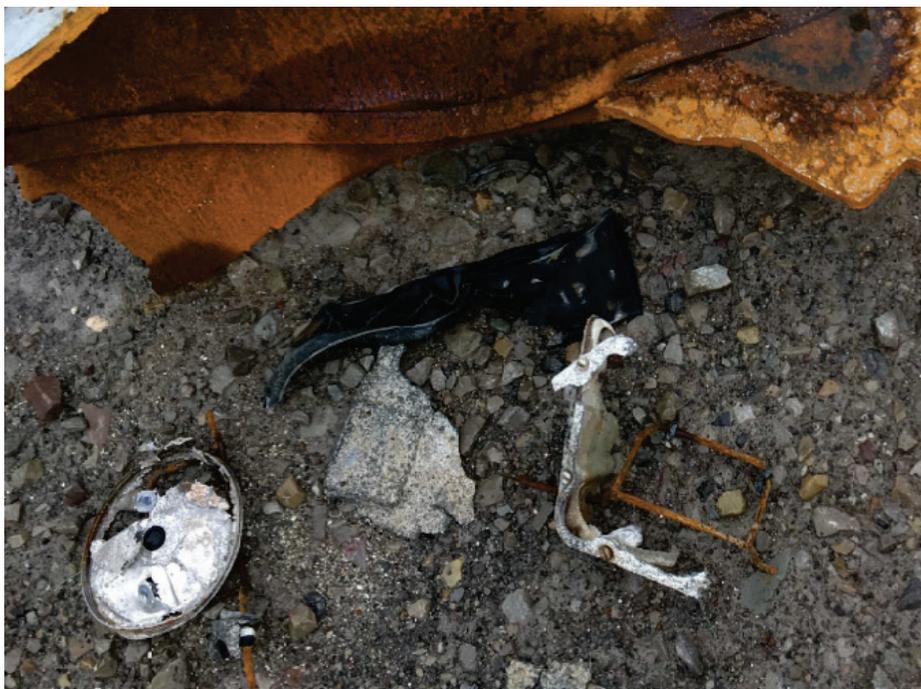
The CSB could not determine the exact actions of the three personnel leading up to the explosion because there were no immediate witnesses, and surveillance footage could not be used to determine their actions definitively. Figure 9 shows still frames of the explosion from the surveillance footage. Figure 10 and Figure 11 show the MP odorizer after the incident. Figure 12 shows the variation in appearance of process water within MRR’s chemical treatment process. Figure 13 shows aluminum components that were likely inside the middle chamber of the MP odorizer. MRR

provided the CSB documents from 1964, showing that Peerless used aluminum components in the middle chamber as part of the gas metering and odorant delivery system.

Figure 13. Aluminum Parts. This photo shows aluminum internal components that were likely in the middle chamber of the MP odorizer, found after the May 24, 2017, incident. The explosion destroyed the aluminum pan and components that were inside the middle chamber of the MP odorizer. (Credit: SPSI).

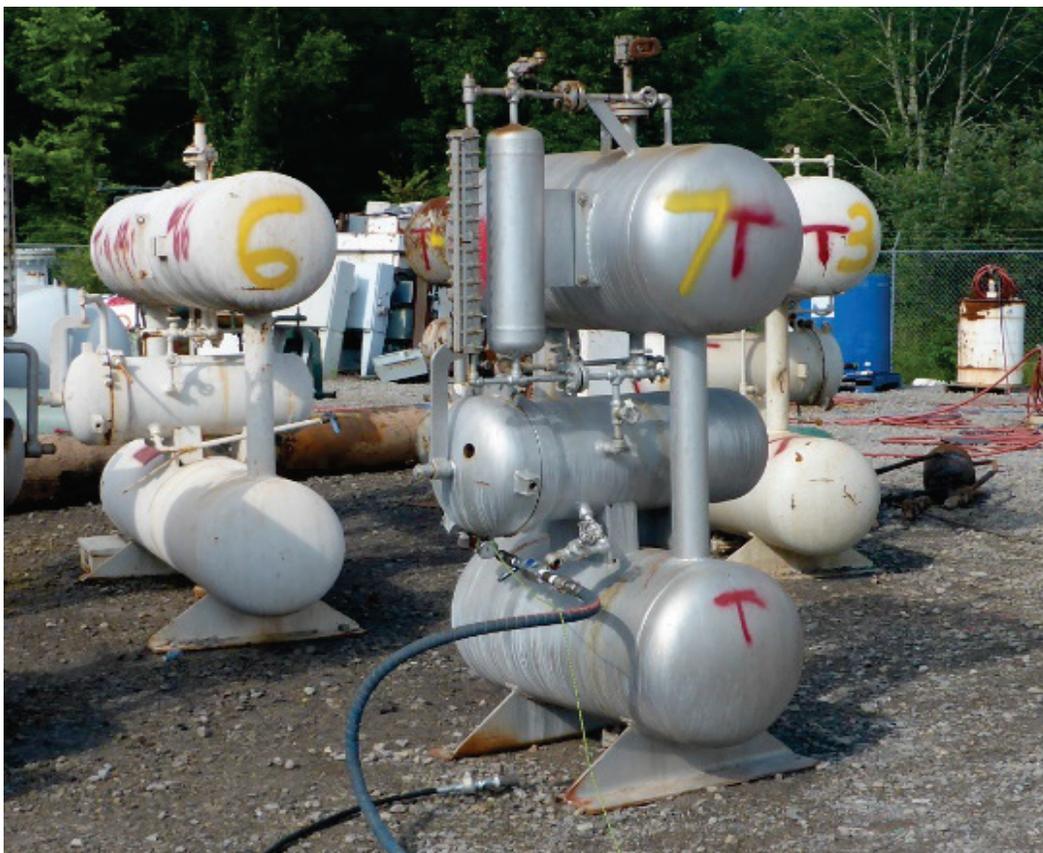
SPSI had installed an additional (new) valve and pressure gauge into the piping coming off the middle chamber (Figure 14—piping to the left of sight glass). SPSI had also put a rope on the existing valve on the pipe, for use in opening the valve (Figure 14). To start the draining operation, SPSI's field supervisor opened the valve using the rope. The pressure gauge indicated zero pressure in the MP odorizer. SPSI's procedure called for halting the operation if the pressure gauge showed more than 30 psig. Because the pressure gauge showed no pressure, the operation continued.

Figure 14. MP Odorizer Before June 20, 2017 Explosion. This pre-incident photo shows the MP odorizer and equipment connections that SPSI workers were using to drain liquid when the June 20, 2017 explosion occurred.^a (Credit: CSB).

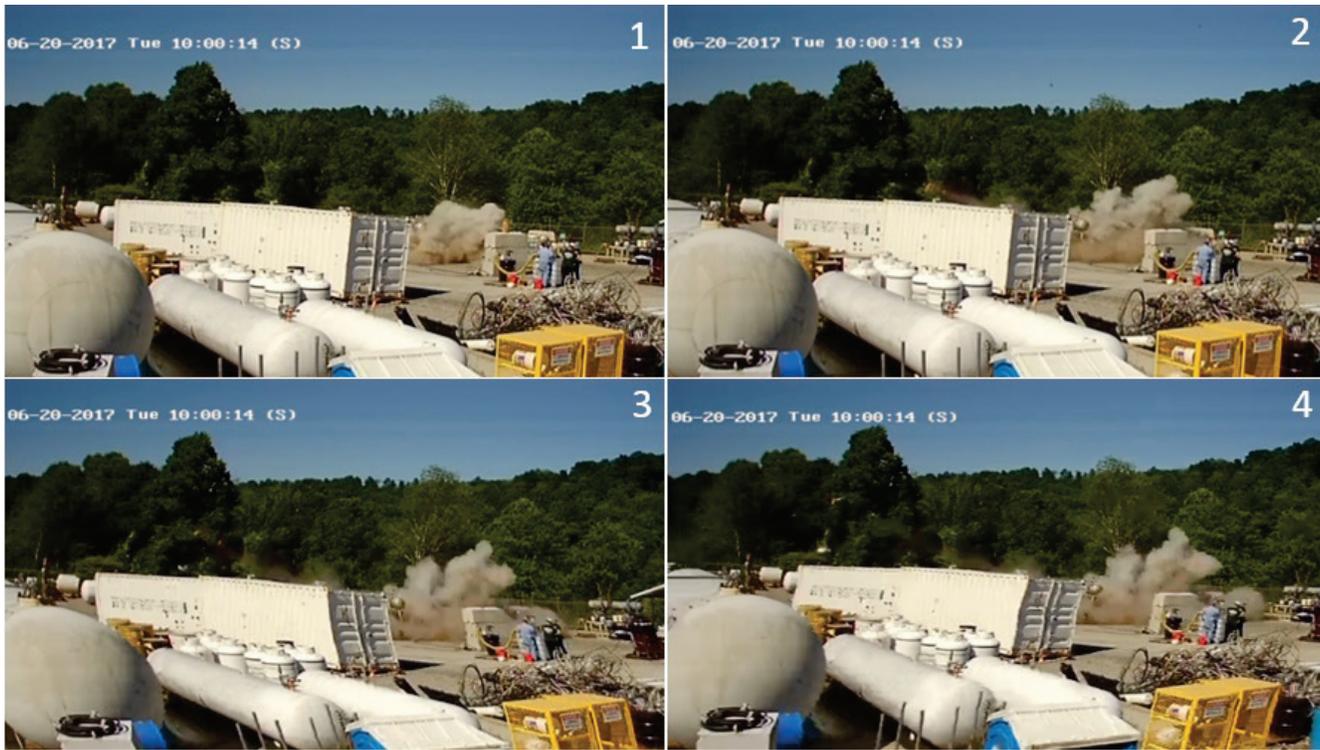
Based on surveillance video, the MP odorizer exploded less than five minutes after the draining operation had begun (Figure 15 and Figure 16). A portion of the MP chamber struck and fatally injured the field supervisor. Figure 15 shows still frames of the explosion from a security video.

Figure 15. Surveillance Video Capturing June 20, 2017, Explosion. These still frames from an MRR surveillance camera capture the June 20, 2017, explosion. The MP odorizer involved in the explosion is partially obstructed from view, behind the white shipping container. No flames were visible in the surveillance footage. (Credit: MRR).

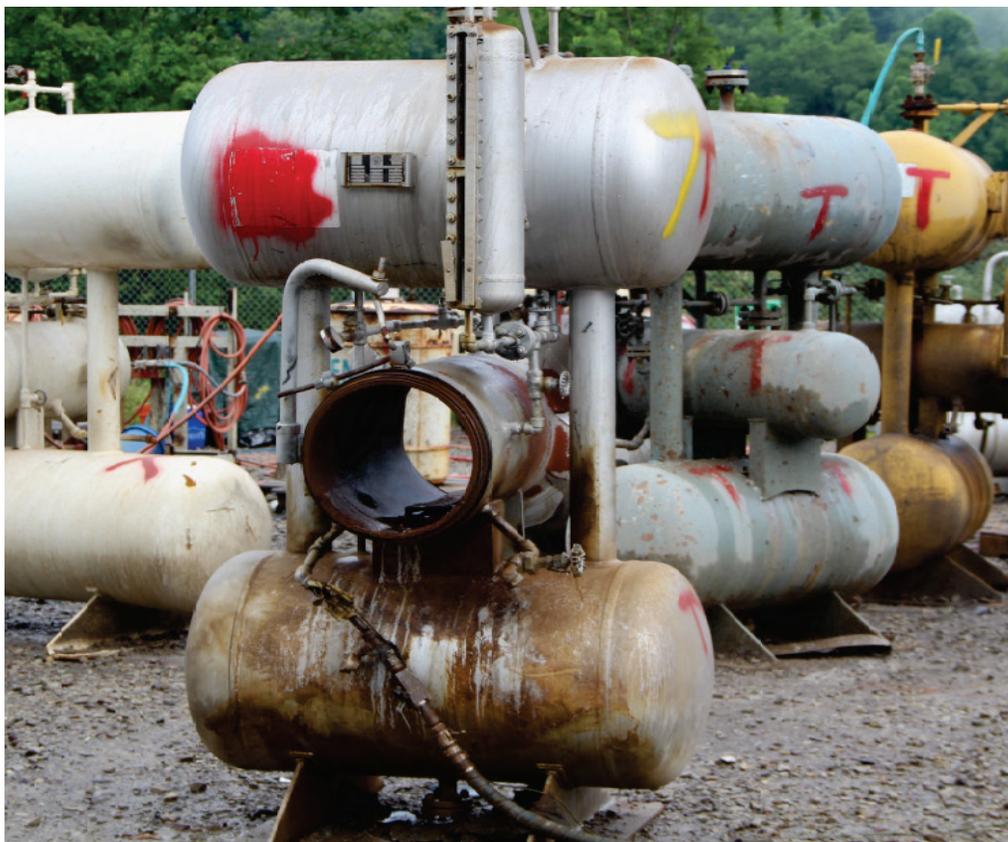
Figure 16. MP Odorizer Vessel That Exploded. This photo shows the MP odorizer that exploded on June 20, 2017. The back portion of middle chamber ruptured (see also Figure 17) and the front threaded section blew off. The aluminum tray and mechanical parts that were inside the middle chamber were expelled from the MP during the event. (Credit: SPSI).

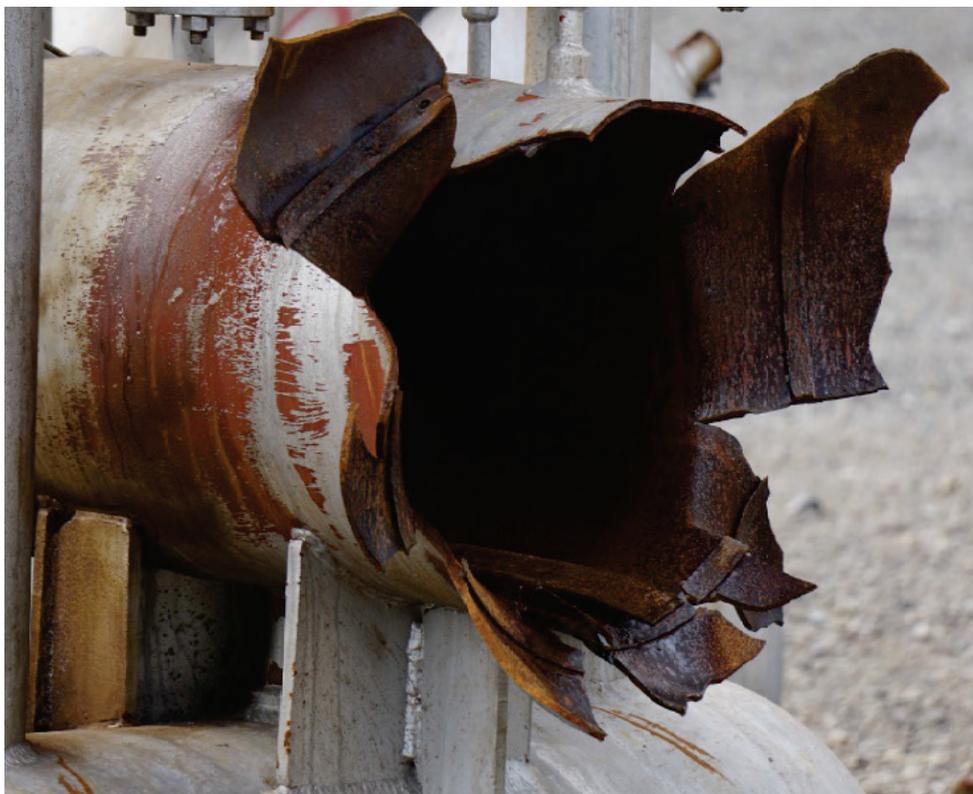
Figure 17. Ruptured MP Odorizer Middle Chamber from June 20, 2017, Incident. This photo shows the post-incident condition of the rounded end of the middle chamber that ruptured in the June 20, 2017, explosion. (Credit: SPSI).

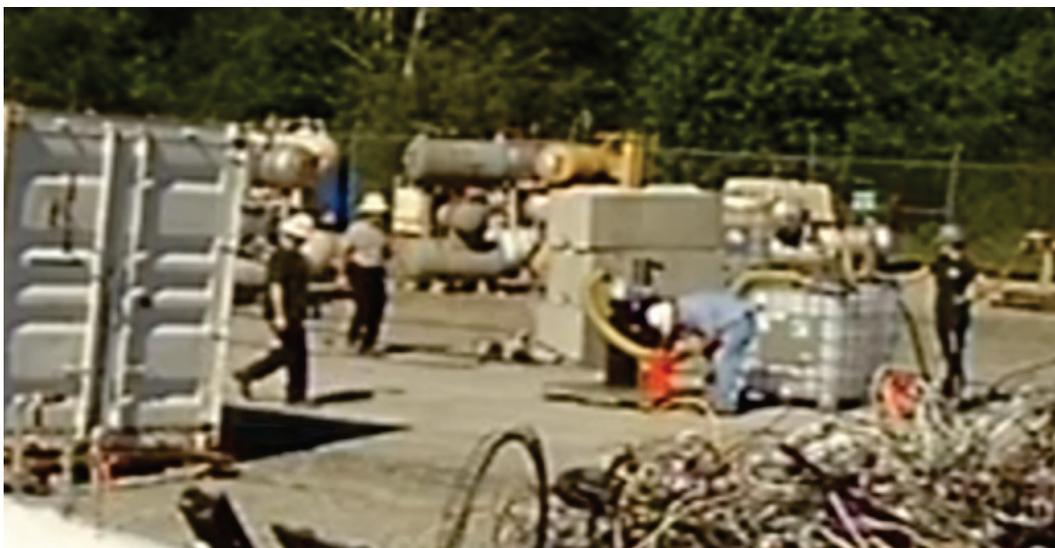
The SPSI manager’s statement about the concrete barriers is consistent with the protocol SPSI developed to drain the process water from the MP odorizers. The protocol does not mention the concrete barriers, establish any type of exclusion zone near the MP odorizer, or suggest that SPSI workers would use the concrete barriers as a safeguard while performing the work. The SPSI manager’s statement is also consistent with the worker actions that took place on June 20, 2017. During the nearly five minutes from when SPSI started their activities to drain the process water from the MP odorizer up to the time of the explosion, only one of the four SPSI employees consistently remained behind the concrete barrier wall (Figure 18).

Figure 18. Concrete Barriers. This surveillance video image from June 20, 2017 at 9:56 a.m., shows only one of four SPSI workers positioned behind the concrete barrier. Two other concrete barriers were placed, but they are outside the view of this surveillance camera (Credit: MRR).

Based on SPSI worker actions captured by the surveillance video leading up to the explosion, MRR and SPSI needed to provide more barriers and strengthen their work plan for these concrete barriers to properly serve as a worker protection safeguard. Had MRR and SPSI established a more robust barrier system, such barriers may have helped to protect the SPSI field supervisor from being struck and fatally injured by the projectile when the MP chamber

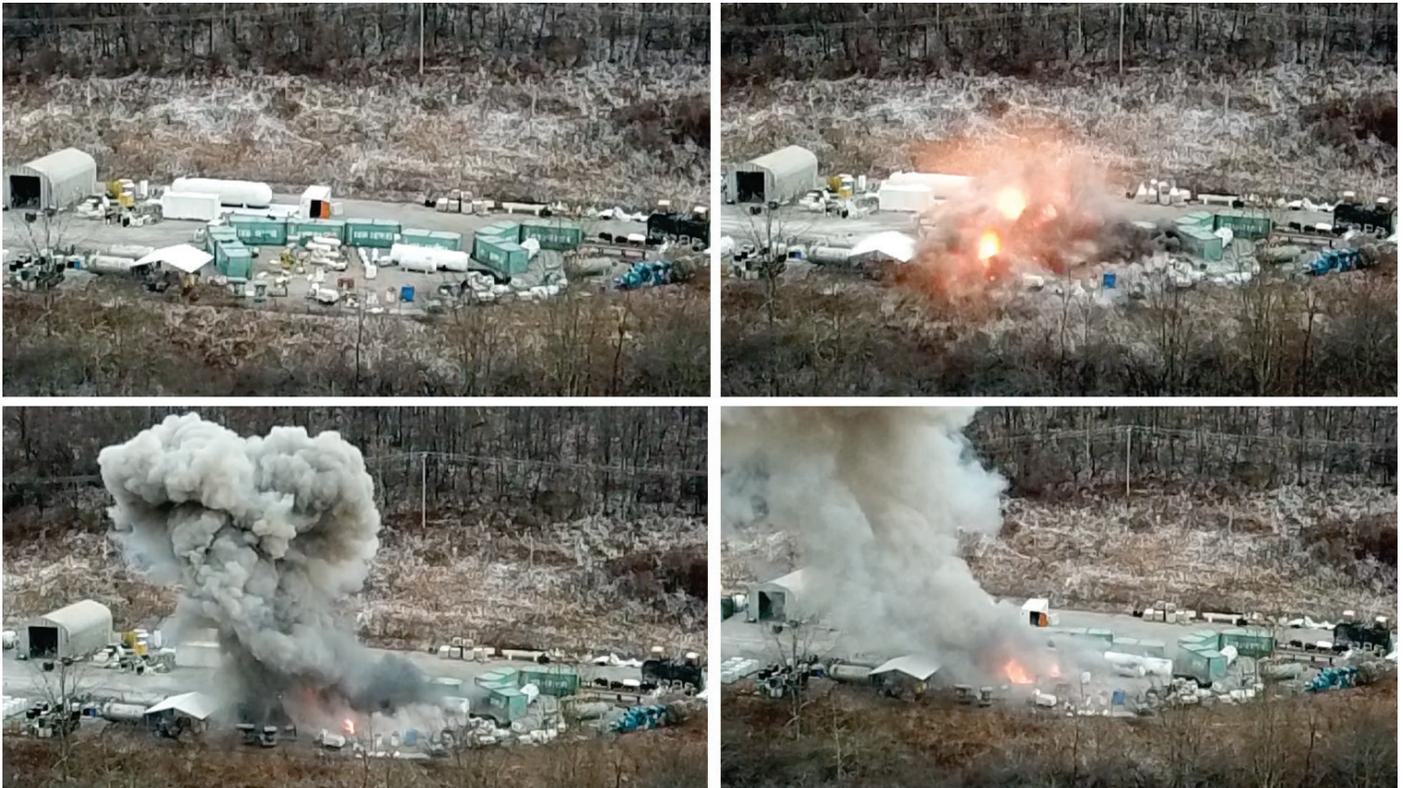
Figure 19. Explosive Venting. These drone video images show the explosive venting used to cut holes in a group of MP vessels to drain the vessels while minimizing risk to people. The bottom right image shows a fire that erupted from flammable liquids that drained from some of the MP vessels. (Credit: MRR).

The use of explosive venting of the vessels at MRR provides the safest means to reduce the risk of another incident. Both incidents have resulted after manual manipulation, of some kind, of valves or fittings on the vessels. The use of explosive venting of large and small compressed gas vessels, is and has been used for at least 35 years and is the industry standard for reducing risk of catastrophic pressure vessel failure [Figure 19].

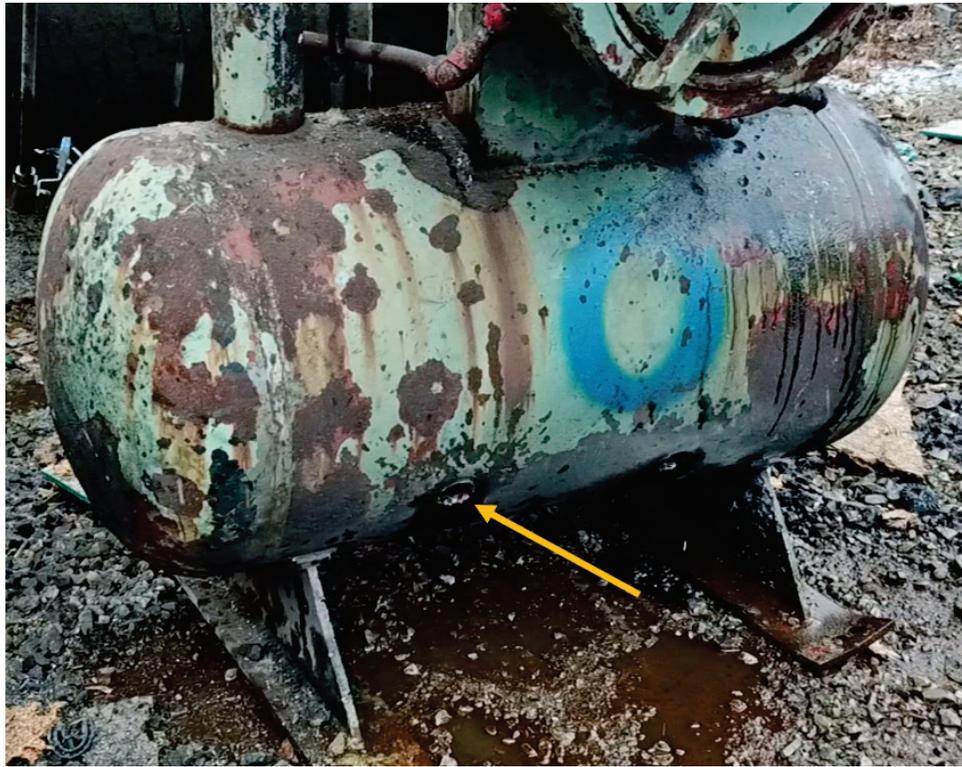
Figure 20. Drain Hole. This drone image shows one of the holes cut by the explosion venting process used to drain the bottom chamber of an MP vessel. (Credit: MRR).

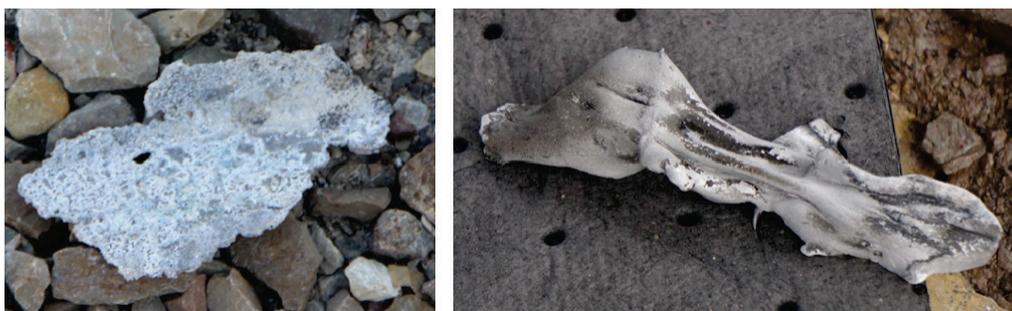
Physical evidence from the May 24, 2017, and June 20, 2017, incidents show differences in the aluminum MP odorizer components. For example, aluminum components from the May 24, 2017, incident have a general corrosion appearance while aluminum parts from the June 20, 2017, incident show signs of melting from heat (Figure 21). These differences could be related to how much exposure the aluminum parts had with the sodium hypochlorite and whether or not liquid was present in chamber two, affecting how much these parts were heated by the explosion. It is also possible that the physical difference in the aluminum parts may indicate that the reactive chemical mechanism involved was not the same.

Figure 21. Aluminum Parts. The picture on the left shows an aluminum part from the MP odorizer involved in the May 24, 2017, incident that appears to have general corrosion. The photo on the right shows an aluminum part from the MP odorizer involved in the June 20, 2017, incident that appears to show signs of melting from heat. (Credit: MRR (left), SPSI (right)).
